Stockton Bridge Debris Mitigation Project Update

City Council November 14, 2024

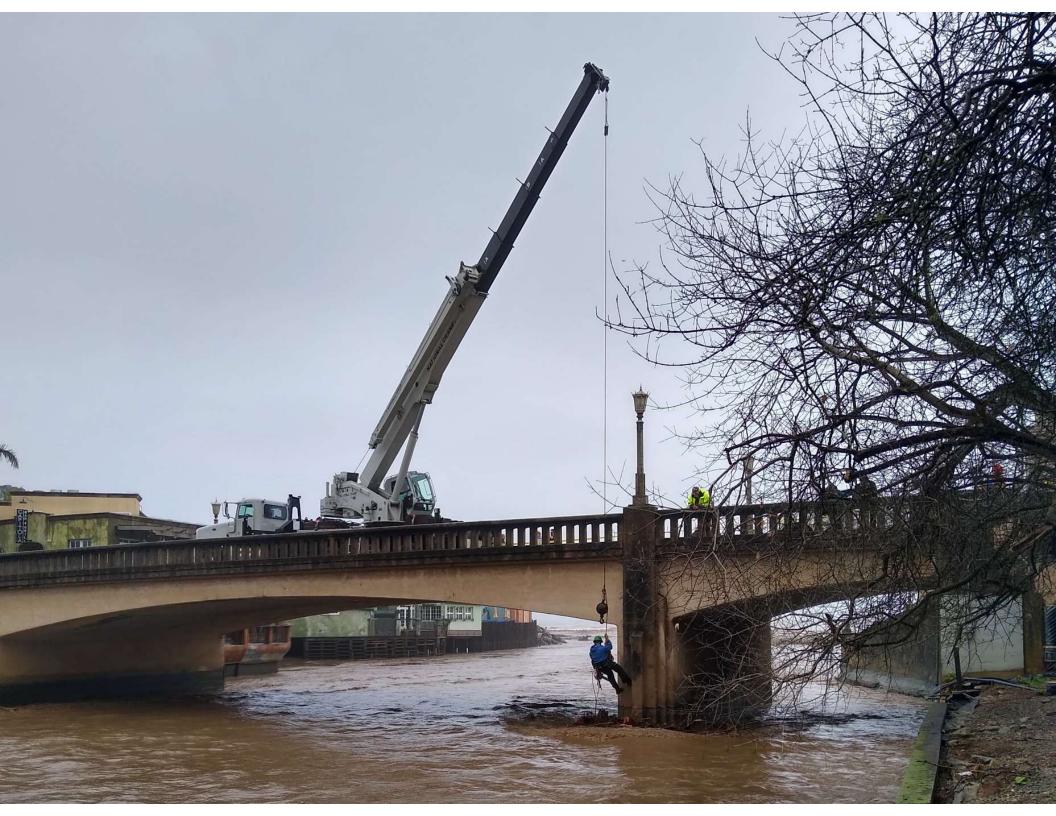
Earliest known bridge of its type in CA

- Porter Street: 1947, replaced 1994
- Soquel Drive: 1955, replaced 2002
- Highway 1: 1947, replaced 1995

Long time flooding concerns

- Documented in City Council minutes as early as 1951
- Narrowest span is 10 ft; typical debris (e.g., fallen trees) measures 15–30 ft

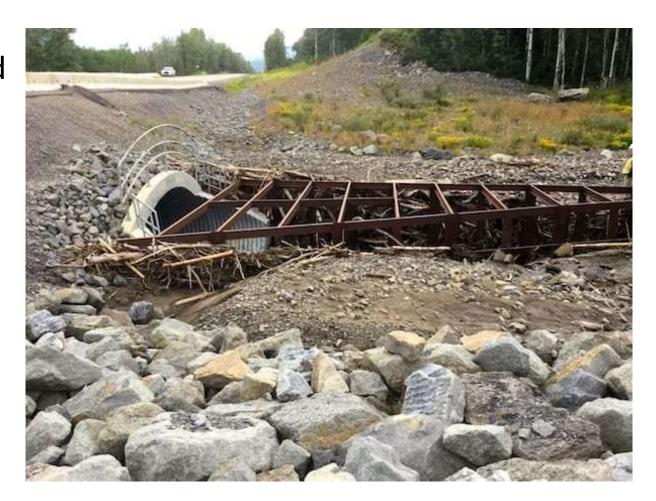
Stockton Bridge Debris Mitigation Debris Diversion Cage

- Cage installed upstream to divert and trap debris while allowing water flow
- Moderately effective, with potential for blockage
- Regular maintenance for small debris
- Effective for large debris control; less visually intrusive than fins; moderate cost

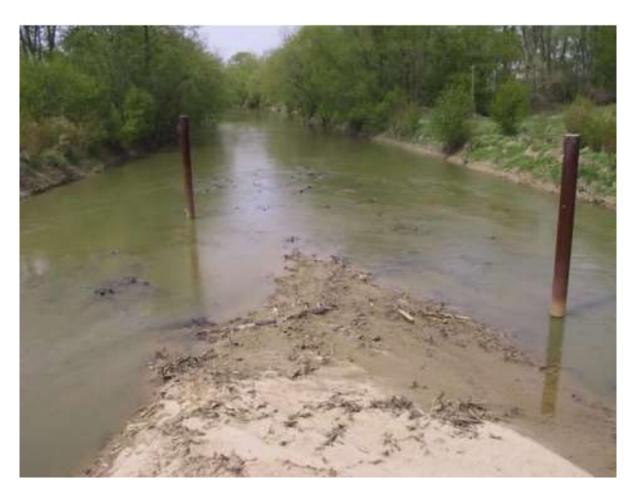
Stockton Bridge Debris Mitigation Debris Diversion Piers

- Vertical structures installed at the bridge piers to redirect debris
- Hydraulically effective, may vary depending on flow conditions
- Requires regular maintenance
- Minimal visual impact; minimal impact on recreational activities

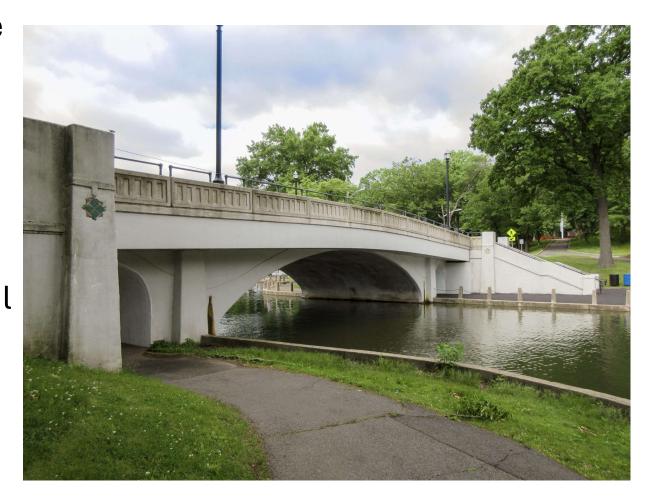
Stockton Bridge Debris Mitigation Bridge Replacement

- Replace the existing with a free span bridge
- Requires significant funding and planning
- Most effective option for reducing risk and enhancing capacity
- Minimal environmental impact; preserves character while improving transportation and connectivity.
