MEMORANDUM

Subject: Due Diligence, Stockton Avenue Bridge, City of Capitola, Ca

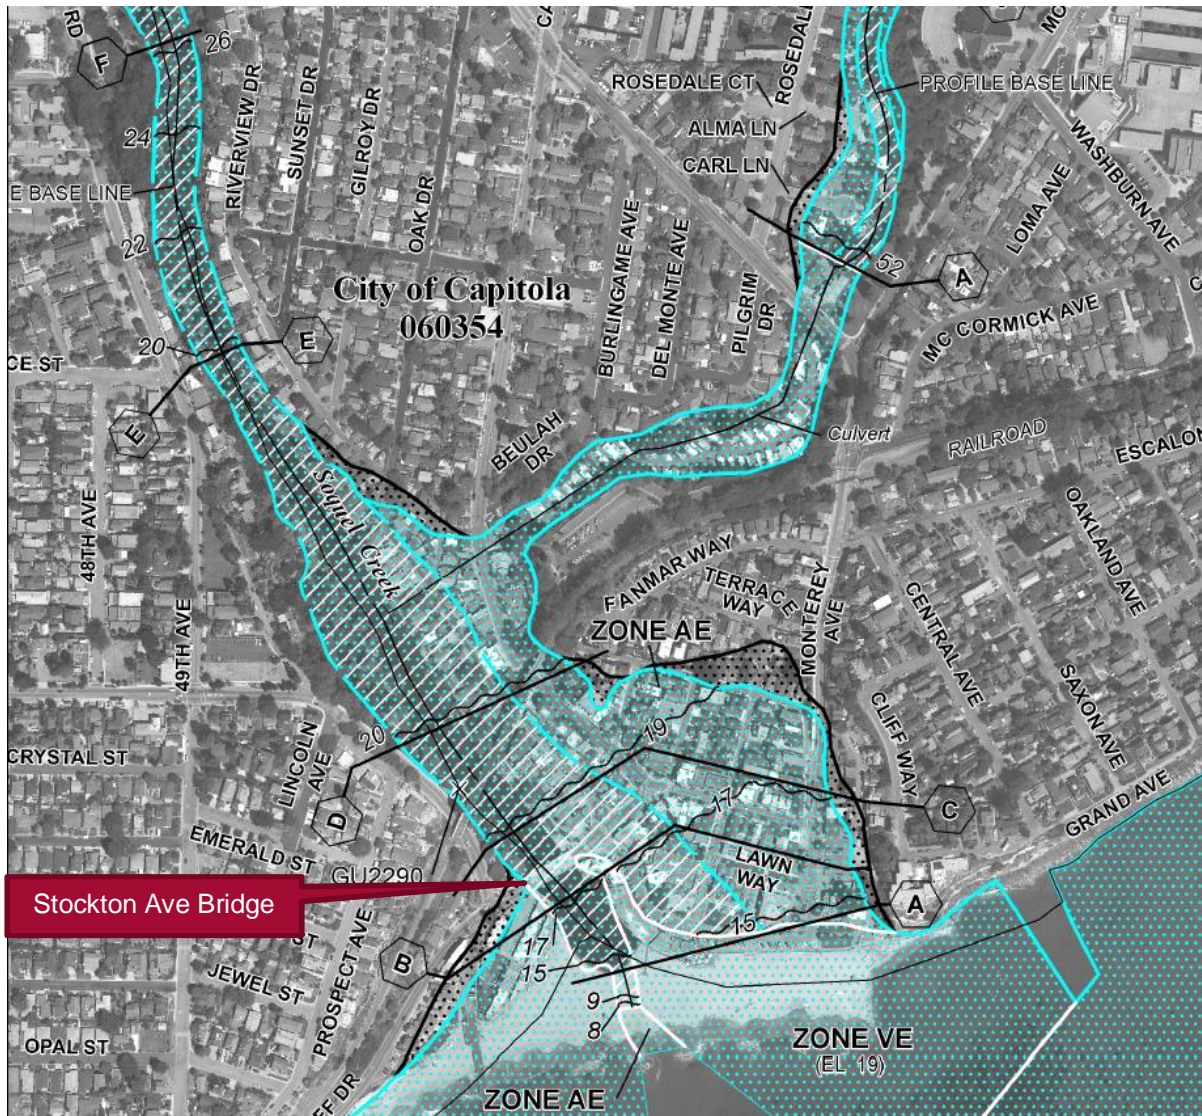
Figure 3. FEMA Flood Insurance Map

The project is located on Map Number 06087C0352E in Zone AE (Figure 3). Zone AE areas are subject to inundation by the 1-percent-annual-chance flood event determined by detailed methods. Base Flood Elevations (BFEs) are provided in Zone AE. Mandatory flood insurance purchase requirements and floodplain management standards apply in this zone.

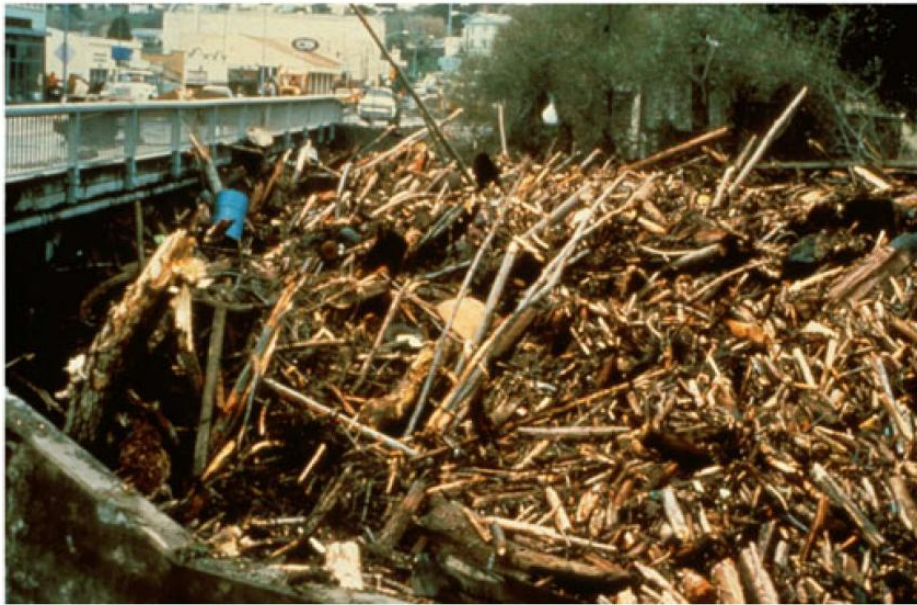
Figure 4. Logjam upstream of Soquel Drive Bridge after January 1982 storm.

Another major flood occurred in January 1982. The estimated peak flow for this event at the Soquel Creek gage was 9,700 cfs, which corresponds to a 6.67-percent-annual-chance recurrence event. A massive logjam occurred at the Soquel Drive Bridge (Figure 4). The floodwaters rose rapidly along Soquel Creek and caused major damage flooding one home on the eastern bank just south of State Highway 1 and eroding the banks of some homes along Riverview Drive in Capitola.

The Soquel Creek watershed has a history of forming log jams at Soquel Drive Bridge during large rain events, specifically in 1955 and 1982 which are the largest rain events on record. Log jams are formed when large, whole trees are introduced into the channel and are anchored to the bed or banks. The large trees act as a filter by trapping smaller floating debris causing constriction in flow and backwater effects upstream. The backwater effect diverts flood water from the channel onto the adjacent floodplain and causes bridge failure. The Soquel Drive Bridge was replaced in 1890, 1927, 1956 and 2003. To mitigate for log jams, the most recent replacement of Soquel Drive Bridge was built over three feet higher, compared to the previous bridge, and with no support piers in the river in to provide increased flood capacity. Soquel Drive Bridge now has a span of 140' for debris to pass under Soquel Drive Bridge. The concern is that the debris that can now pass freely under Soquel Drive will cause a log jam upstream of the Stockton Avenue Bridge.

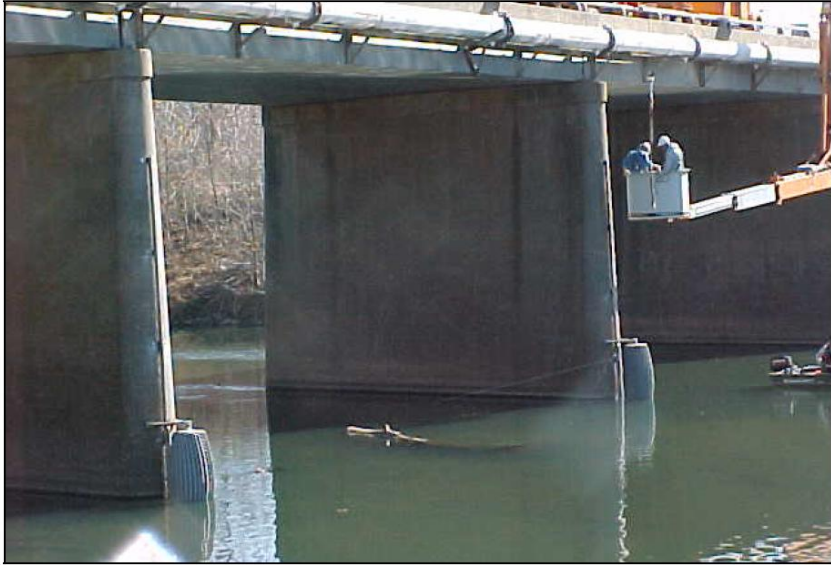
Figure 7. Photo of a debris sweeper being installed on bridge in Virginia

A debris sweeper can be installed on the upstream side of the bridge pier to deflect debris. A debris sweeper is a polyethylene device that is rotated by the channel flow, causing the debris to be deflected away from the pier and through the bridge opening. The deflectors are intended to buffer the structure itself from impact and steer debris around the structure. Because sweepers rotate freely, they shed debris, greatly reducing the likelihood of accumulation. The device is attached to a vertical stainless steel cable so that it can travel vertically as the water surface rises and falls (Figures 7 and 8). The device is suitable for medium to large floating debris and requires low maintenance. Debris sweepers have been installed on bridges in Oklahoma, Virginia, Tennessee, Washington, and Oregon.

Since installation of this system does not require disturbance of the stream channel, installation causes little environmental impact. For the Stockton Avenue Bridge, a minimum of two debris sweepers would be needed, one on each pier to deflect debris into the wider, center span. Four sweepers, one on the water surface and one submerged on each pier, may result in better deflection. Installation of debris sweepers does not guarantee that all logs will be deflected. There will still be a chance that tree logs that do not get deflected would jam within the shortest 10-foot span.

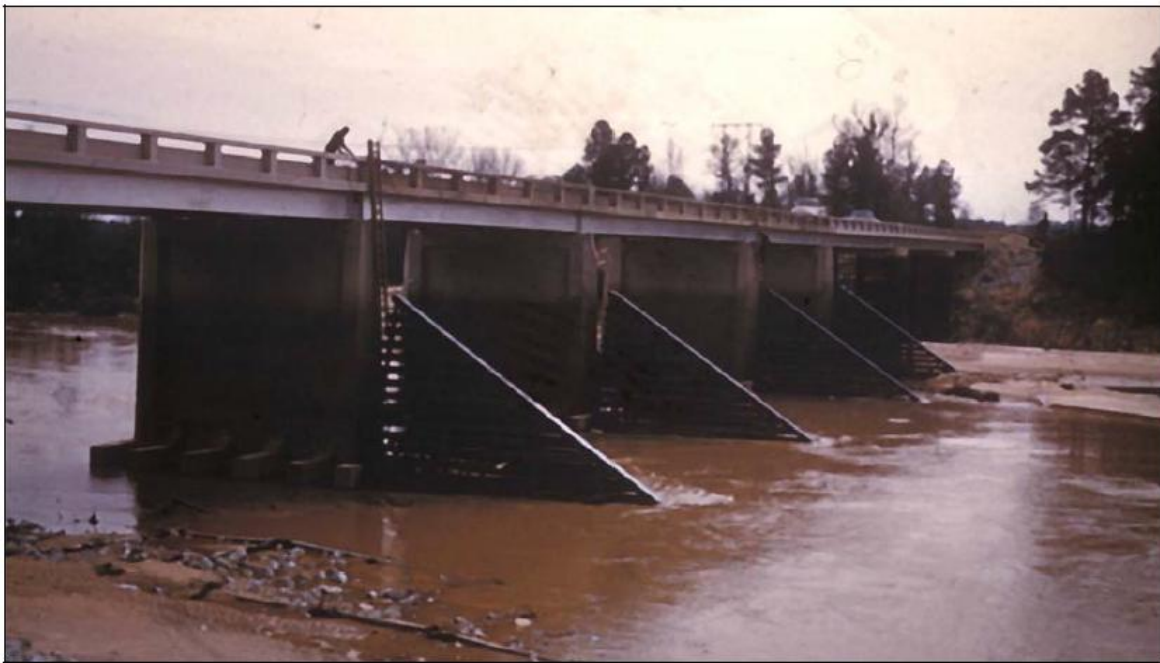
Figure 9. Photo of timber debris fins with sloping leading edge.

Debris fins are thin walls built in the stream channel just upstream of the bridge to help align large floating trees so that their length is parallel to the flow (Figure 9). The fins' purpose is to align the debris to the openings so that debris will move through. Debris fins have been successfully used to align debris within the waterway opening and to avoid the accumulation of debris on bridge piers. They are used when the debris consists mostly of floating material. An angled debris fin is recommended for the Stockton Avenue Bridge to direct debris to the larger, center span. Debris fins require maintenance for debris removal. If debris is not removed, flow conveyance is reduced.

Based on the comparative results from Table 1, it is recommended that the City consider installing debris fins to direct debris through the larger, center span of the Stockton Avenue Bridge. Debris fins are recommended over the other countermeasures due to the high failure potential of debris sweepers, the potential for debris deflectors to trap instead of redirect debris upstream of the bridge, and the high cost/impacts of bridge replacement.

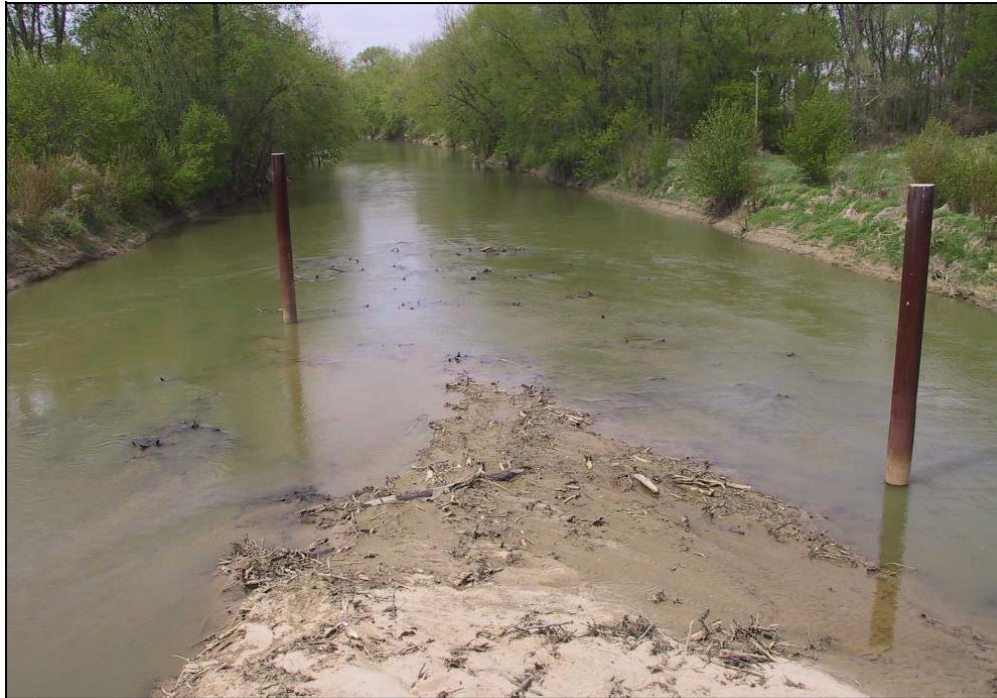
Figure 10. Photo of debris deflectors used in Indiana

Debris deflectors are structures placed upstream of the bridge piers to deflect and guide debris through the bridge opening. They are normally "V"-shaped in plan with the apex upstream. The effectiveness of the structure is dependent on flow patterns which are difficult to predict. An example of this type of structure is shown in Figure 10. The Stockton Avenue Bridge would require several deflectors to direct debris through the larger center span.
