RE: Preliminary Historical Evaluation of Detached Garage – 529 Capitola Avenue, Capitola, CA
APN# 035-093-01

This letter constitutes a preliminary historic resource evaluation (Phase One Report) for the garage on the property located in the City of Capitola, County of Santa Cruz, at 529 Capitola Avenue. The property contains two buildings: the main house and a detached garage.

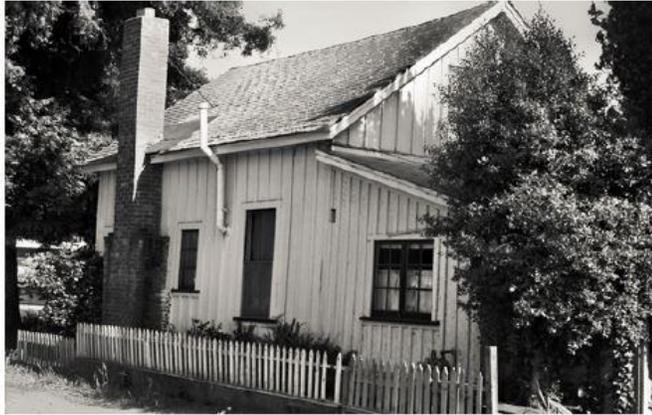
**Vincent Canepa home, 529
Capitola Avenue (Survey, 52):**

Architectural style:
Vernacular board-and-batten
Construction date: ca.1874
Theme: Economic
Development

Vincent Canepa home, 529 Capitola Avenue (Survey, 52): Canepa migrated to California in 1896, and his daughter, Edith Canepa Castagnola, was born in the house, a vernacular, two-story board-and-batten built in the mid-1870s. Historians believe the home may have originally been associated with the California Beet Sugar Mill located nearby.

Detail photo and text from the 2004 Draft Historic Context Statement for the City of Capitola

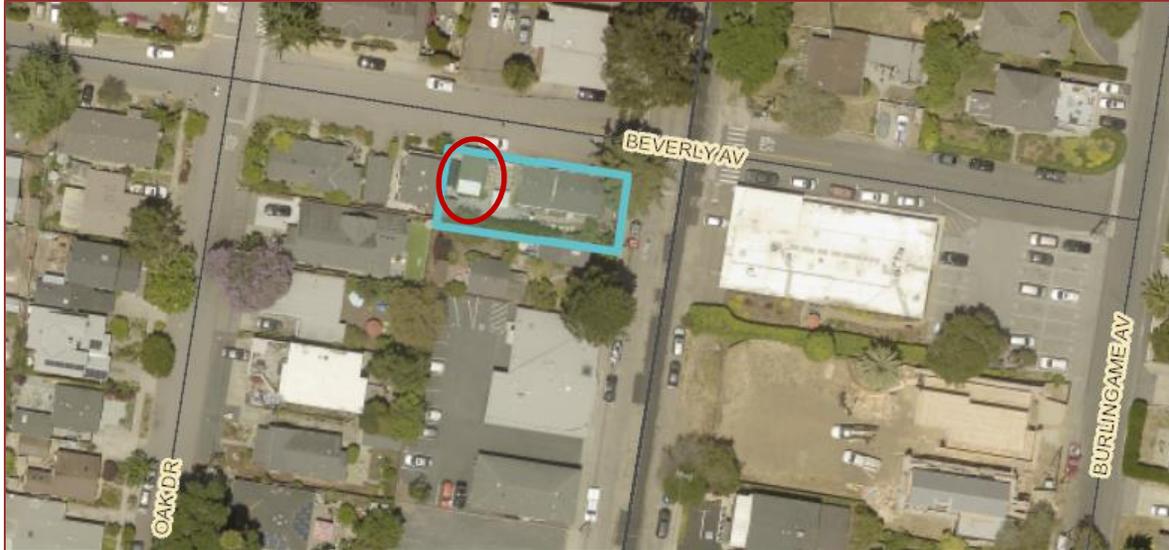
*Assessor's Map of 529 Capitola Avenue, Capitola
The blue rectangle follows the property lines; the red oval encircles the subject garage building*

The subject property consists of a rectangular parcel of just under a tenth of an acre. The one-and-one-half-story house is set to the northeast on the parcel, facing the main frontage on Capitola Avenue (approximately east) and running parallel to the secondary frontage along Beverly Avenue. The one-story detached garage, the subject of this preliminary review letter, is located in the northwest corner of the property, accessed directly from Beverly Avenue.

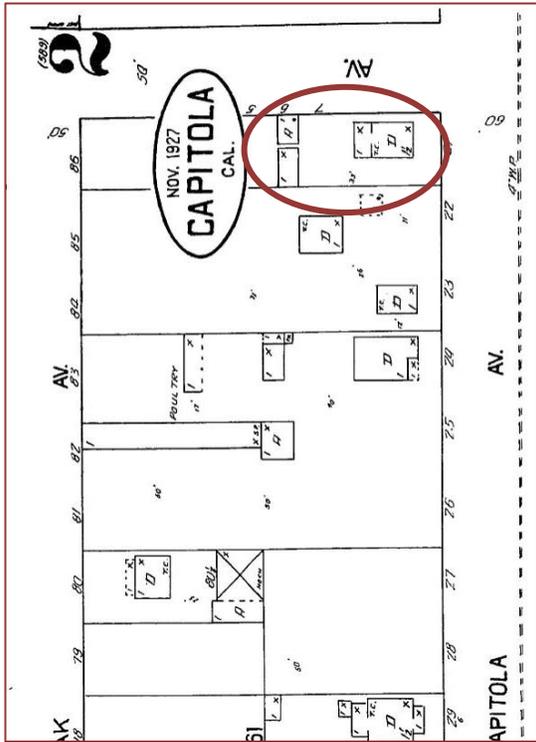
1927 Sanborn Insurance Map, showing historic house and two outbuildings.
One of the outbuildings is no longer extant

Although the use of the building is identified on the Sanborn Insurance Map as automobile-related in 1927, and it is of a size that might have housed a single car of that era, the **feeling** the garage conveys is more of a stripped-back functional outbuilding (e.g., more of a storage shed). It has no architectural features, such as trim or windows, siding, or even cross-facing boards that might indicate that it would house something of value. It does not embody strong **associations** with the house design or the historical development of the city in this neighborhood.

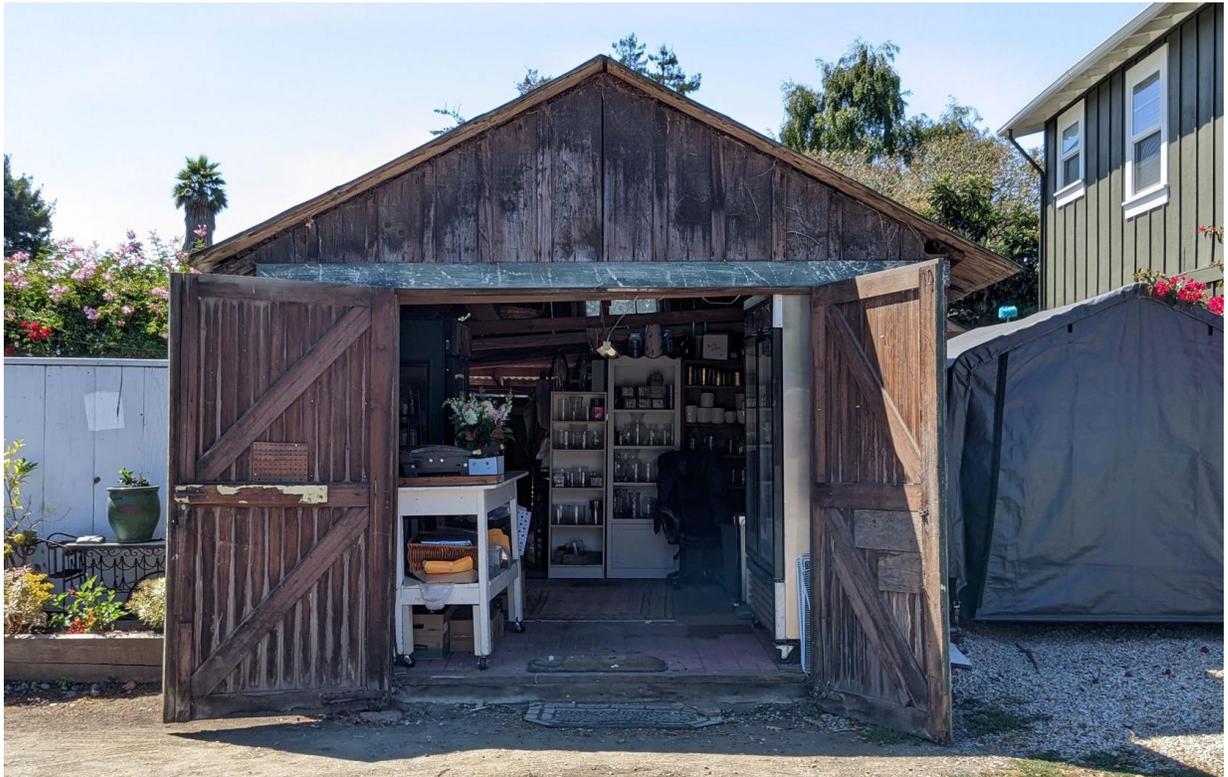
The subject detached garage building is a vernacular design, not associated with a specific style, meaning it doesn’t include such elements such as trim or cladding that might visually tie it to the house design or other design movements, even though the house and garage share board-and-batten exterior siding design. It features a rectangular footprint on a mud sill with a recent brick floor. The board-and-batten vertical walls serve as both structure and siding. The roof is a moderately pitched gable, covered in rolled roofing. The shallow eaves have exposed rafter tails and no blocking. The front (north), main opening consists of a pair of swinging board-and-batten doors. There is a small gable-end window facing south; it is a fixed wood sash with three lites and thin muntins; it appears to be salvaged from an earlier structure and added into a simple opening cut into the rear wall without trim.

*Detached Garage – 529 Capitola Ave., Viewed from the north (from Beverly Avenue), August 2022
(Photo by Leslie Dill)*

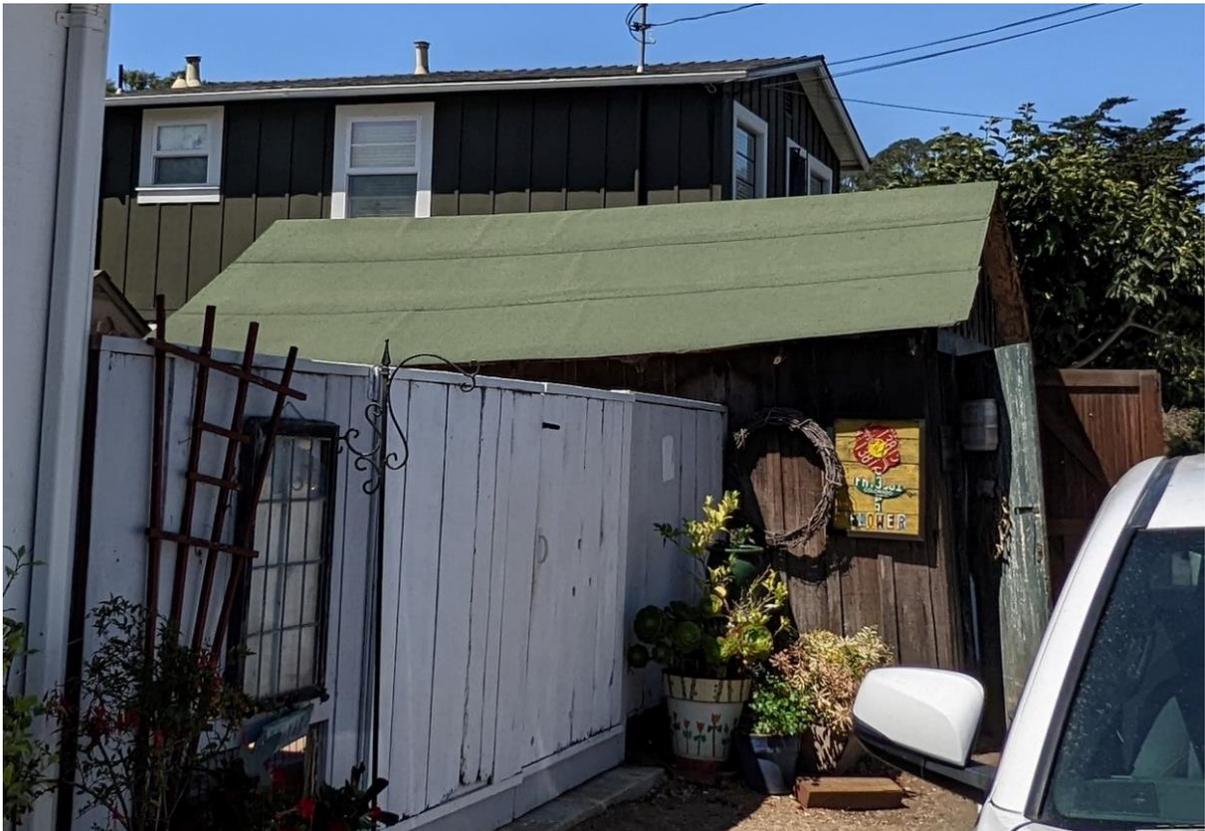
Detached Garage – 529 Capitola Ave., Viewed from the northeast, August 2022 (Photo by Leslie Dill)

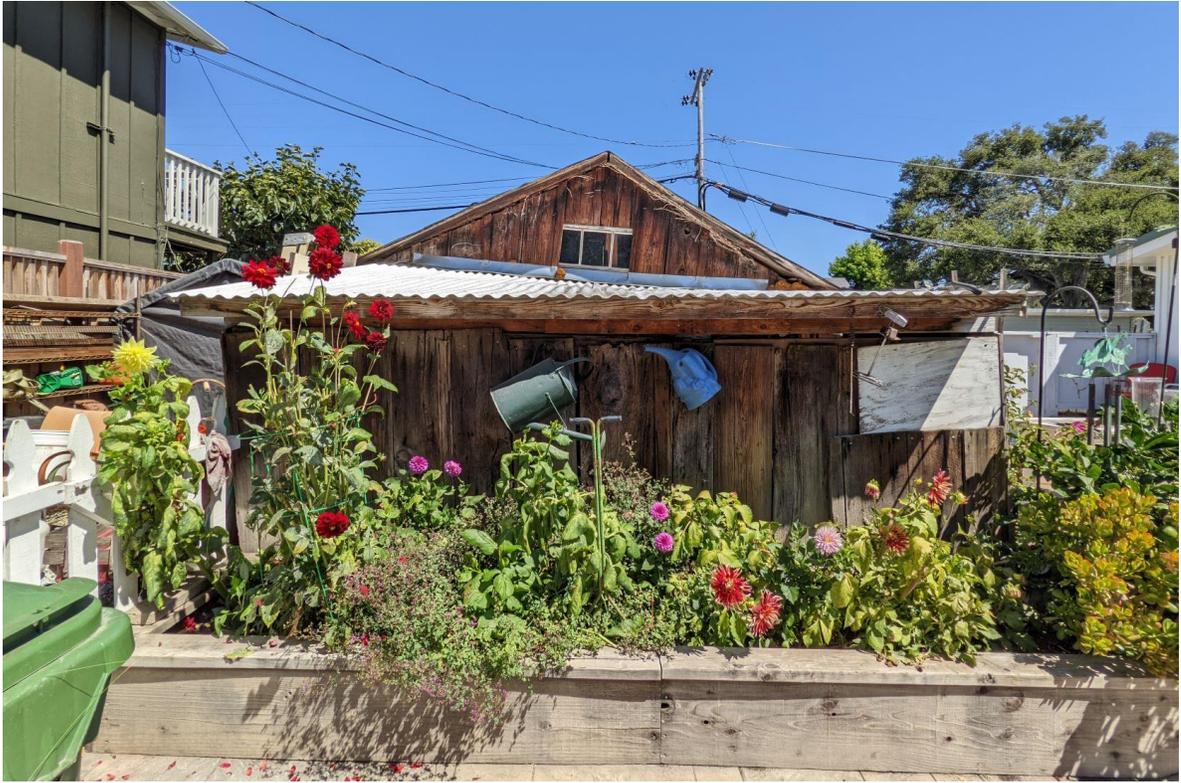
*Rear of Detached Garage and Shed Addition – 529 Capitola Ave., Viewed from the south, August 2022
(Photo by Leslie Dill)*

The south lean-to addition has removed some original materials, but the vast majority of its **materials** are obviously of an earlier age. The board-wall **design** of the garage is authentic. There is no “**workmanship**” to evaluate.

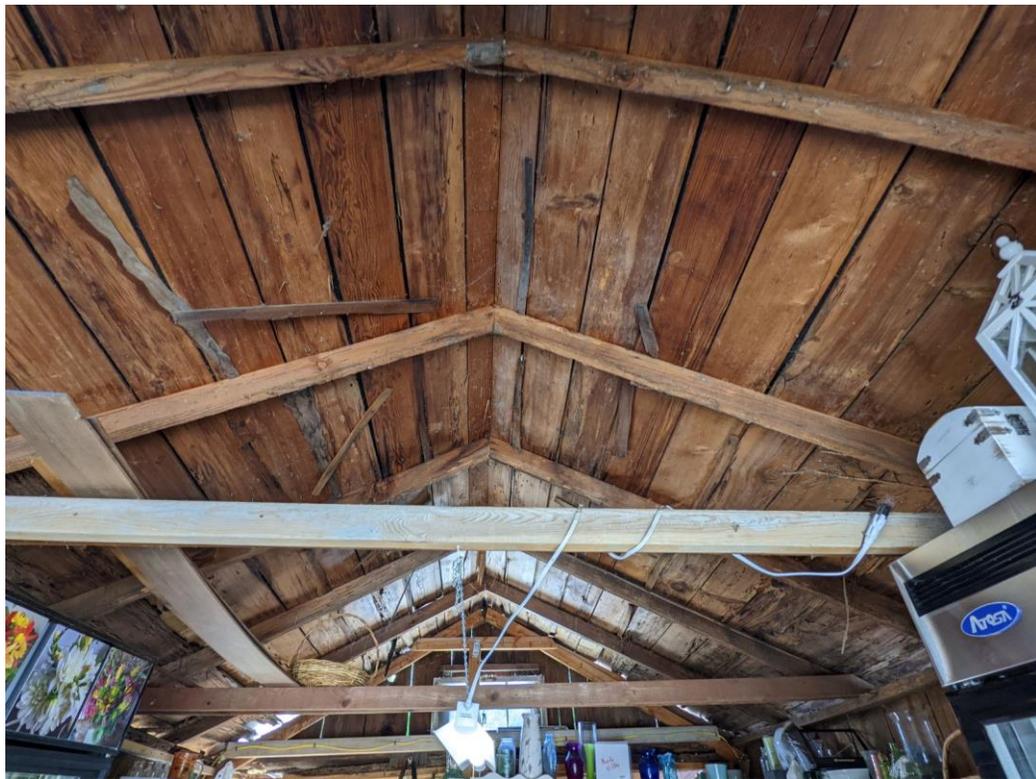
Detached Garage View of Interior Roof Framing – Detail, August 2022 (Photo by Leslie Dill)

From observing lack of ridge beam (creating a vulnerable structure for relocation), one can assume that the garage was likely built in-situ, so the **location** is likely original or at least dating from almost 100 years ago, the established period of significance of the property.

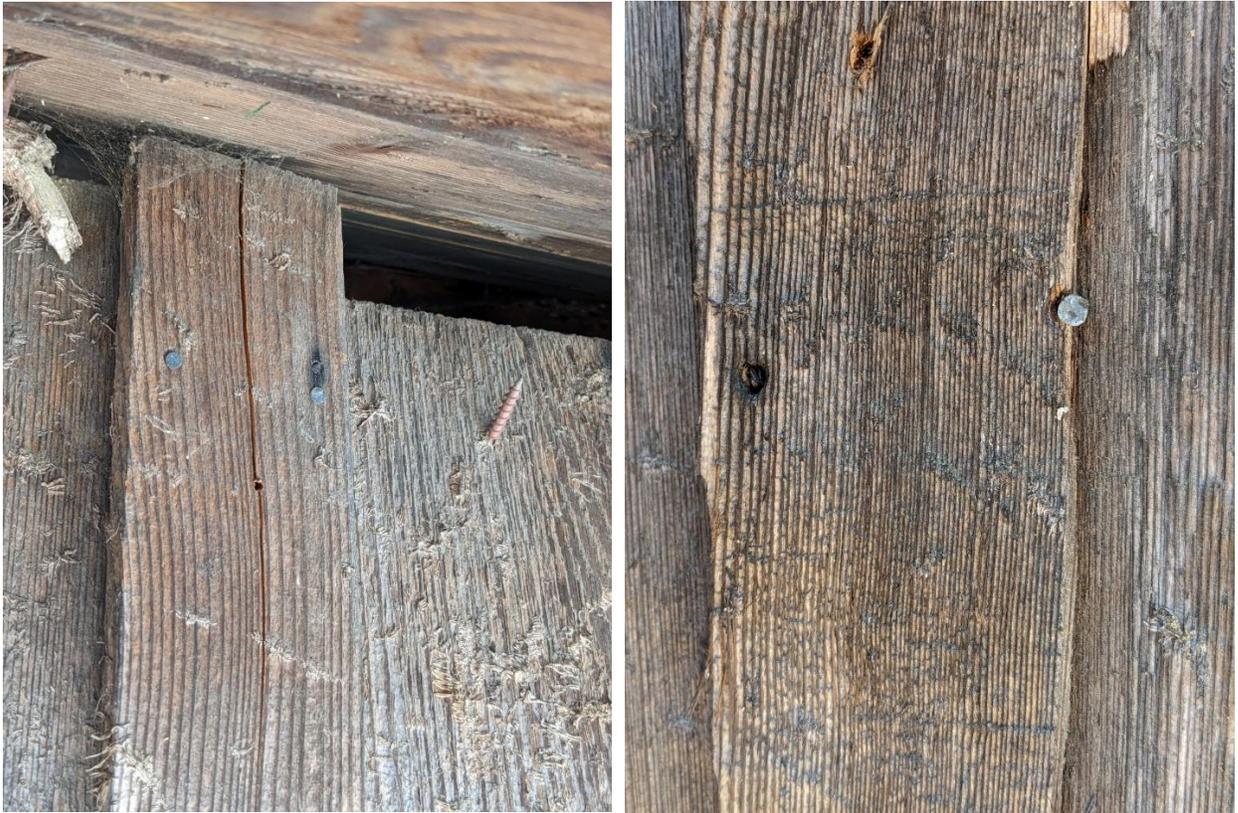
agricultural buildings. The boards do not exhibit saw cuts or square nails that would associate the design with an early (i.e., mid-nineteenth-century) structure. The closely spaced board sheathing also suggests that the structure is not from the 1860s through 1870s when skip sheathing was used (boards laid with gaps). The board walls do not appear to be old-growth redwood, which would signify age and regional use of materials, and the boards and structure are seriously deteriorating. The lack of ridge board or ridge beam, along with the single-wall construction, suggests a turn-of-the-twentieth-century design, and likelihood of having been built on-site, but these features could have been incorporated into a later building (1910 or 20s) because of the building's simple historic function as a shed or garage in a relatively rural area. So, the materials and design of the building are consistent with the maps that show the range of construction from 1914 to 1926, most likely at the earlier end of that range.

Detached Garage Round Nail Examples – Details, August 2022 (Photo by Leslie Dill)
