# Grand Avenue Pathway

City Council

April 10, 2025

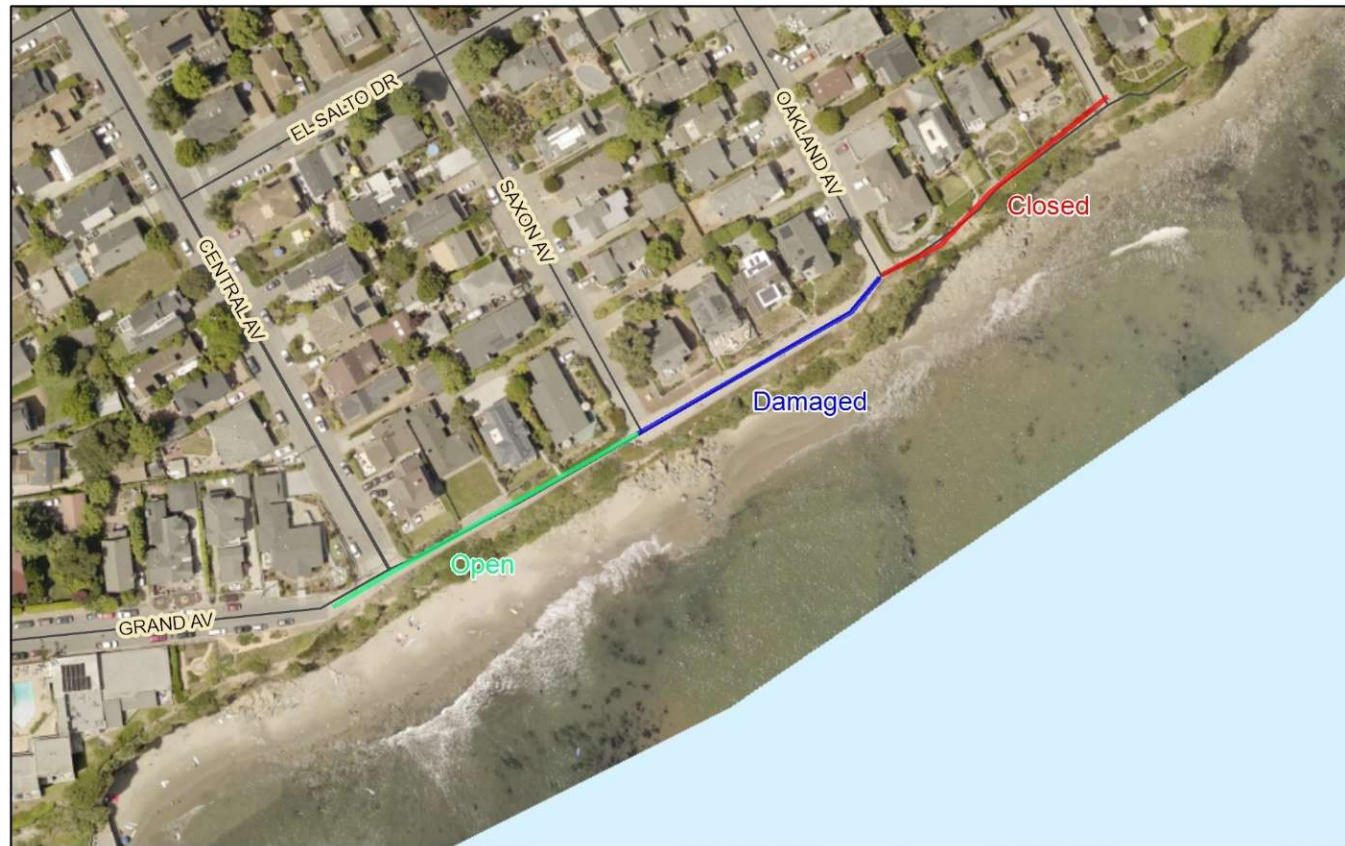
- Current pedestrian path: Central Avenue to Oakland Avenue
- Due to erosion, has faced multiple closures and relocations since 1980's
- Part of California Coastal Trail
- Previous efforts, including proposed seawall, denied due to concerns about effectiveness and environmental impact

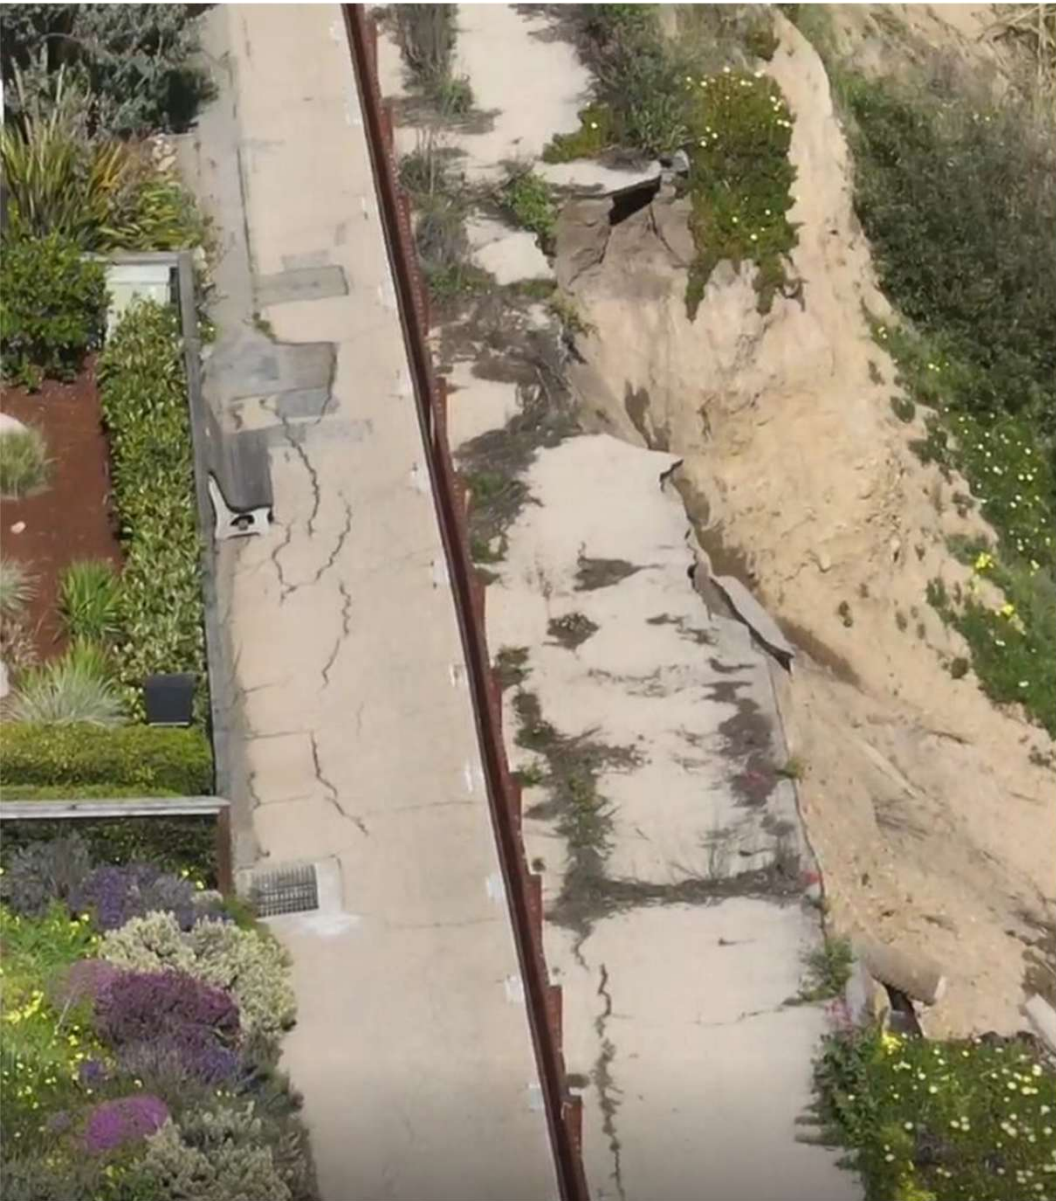
- February 2025: storms caused bluff failures between Saxon Avenue and Oakland Avenue.
- Undermined pedestrian path, damaged storm drain infrastructure
- Existing fencing, installed in 2023, remains but is no longer secure or safe

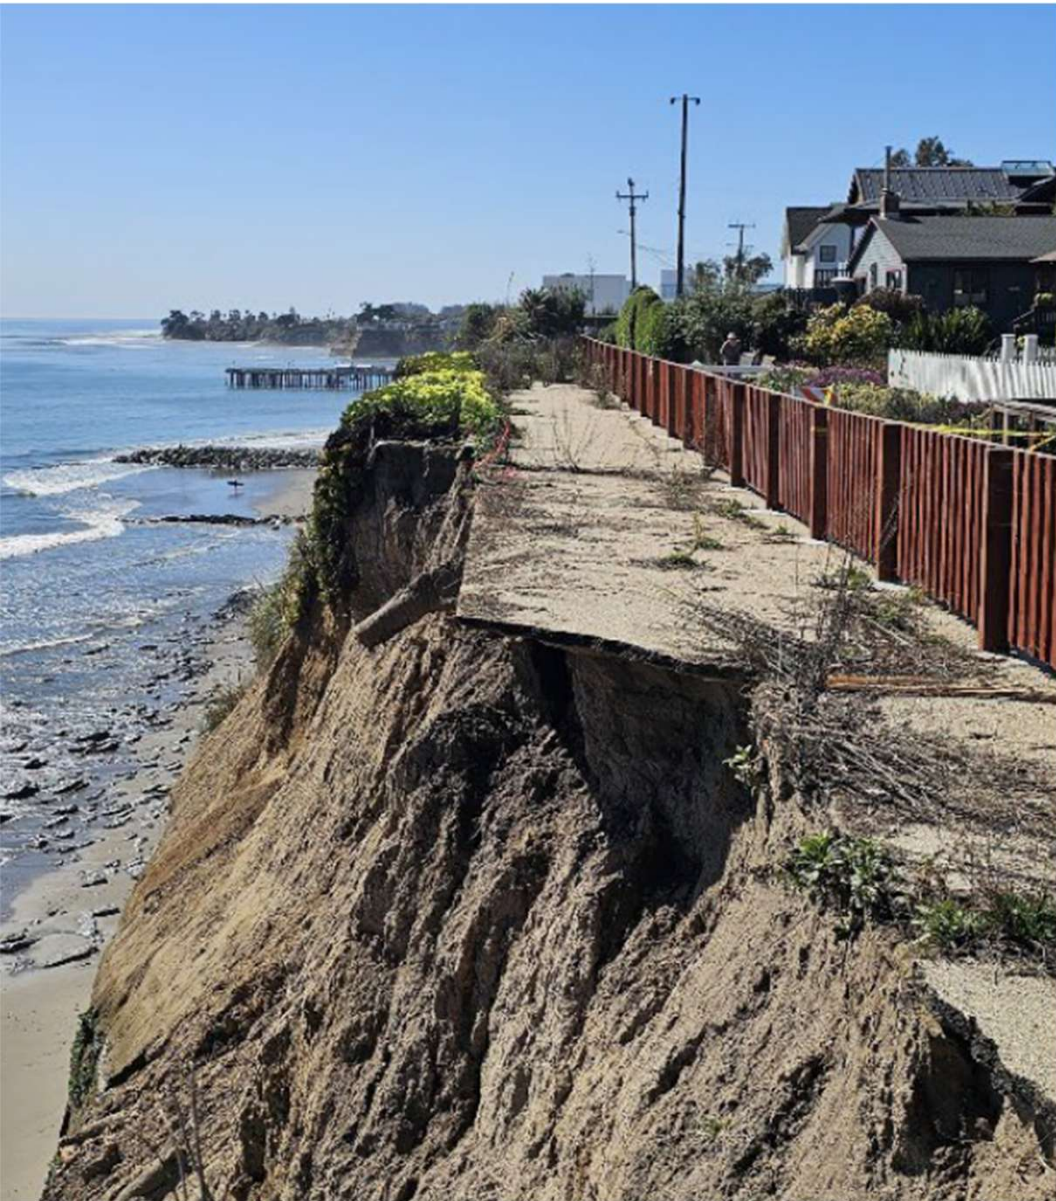
- Pathway is situated atop a narrow bluff (limited space for relocation)
- Encroachments from adjacent private properties further restrict available space
