Re: Limited geological investigation of coastal bluff failure  
Grand Avenue footpath near intersection with Oakland Avenue and Saxon Avenue  
Capitola, California 95010

**Pacific Crest**  
ENGINEERING INC.  
**SITE MAP & GEOLOGIC CROSS SECTIONS**  
City of Capitola  
Grand Avenue Footpath  
Between Saxon Ave. and Oakland Ave.

ANNOTATED APRIL 2023  
SNAPSHOT OF COASTAL BLUFF  
*City of Capitola*  
Grand Avenue Footpath  
Between Saxon Ave. and Oakland Ave.

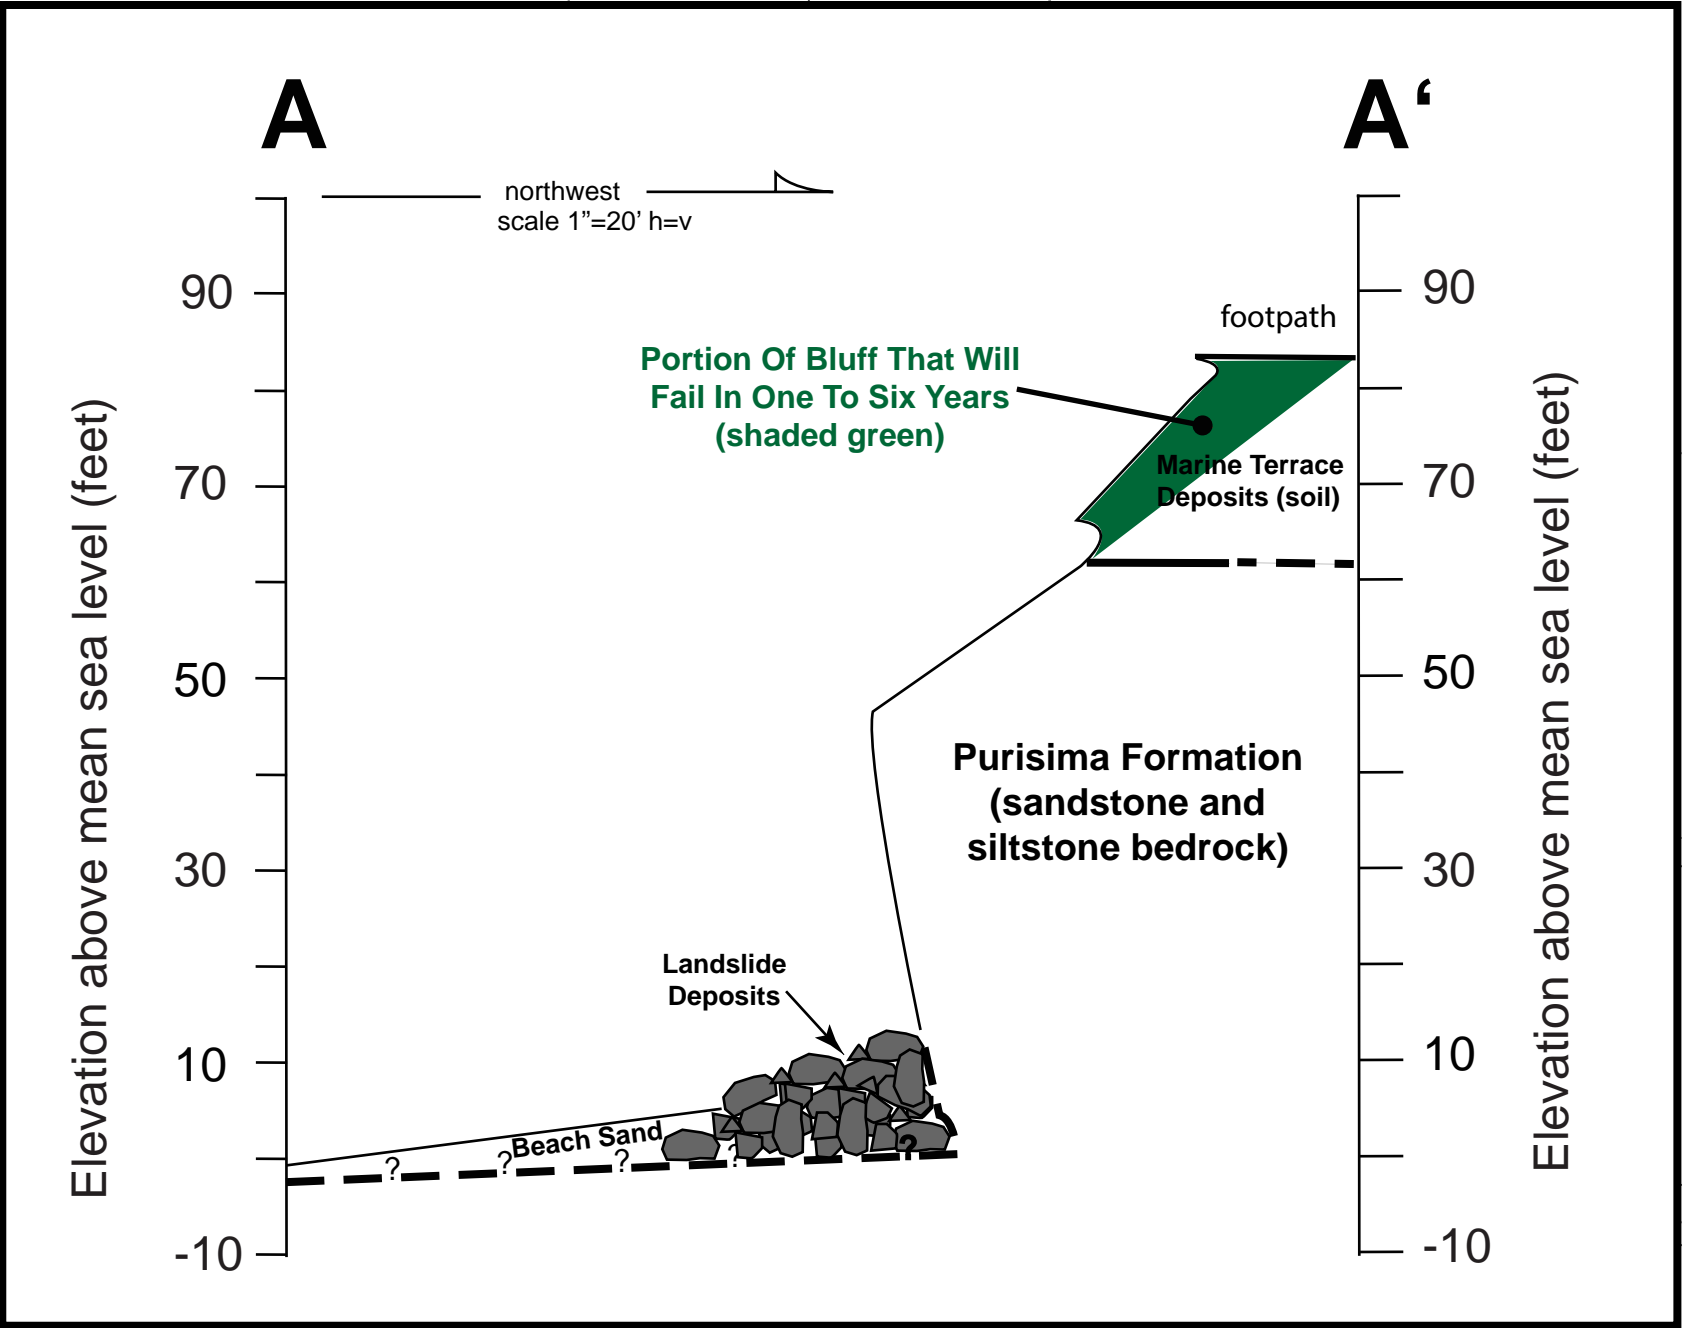
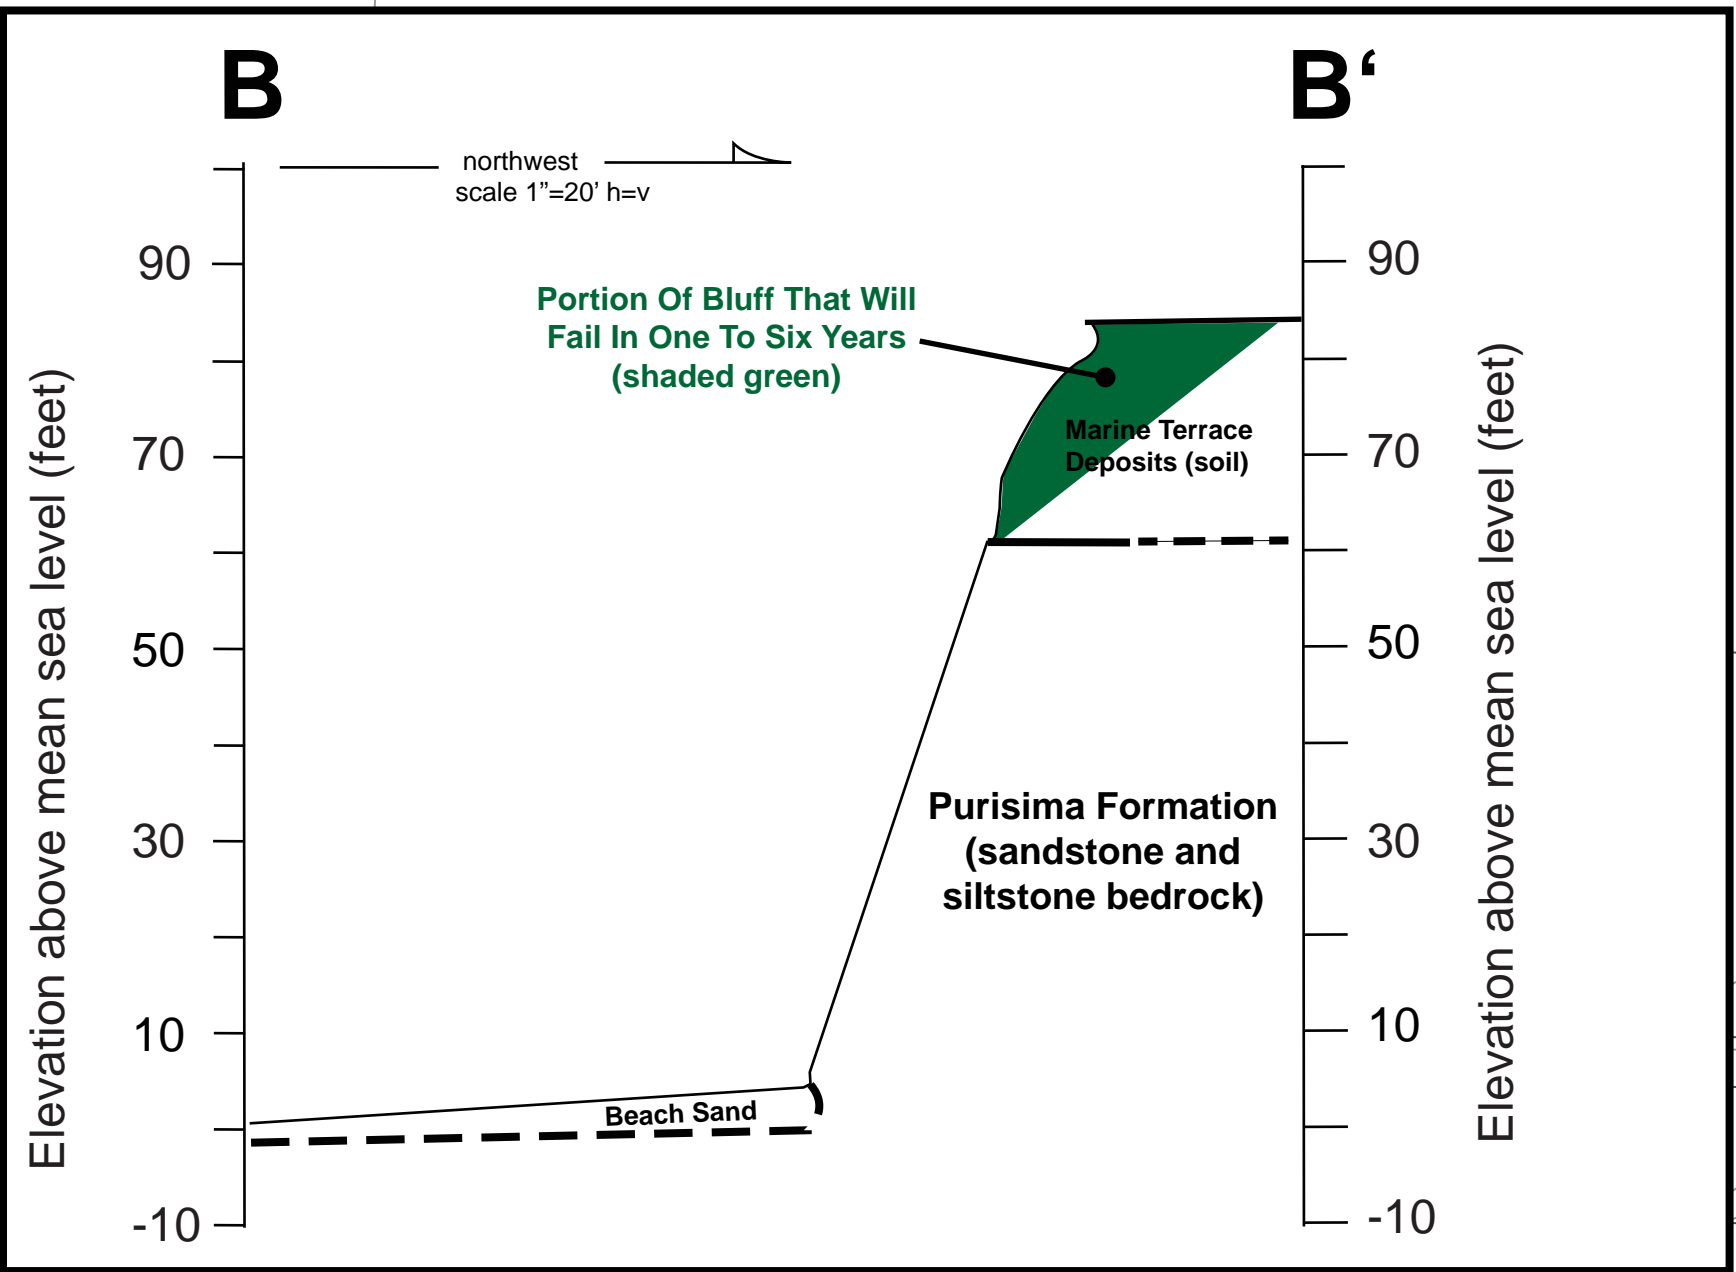
**Plate 1**

We have projected where the top of the bluff will retreat if the marine terrace deposits lay back to the angle of repose of about 38 degrees on two cross sections and the site map (see Plate 1). Using just this analysis pushes the top of the bluff back between 11 to 19 feet from the current position. This line represents the retreat that could happen in one to six years.

Turning to Plate 1, the reader may note that our projected one to six year bluff retreat line impinges upon the seaward end of the residential properties. This implies that even if the footpath is pushed landward and snugged up against those properties, it may be undermined and threatened in less than a decade.

This letter presents the results of our limited geological investigation of the bluff failure that has undermined portions of the footpath along Grand Avenue between its intersection with Oakland Avenue and Saxon Avenue (see Plate 1).

We mapped the position of the bluff and the exposed formations using the base map by Bowman and Williams provided to us by the City of Capitola. We relocated the top of the bluff on that map as well as the fence line because the bluff has apparently receded since

the last time that portion of the map was modified and the fence at the top of the bluff has been relocated in locations in response to the bluff failures.
