41ST AVENUE

CLARES ST. TO CAPITOLA RD.
ACTIVATING THE RETAIL EXPERIENCE

HIGHWAY ONE TO CLARES ST.
TRANSITION FROM HIGHWAY TO AVENUE

3.2.3 HIGHWAY ONE TO CLARES STREET

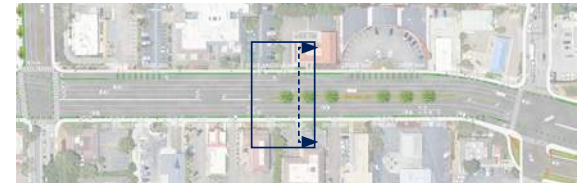
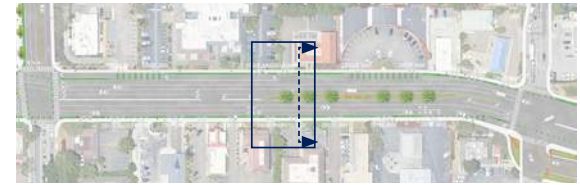
SECTION - TYPICAL EXISTING

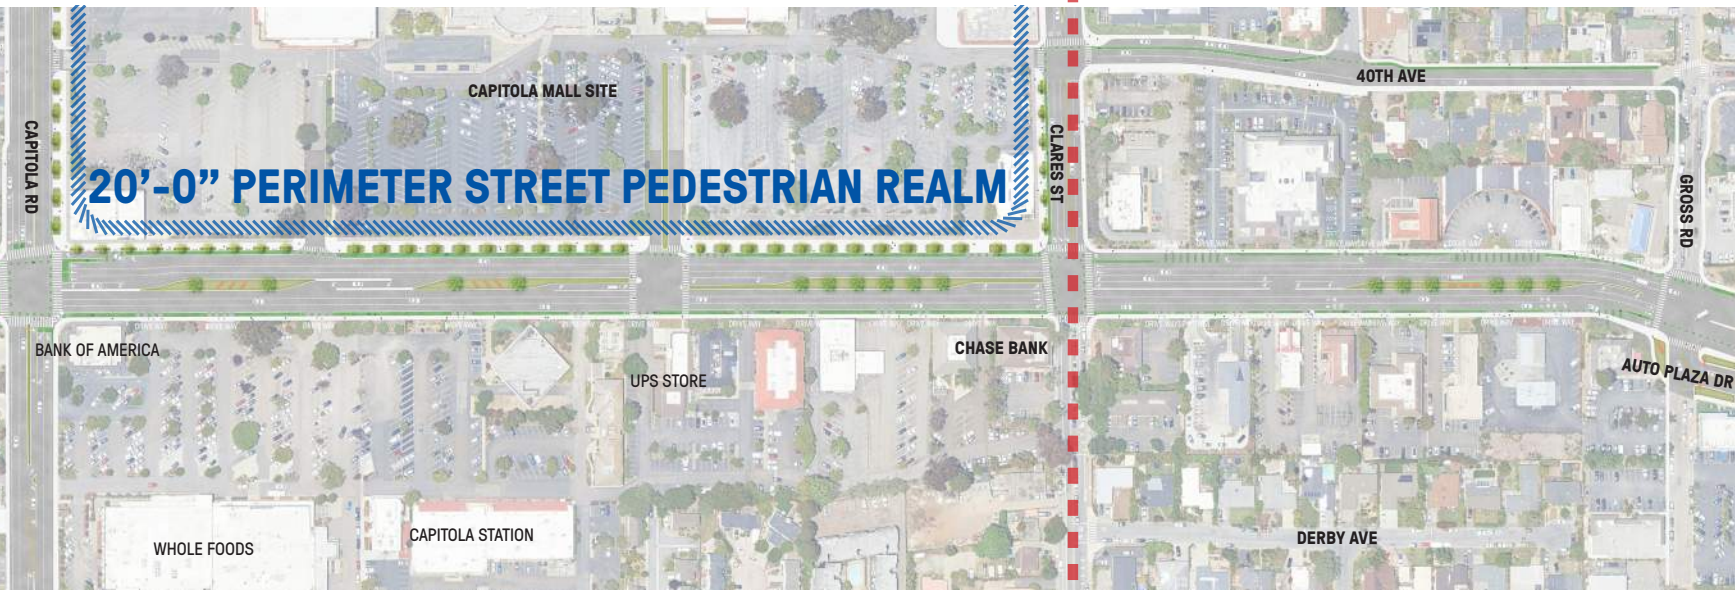
EXISTING CONDITIONS

The existing conditions from Highway One to Clares Street include narrow sidewalks, numerous curb cuts, wide lanes with unprotected bike lanes, car-centric street retail with some dedicated parking, and sparsely planted small trees.
