Revised 15 May 2017

Job #2017013-G-SC

Re: Limited geological investigation of coastal bluff failure  
Grand Avenue near intersection with Oakland Avenue and Hollister Avenue  
Capitola, California 95010

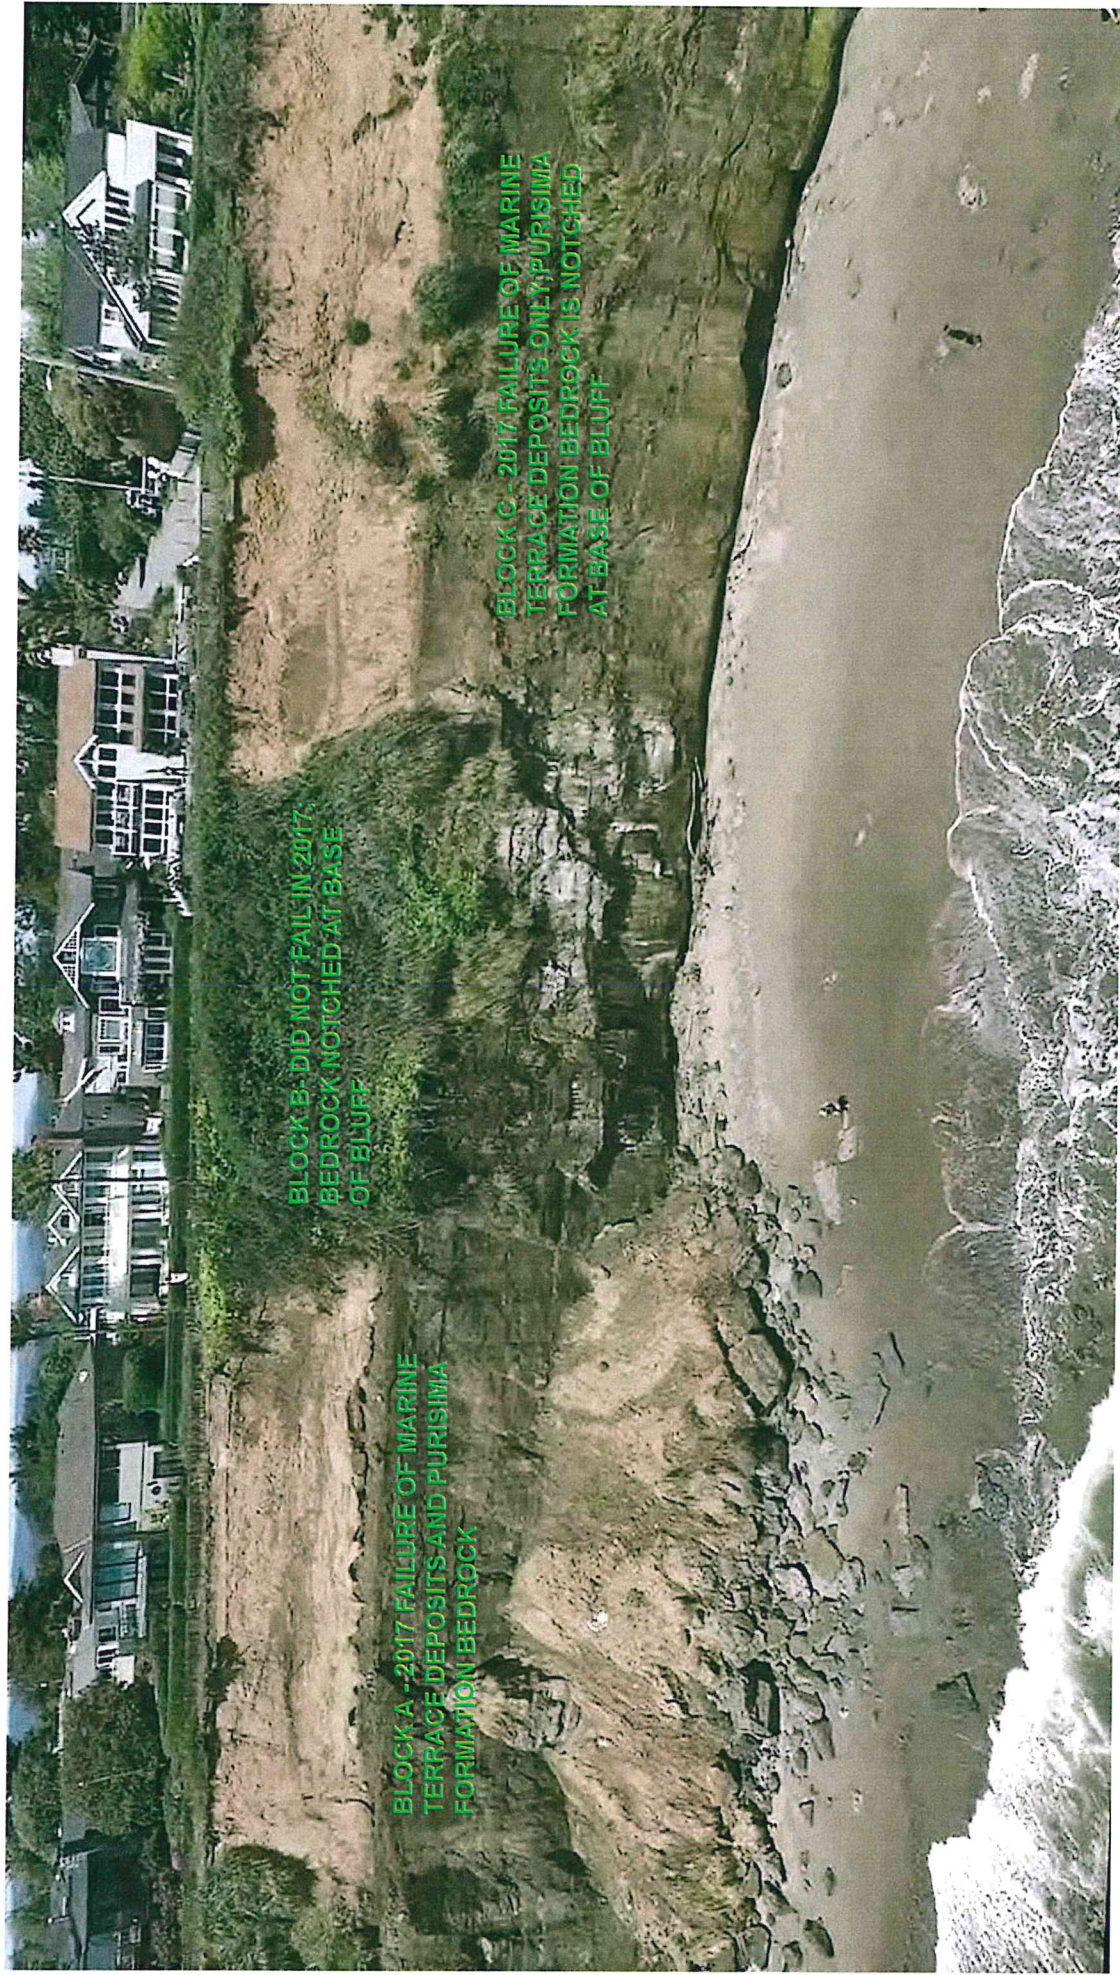
FIGURE #  
**1**  
JOB #  
2017013-G-SC

The portion of the bluff studied for this investigation can be broken into three distinct zones based upon the stage of failure of the bedrock at the base (see Figure 1). The portion of the bluff nearest to the Oakland Avenue, designated "Block A", involved a toppling failure this past winter of the undercut bedrock and the marine terrace deposits. Additional failure of just the marine terrace deposits also occurred with Block A due to intense storms that saturated the slope of the upper bluff.

The portion of the bluff designated "Block B" on Figure 1 did not fail this winter. This block is marked by a vegetated upper bluff and a significantly undercut bedrock bluff face mid- and lower-bluff. This block is primed and ready to fail in a fashion similar to Block A.

The portion of the bluff designated "Block C" on Figure 1 failed only within the marine terrace deposits on the upper portion of the bluff. The bedrock exposed in the bluff face for this portion is undercut in a fashion similar to Block B and will likely fail in the near future.

Oblique Photo Of Study Area On 19 April 2017  
*City of Capitola*  
Grand Avenue Coastal Bluff Footpath  
Capitola, California

1. The landslide that occurred this winter closest to Oakland Avenue within Block A appears to have been triggered by toppling of undercut bedrock. Although we could not observe the base of the bluff in this area, since it is still obscured by landslide debris, the volume of large sandstone blocks in the debris indicates that bedrock portion of the bluff failed, perhaps as much as five to eight feet of the undercut bluff face.
2. The landslide that occurred this winter closest to Hollister Avenue in Block C, appears to have been within the marine terrace deposits only. The bedrock bluff face in this area appears to be undercut by at least ten feet and is primed to topple.

3. Although no landsliding occurred within Block B, between the end blocks A and C, the bedrock is primed to topple at this location due to being notched at the base and overhung above the base (see Figure 1).

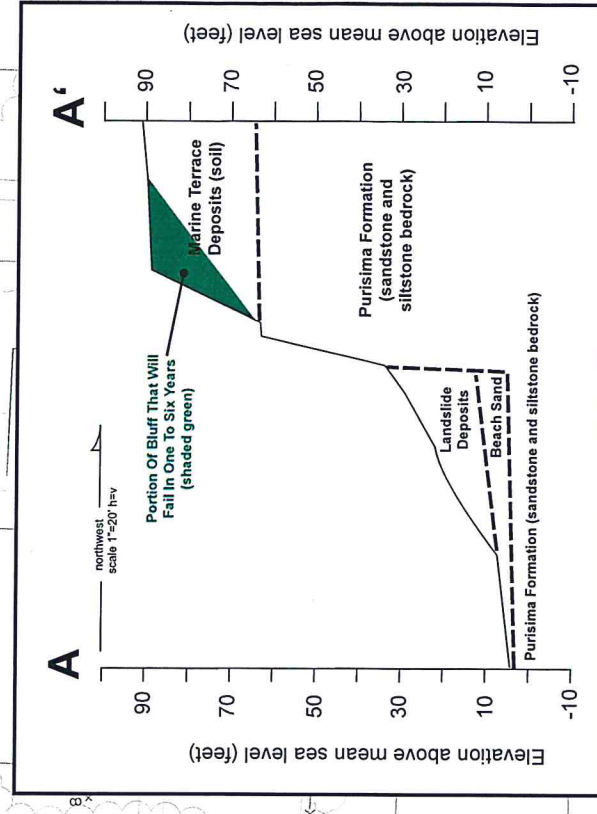
**Plate 1**

We have projected where the top of the bluff will retreat if the marine terrace deposits lay back to the angle of repose of about 38 degrees on two cross sections and the site map (see Plate 1). Using just this analysis pushes the top of the bluff back from its current 20 to 22 feet. This line represents the retreat that could happen in one to six years.

Geological Site Map & Cross Sections  
 City of Capitola  
 Grand Avenue Footpath  
 Between Oakland Ave. & Hollister Ave.

This letter presents the results of our limited geological investigation of the bluff failure that has undermined the footpath along Grand Avenue between its intersection with Oakland Avenue and Hollister Avenue (see Plate 1).

Turning to Plate 1, the reader may note that our projected one to six year bluff retreat line impinges upon the seaward end of the residential properties. This implies that even if the footpath is pushed landward and snugged up against those properties, it may be undermined and threatened in less than a decade.
