RE: Century Miscellaneous Wastewater Improvements (Phase II)  
Change Order No. 3

**Project:** Crack, Joint and Coating  
WWTP and Lift Station Rehabilitation  
7360 Jefferson Ave  
Century, Florida 32535

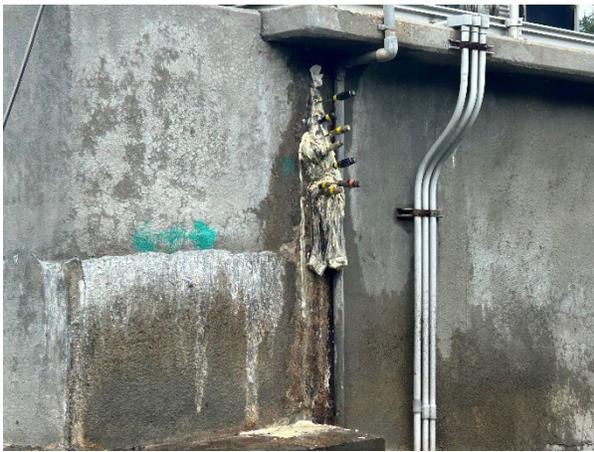
Northeast corner - Aeration Effluent Channel

- 1.1.1. "Jensen's can fill the gap with the Velosit RM 202 patch filler material after the channel has been emptied and ready for repairs. These gap fillers will encompass the northeast and northwest control joints. After the gaps are filled, Jensen's will proceed to perform the same original injection process as previously mentioned."

- 1.2. Jensen's had a meeting to discuss these recommended alterations and decided to use Sika 328 grout in-leau of the Velosit RM 202 patch filler.
- 1.3. Sika 328 is stronger and has a quicker setup time frame. Sika 328 can also be placed with a higher moisture content making it more liquid enabling the grout to reach the more difficult spaces within the wall separation.

- 1.4. Jensen's will proceed to build forms following the separation with a ventilation valve at the bottom of the form. This, of course, will after the channel has been fully emptied.

- 1.5. Jensen's will mix and pour the Sika 328 at a "flowable" rate and allow the material to cure for 3 hours.
  - 1.5.1. Sika 328 "flowable" has a compressive strength of 4,000 psi after 24 hours and 8,000 psi after 28 days.

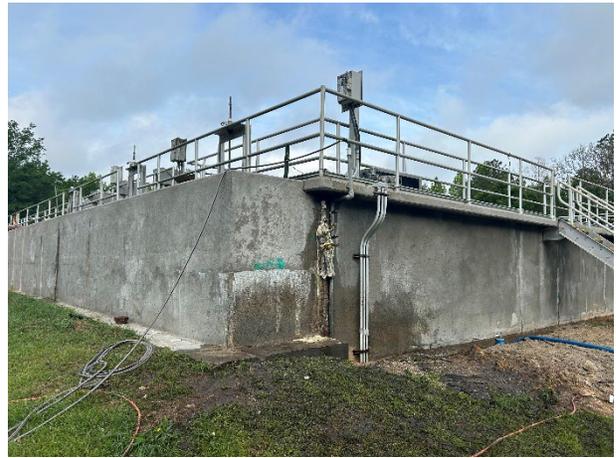
Northeast corner - Aeration Effluent Channel

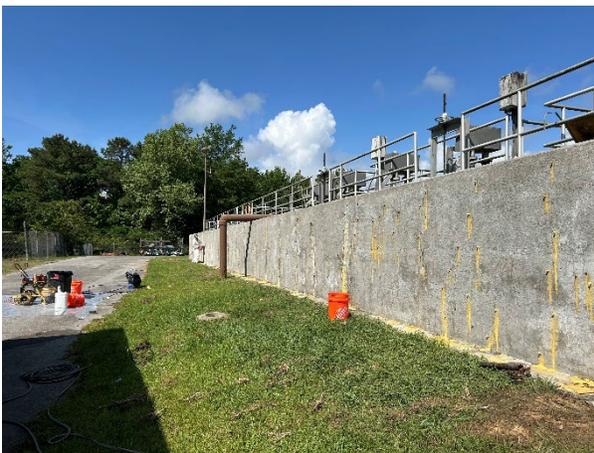
Footing Line - Aeration Effluent Channel

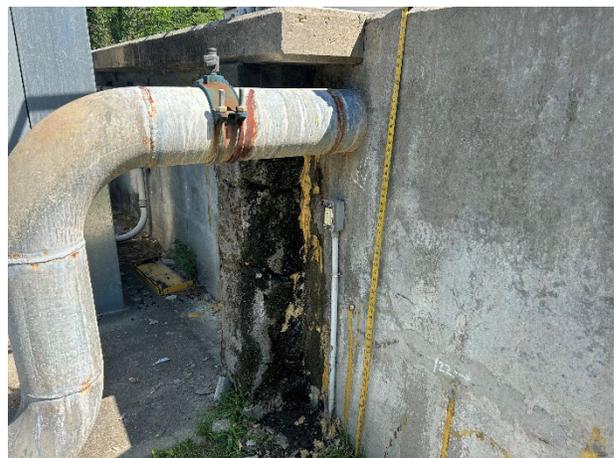
Northwest corner - Aeration Effluent Channel
