Washington County Historical Museum Existing Conditions Report

Washington County Historical Museum

685 Seventh Street- Chipley, FL 32428

The Lane Group, Inc.
1022 Park Street, Suite 209 Jacksonville, FL 32204
w: 904.355.5833 f: 904.355.5809
www.lanegroupinc.com

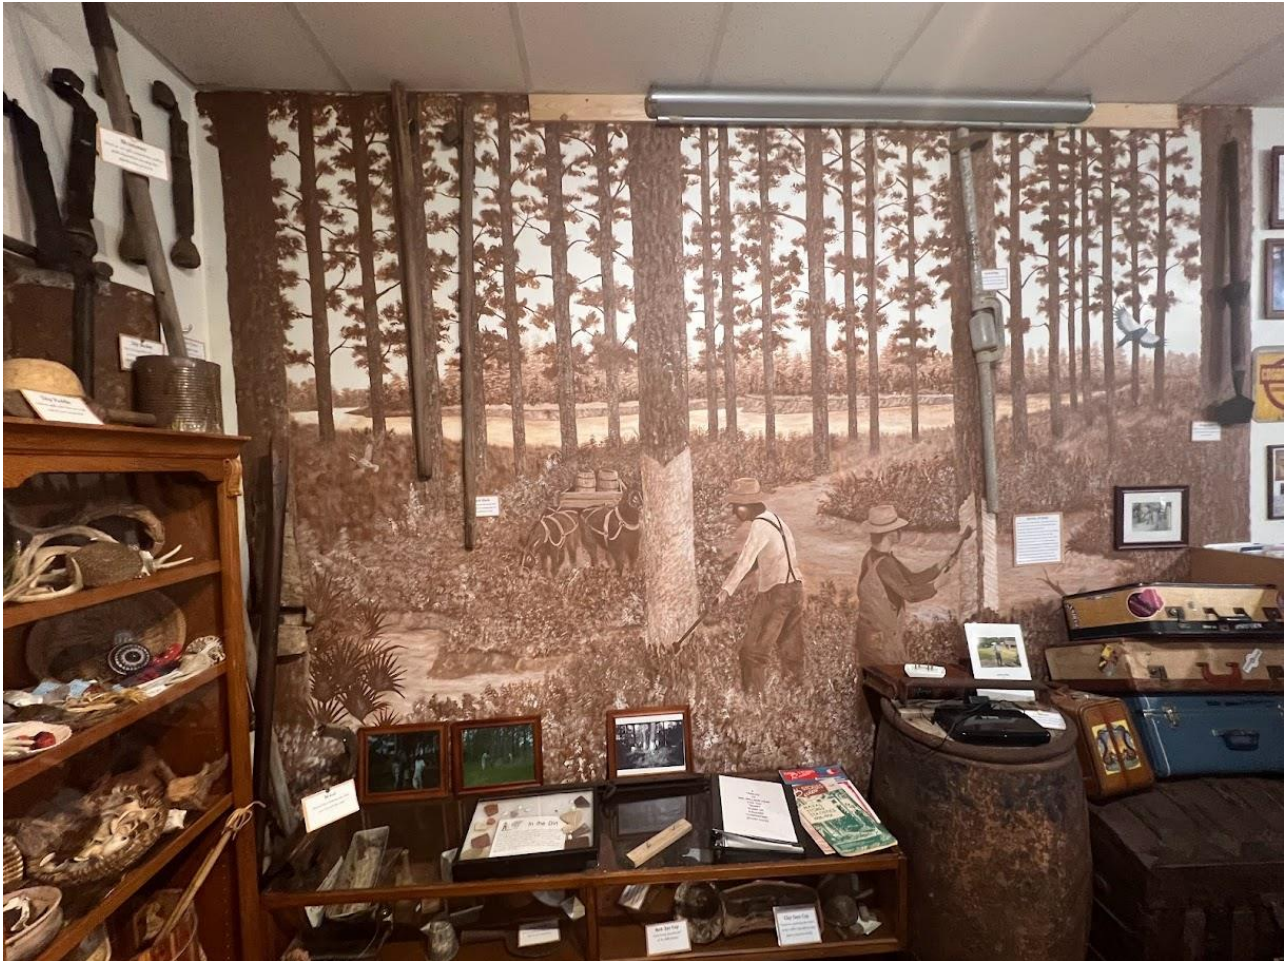
Expansion Needs - Photo 1

Local Artist Frank Roberts painted this original mural scene on the GWB of the East Wall of the Museum. Washington County was the country's largest producer of Naval Stores and Turpentine at one time. This industry was a significant part of the economy and cultural history of Washington County; as such, the mural will be maintained as part of any future changes/expansions. As you can see by the surrounding displays, expanding the Museum would make more room to relocate some of the items in front so visitors can fully appreciate the mural. See the proposed addition diagram on the following page.

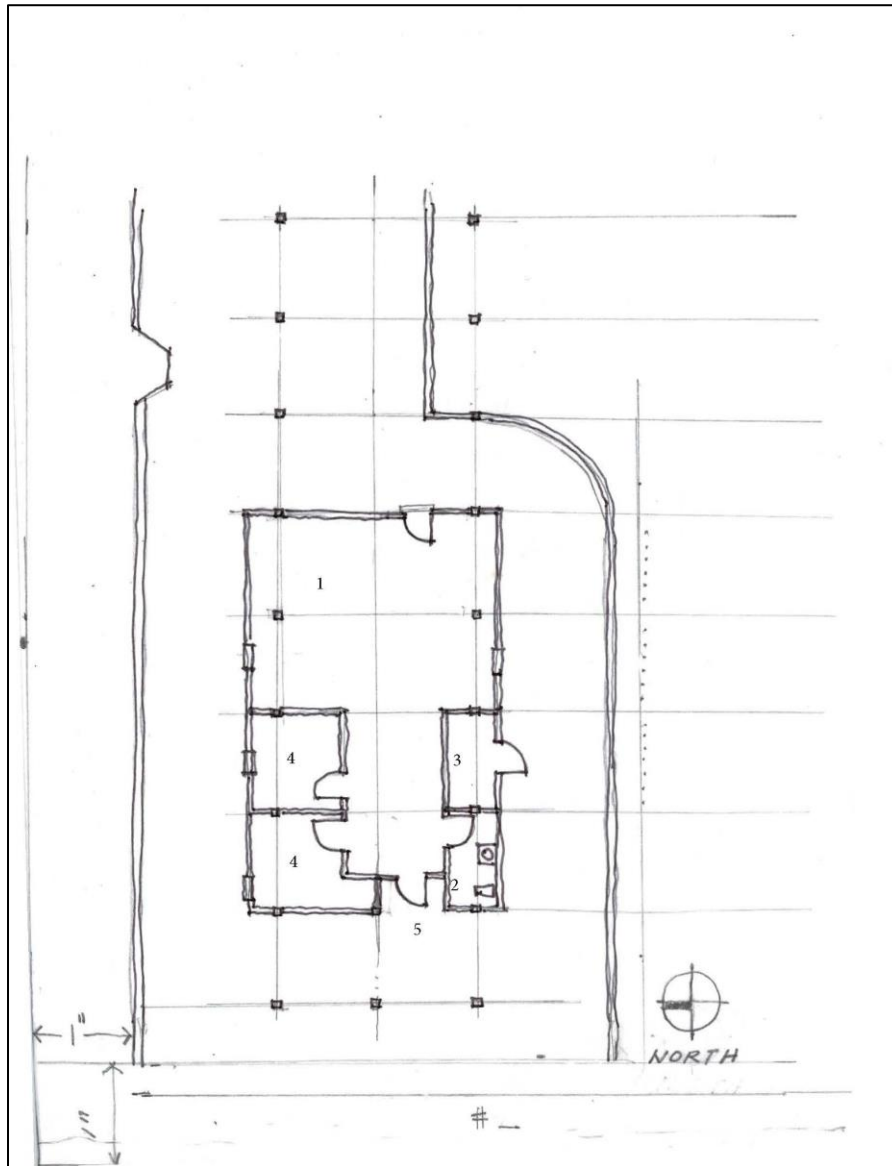
Existing Facility – 1040 S.F. Conditioned Space

1. Local Artist Frank Roberts wall mural to remain.
2. Upgrade existing restroom to current accessibility standards.
3. Mechanical Room to remain, upgrade obsolete equipment.
4. Remove interior non load bearing partitions.
5. Replace, single door with double doors.
6. Replace, single door with double doors and provide H.C. Ramp.

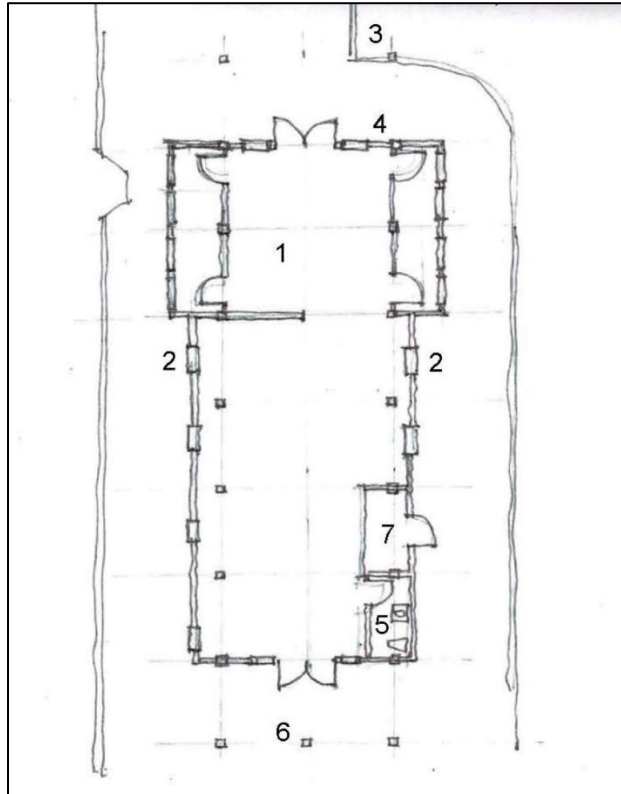
Proposed Addition with Improvements

1. Approximate 930 S.F. addition with flanking storage rooms.
2. Add windows to match existing.
3. Relocate Handicapped Parking Space.
4. Add Ramp.
5. Upgrade existing Restroom to current accessibility standards.
6. Provide double doors at entry.
7. Upgrade Mechanical and Electrical.

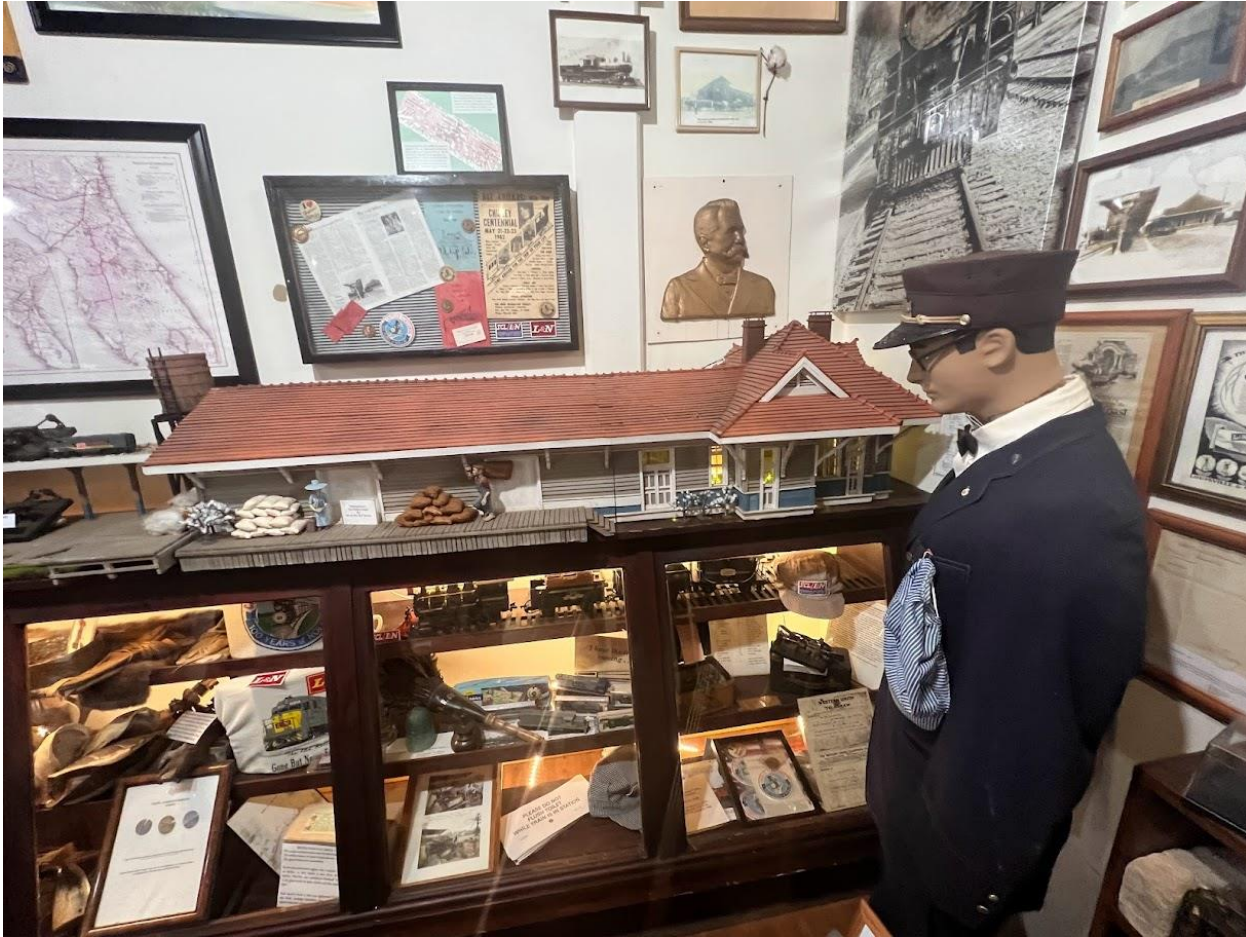
Expansion Needs - Photo 2

This corner of the museum is staged to illustrate the importance that the Railroad played in the growth of Chipley in the late 1800s. With an expanded footprint, the model of the original train station could be viewed on all sides, and this display could be developed with room to move closer to see the pictures, maps, documents, etc.

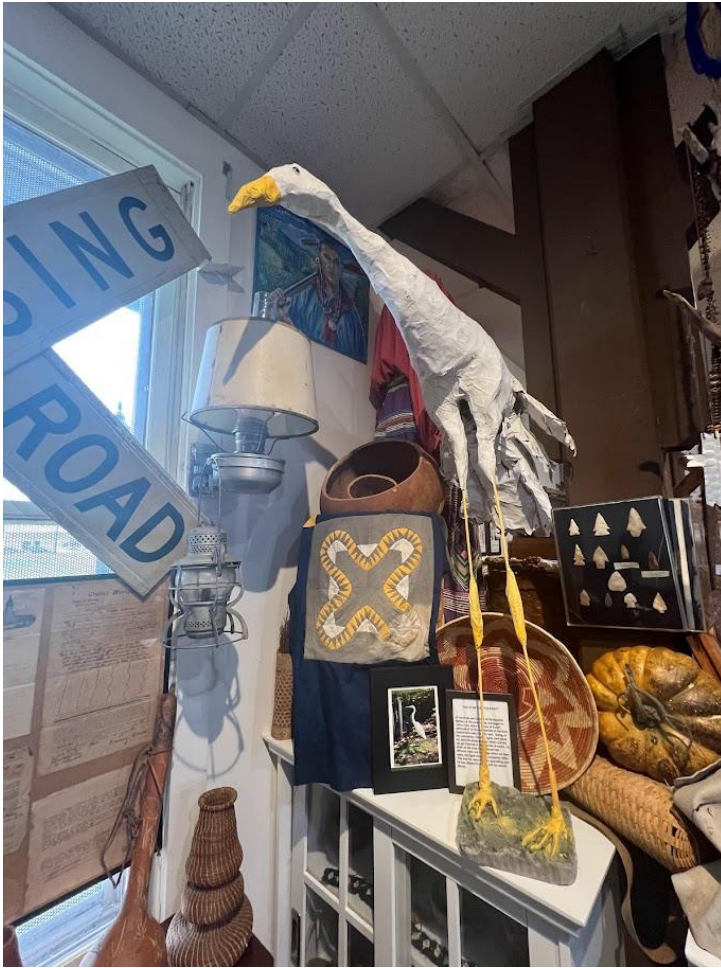
Expansion Needs - Photo 3

Certain items displayed outside could be moved inside and suspended higher up if the acoustical ceiling was removed. This extra volume of space would not only improve and increase the display space but would enhance visitors' experience. As this picture indicates, many of the items displayed currently could be placed higher up on the walls, expanding the floor space.

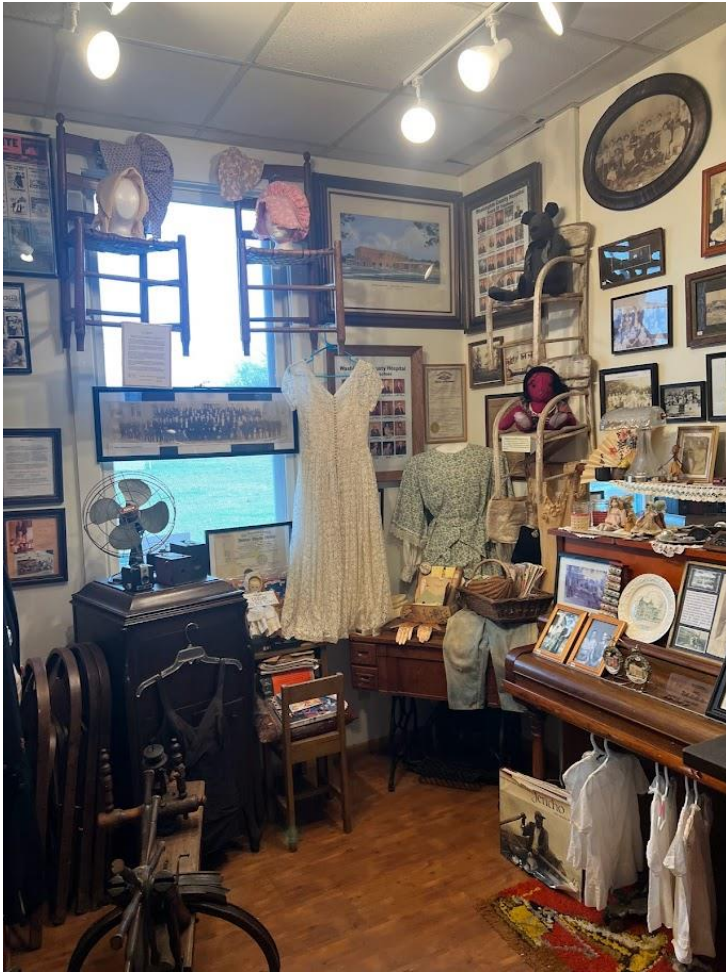
Expansion Needs - Photo 4

This photograph is one of (2) existing small rooms that were part of the 1989 facility. We recommend removing these (2) existing non-load-bearing interior walls to open up and create a space to accommodate and orient visitors, children, school groups, etc. The current displays will be relocated to the expanded area of the museum. We also recommend that the current single door be moved to the center of the front façade and that (2) doors with a glass transom overhead be designed to accommodate large groups further and to improve visibility, accessibility, and invitation to visitors/guests.

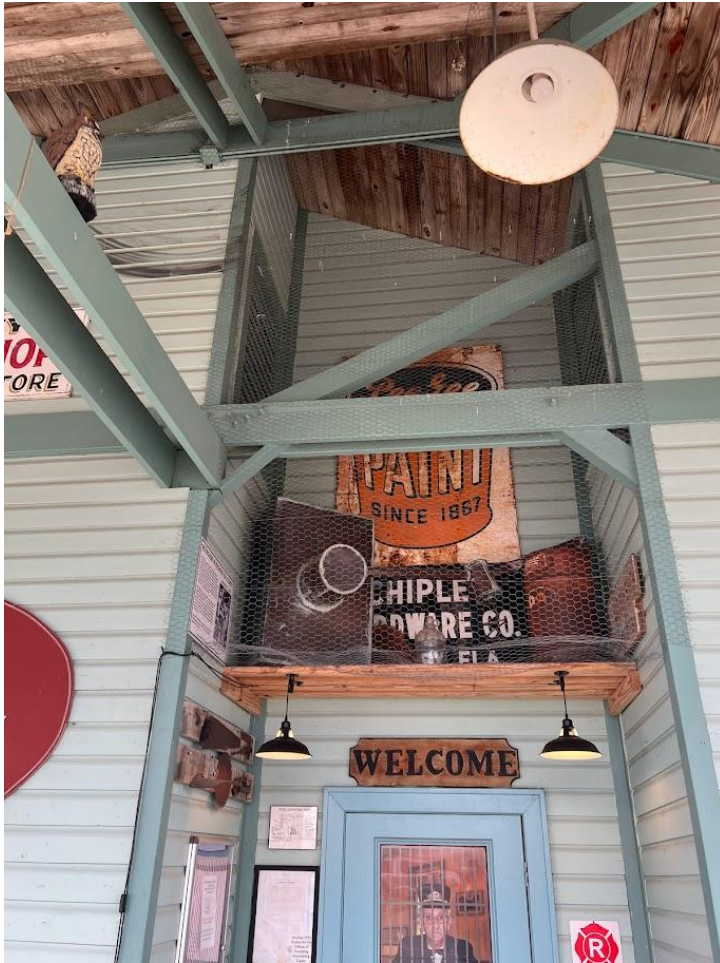
Expansion Needs - Photo 5

Both the front and rear of the Museum have display pieces mounted up high and protected with chicken wire to prevent birds from roosting. These display pieces mounted up high and protected could be included inside an expanded museum to protect them from the elements and improve their enjoyment by visitors who wish to see them up close.

The original 1989 plans had double doors at the entry instead of the current single door. We propose to provide the double doors again with more windows at the front entry as indicated by the sketch in the following page.

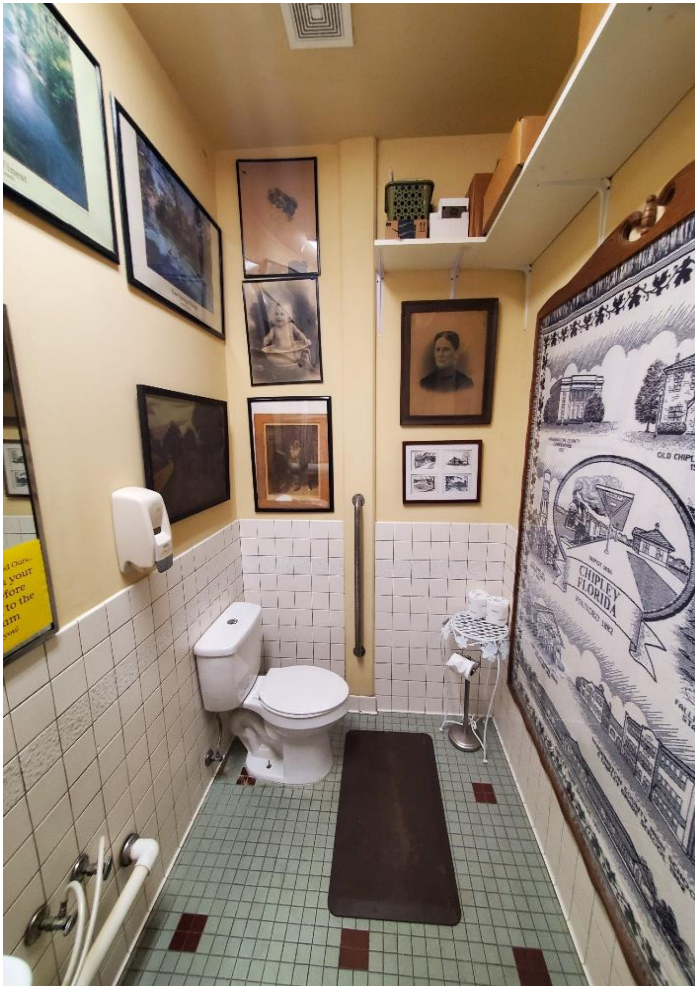
Accessibility - Photo 6

The following items were noted as potential issues that could impede full restroom use and should be verified/changed/corrected.

1. The toilet should be 17"-19" from the floor to the seat.
2. The existing vertical grab bar does not meet the accessibility code. Grab bars are required on the rear and side walls by the toilet.
3. The toilet paper dispenser is not ADA-compliant.

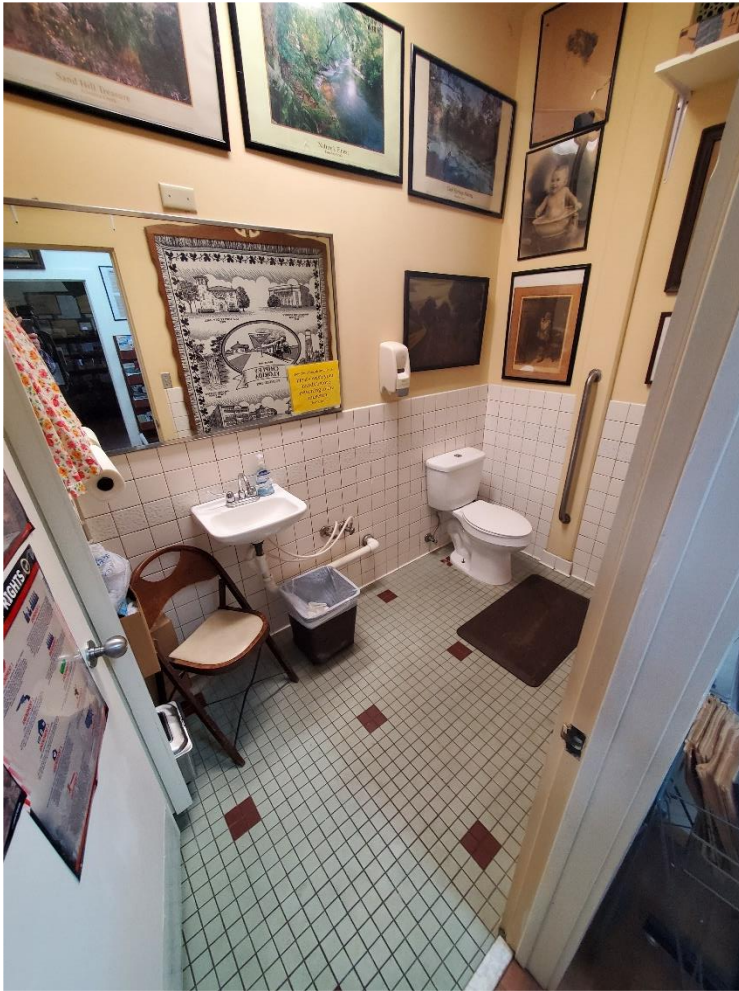
Accessibility - Photo 7

The following items were noted as potential issues that could impede full restroom use and should be verified/changed.

1. The sink must be 19" wide x 17" deep minimum. The existing sink appears too small.
2. All piping under the sink must be insulated.
3. The top of the sink should be mounted at 34" to the top above the finish floor.
4. The faucets should be able to operate with one hand.
5. The soap dispenser is not located within the reach range of the sink.

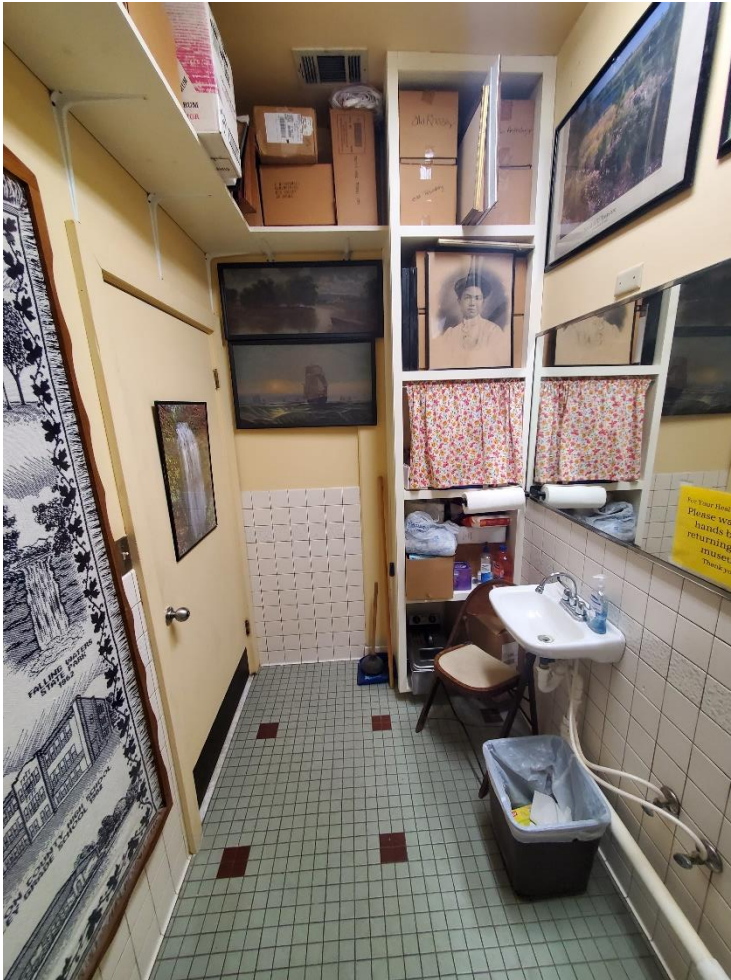
Accessibility - Photo 8

The following items were noted as potential issues that could impede full restroom use and should be verified/changed.

1. Provide a lever handle for the door.
2. The door must have a self-closing device.
3. Place Accessible Sign outside the door on the right side with Raised Letters 48" min. to 60" max. above the finish floor.

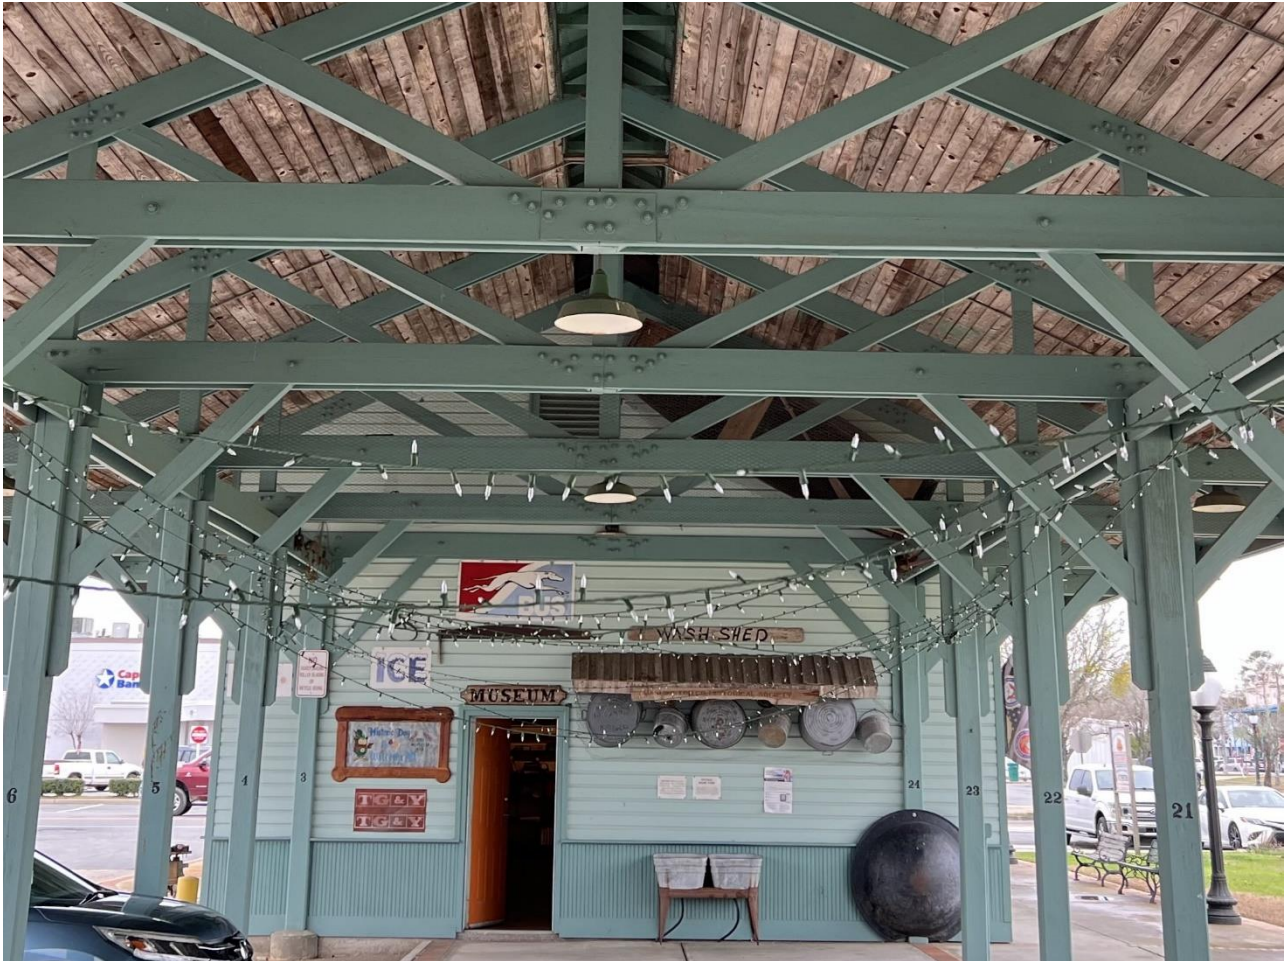
Improved Accessibility - Photo 9

This picture illustrates the existing door on the East Wall of the Museum that the staff would like to make accessible. Please note the following items to provide/verify;

1. The door opening must be 32" clear, although double doors are requested for improved accessibility, accommodation of large groups, movement of traveling displays, etc.
2. The door must have a lever handle.
3. A small ramp is required to access the 3" – 4" curb.
4. The threshold cannot be more than ½" tall.
5. Add Accessible Sign.
6. Provide a self-closing door device.

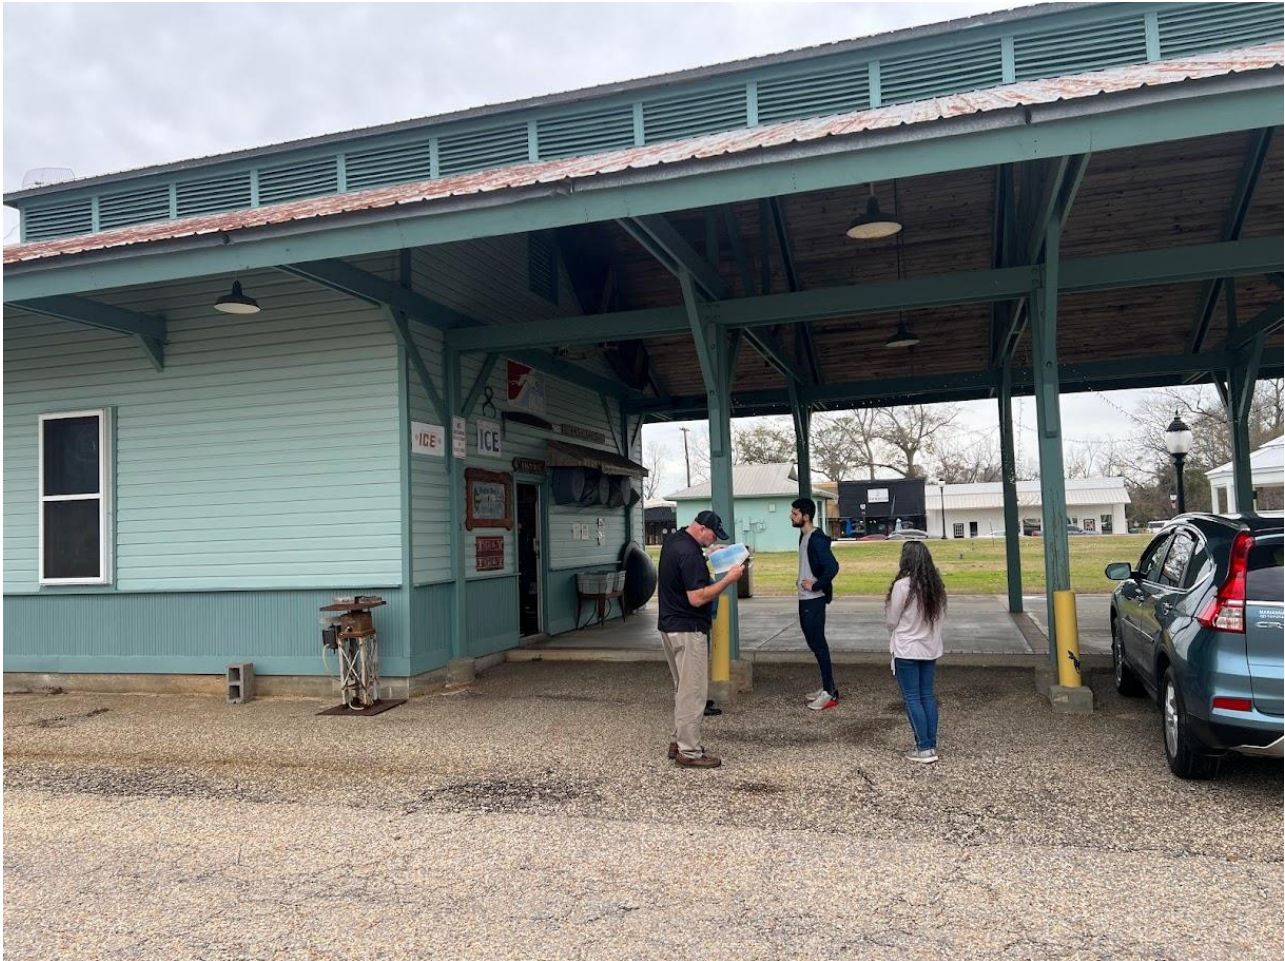
Accessibility - Photo 11

The original drawings for the facility illustrated double doors at the front entry to the facility instead of the current single door. Besides improving accessibility, the wider doors will help accommodate larger groups, access for traveling displays as well as helping staff move items inside.

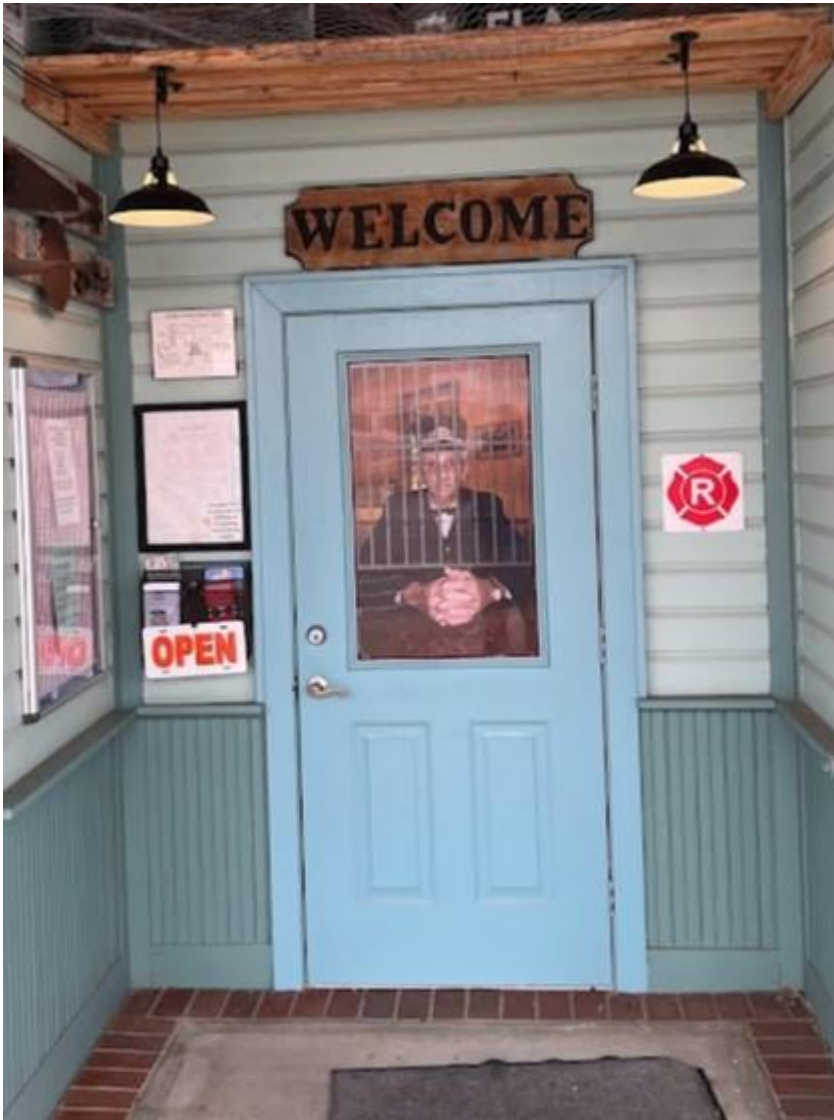
Accessibility - Photo 11

The original drawings for the facility illustrated double doors at the front entry to the facility instead of the current single door. Besides improving accessibility, the wider doors will help accommodate larger groups, access for traveling displays as well as helping staff move items inside.

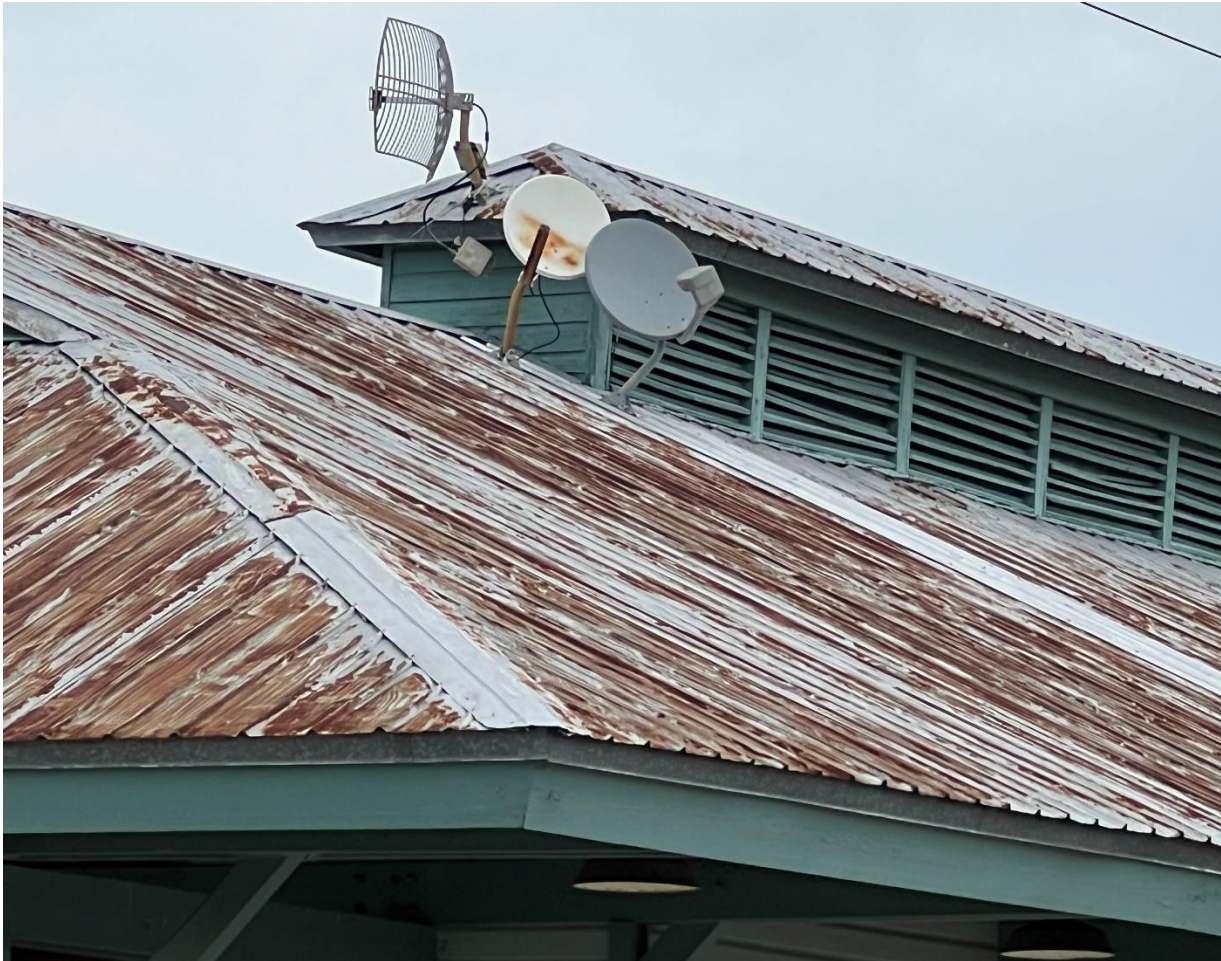
Storm Hardening and General Maintenance - Photo 12

The following comments apply to the exterior and are typical throughout the facility.

1. Prep Roof Panels for New Paint. Replace missing attachment screws and re-tighten existing loose screws, this is a maintenance task.
2. Repaint the Roof Panels. Remove all obsolete and abandoned communication disk. Patch all penetrations into the roof panels. This task is to extend the life of the roof.
3. Repair all damaged louvers in the Center Cupola and repaint them. Ensure all sections of the Cupola over-conditioned space below are sealed from blowing rain entry. Repaint Cupola metal roof.

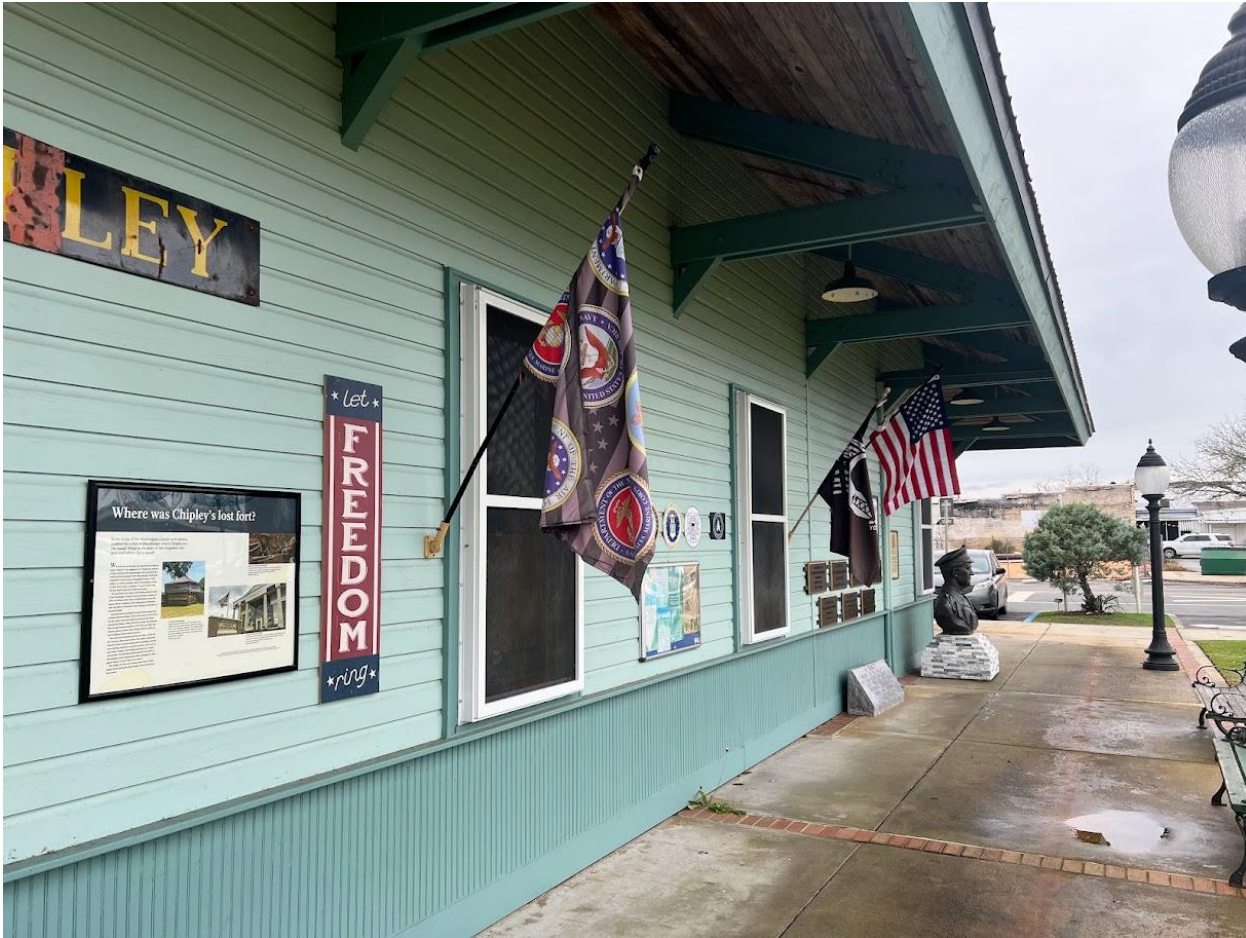
Storm Hardening and General Maintenance - Photo 13

The following comments apply to the exterior and are typical throughout the facility.

1. Pressure wash all paved surfaces of the facility.
2. Inspect all wood trim and bead board wainscoting for damage and repair/replace as required. Prep and paint all exterior wood surfaces.
3. Replace all rusted exterior hanging light fixtures. Consider LED fixtures for replacement.

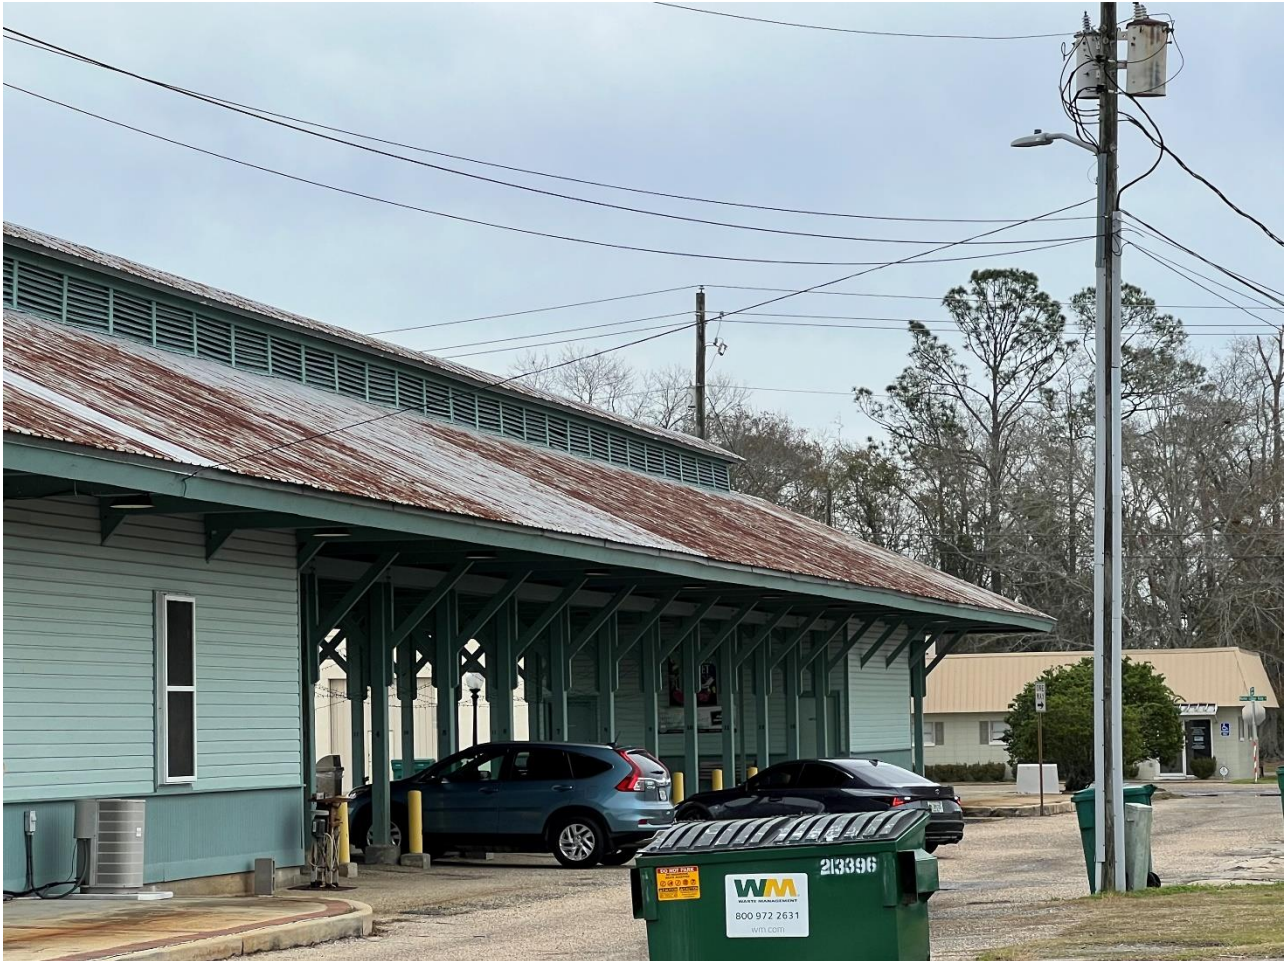
Storm Hardening and General Maintenance- Photo 14

The following comments apply to the exterior and are typical throughout the facility.

1. Prep Roof Panels for New Paint. Replace missing attachment screws and re-tighten existing loose screws.
2. Repaint the Roof Panels.
3. Repair all damaged louvers in the Center Cupola and repaint them. Ensure all sections of the Cupola over-conditioned space below are sealed from blowing rain entry. Repaint Cupola.

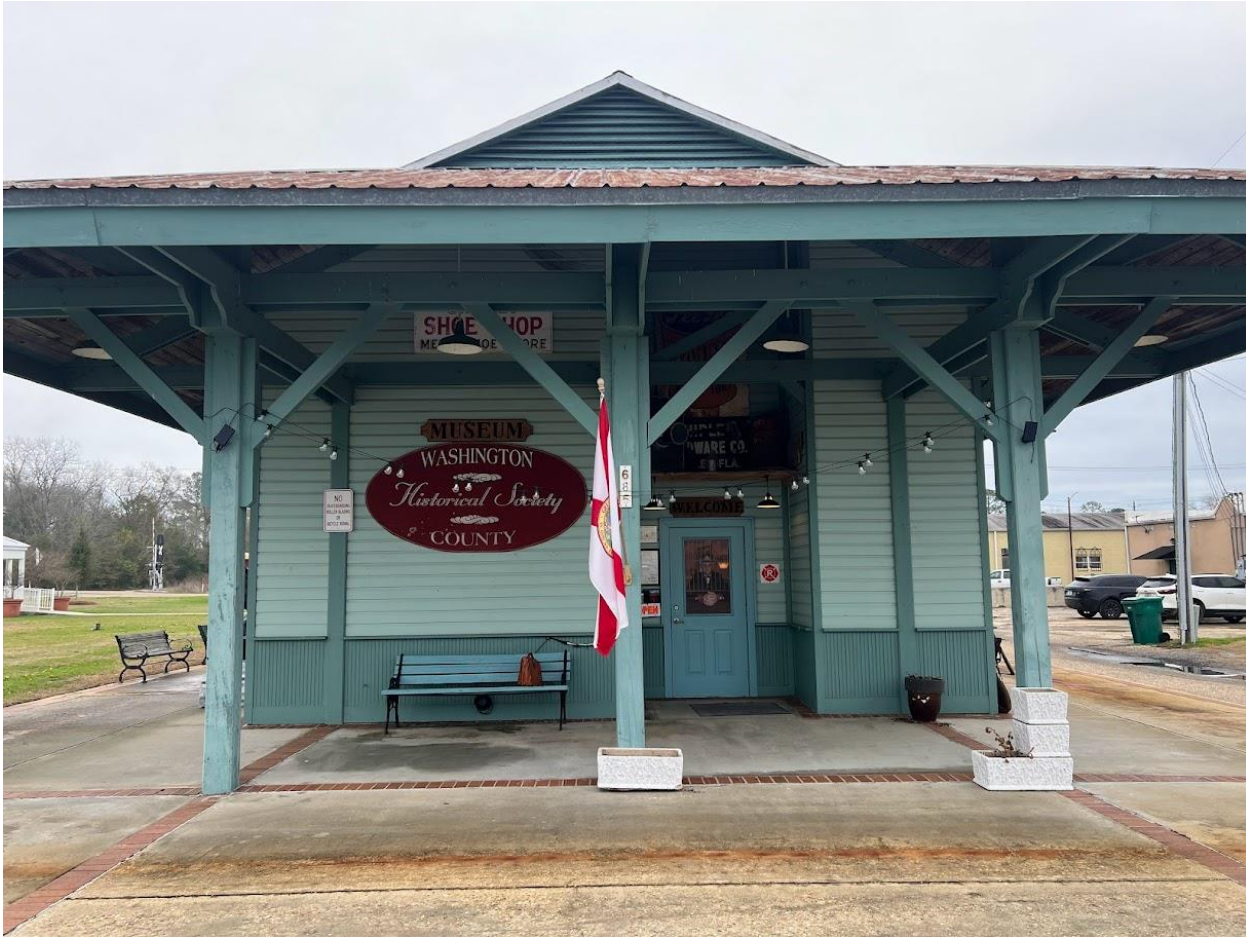
Storm Hardening and General Maintenance- Photo 15

The following comments apply to the exterior and are typical throughout the facility.

1. Roof Repainting. We recommend that the Metal Roof for the Farmers Market be changed to a red color to resemble the Old Railroad Train Station
2. Pressure wash all paved surfaces of the facility.
3. All woodwork prep and repaint.
4. Inspect inside the attic to ensure the interior space is closed off from any potential blowing rain into the Gable End Louvers. Inspect the louvers and repair/replace and repaint them.

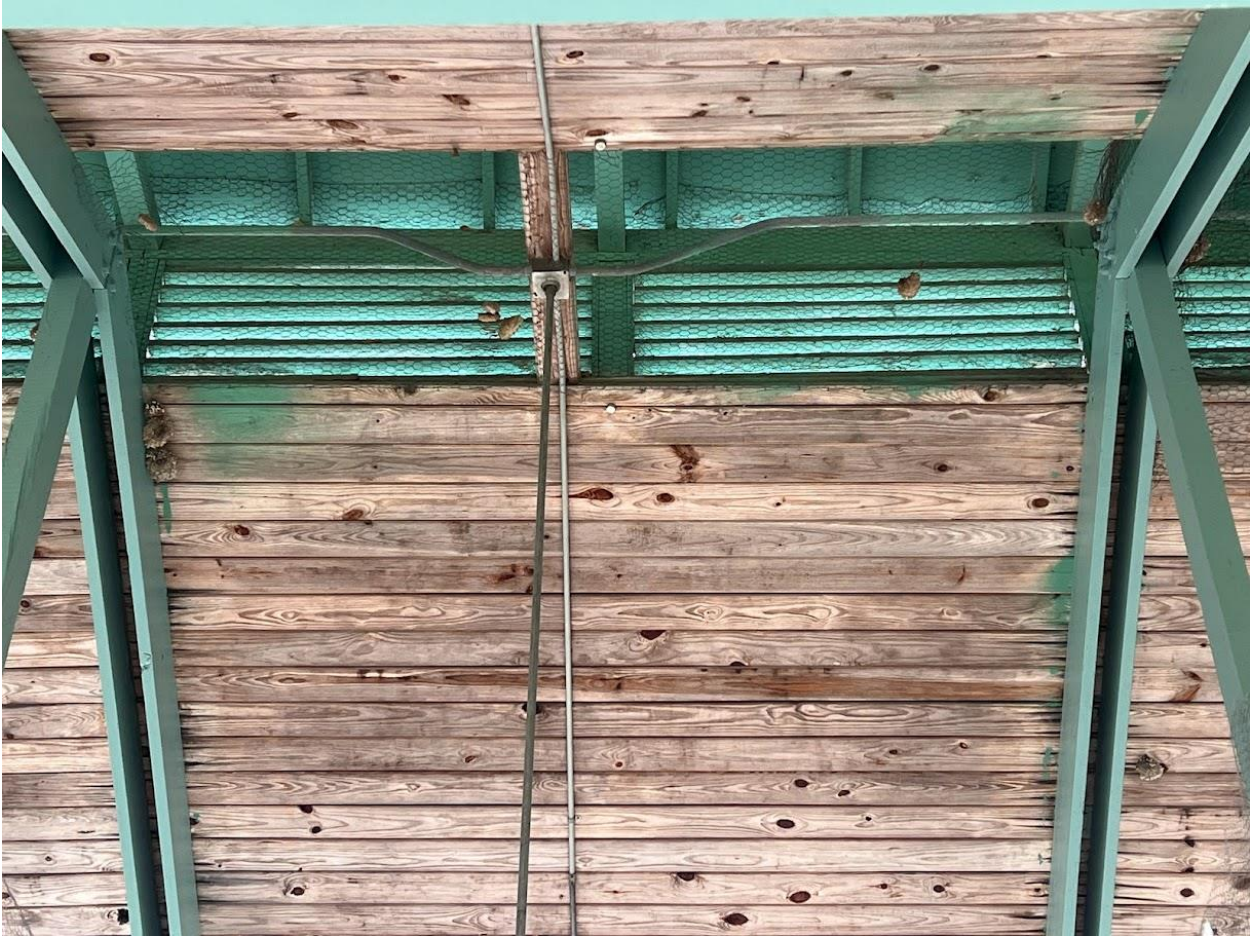
Storm Hardening and General Maintenance- Photo 16

The following comments apply to the exterior and are typical throughout the facility.

1. Pressure wash and prep the bottom of the wood roof decking and apply a coat of semi-transparent stain if you wish to have a cleaner, more uniform appearance.
2. Prep and paint the exposed woodwork, including beams, louvers, etc.
3. Replace the rusted exterior lighting typical.
