**Re: City of Castroville's Gas Distribution System 2025 Annual Cathodic Protection Survey Report**

Chapman Engineering was tasked with performing the 2025 Annual Cathodic Protection (CP) survey and assessment for the City of Castroville's gas distribution CP system. The city's underground metallic gas pipeline distribution system has two existing Impressed-Current CP (ICCP) systems and multiple supplemental Galvanic Anode CP (GACP) systems installed as a means of corrosion protection. Below is an aerial image of The City of Castroville with the two rectifiers labeled:

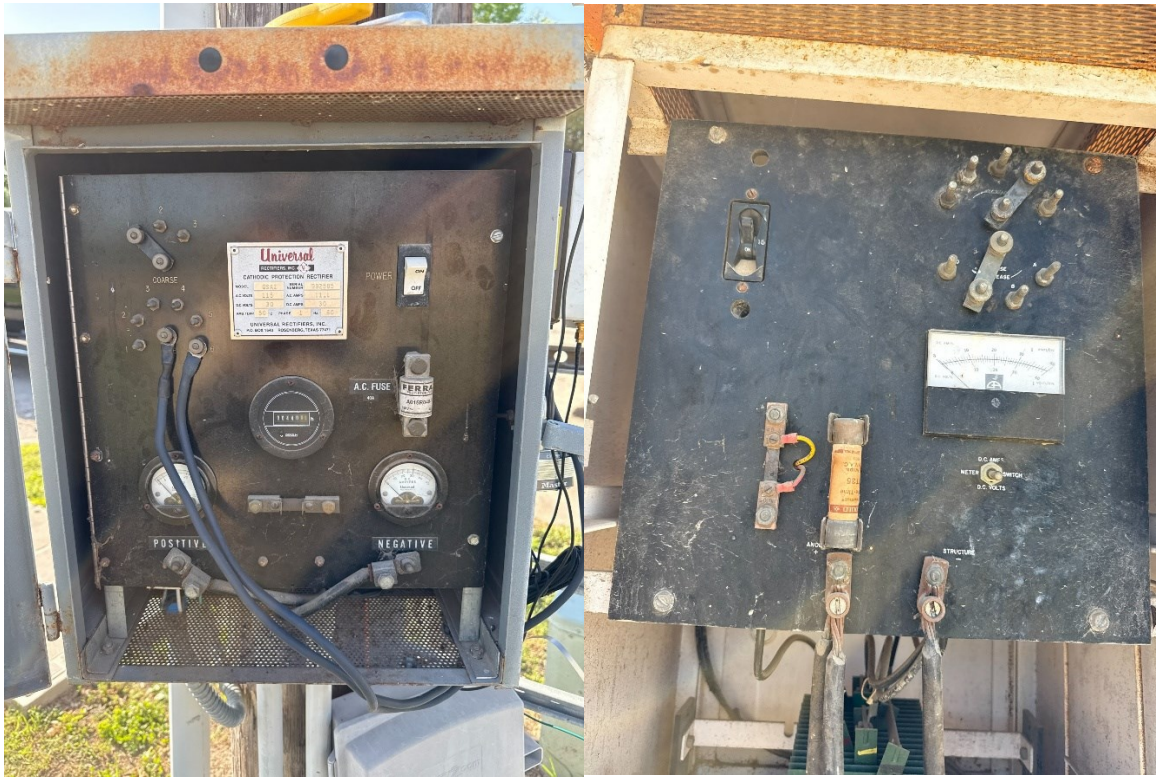
**Gas Distribution System Rectifier Field Imagery**

At the Visitor Center, the rectifier exhibited smaller than normal tap setting connections and was unsuitable for current interruption due to poor contact and visible sparking, posing a safety hazard. The rectifier located at the baseball field was mounted at a height that required additional support for safe access. Operating electrical components at that elevation without proper assistance was considered unsafe. Consequently, current interruption testing could not be safely performed at either location.

Photographs of each rectifier followed by the rectifier operating record are shown below:
