Garcia Creek Channel Stabilization

October 28, 2025

Garcia Creek | Preliminary Engineering

Garcia Creek | Bank Erosion Progression

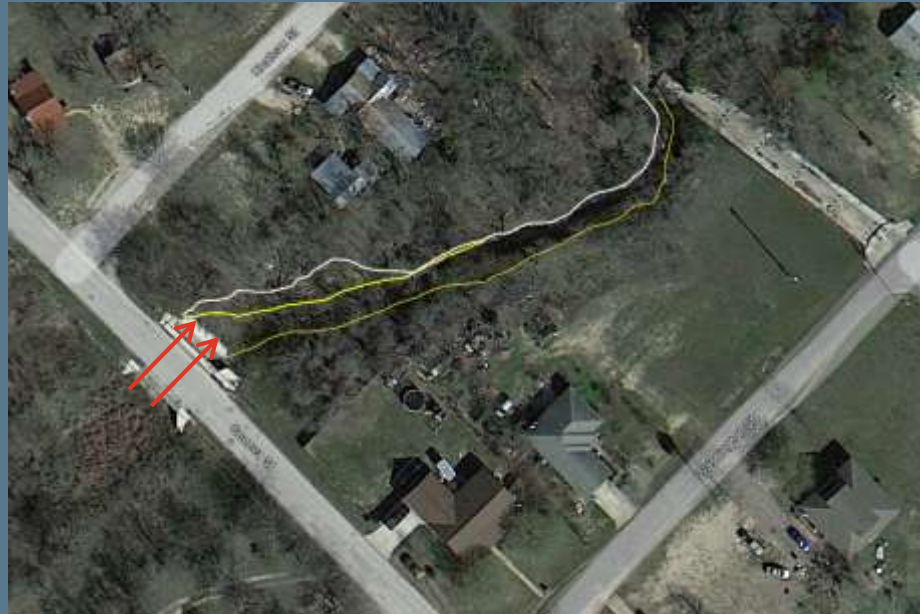
February 2013

Observation: ~20 feet of bank erosion in 10 years demonstrate continued degradation that could jeopardize localized repairs.

- Following the independent technical review and observed bank erosion of ~20 feet over the past decade, staff and Lochner reaffirm Option 1 as the most effective and resilient long-term solution.
- **Option 1 addresses:**
 - Stabilization of the headwall, culvert, and channel banks
 - Reduction of future erosion and maintenance risk
 - Protection of adjacent public infrastructure and properties

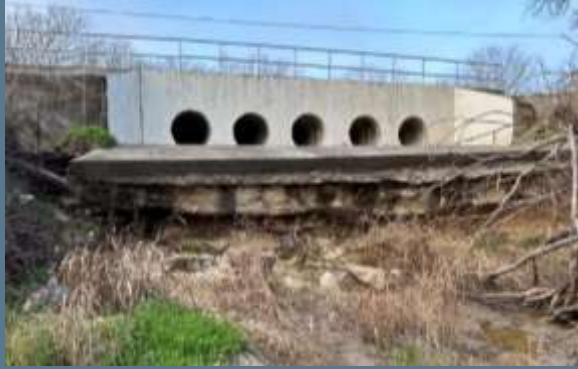
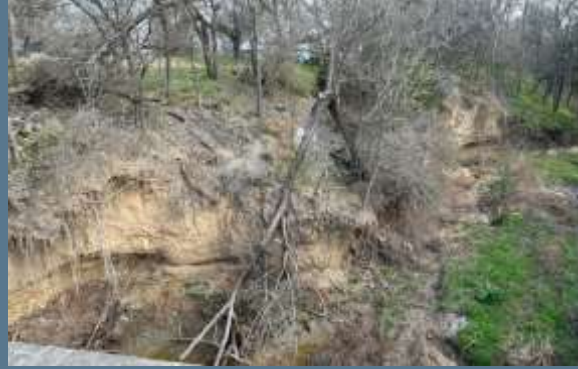
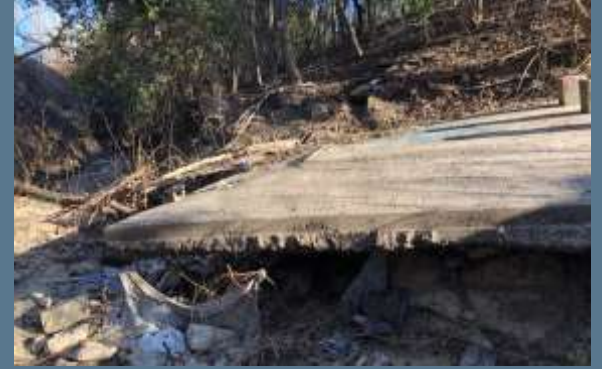
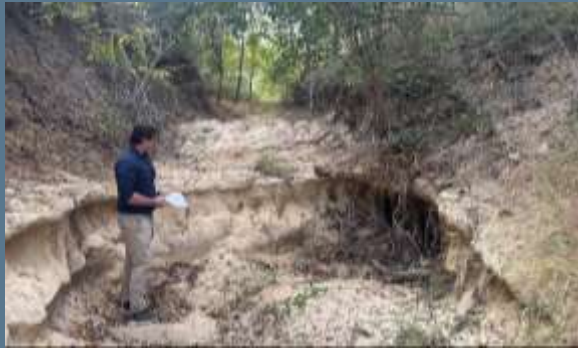
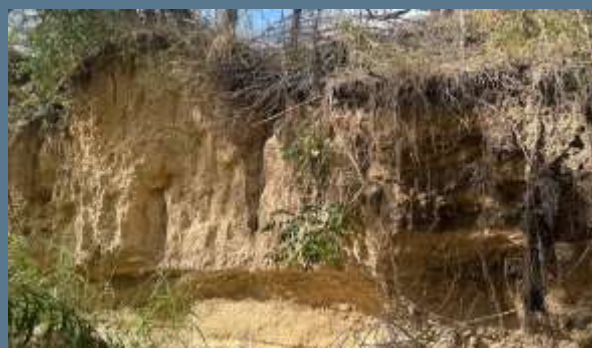
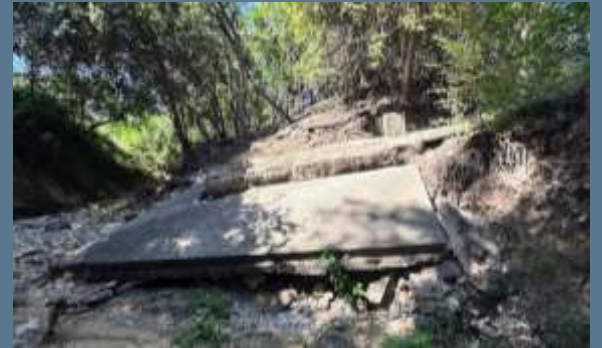
Garcia Creek | Channel Erosion Examples

- Senior geomorphologist and senior engineer evaluated long-term stabilization options.
- Review reaffirmed Option 1 as the most effective solution.
 - Headwall-only stabilization would not address ongoing channel erosion and could undermine repairs over time
 - Option 2 provides comprehensive stabilization of the culvert, headwall, and channel banks reducing long-term maintenance needs or creating new downstream erosion instabilities
