City of Cartersville Historic Preservation Commission COP Application Staff Report

Case: COP 23-20

Address: 11 Luckie St. Applicant: Gary L. White Historic District: Olde Town Zoning: R-7 (Residential)

Summary Description: Demolish existing house and rebuild a house.

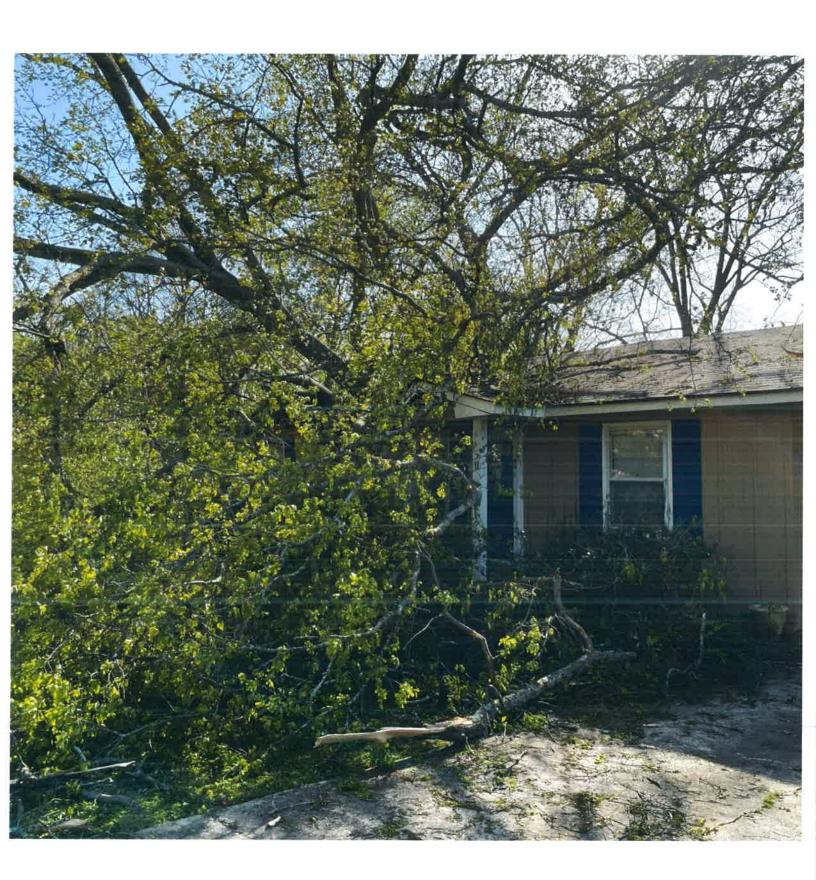
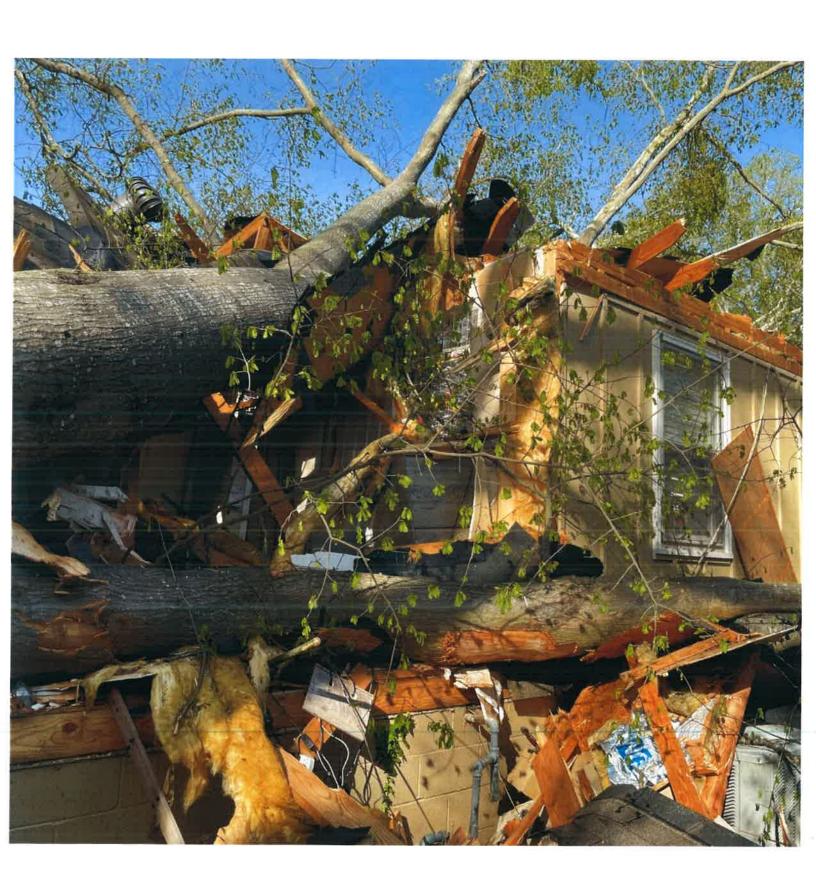
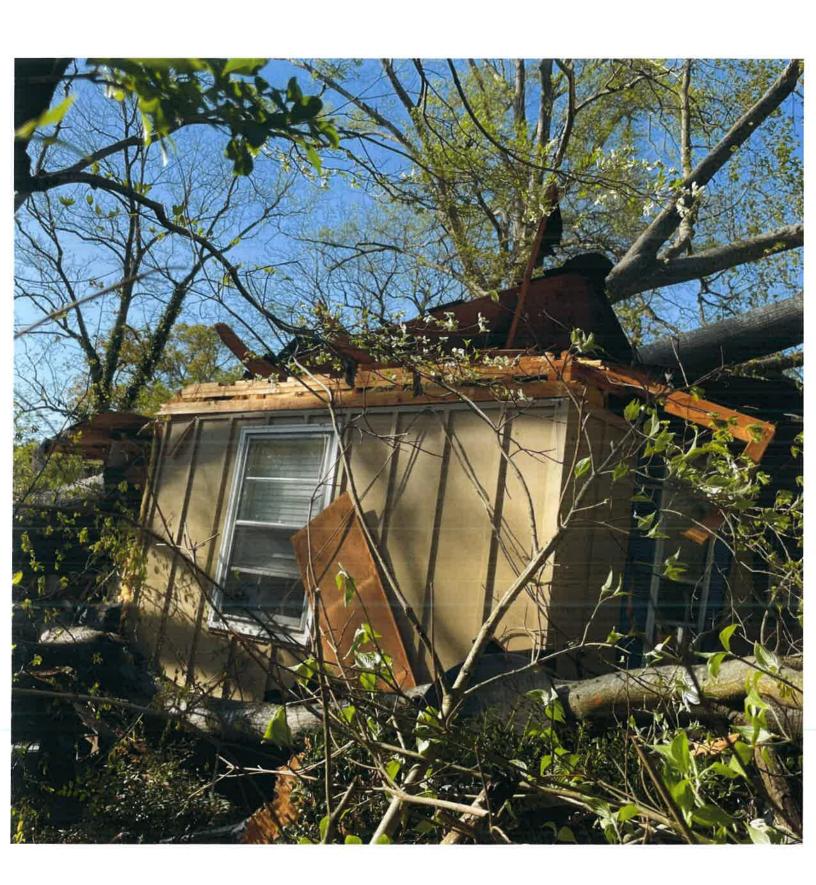
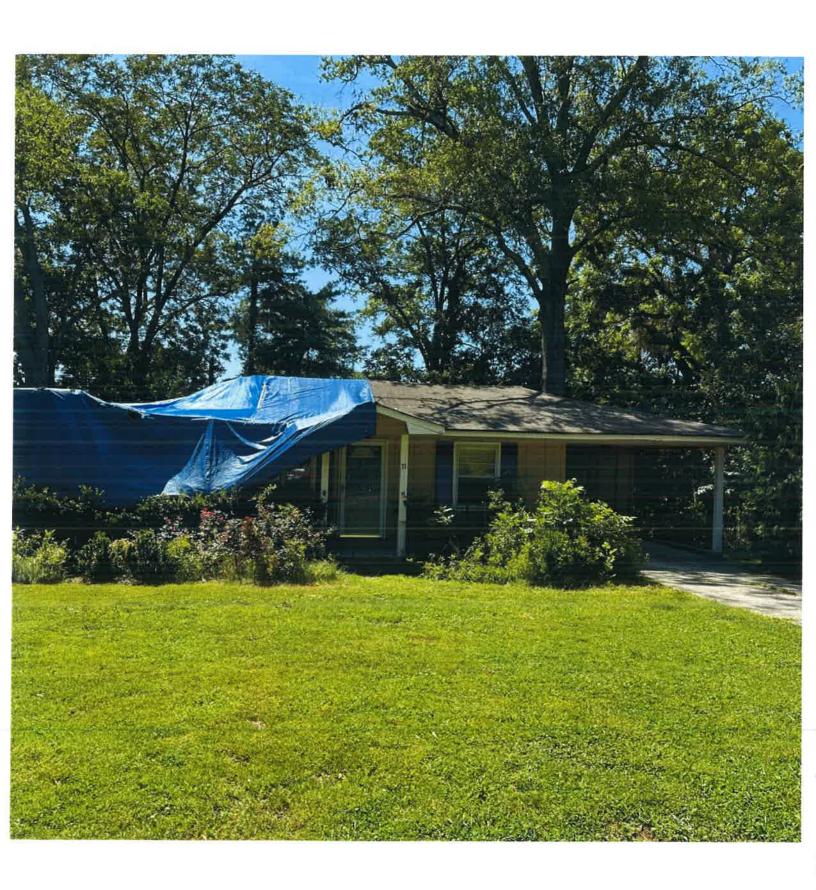
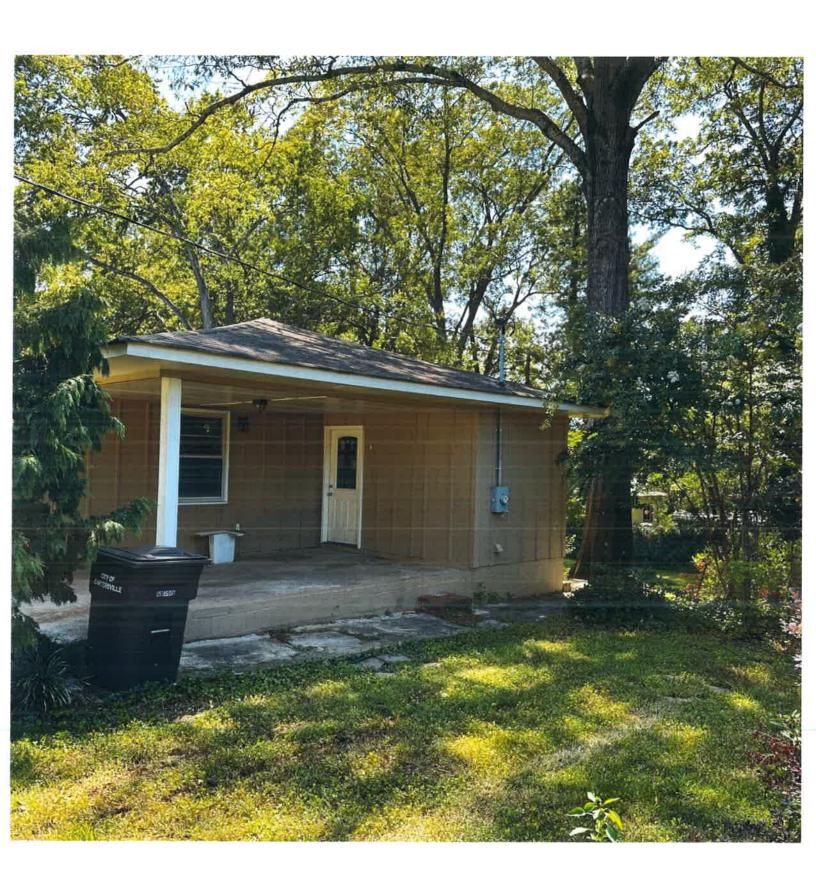
On April 1st, a large oak tree fell diagonally across the house from the left rear corner to near the front door. Damaging at least half the house including the roof, floor and walls. A structural engineers' report dated 6/23/23 is included with the application. The report recommends repair of the structure; however, the applicant would like to replace the structure in its' entirety.

Upon arriving Mr. Wages found a single level Ranch style home with wood siding. The home is constructed over a partial basement to the rear left corner and remainder is constructed over a crawl space approximately 36-inches to 24-inches in height, with the basement area approximately 7-feet in height. The foundation walls were constructed with 8-inch CMU block. Mr. Wages found the floor system to be constructed with 2"x6" floor joists with spans of approximately 11-feet and spacing of 16-inches on center. The center girder beam consists of a built up 2"x8" (3)-ply beam constructed with SYP. The girder beam is supported approximately 8-feet on center with 16"x16" CMU columns. The walls located on the main level consists of 2"x4" SYP studs with spacing of 16-inches on center. The roof system consists of 2"x6" stickbuilt style framing spanning approximately 11-feet and spaced at 16-inches on center. The impact occurred on April 1, 2023. The location of the impact is approximately rear left corner travelling towards the front central location, near the front stoop. Mr. Wages found extensive damage at the left portion of the home starting at the left side to the central location of the home. The complete roof system was damaged over the two left bedrooms and traveled to the right approximately 20-feet. Due to the impact of the 40-inch diameter tree, the damage travelled from the roof system down through the wall system and complete to the floor framing, breaking approximately (12) floor joists. Along with the floor joists Mr. Wages noted the center built up girder beam suffered damage, approximately 12-16-feet from the left side. Mr. Wages noted the damage to the interior and exterior walls travelled approximately 20-feet from the left side to the central area of the home. Mr. Wages checked the remaining intact walls of the home and found slight displacement to the remainder of the home. The wall to the right of the front entry door was out of plumb approximately 1/4" to the

right for the full height of the wall but is intact. The load path from the tree strike travelled across the lateral bracing found at the center span of the Great room ceiling. This is the determined cause of the displacement of the Great room wall. The remainder of the interior walls were found to be plumb and stable. Mr. Wages found the impact to the front stoop of the home to have suffered damage as well. The impact fractured the roof framing and shifted the roof structure approximately 2-inches out of plumb.

We recommend removal and replacement of the floor system from the left side of the home to the right approximately 14-feet. We recommend using #2-SYP 2"x10" floor joists and replace center girder beam with new 3-ply #2-SYP 2"x10" for approximately 16-feet starting at the left side to the right. We recommend removal and replacement of the complete left wall with new stud grade or better with the spacing of 16-inches on center. We recommend removal and replacement of the front wall starting at the left side to the right approximately 18-feet. We recommend removal and replacement of the rear wall starting at the left side to the right approximately 12-feet. We recommend removal and replacement of the roof framing, and decking starting from the left side to the right approximately 20-feet, using new #2 or better SFP or SYP 2"x6" rafters with the spacing of 16-inches on center. We recommend removal and replacement of the 5-feet x 5-feet front stoop.

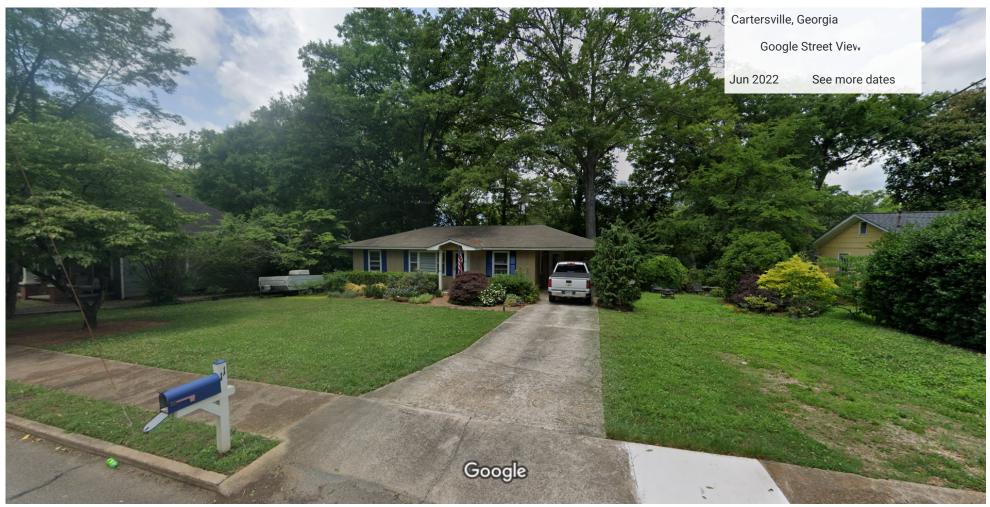
16 Luckie St. (16) as of 2007.

Per applicant, the original house at 11 Luckie St (11) looked like 16. 11 burned in 1965-66 and the current ranch house was built in it's place.

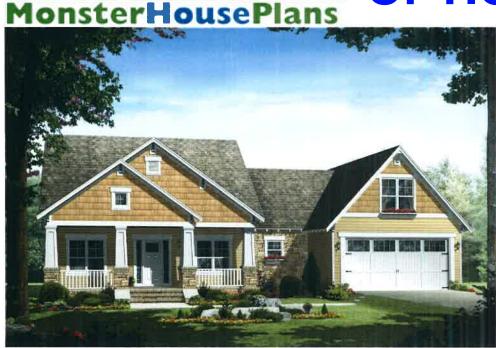
Plan 2-171 Detail

Bedrooms: 3 Total Sq. Ft.: 1800 Width: 65' 0"
Full Baths: 2 Main floor: 1800 Depth: 56' 8"
Levels/Stories: 1 Bonus Room: 326 Height: 23' 7"

- A cheerful Craftsman, complete with spacious front and back porches and one of our best sellers.
- Entry foyer whisks you into the vaulted Great Room which opens to the casual breakfast room and kitchen with Island and eating bar.
- A 'flex space' off the entry awaits your decision for an office /study, formal dining, home school, you name it!
- Master bedroom is set apart from the secondary bedrooms for privacy and is referred to as a 'split' design or just 'split-bedrooms'.
- Garage incorporates a spacious storage room or work-shop area.
- An optional bonus room is accessed inside to the optional bonus room above the garage.
- This floor plan is so popular that several spin-offs have been created. Be sure to check out those plan under 'Design Comments' below if this one isn't 'quite' what you want but almost there!

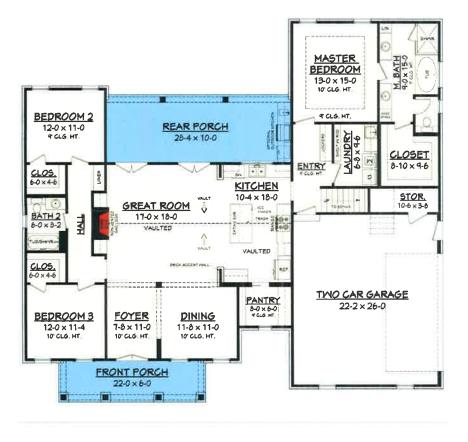
Main Level

- Amazing 3 or 4 bedroom home design with features galore.
- This plan offers 3 bedrooms along with an optional bonus room which can be used as a 4th bedroom or flex area.
- First floor offers volume ceilings and open design perfect for entertaining.
- All bedrooms enjoy walk-in-closets and both bathrooms are large with room to move.
- The rear porch is spacious and offers an optional outdoor kitchen.
- The garage is oversized and includes needed storage space.
- All of this is packed into a plan that is less than 2000 square feet and very economical to build.
