Historic Image Analysis of Deadwood Main Street

This document is a working paper, which illustrates the history of Main Street in a series of different topics. Topics include “Street & Sidewalk Paving,” “Street Lighting,” “Utilities,” “Special Structures,” “Vehicles,” “Street Furnishings,” and “Signs.” Within each topic, photos are arranged in chronological order, to the extent feasible. The focus is on the street itself, not the buildings that frame it.

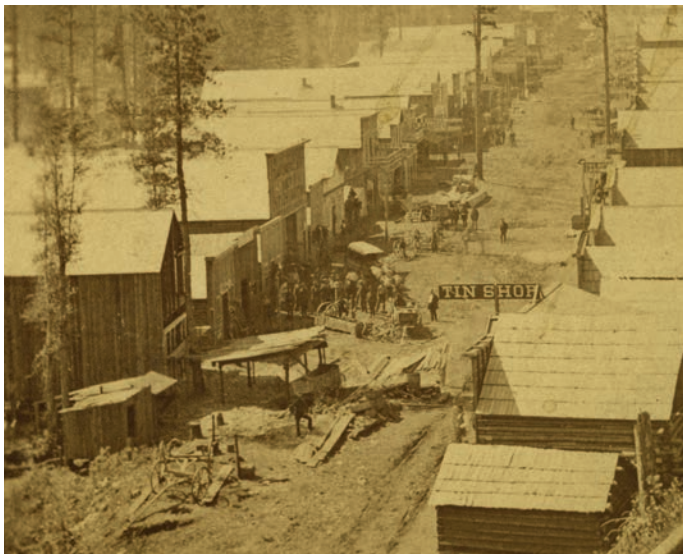
Early 1870s: Early Main Street with no paving. ("PHO.2009.69.1.22 early street no paving.tif")

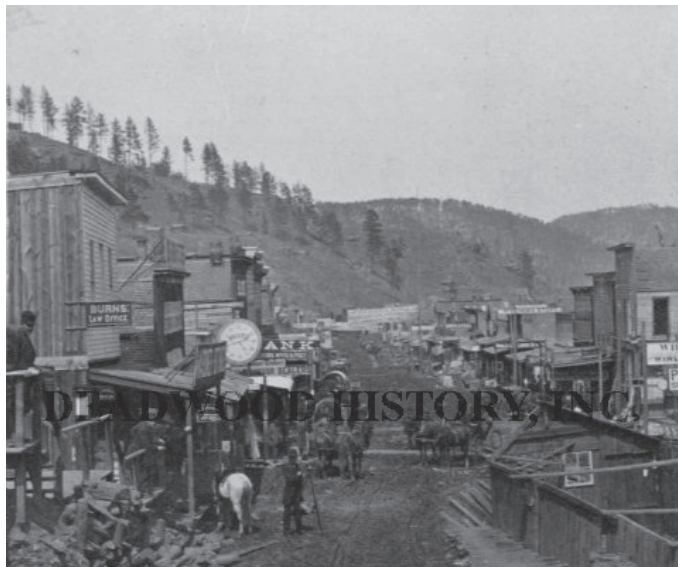
1877-1879: Dirt street. ("877-1879 0070750001 dirt street DHI.jpg")

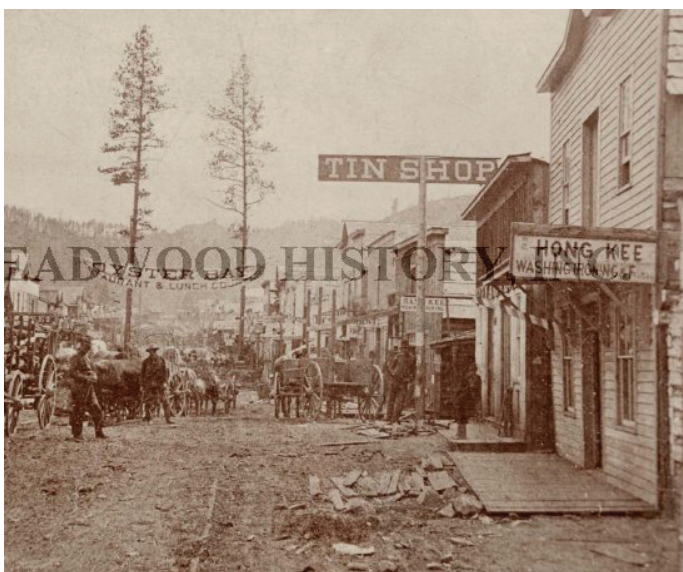
1877: Random boardwalks at individual buildings. ("1877 0070823001 Chinatown Board entry DHI.jpg")

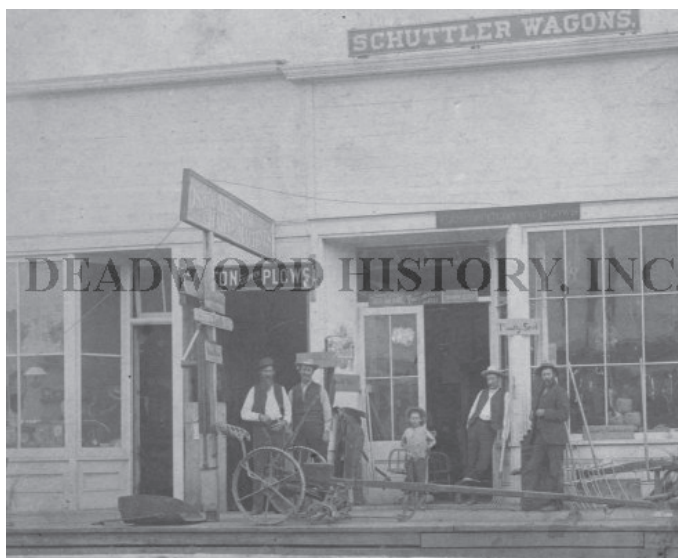
1870s-1880s: Boardwalk detail. ("1870s-1880s 0070131001 boardwalk detail DHI.jpg")

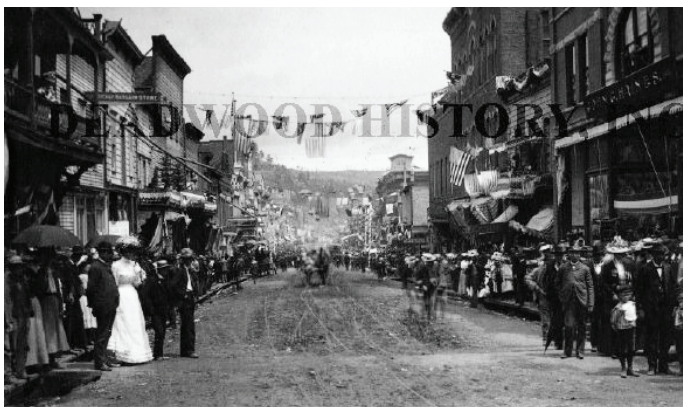
1890s: Macadam street paving in the core of Main St with a continuous boardwalk. ("1890s hmcc 46125 dirt street DHI.jpg")

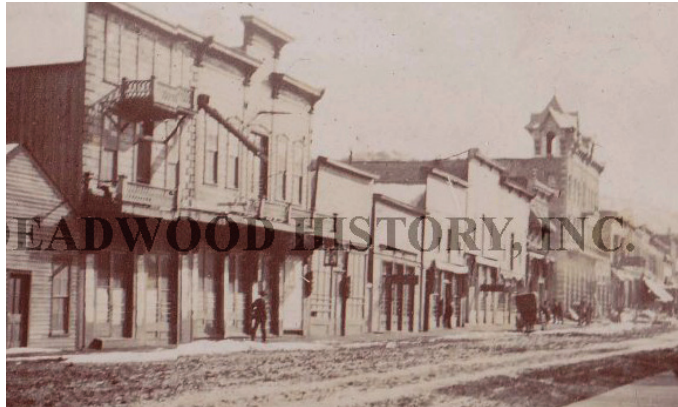
1896: Continuous boardwalk detail on Lower Main St. ("1896 0070194003 boardwalk detail DHI.jpg")

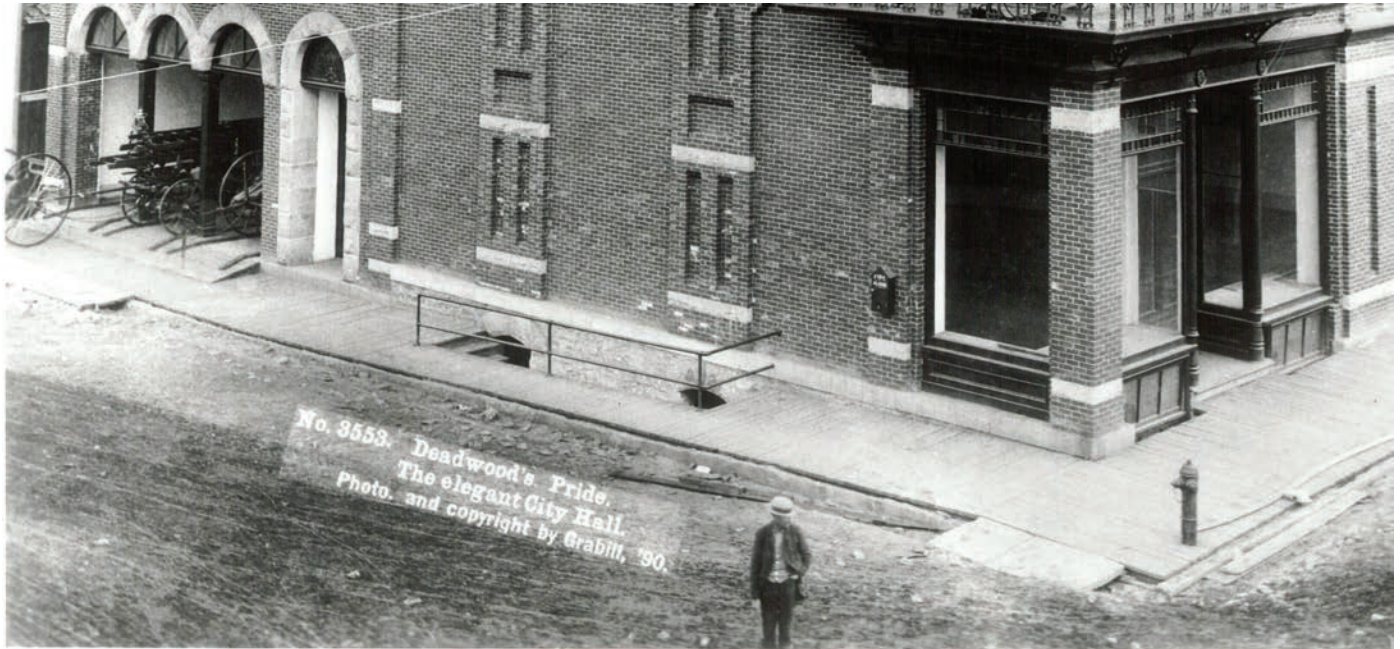
1890: City Hall sidewalk at the corner of Deadwood and Main Streets with board extensions over the gutter - early bump-outs. ("PHO.2000.0031.2 bumpouts 1890 city hall.jpg")

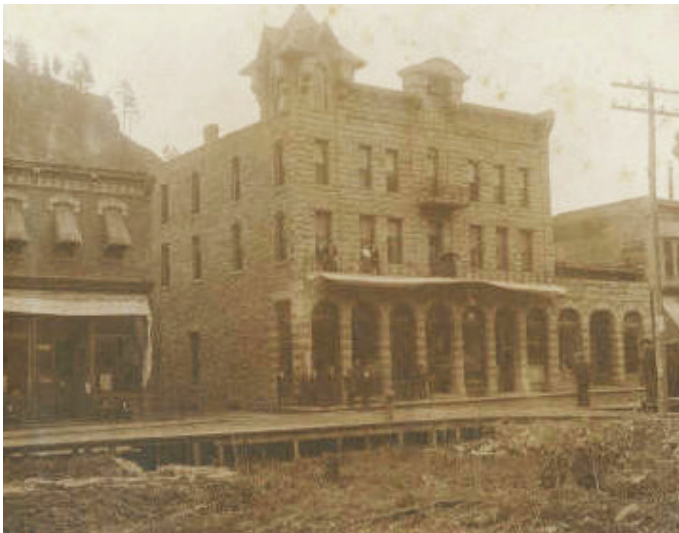
After 1896: Boardwalk reconstruction after a fire. Bullock Hotel in the background. ("The Bullock 1895 2008-01-16-014 SDDA Street construction?.jpg")

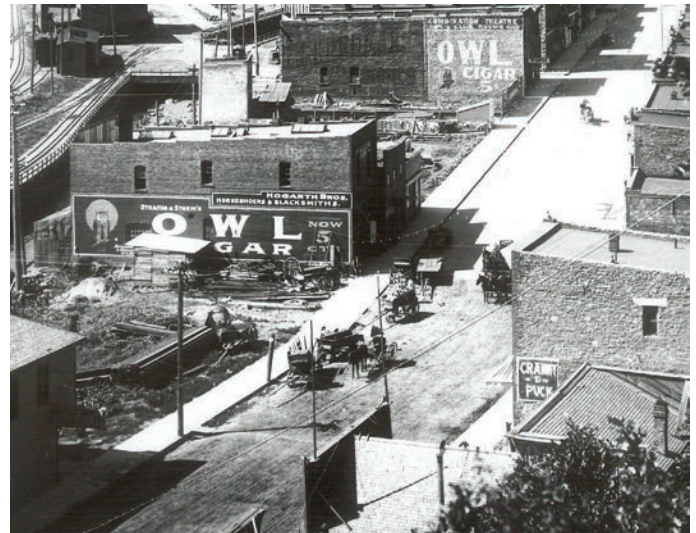
DATE?: Lower Main St. boardwalk with ramp across gutter. ("PHO.2000.0079.1 lower main boardwalk and ramp.jpg")

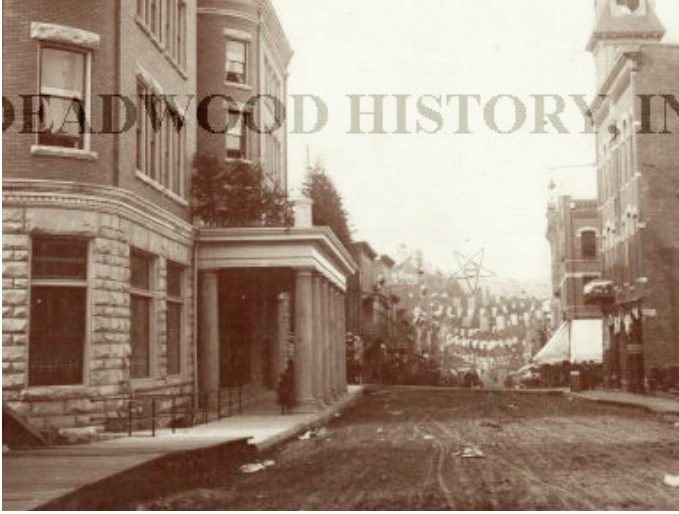
1903-1905: Concrete in front of hotel; boardwalk to the south of it. Franklin sidewalk change extends further South. ("1903-1905 0070016001 Franklin sidewalk change DHI.jpg")

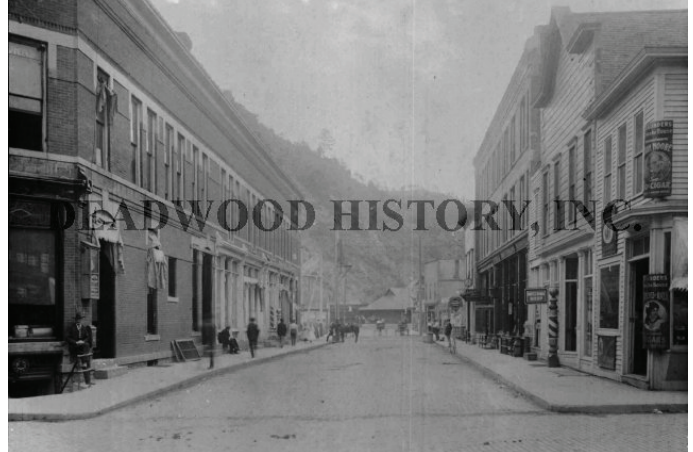
DATE?: Brick street paving. Concrete sidewalk, no curb and gutter on Lee St. ("Lee St 0070066001 brick paving.jpg")

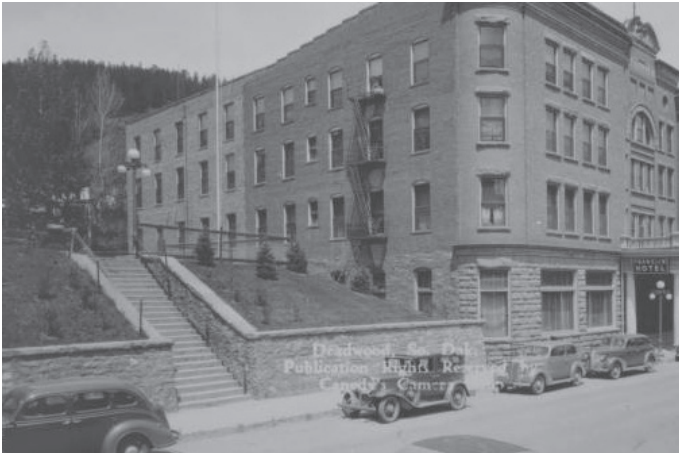
1930s: Franklin Hotel concrete sidewalk. ("2008-01-10-002 Franklin hotel 1930s conc sidewalk SDDA.jpg")

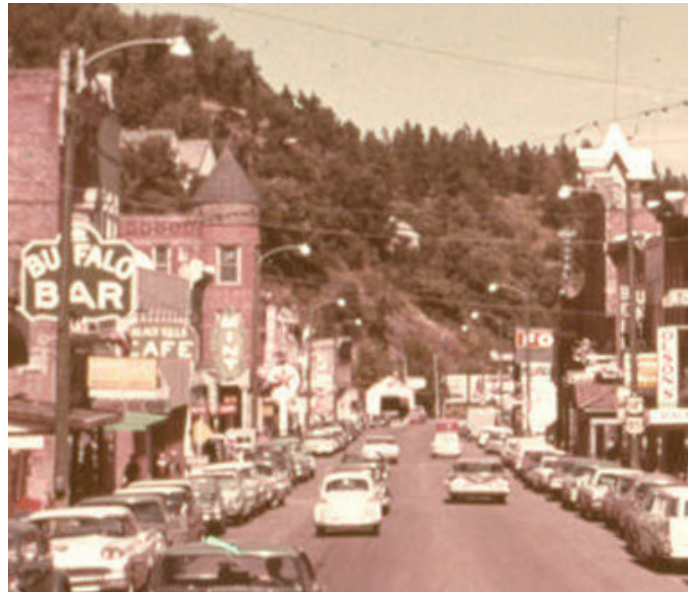
1960s: Asphalt paving & cobra street lights. ("2012-07-02-325 asphalt & cobra lights 1960s? SDDA")

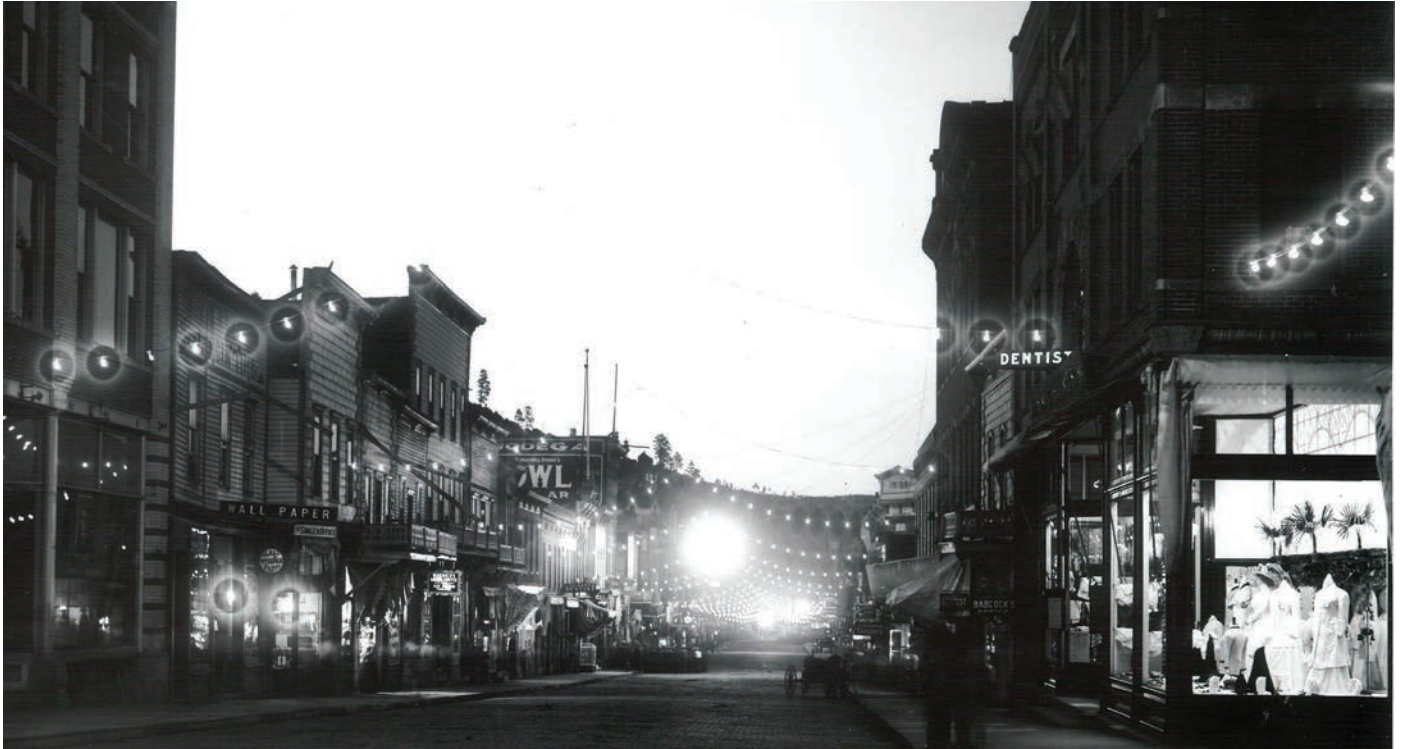
DATE?: Unshielded Edison lights at night. ("PHO.2000.0102.1 Edison lights at night.jpg")

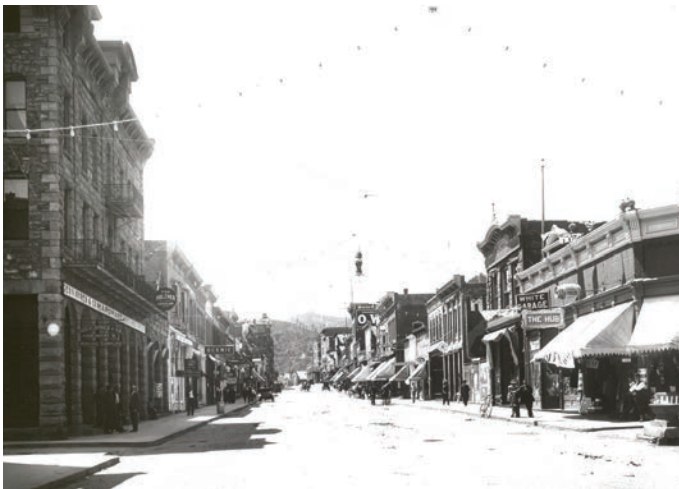
DATE?: Unshielded Edison lights. ("Stemin Photos_4.jpg")

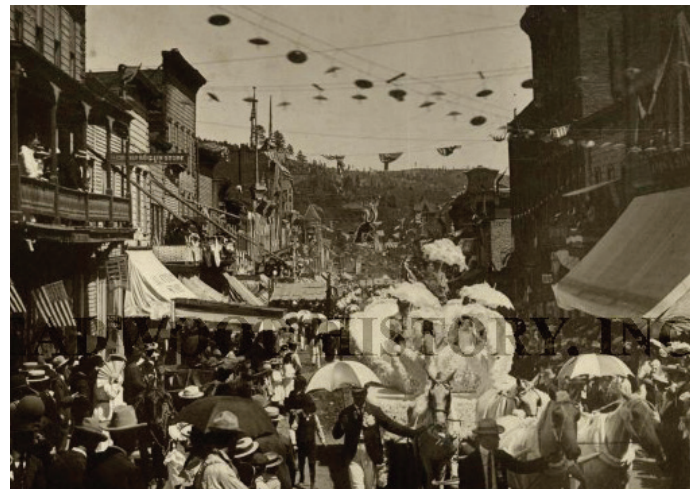
1902: Shielded Edison lights. ("1902 0070019001 shielded lights DHI.jpg")

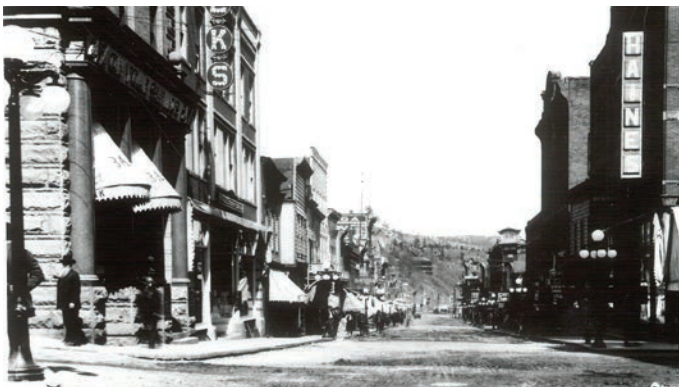
After 1912: Original 5-Globe lights. ("PHO.2000.0173.1 original 5 globe lights.jpg")

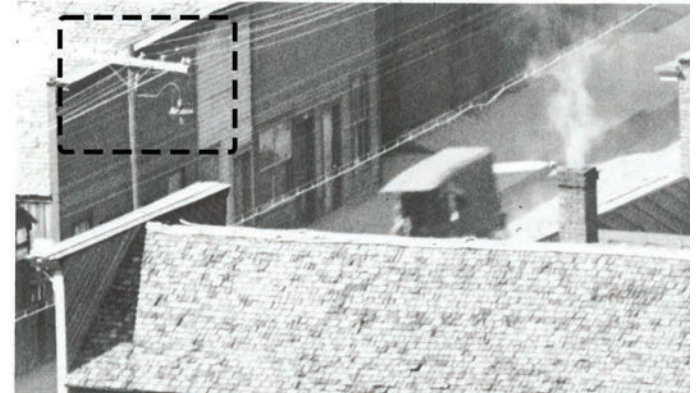
Date?: Shielded Pole Mounted Lights ("Pho-2000.439.jpg")

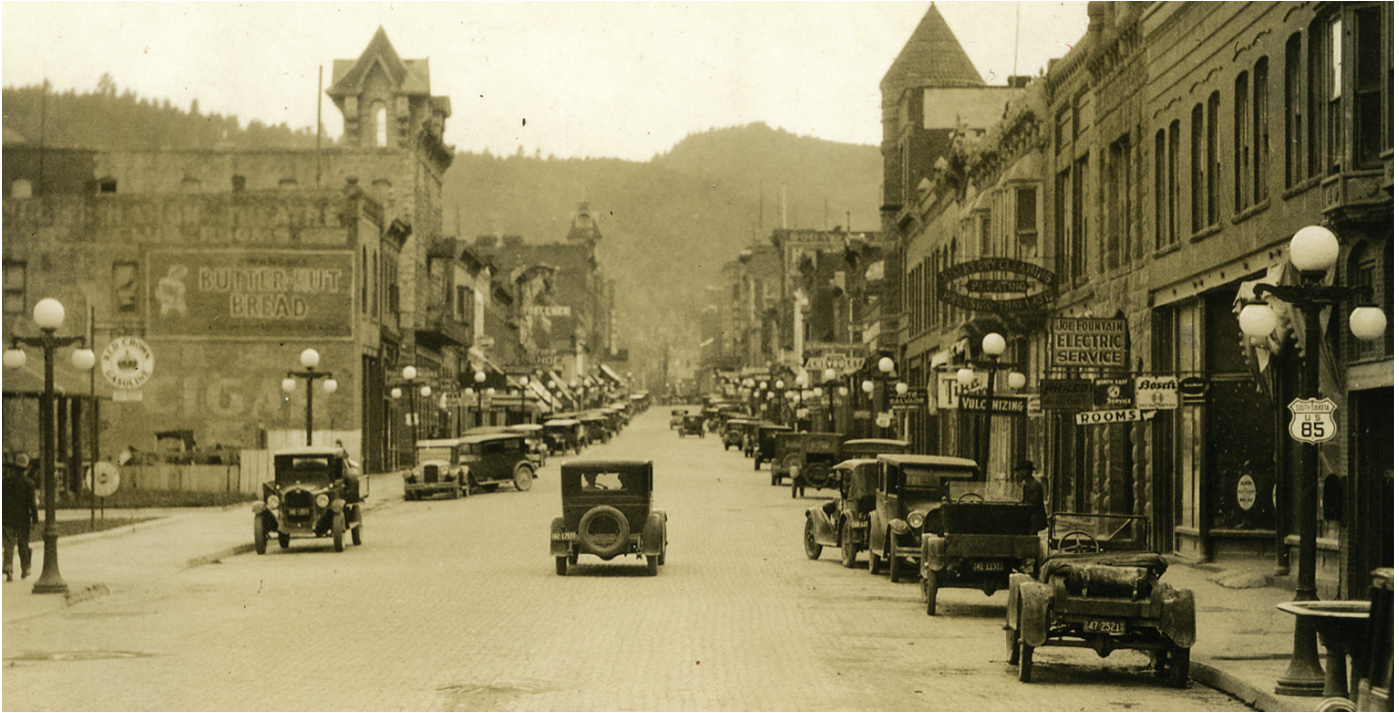
1928: 3-Globe lights on dark poles along Lower Main St. Note the “basin” on sidewalk to the right. (“PHO.2018.22.1 Lower Main 3 globe lights 1928.tif”)

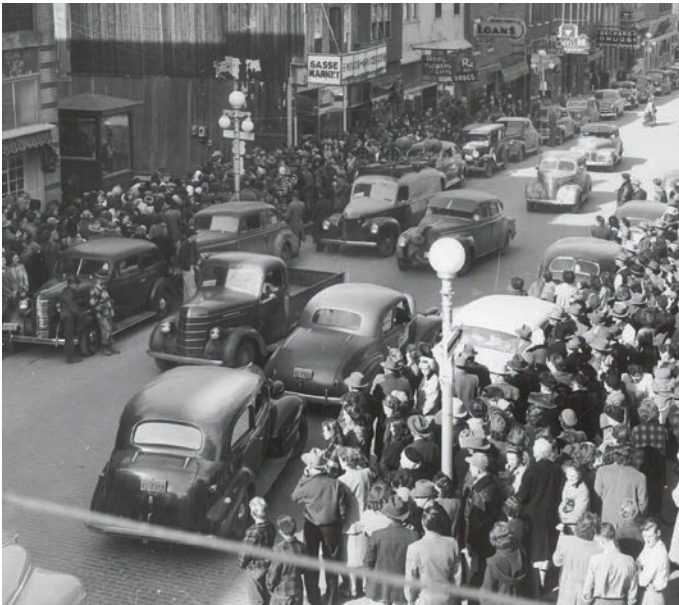
1950s: Combination of 3-globe and 1-globe lights on white light poles. (“PHO.2000.0309.1 white light poles 1950s?.jpg”)

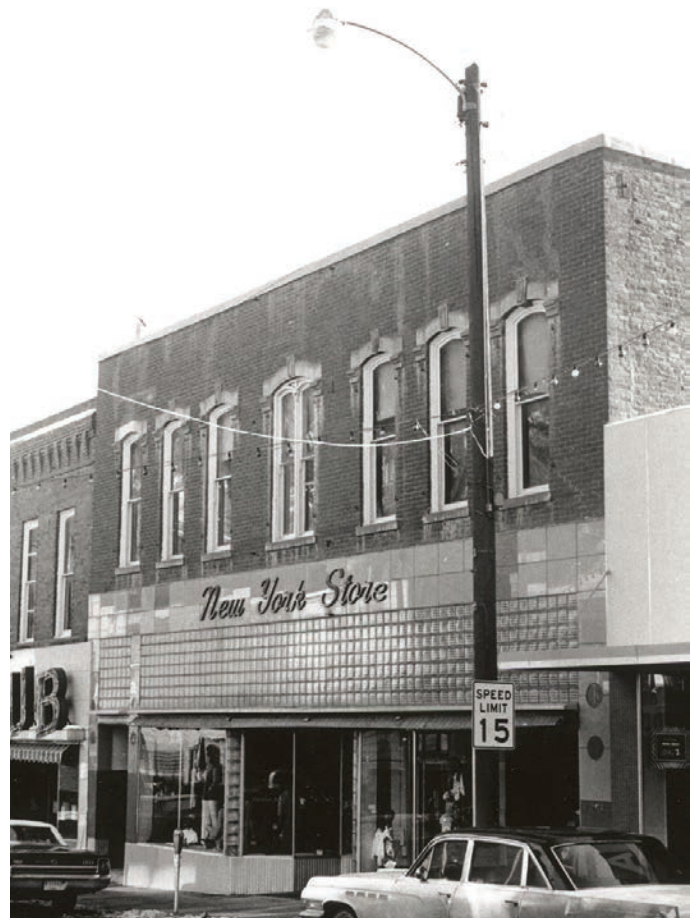
1974: Cobra light poles. Note the parking meters. (“cobra light DWD archives 1974_survey_23.jpg”)

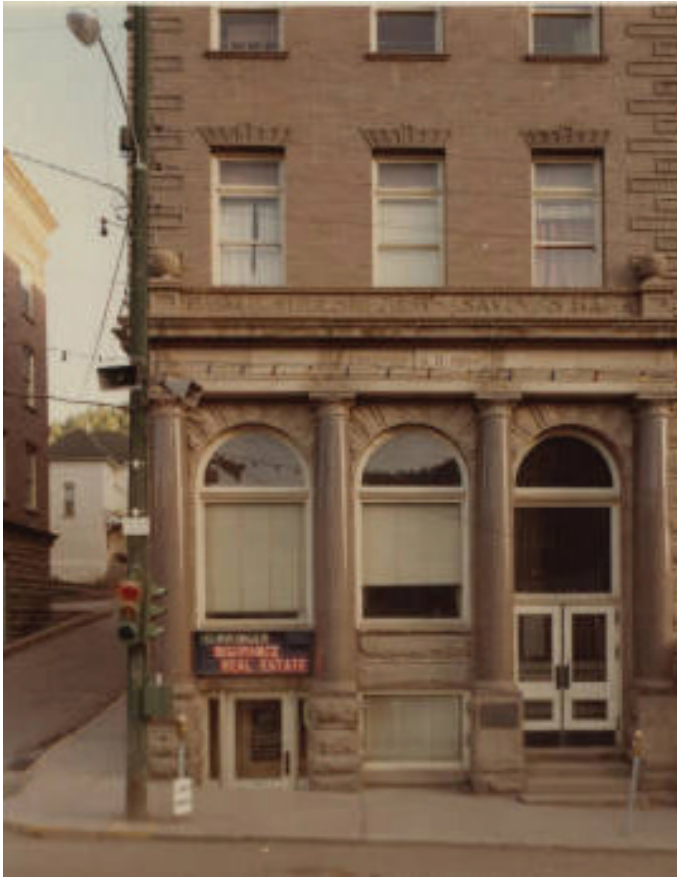
DATE: Cobra light poles and traffic lights. Also note audio speakers on the pole. ("2008-03-06-060 cobra and traffic lights SDDA.jpg")

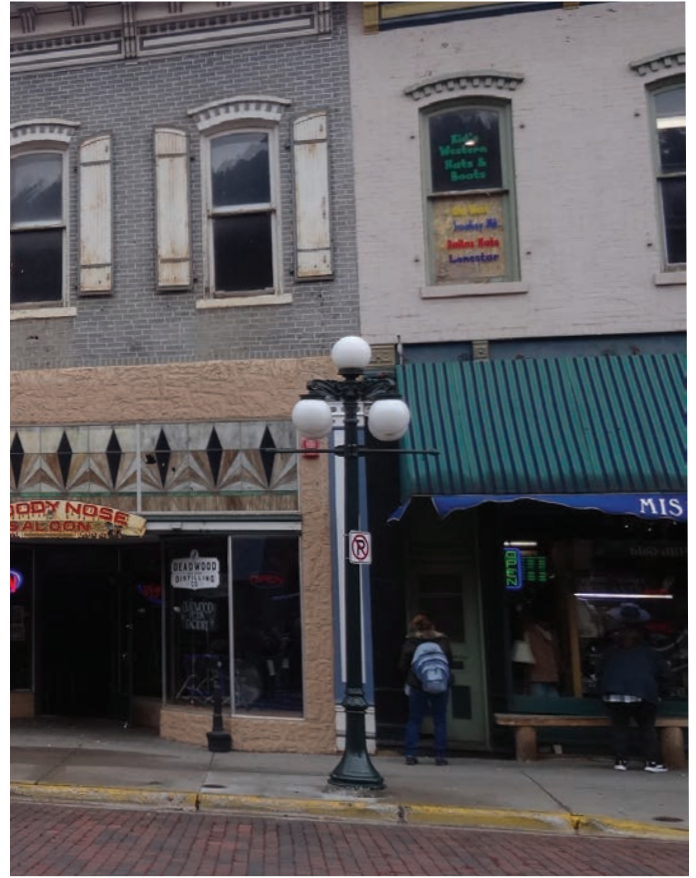
2019: New (replica) 5-globe lights. ("2008-03-06-060 cobra and traffic lights SDDA.jpg")

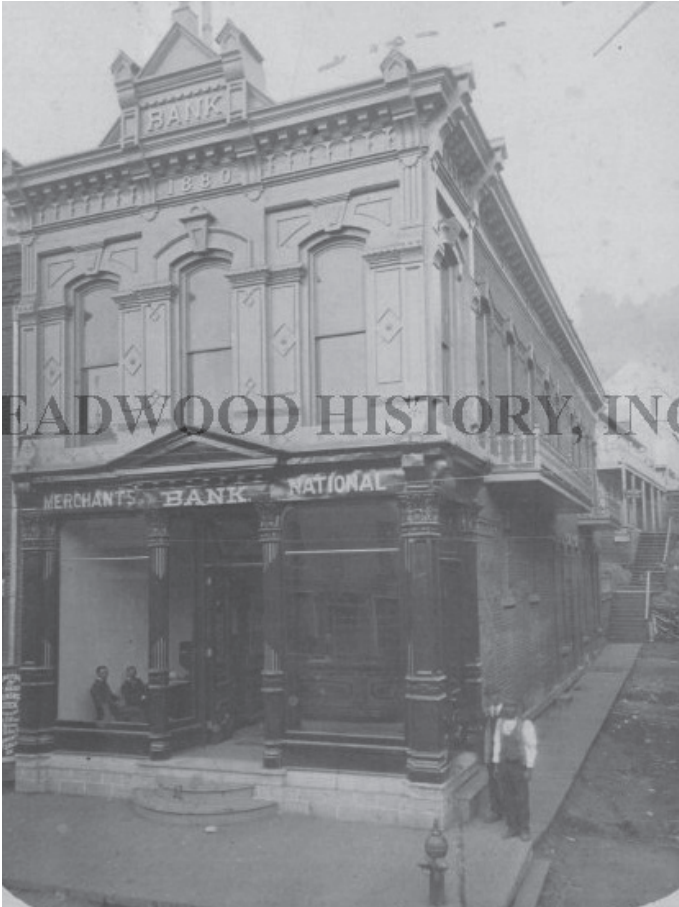
1880-1885: Note the hydrant at the bottom of the image. Concrete sidewalk on Main St. and a boardwalk on Shine St. ("1880-1885 0070021001 hydrant DHI.jpg")

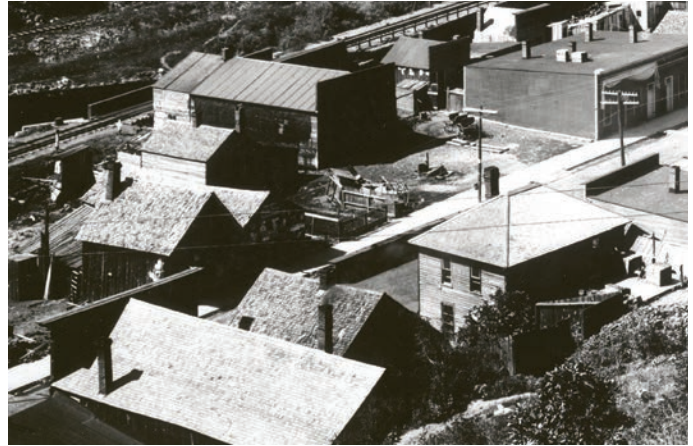
DATE?: Utility poles along lower Main Street. ("Stemin Photos_3")

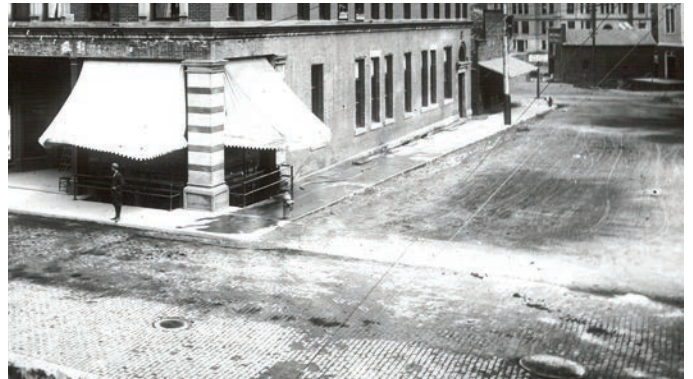
DATE?: Manholes at the Masonic Building. Main Street has brick paving; Deadwood Street does not. ("PHO.2000.0075.1 manholes Masonic Bldg.jpg")

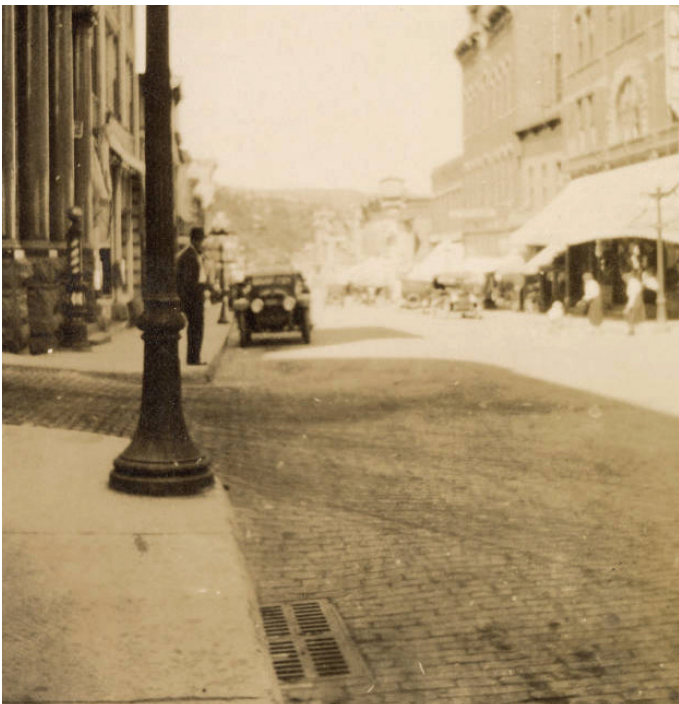
DATE?: Storm sewer grate. Concrete sidewalk with no curb and gutter, brick street. ("2019-10-28-319 storm sewer grate SDDA.jpg")

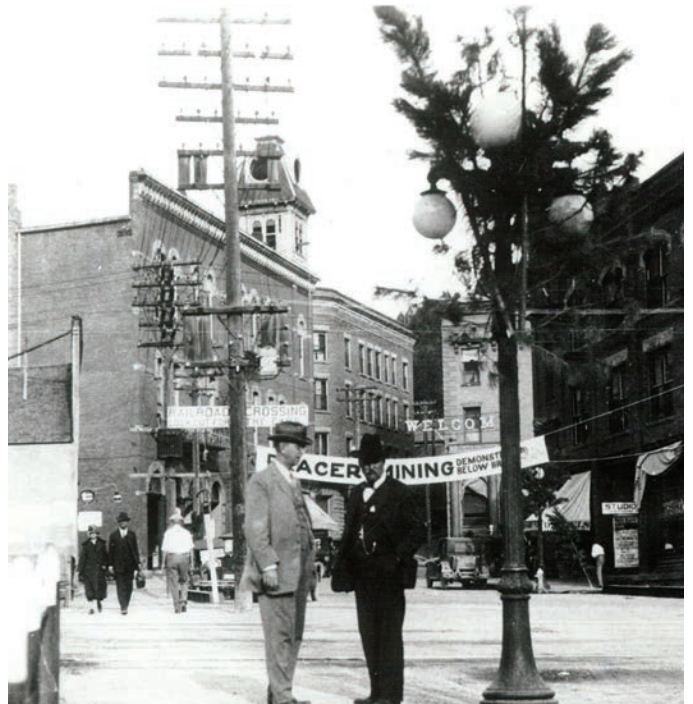
DATE?: Utility poles along Deadwood Street to Main Street. (2000.0221.1.jpg)

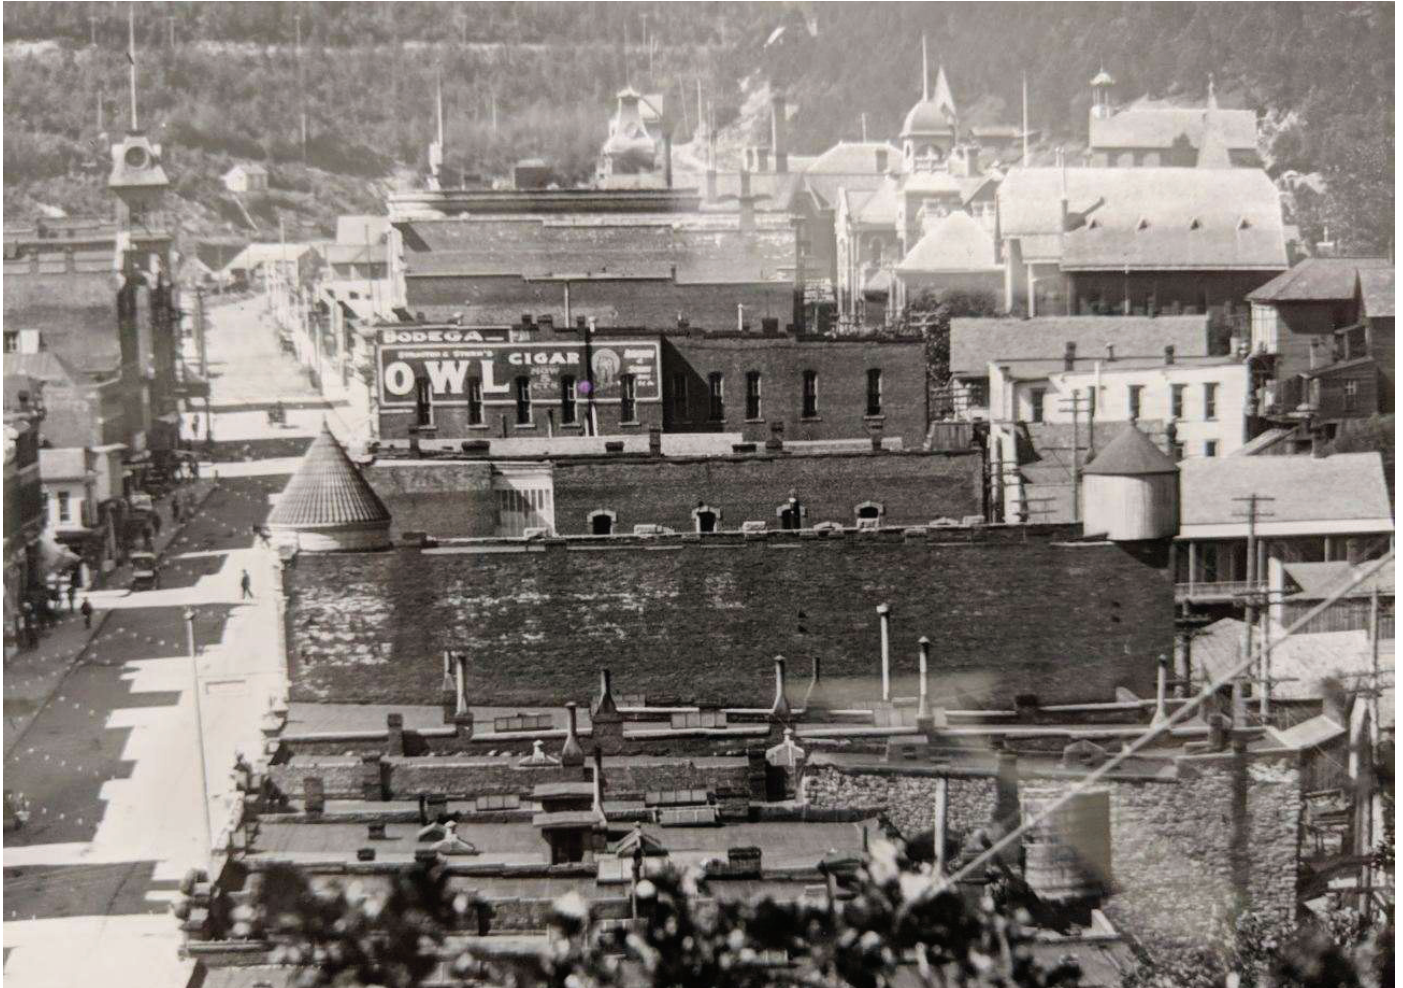
DATE?: The following features in this image are more related to buildings but certainly had a presence along Main Street; they include water towers and flag poles (lightening rods?). (Water Tower 2.jpg)

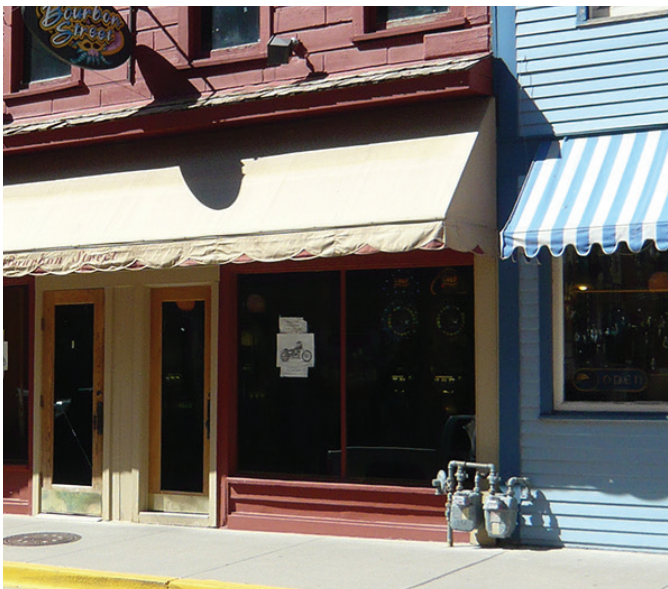
2009: Gas meter located in front of the building. (Winter & Company).

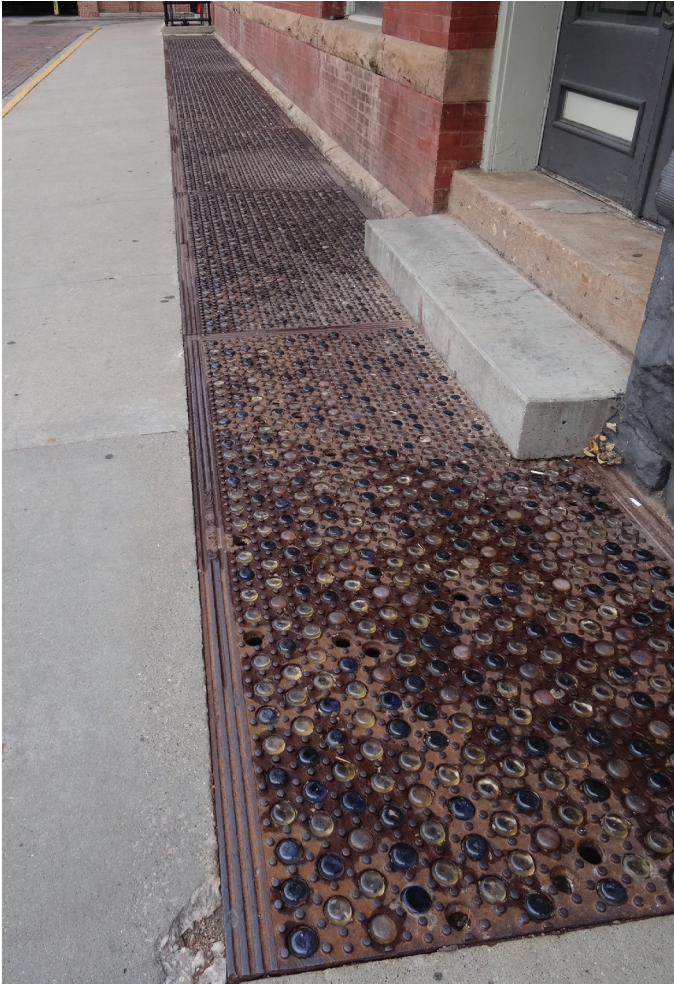
2018: Outside view of sidewalk vault with restored glass pucks. (Winter & Company)

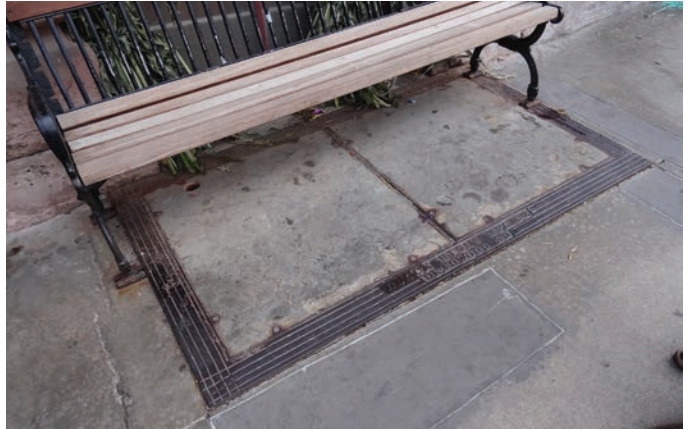
2018: Outside view of sidewalk vault covered with concrete coating. (Winter & Company)

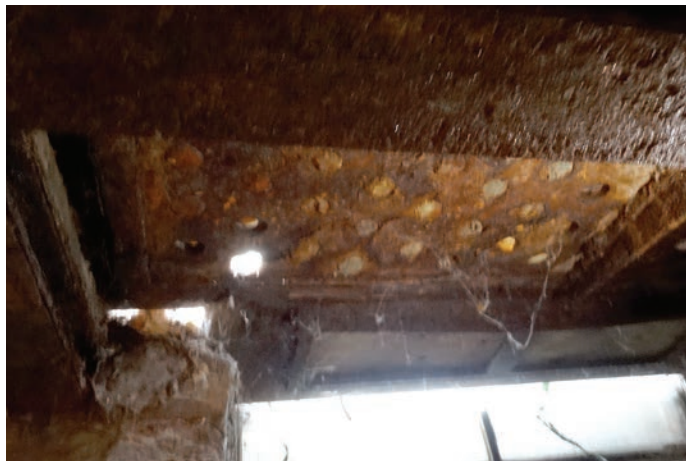
2018: Inside view of sidewalk vault cover. (Winter & Company)

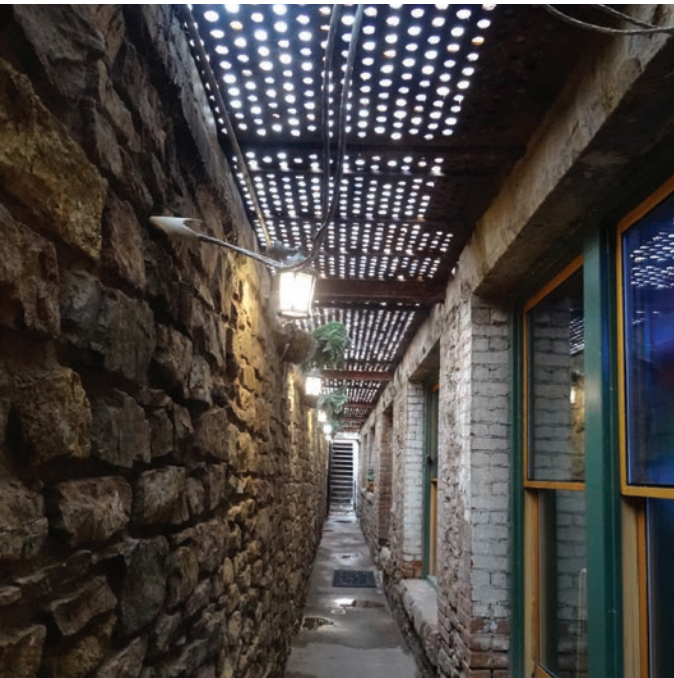
2018: Inside view of restored sidewalk vault cover along Franklin Hotel. (Winter & Company)

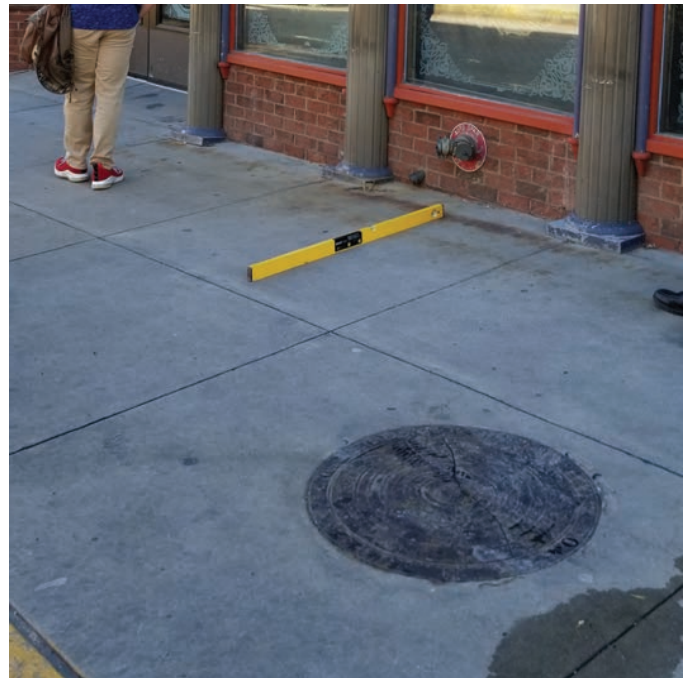
2018: Restored sidewalk manhole cover. (Winter & Company)

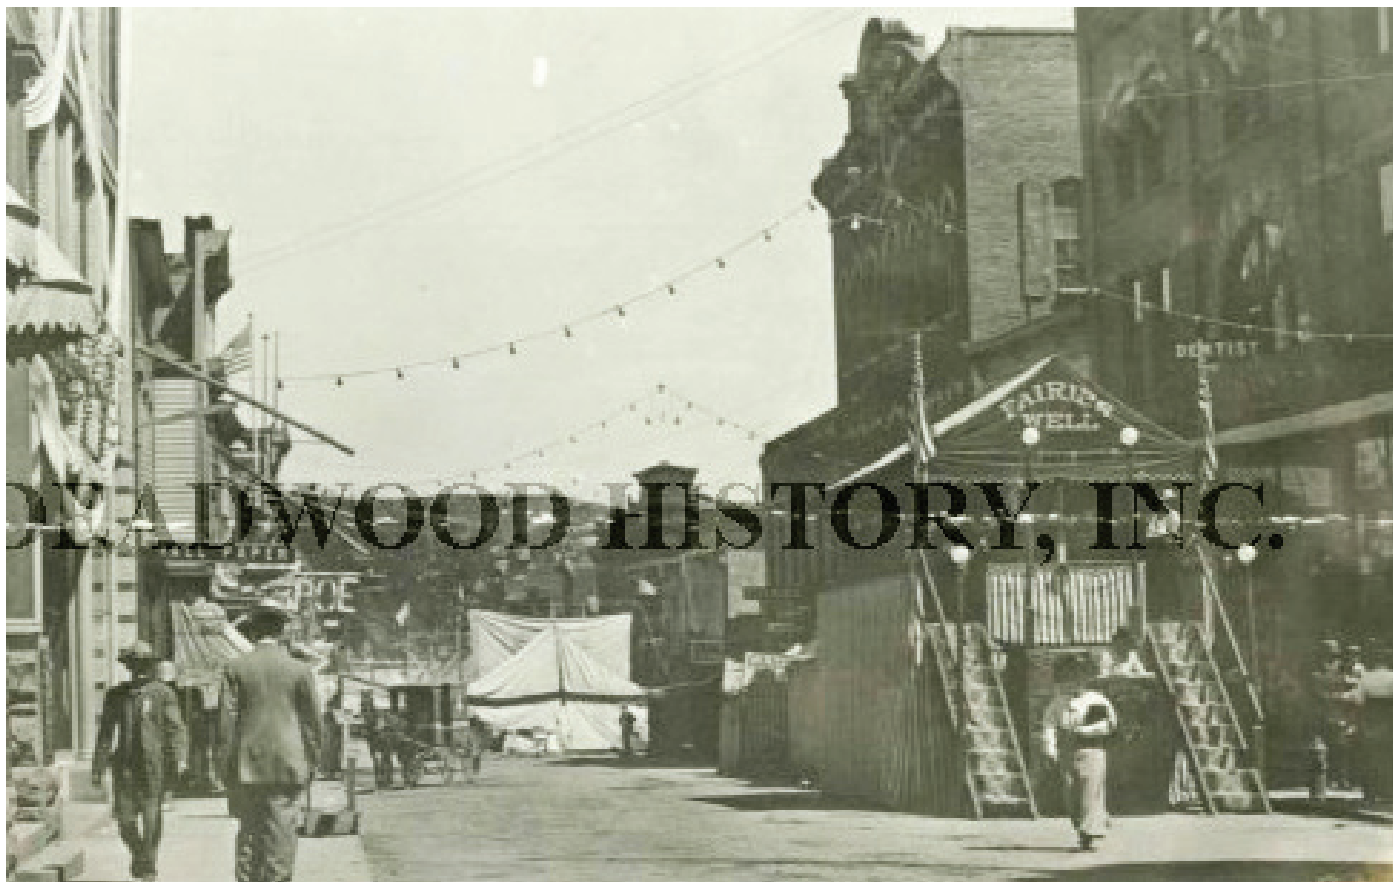
1880s-1890s: Booths in the street. Note the unshielded Edison lights. ("1880s - 1890s 0070163001 booths in street DHI.jpg")

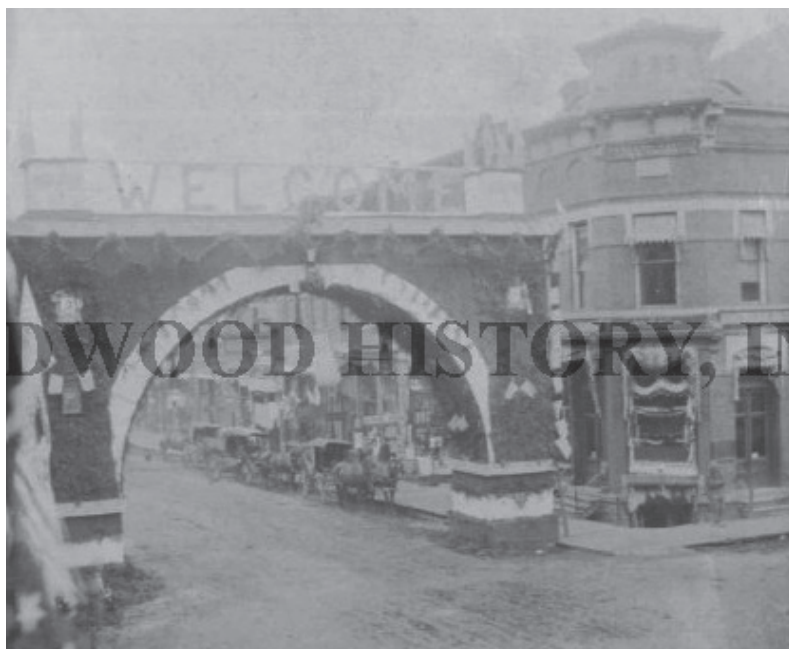
1900: Welcome arch over Main St. Note the ramp at the corner. ("1900 0072105001 welcome arch DHI.jpg")

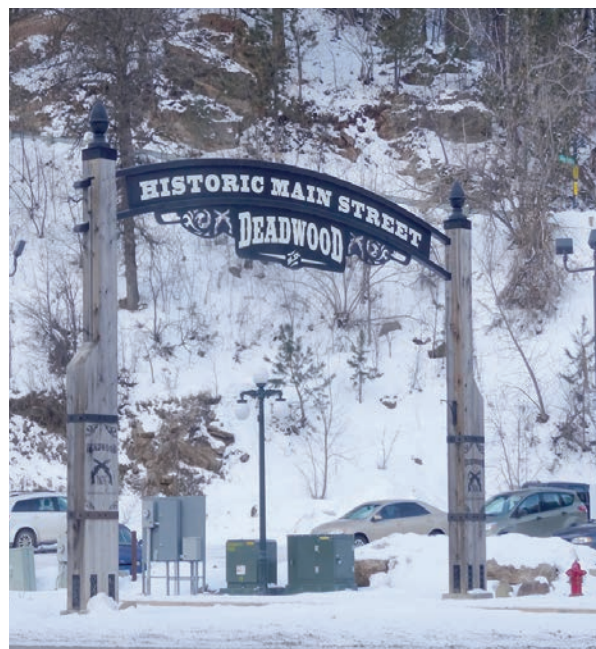
2020: Welcome arch over Main St. (Winter & Company)

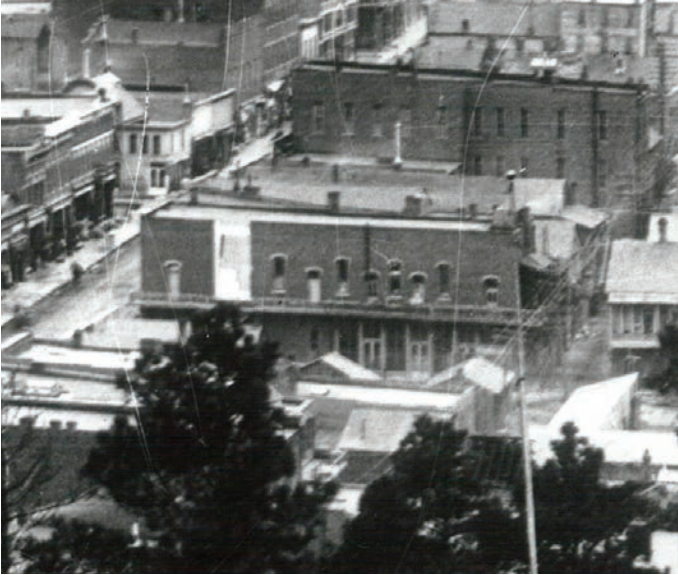
DATE?: A wood balcony overlook is attached to the side of the building and stretches from the front to the back of the building. ("PHO.2000.0123.1.jpg")

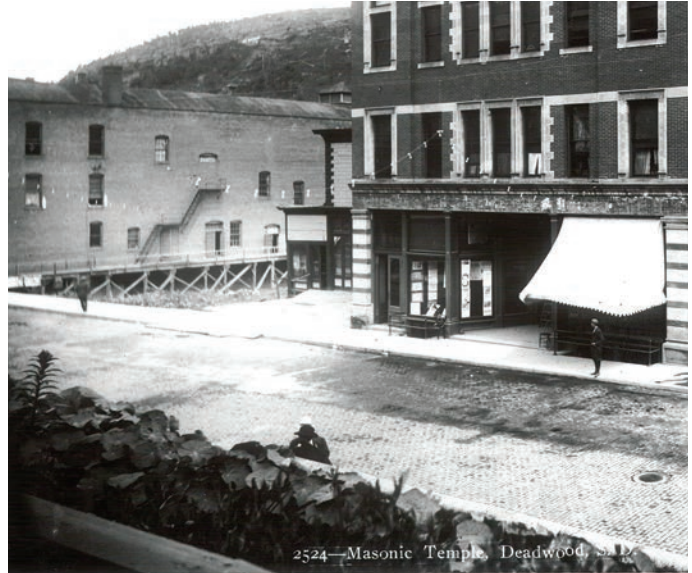
DATE?: Masonic building sidewalk chairs. Nearby, recessed storefront with small plaza space, planted retaining wall across the street and wood framed pass-through. ("PHO.2000.0075.jpg")

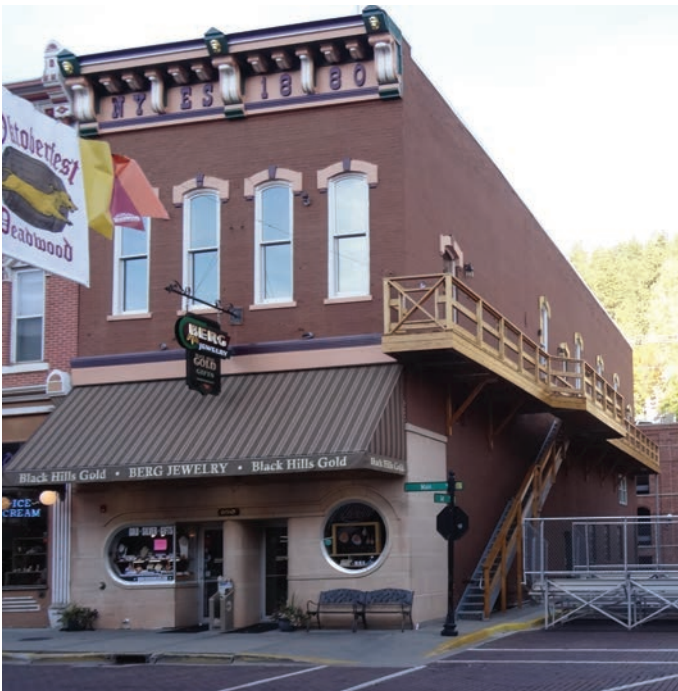
2018: Balcony reconstruction along Gold Street. (Winter & Company)

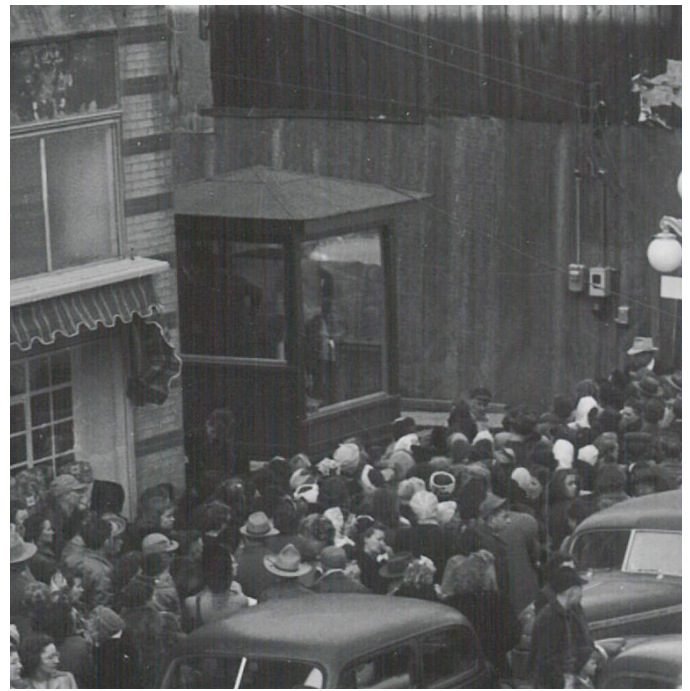
1950s: Sidewalk booth with windows. ("PHO.2000.0309.1 white light poles 1950s?.jpg")

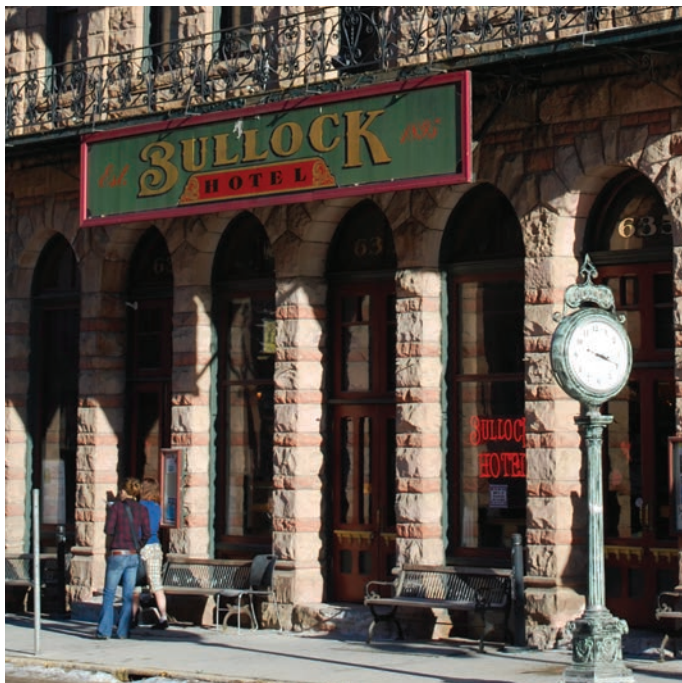
2009: Bullock Hotel clock, benches and wrought iron balcony.
(Winter & Company)

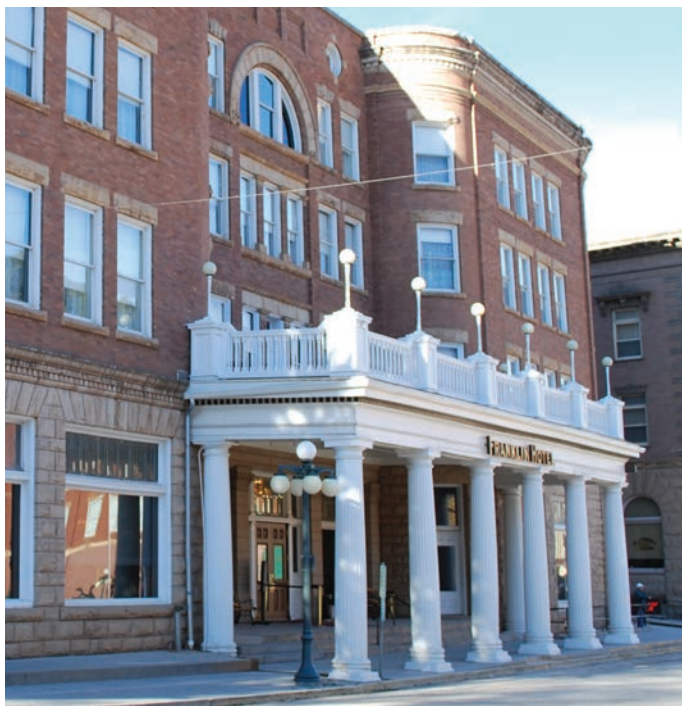
2009: Franklin Hotel covered walkway, with lighted balcony.
(Winter & Company)
