Historic Image Analysis of Deadwood Main Street

This document is a working paper, which illustrates the history of Main Street in a series of different topics. Topics include “Street & Sidewalk Paving,” “Street Lighting,” “Utilities,” “Special Structures,” “Vehicles,” “Street Furnishings,” and “Signs.” Within each topic, photos are arranged in chronological order, to the extent feasible. The focus is on the street itself, not the buildings that frame it.

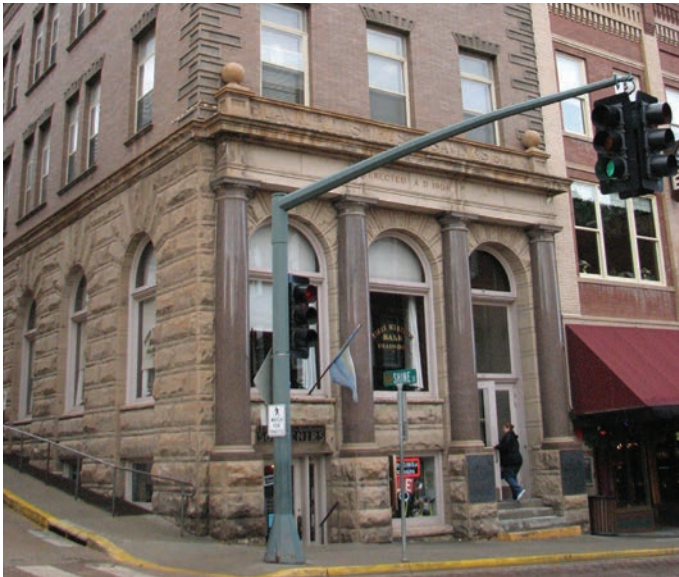
2008: Traffic lights at Spine and Main. (Winter & Company)

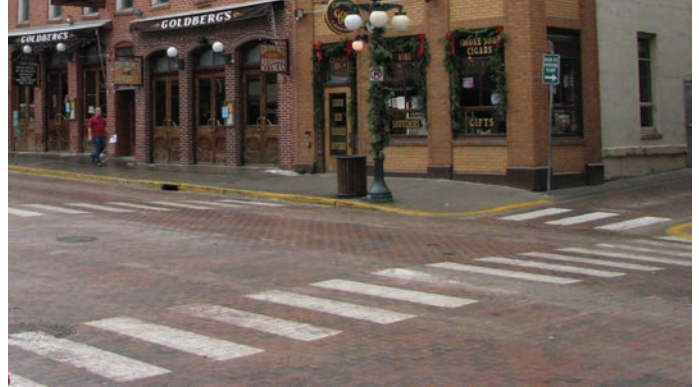
2009: Painted pedestrian crosswalks. (Winter & Company)

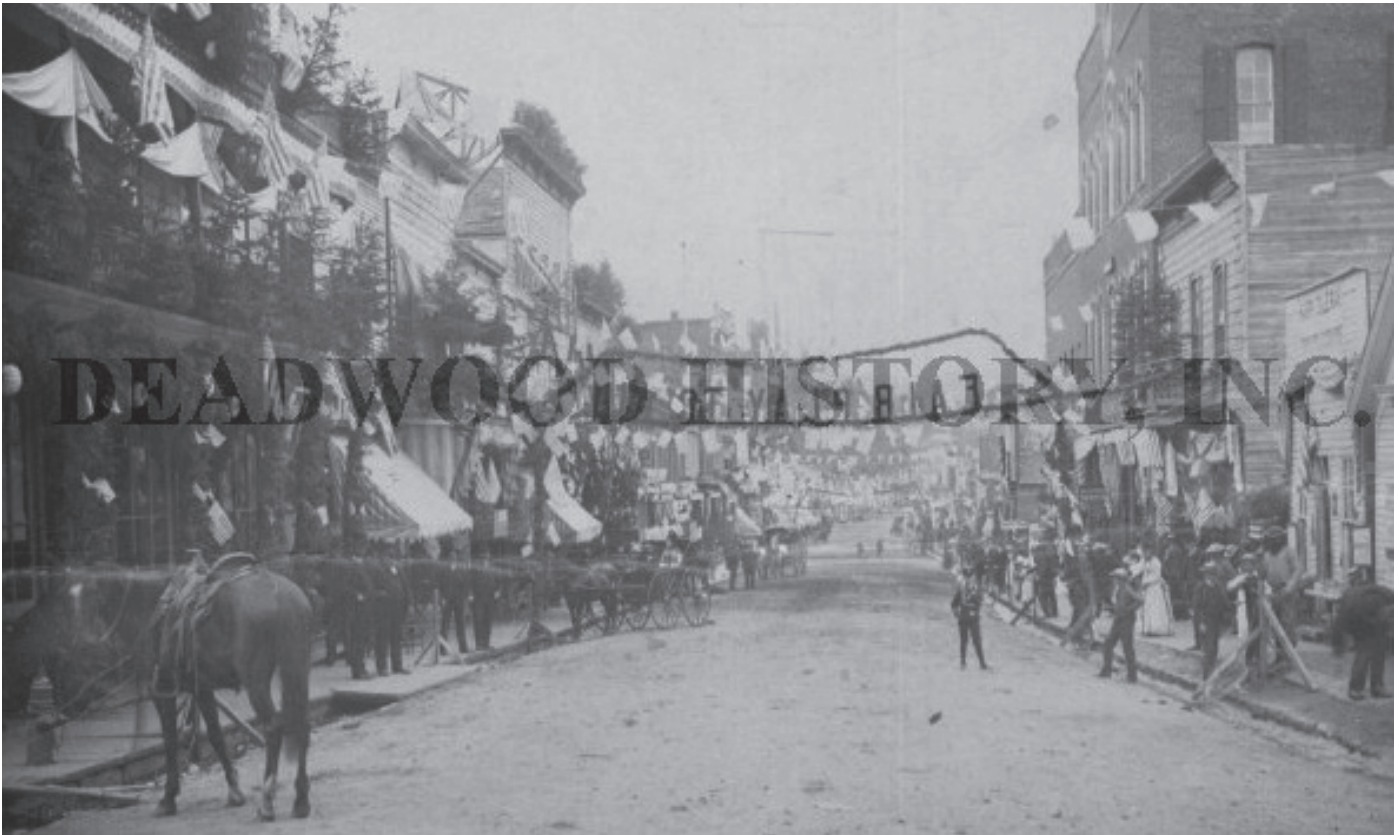
1890s: Wire fencing at sidewalk edge on wooden posts with bracing. Also note wood ramp over gutter. ("1890s 0070002001 wire fence DHI.jpg")

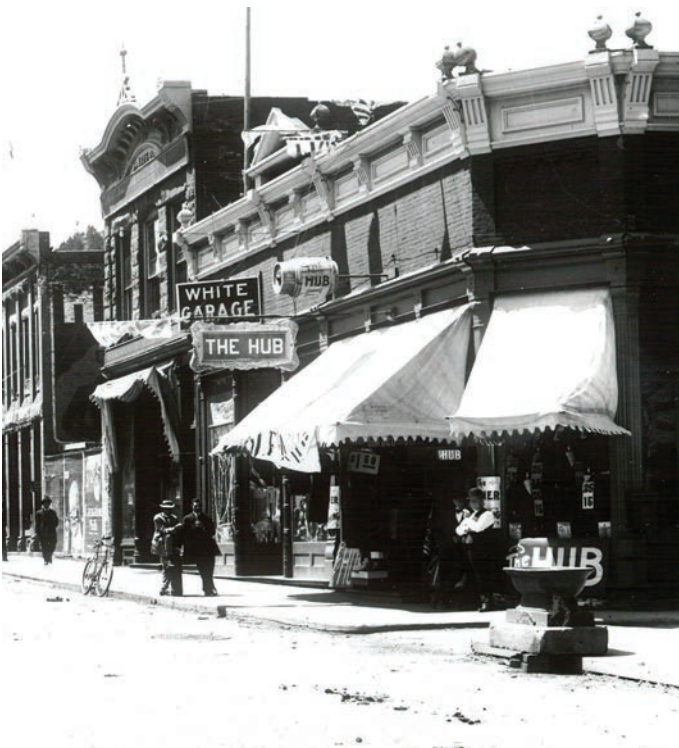
DATE?: Water basin and stone step at the curb. ("PHO.2000.0088.1 stone step and basin.jpg")

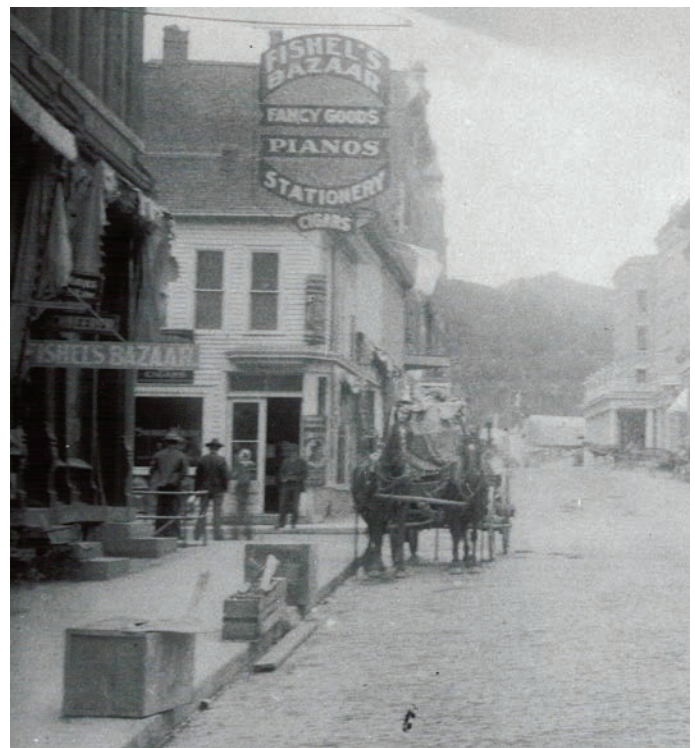
DATE?: Boxes at the curb. Also note steps at building entries. ("PHO.2000.0151.1 boxes at curb.jpg")

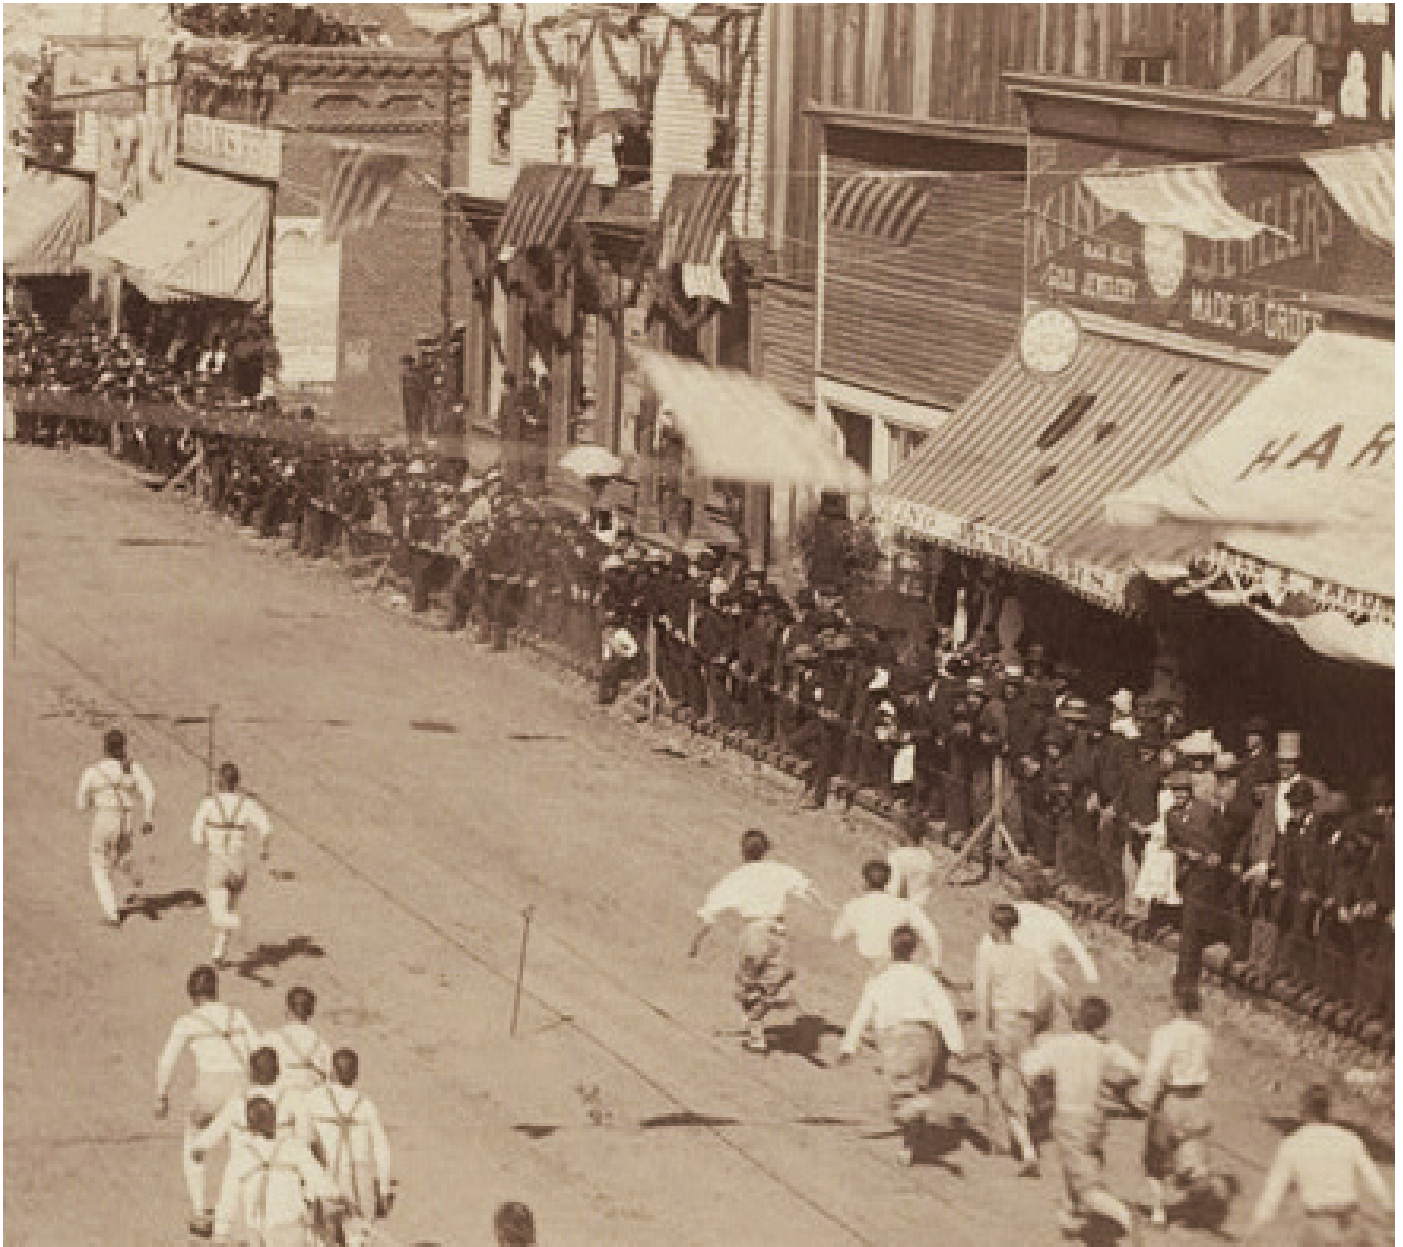
July 4, 1888: LibCon Race with wire fencing along Main St. Also note wire fencing in street to separate running teams. ("service-pnp-ppmsc-02600-02678v LibCon Race with fences.jpg")

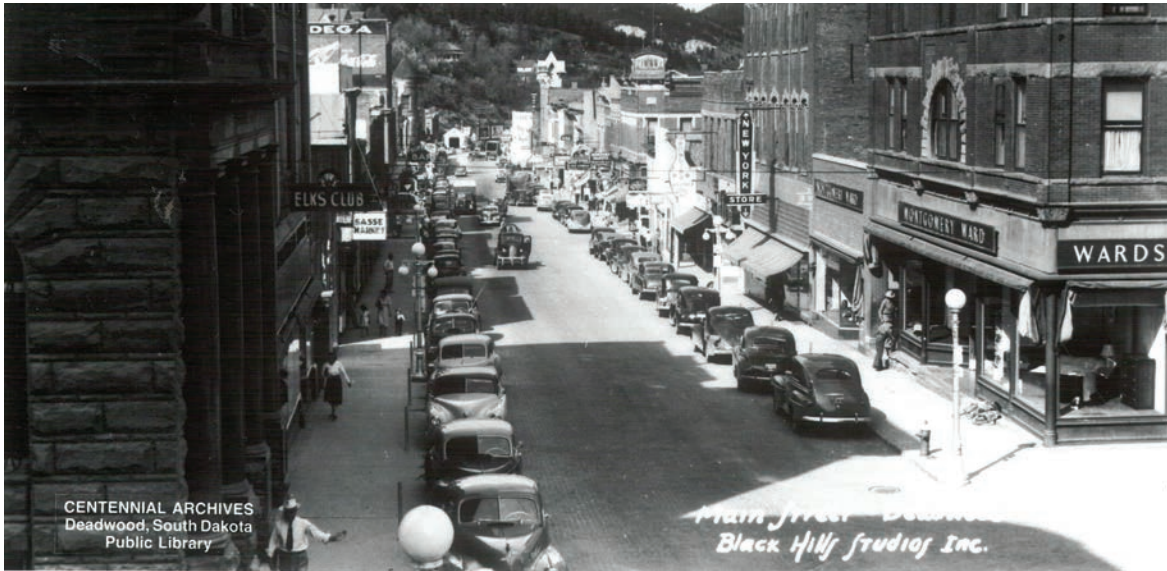
DATE?: Anchored sidewalk posts (2000.0215.1)

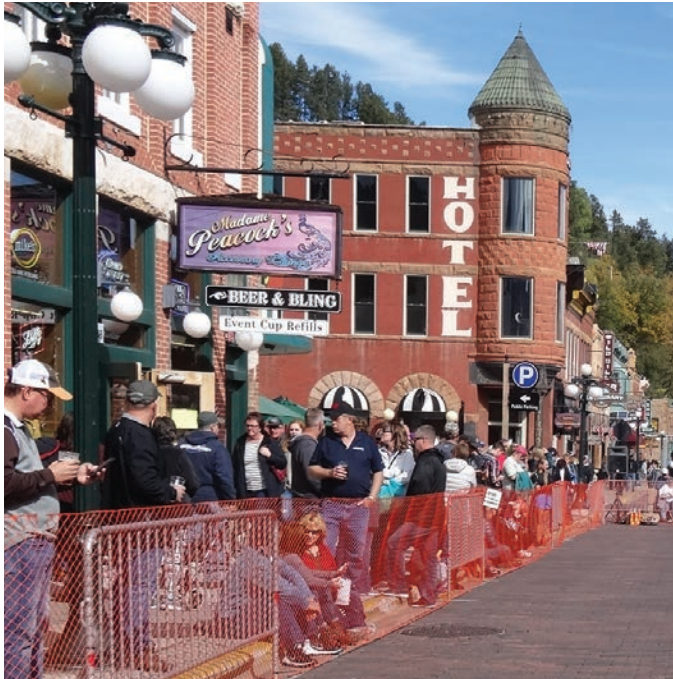
2018: Temporary crowd control for an event along Main Street (metal & plastic fencing). (Winter & Company)

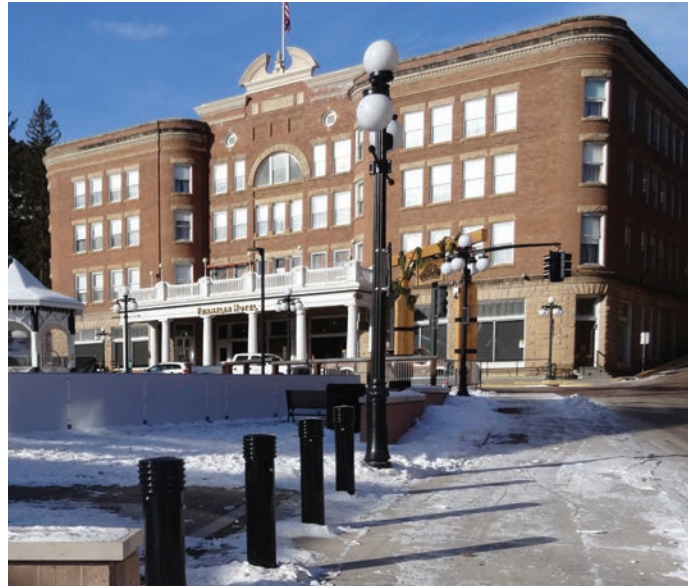
2020: Removable bollards are located along the sidewalk edge of Deadwood Street (metal). (Winter & Company)

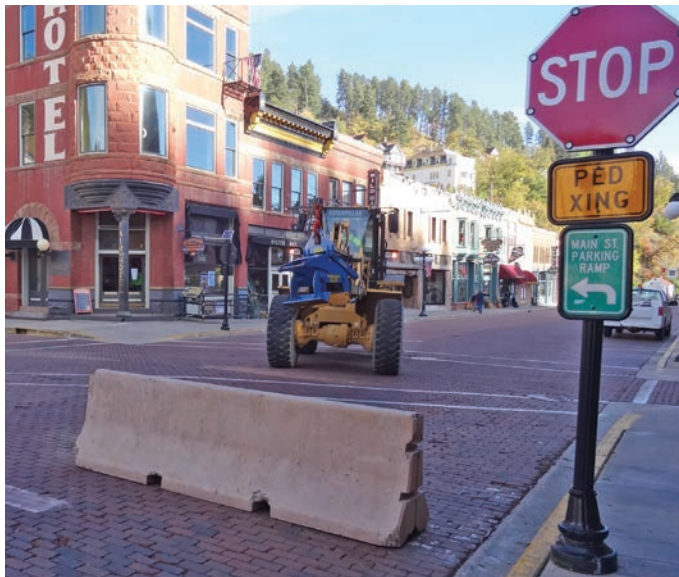
2018: Temporary vehicular control for an event along Main Street (concrete barrier). (Winter & Company)

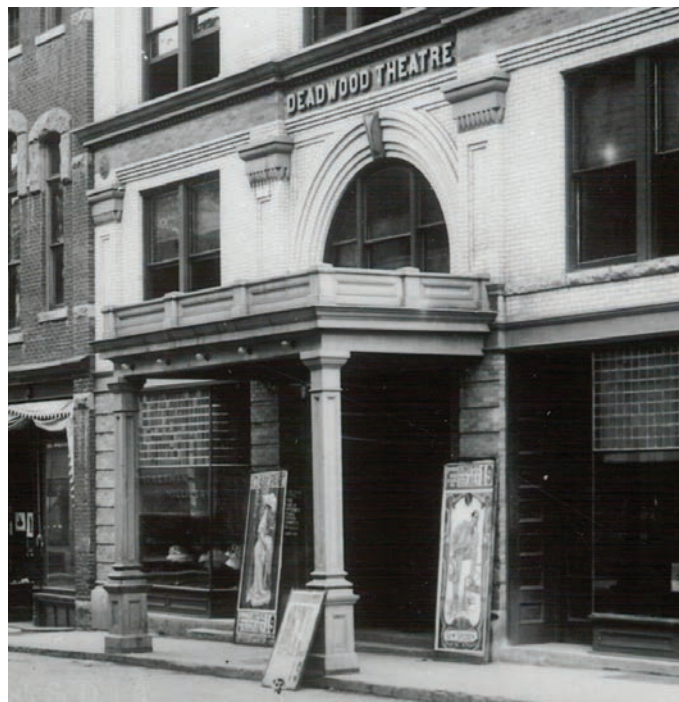
DATE?: Canopy posts and signs for Theatre on sidewalk. ("PHO.2000.0071.1 canopy posts Theatre.jpg")
