**APPEAL APPLICATION**

Exhibits to Appeal Application for Land Use Application
247-22-000415-MC-416-SP

Land Use Action Comment 247-22-000415-MC-416-SP

TECHNICAL MEMORANDUM

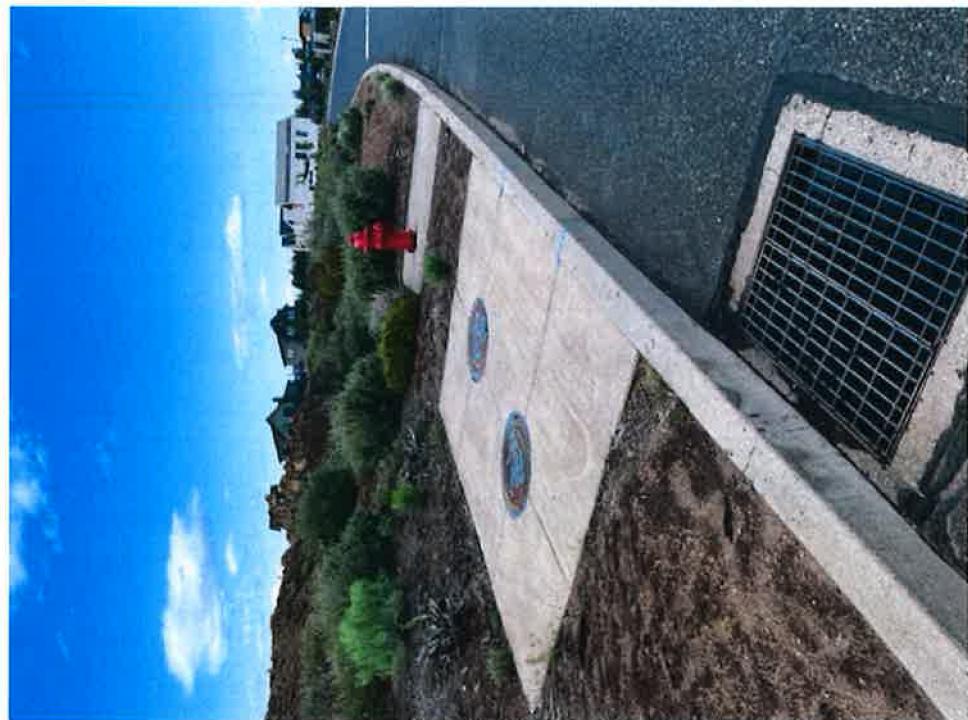
Catchment basin adjacent
to Proposed Land Use

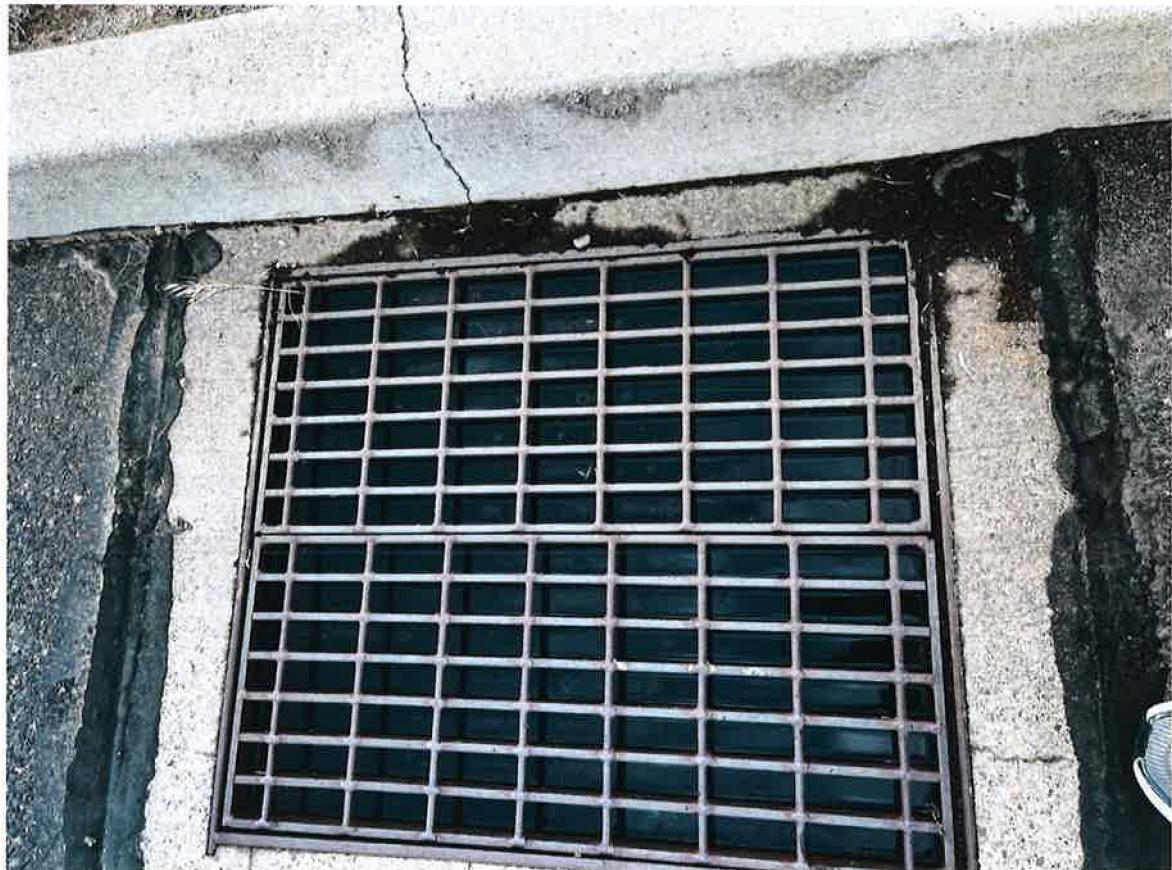
June 13, 2022, 10 days after rain event,
The catchment basin remained full.

Three weeks after the rain event, drains were pumped around the neighborhood. How often are they maintained?

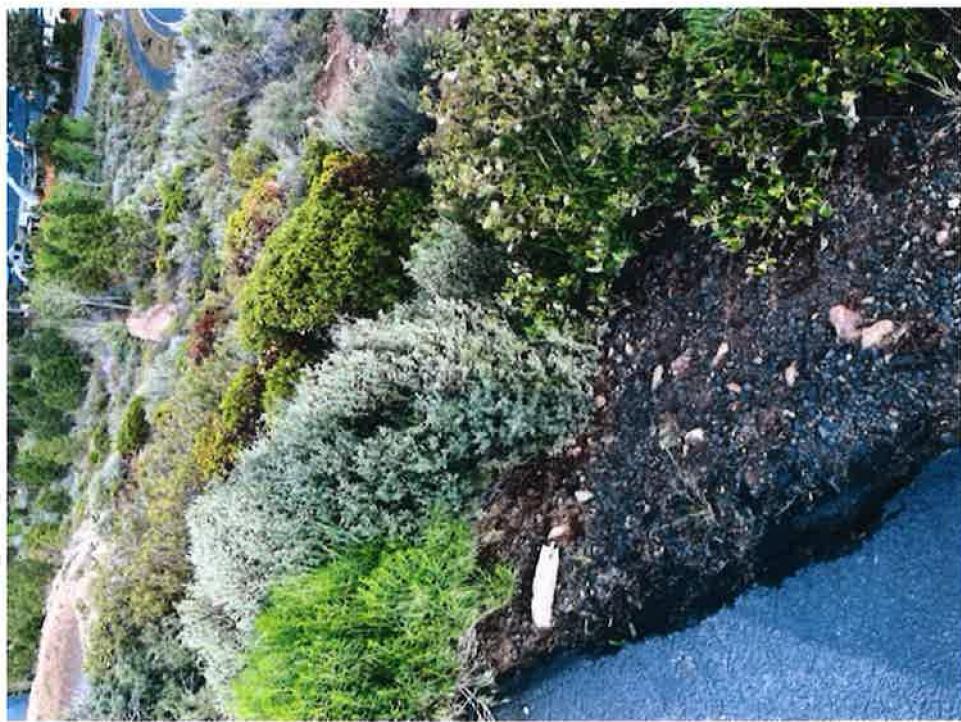
June 13, 2022. Evidence of remaining flooding on the south side of Meeks Trail, across the street from the proposed site of land use.

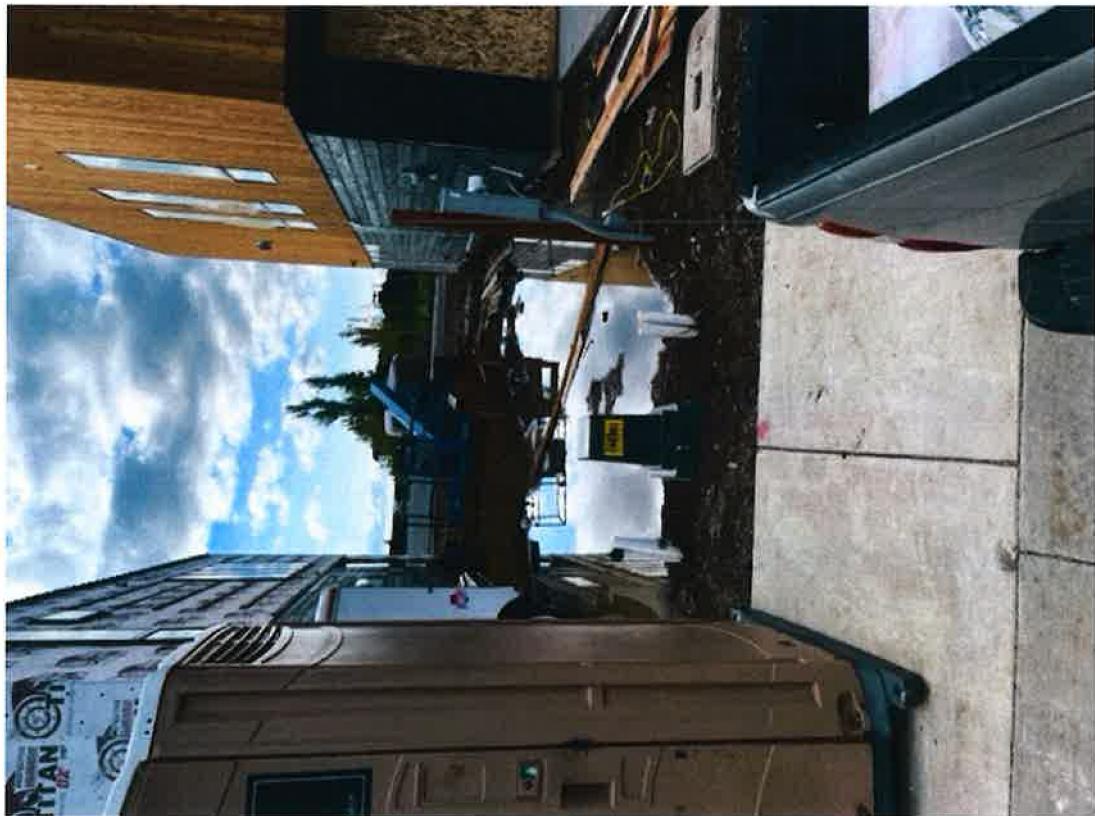
Evidence of erosion Lost Hollow Loop and Meeks Trail. A pattern?

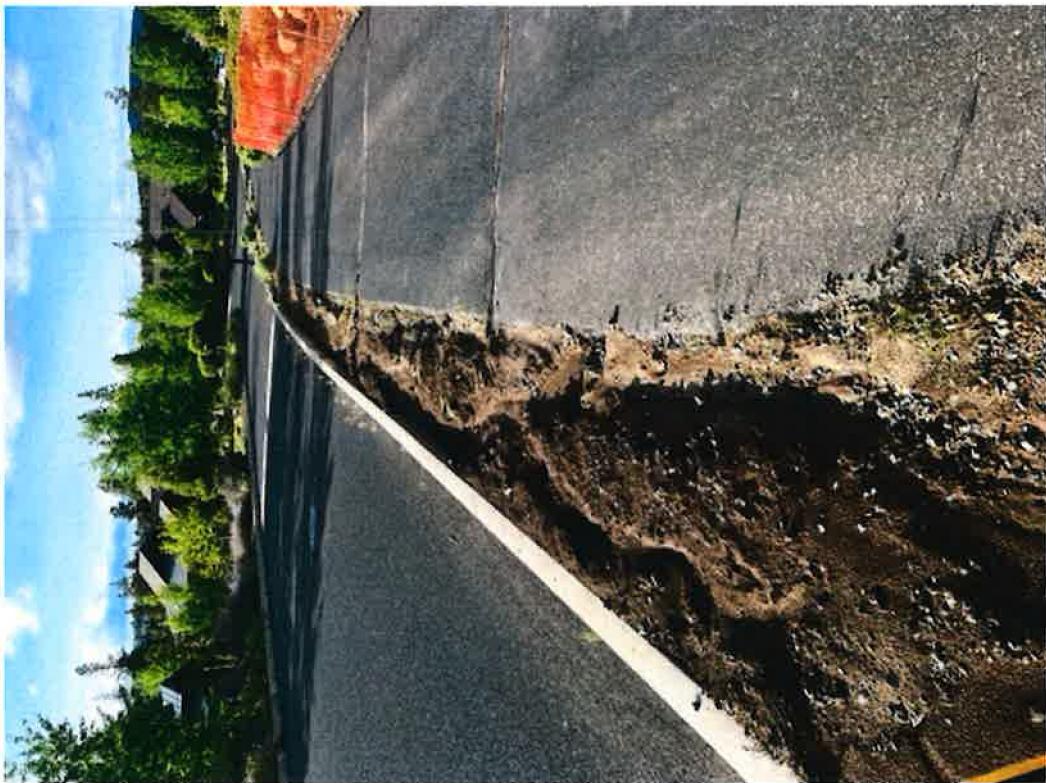
Evidence of erosion from Tetherow Vista. No catchment infrastructure. A pattern?

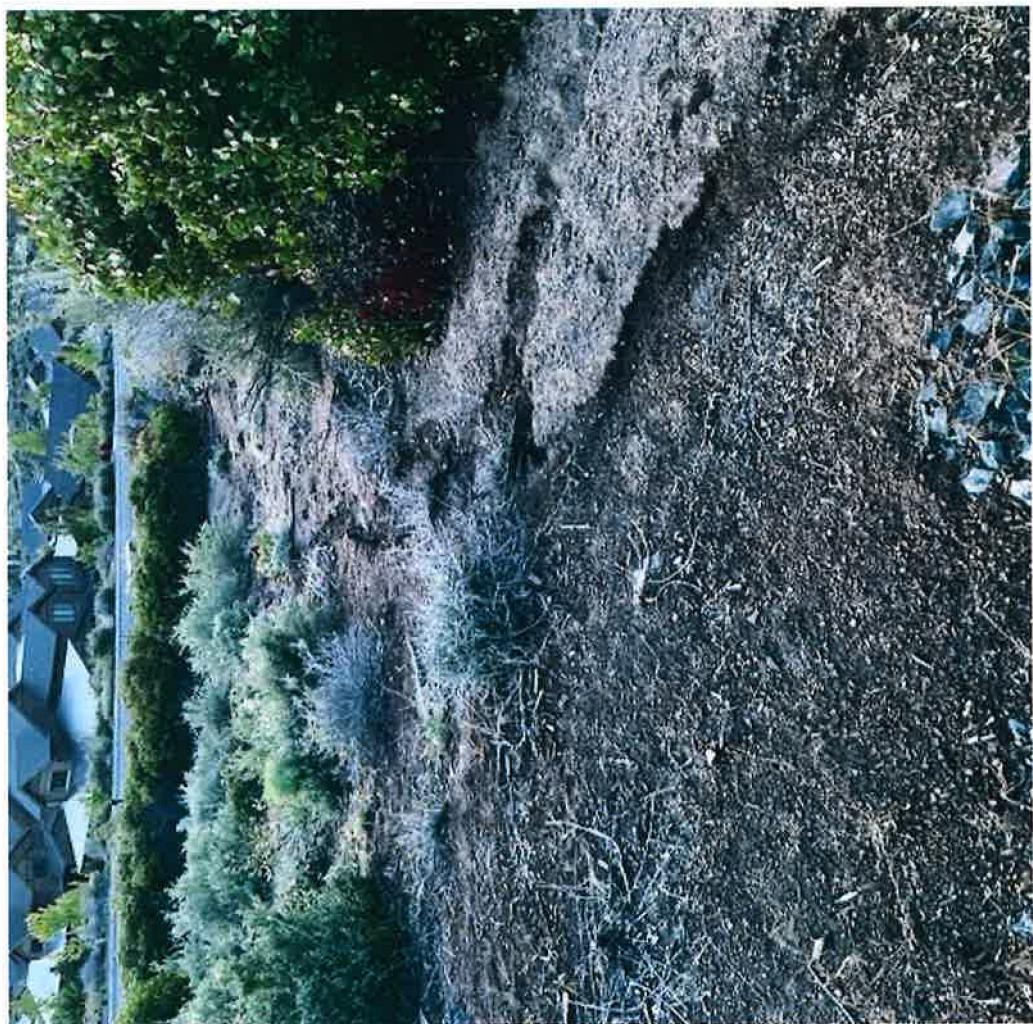
Before and After: Catchment Basins and Drainage Ponds Eliminated and Not Replaced. A pattern?

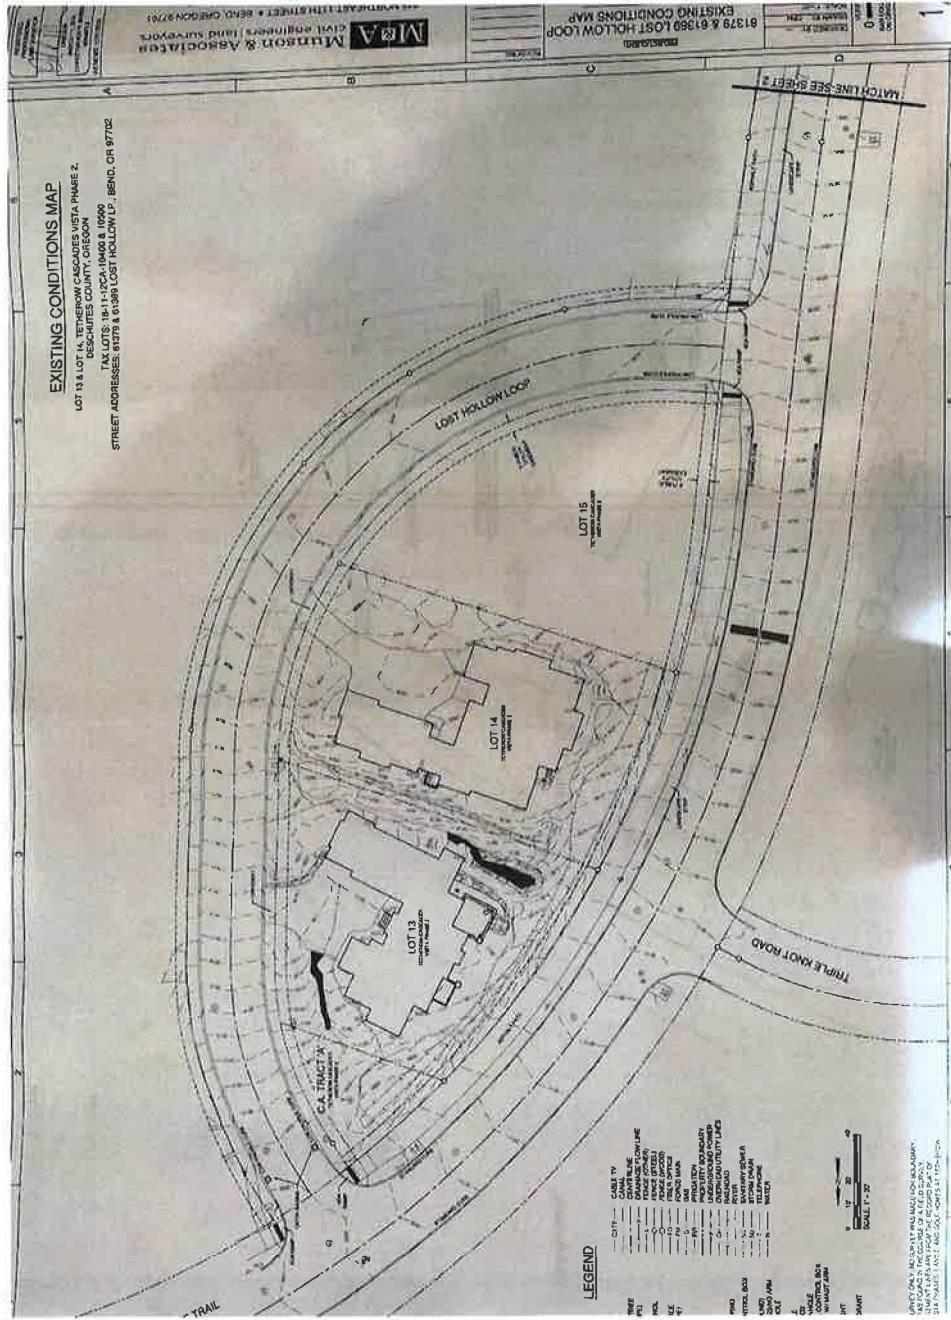
Findings on Upstream Drainage Analysis

- ADA ramp is negatively graded compromising the street gutter and allowing the upstream runoff to enter the ramp and flow down the asphalt path and into residents' yards
- Catch basins were removed with the development of Tetherow Cascades Vista Phase 2, along with the storm Drainage pond, presently occupied by CV15
- Channel flow observed in eroded median strips

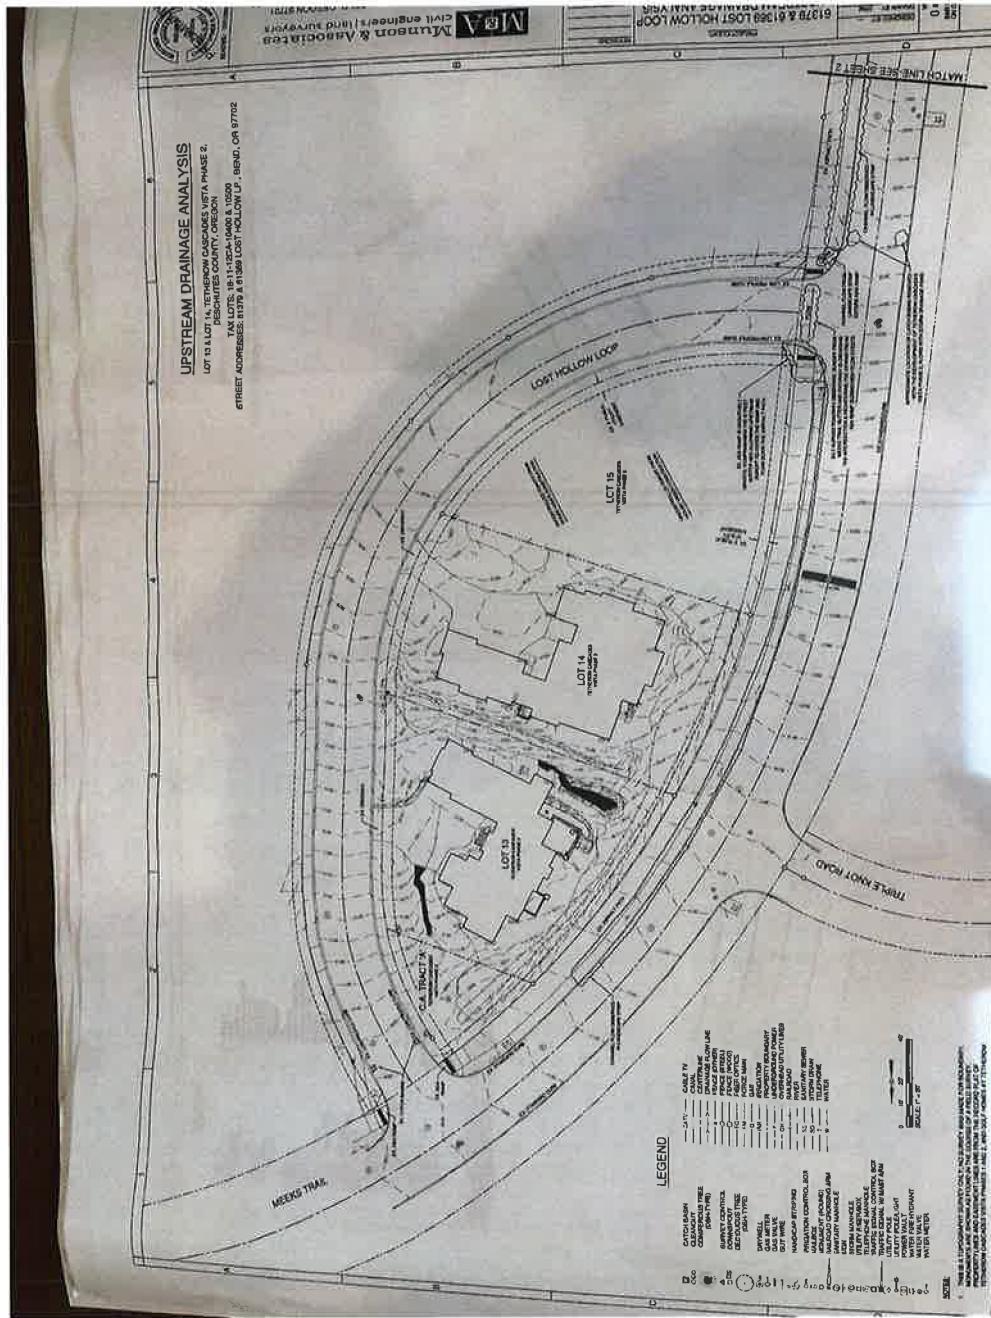
Findings on Upstream Drainage Analysis

- Uncontrolled runoff (channel flow) observed from Tetherow Vista Drive
- ADA ramp is negatively graded, compromising the street gutter and allowing upstream runoff to enter the ramp and flow down the asphalt path
- Channel flow observed in between asphalt path and backslope

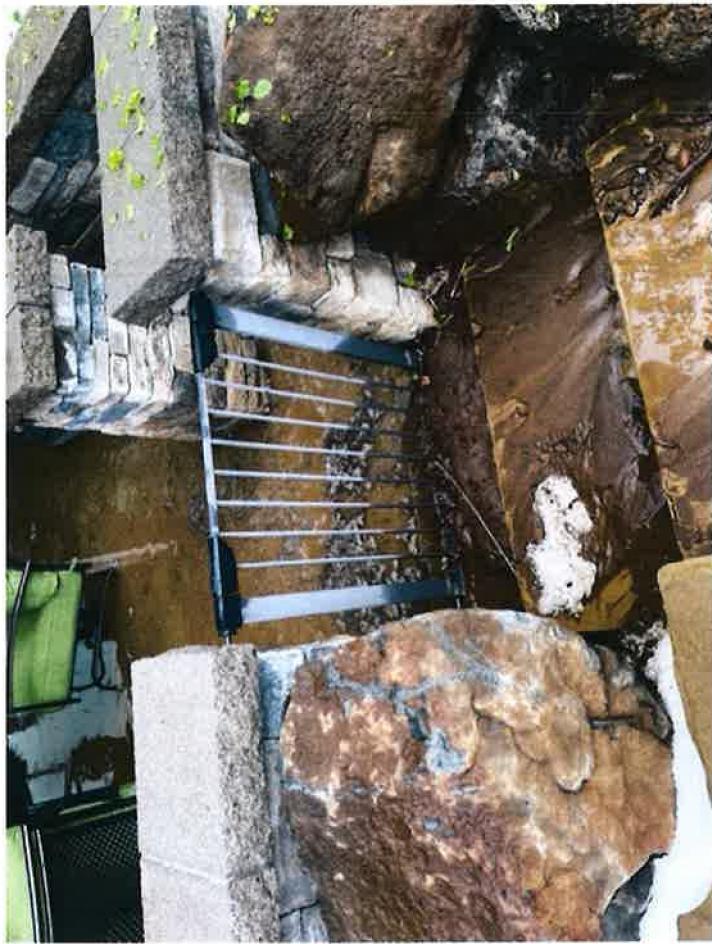
The Result of Negligent and Grossly Inadequate Infrastructure:
Community Erosion

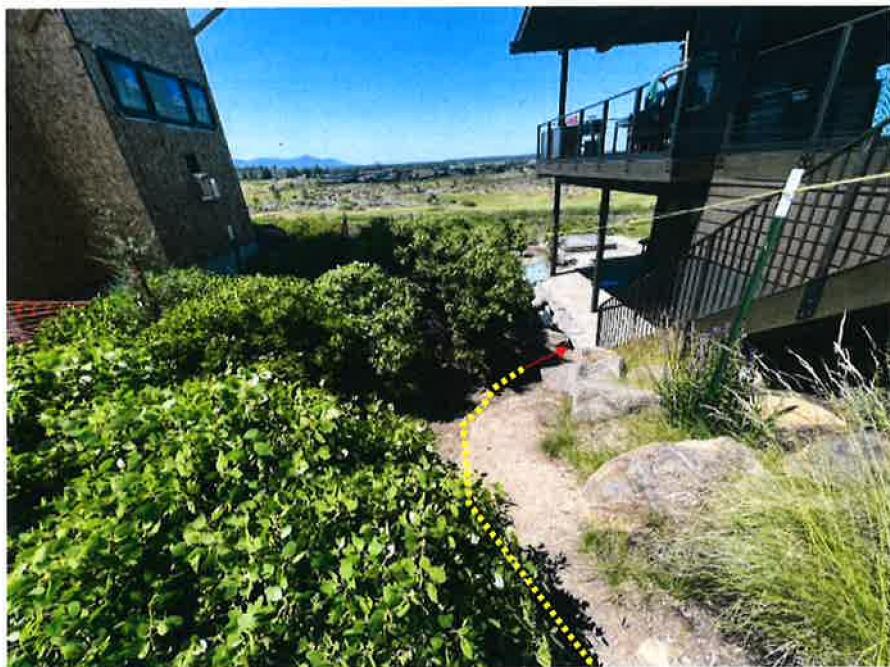
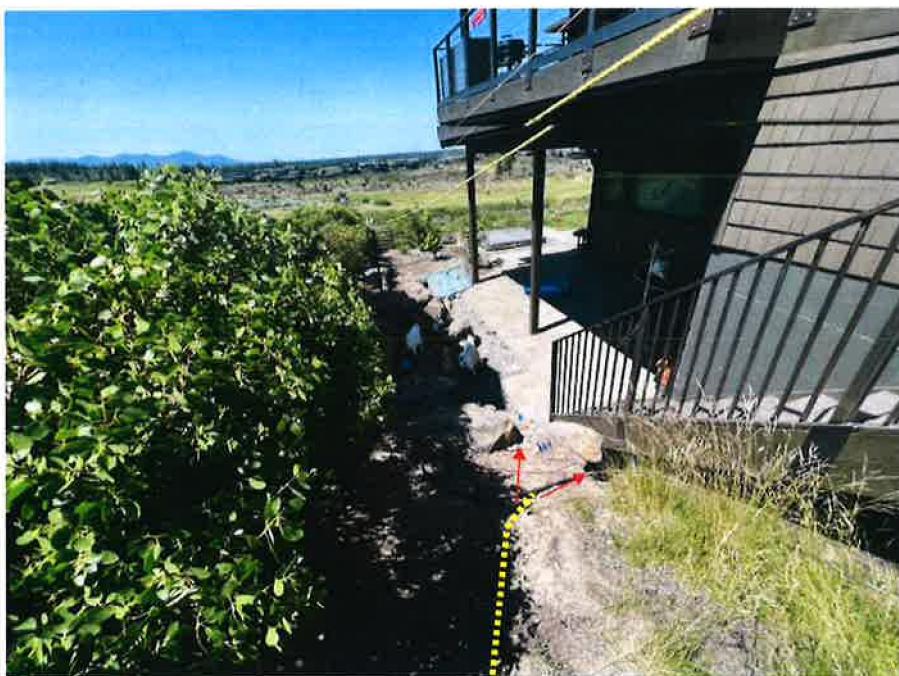
As can be shown on the enclosed photo exhibit, stormwater origination within Highlands Ridge appears to come directly from some of the northerly lots and not from roadways or common areas within Highlands Ridge. While the owners/contractors of those private lots need to improve course of construction mitigation efforts, it should be noted that final site stabilization and drainage control measures on those lots should be permanently addressed and implemented on each lot, upon final home construction completion.

Photo Exhibit along the property line between Highlands Ridge, Lot 5 and Tetherow Rim, Lot 1 of the observed drainage pattern due to a channel that has developed
