**City of Diamondhead**

**Opinion of Probable Cost**

**Modernization of Utility Infrastructure**

Modernization of  
Utility Infrastructure

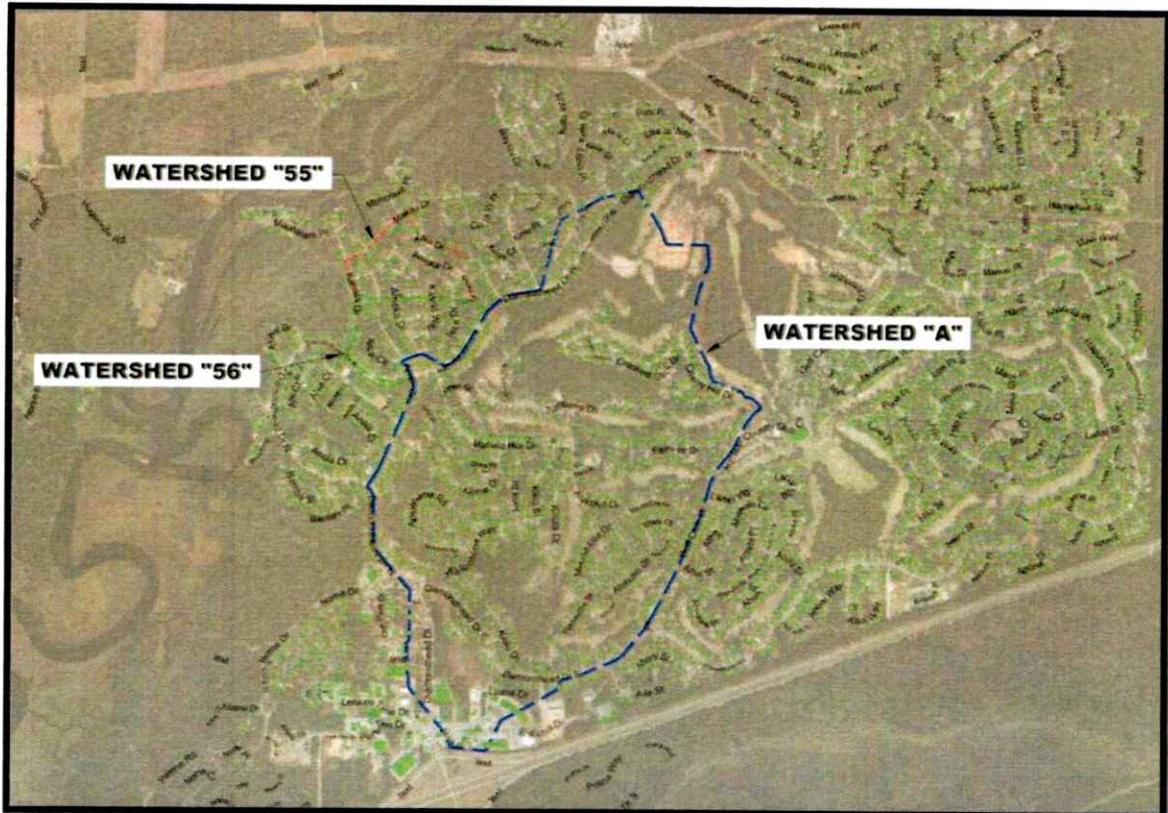
*Watershed A, 55, and 56 Overview*

- The existing drainage system in this area consists of open ditches, driveway culverts, and landscape culverts which discharge to natural tributaries.
- Consists of tributaries that drain into Montjoy Creek also known as Rotten Bayou. Tributaries include Apelehama and Kalipekona. These tributaries were modeled and analyzed for capacity and erosion issues.
- These drainageways are heavily vegetated and meander between private property making access difficult for future inspection and maintenance.
- There are locations where there are abrupt changes of direction with minimal to no bank protection that have led to erosion issues.
- Residents have also reported erosion issues along these streams that adjoin their properties.

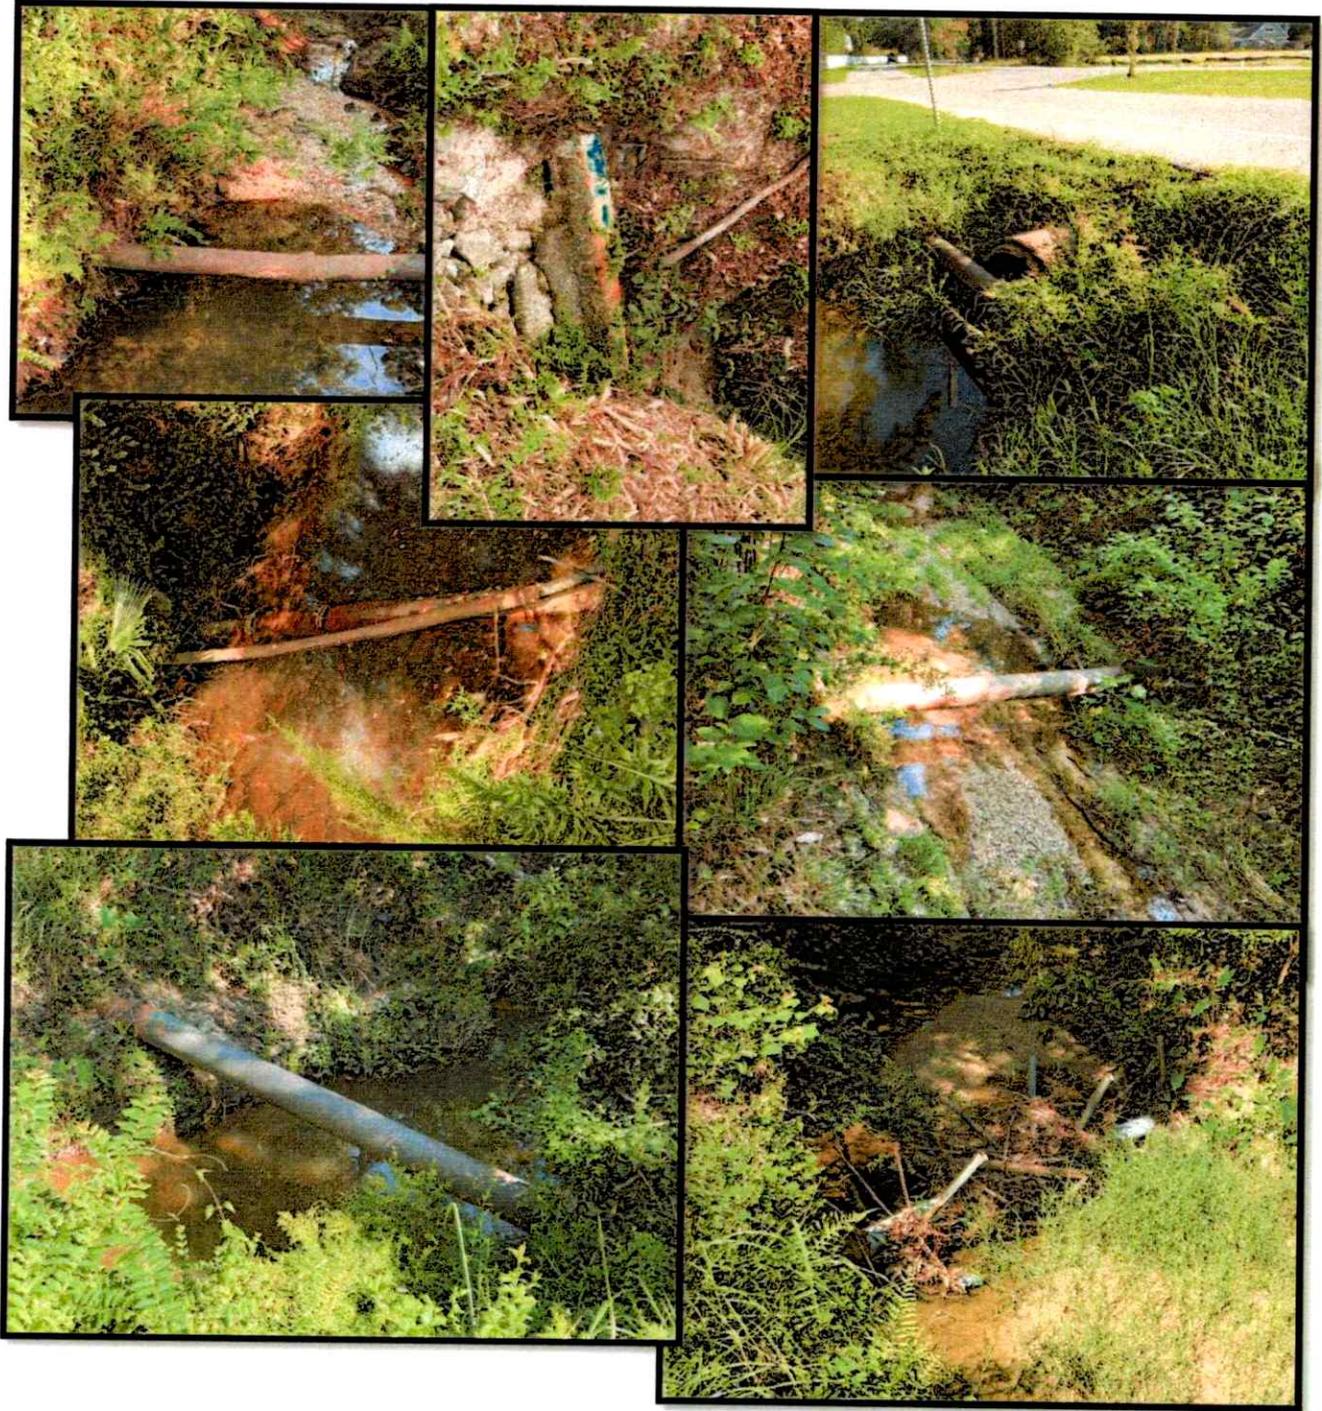
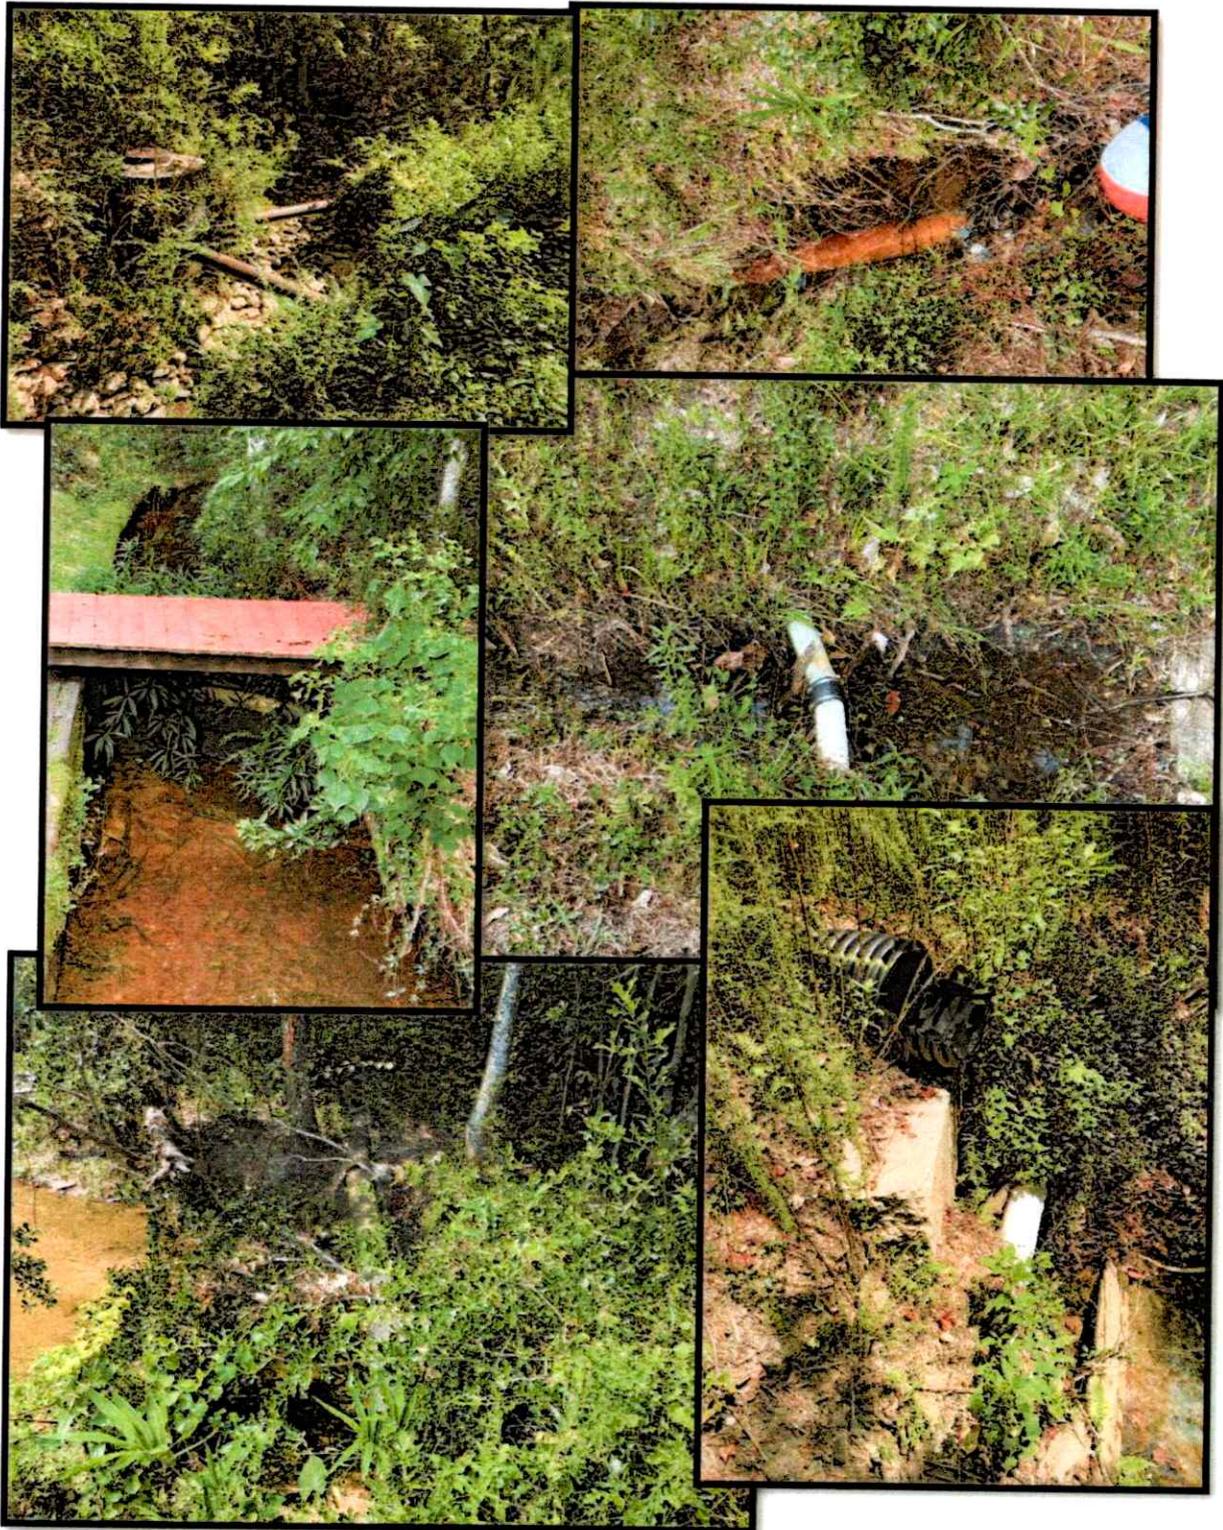
Exposed Utility Locations

The following list contains utility lines that are exposed and/or aerial among drainage crossings. With over 150 intersections between water/sewer and drainage structures in Diamondhead, without preventative evaluation, the number of exposed utilities could continue to grow.

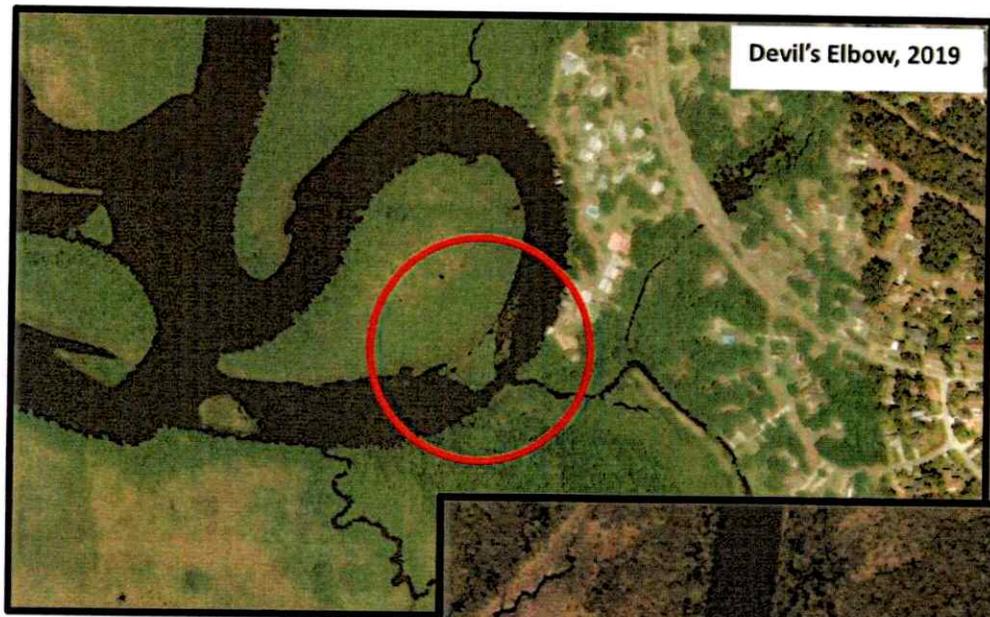
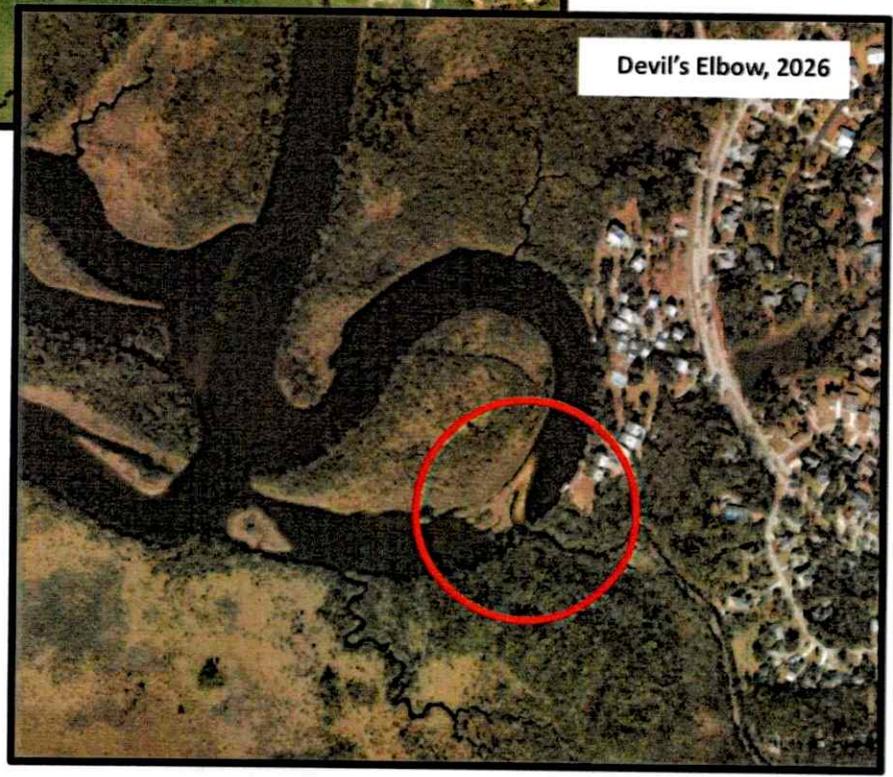
- Upstream erosion causes downstream sedimentation causing loss of drainage capacity and flooding of drainage system.
- The erosion is due to urbanization and increased runoff.
- Currently, the City of Diamondhead is designing and constructing sediment traps in Montjoy Creek to prevent future sedimentation.
- Dredging is needed to restore capacity function and use to the City of Diamondhead.
-

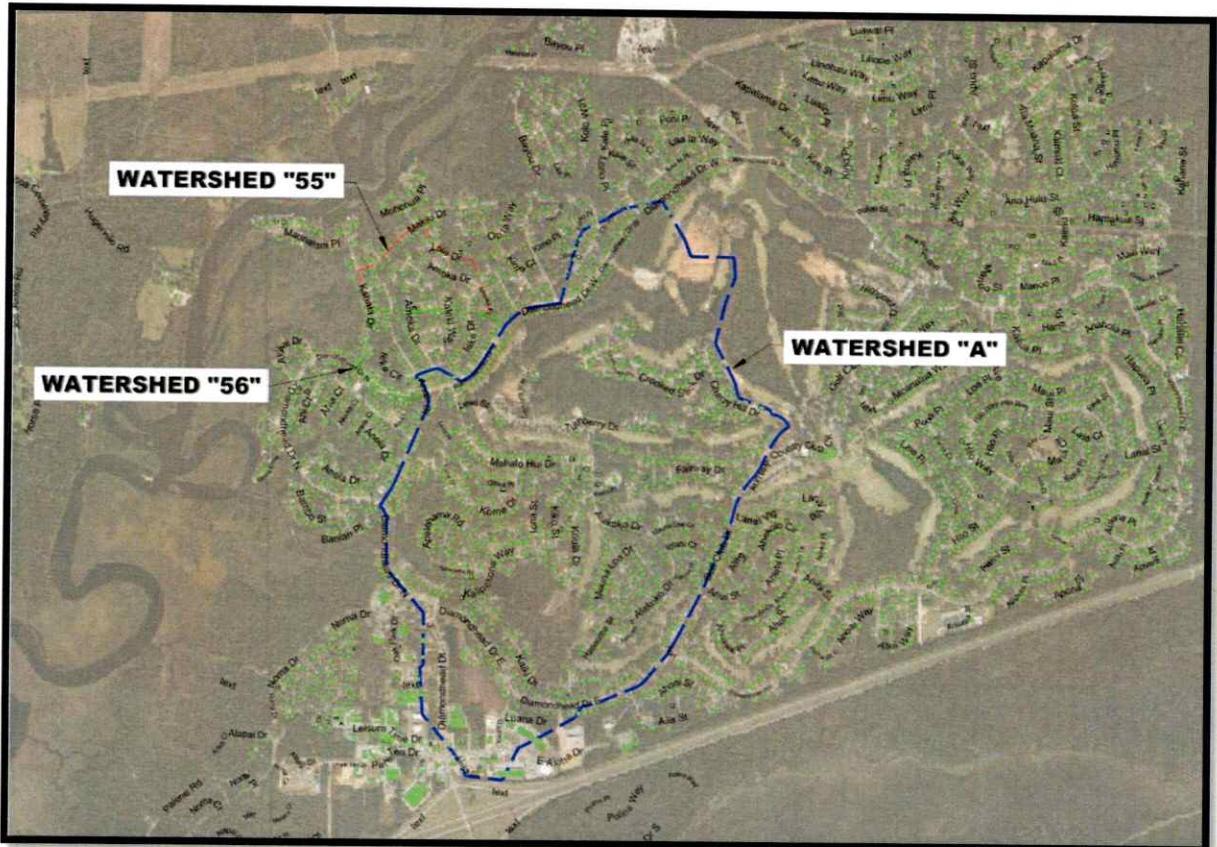
*Watershed A, 55, and 56 Overview*

- The existing drainage system in this area consists of open ditches, driveway culverts, and landscape culverts which discharge to natural tributaries.
- Consists of tributaries that drain into Montjoy Creek also known as Rotten Bayou. Tributaries include Apelehama and Kalipekona. These tributaries were modeled and analyzed for capacity and erosion issues.
- These drainageways are heavily vegetated and meander between private property making access difficult for future inspection and maintenance.
- There are locations where there are abrupt changes of direction with minimal to no bank protection that have led to erosion issues.
- Residents have also reported erosion issues along these streams that adjoin their properties.

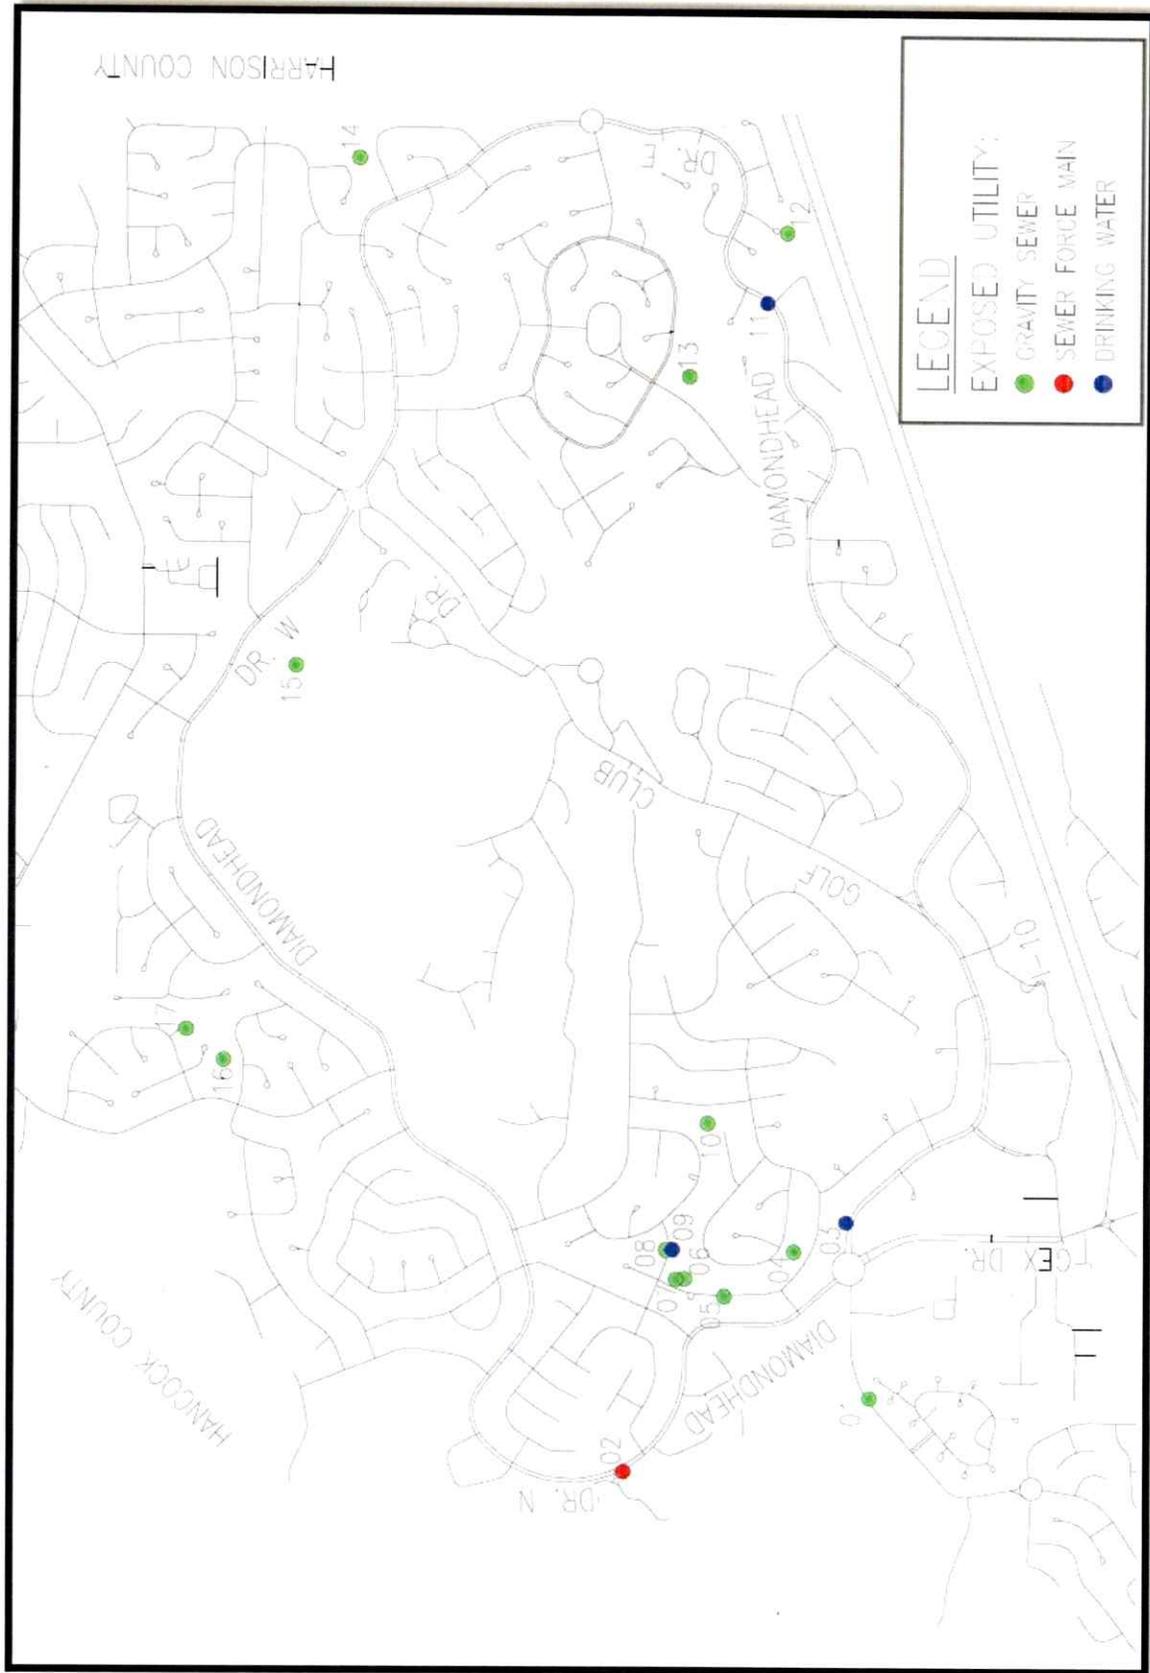
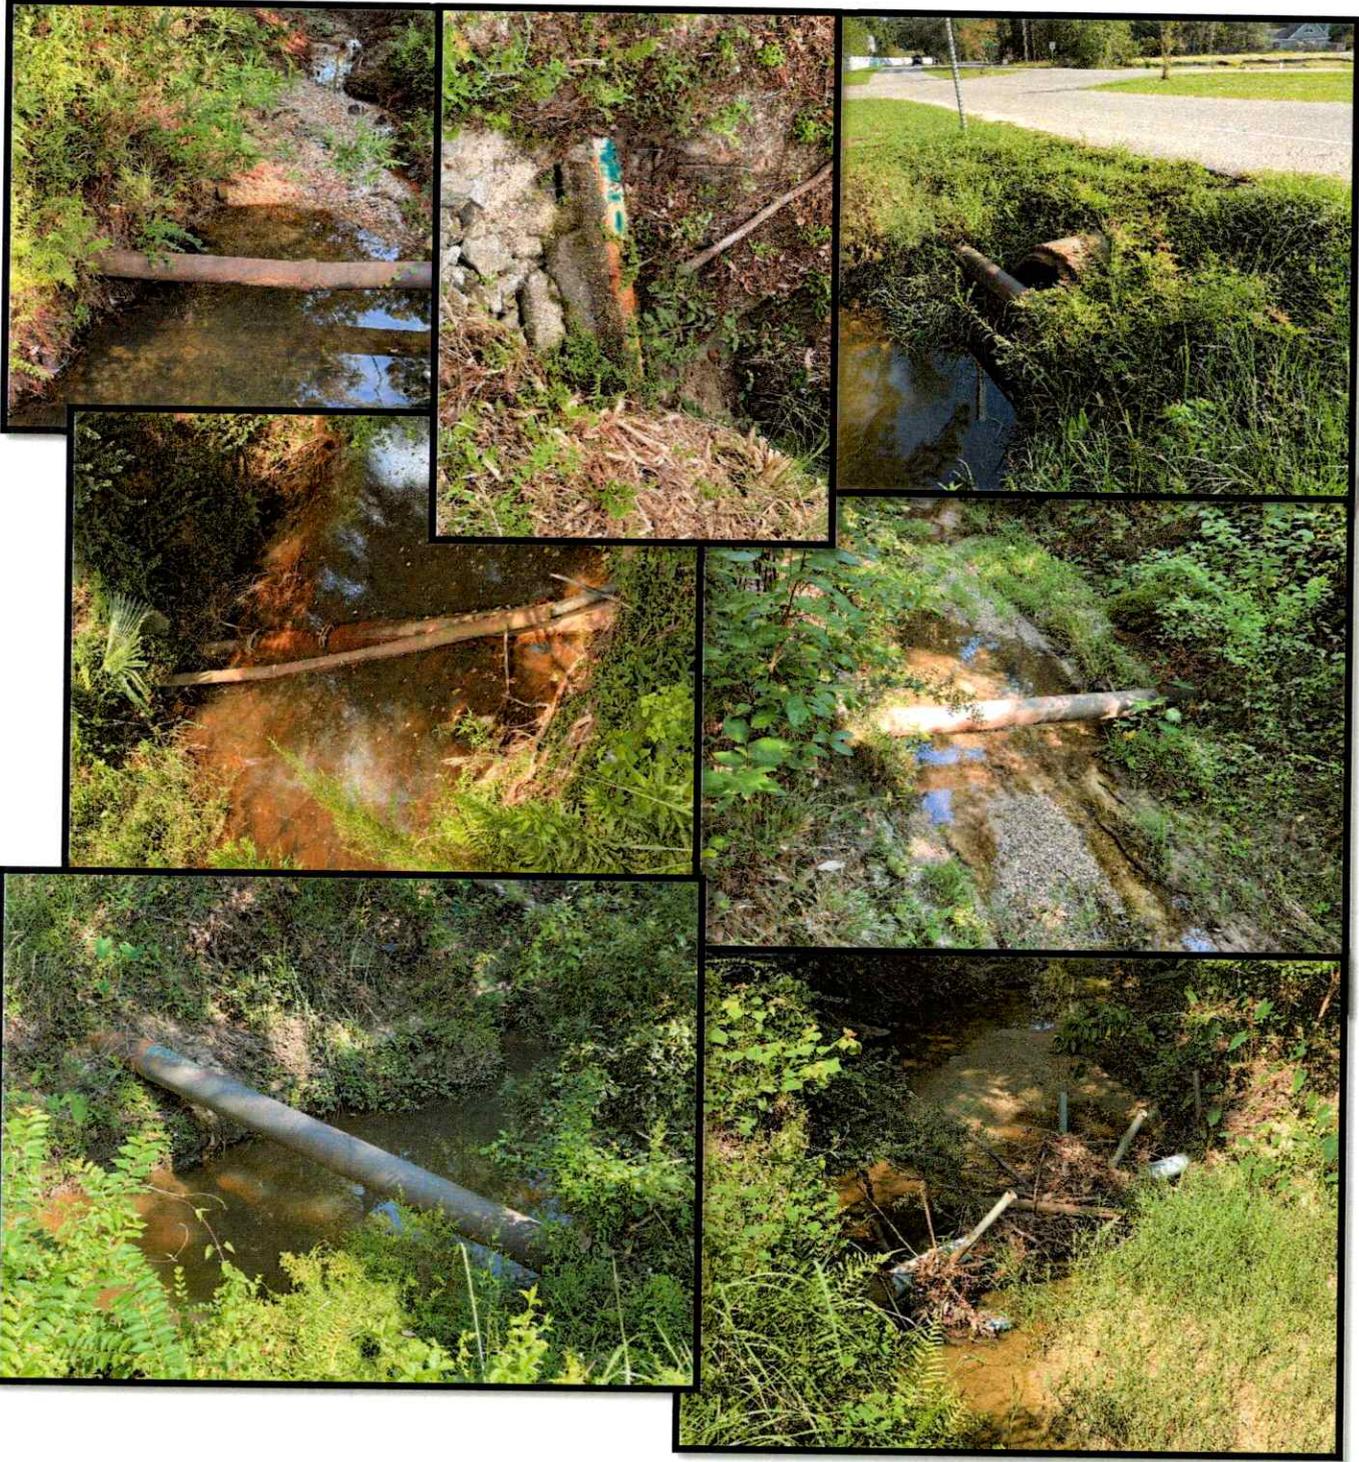
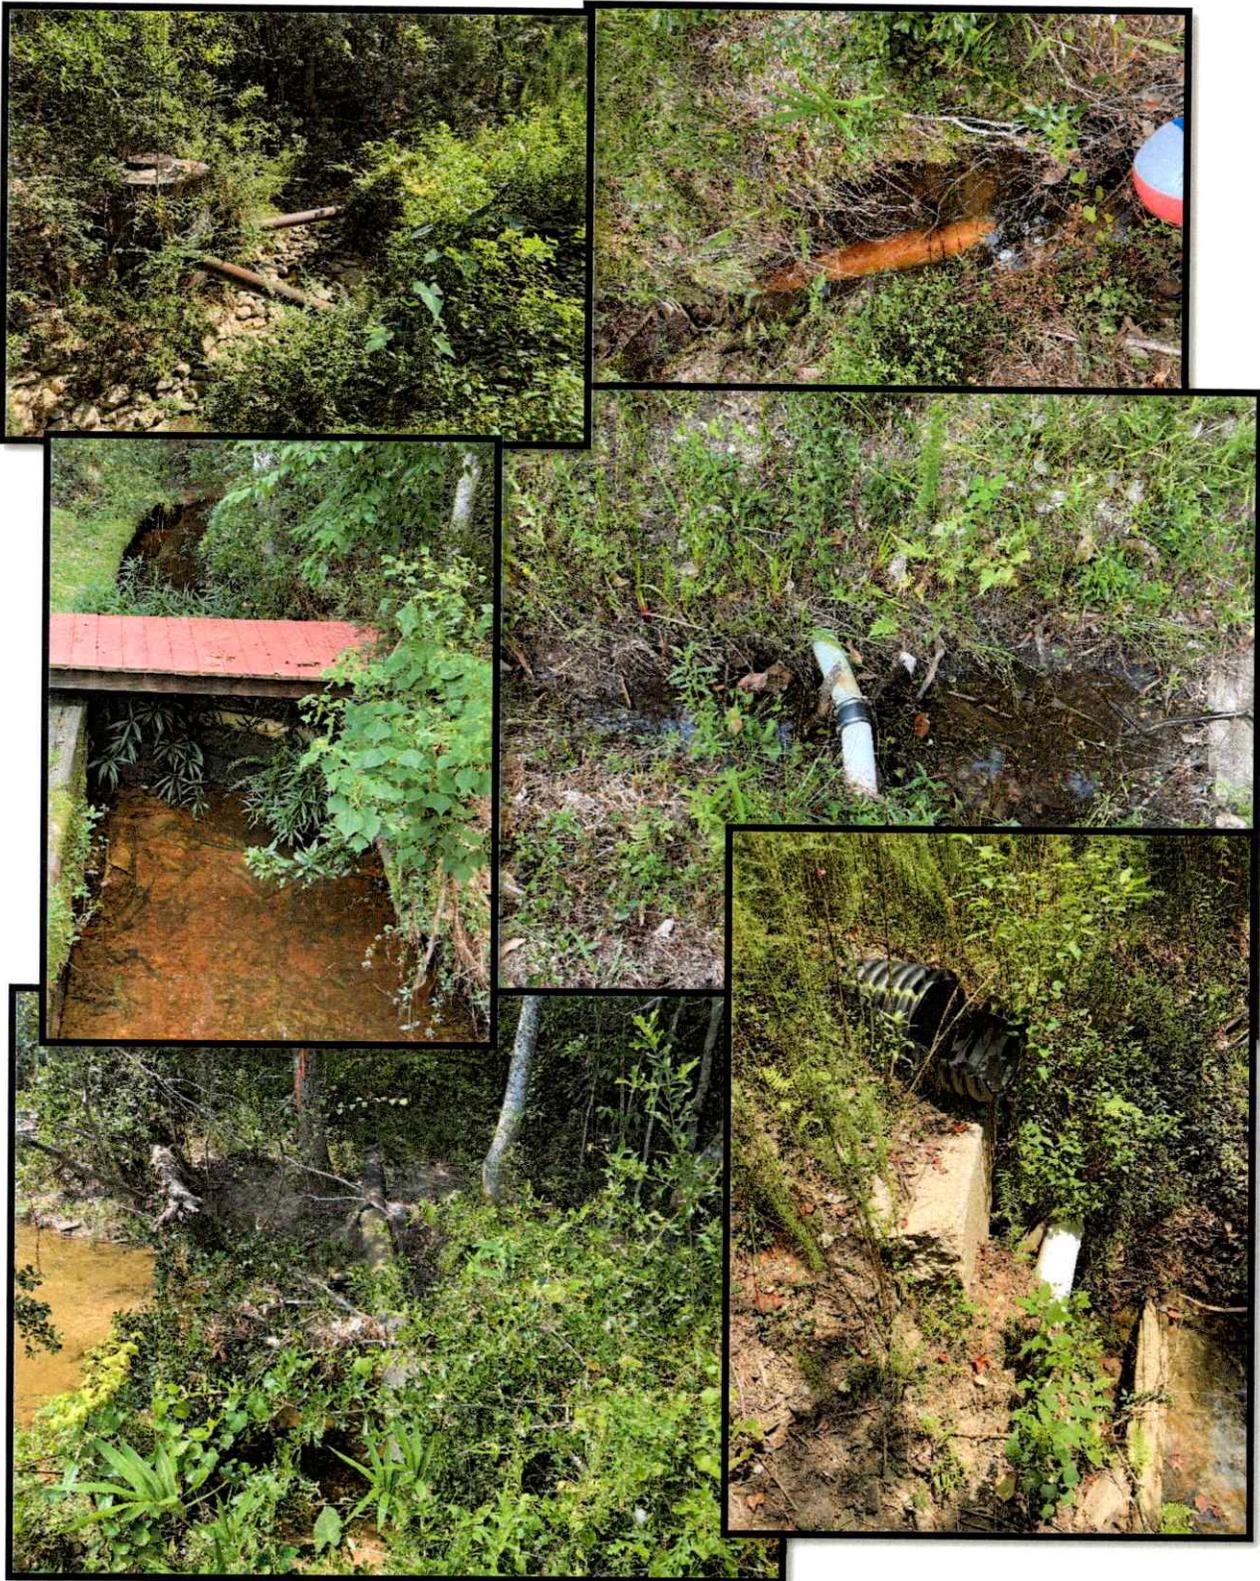
Exposed Utility Locations

The following list contains utility lines that are exposed and/or aerial among drainage crossings. With over 150 intersections between water/sewer and drainage structures in Diamondhead, without preventative evaluation, the number of exposed utilities could continue to grow.

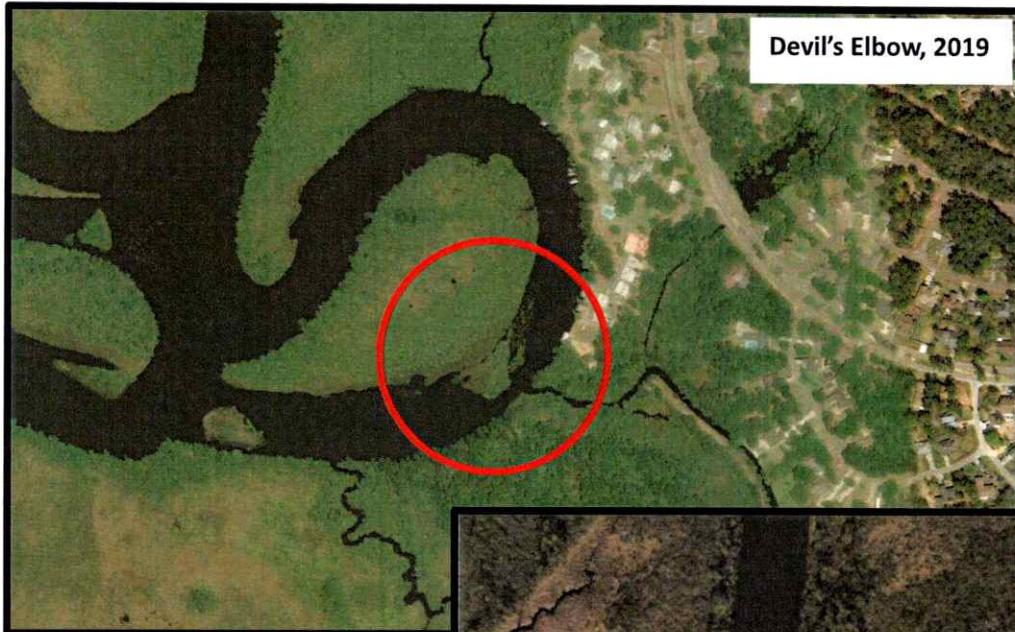
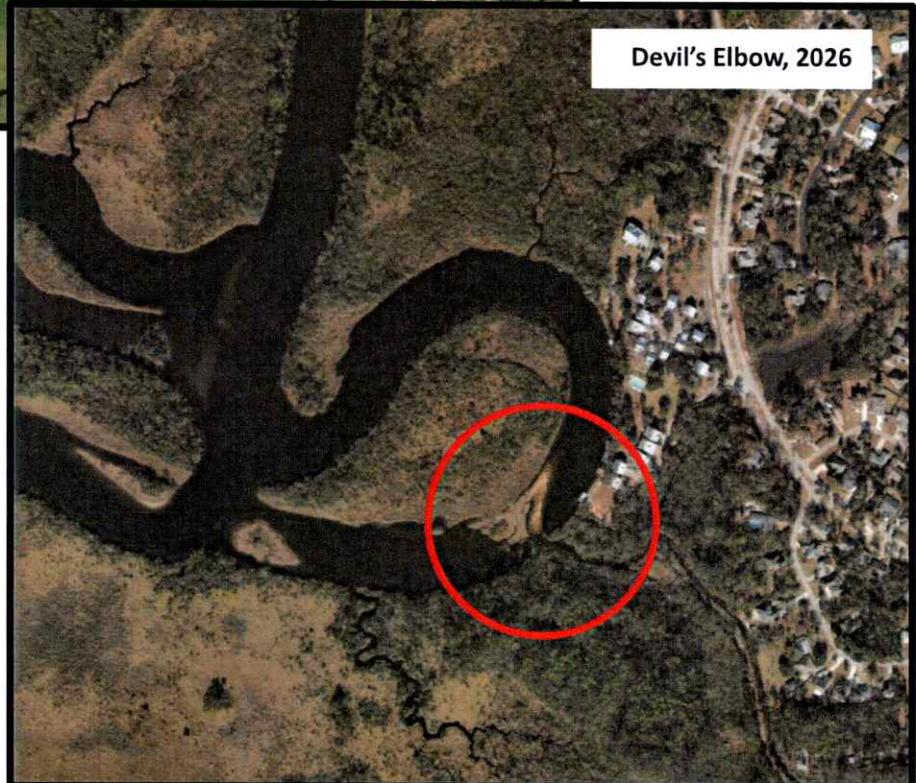
- Upstream erosion causes downstream sedimentation causing loss of drainage capacity and flooding of drainage system.
- The erosion is due to urbanization and increased runoff.
- Currently, the City of Diamondhead is designing and constructing sediment traps in Montjoy Creek to prevent future sedimentation.
- Dredging is needed to restore capacity function and use to the City of Diamondhead.
-
