**DILLINGHAM SHORELINE  
EROSION ANALYSIS**

DRAWN BY: SM	DATE: 11/18/2022	JOB NUMBER: 16-134
CHECKED BY: MA	SCALE: 1" = 200'	SHEET: 1 OF 1

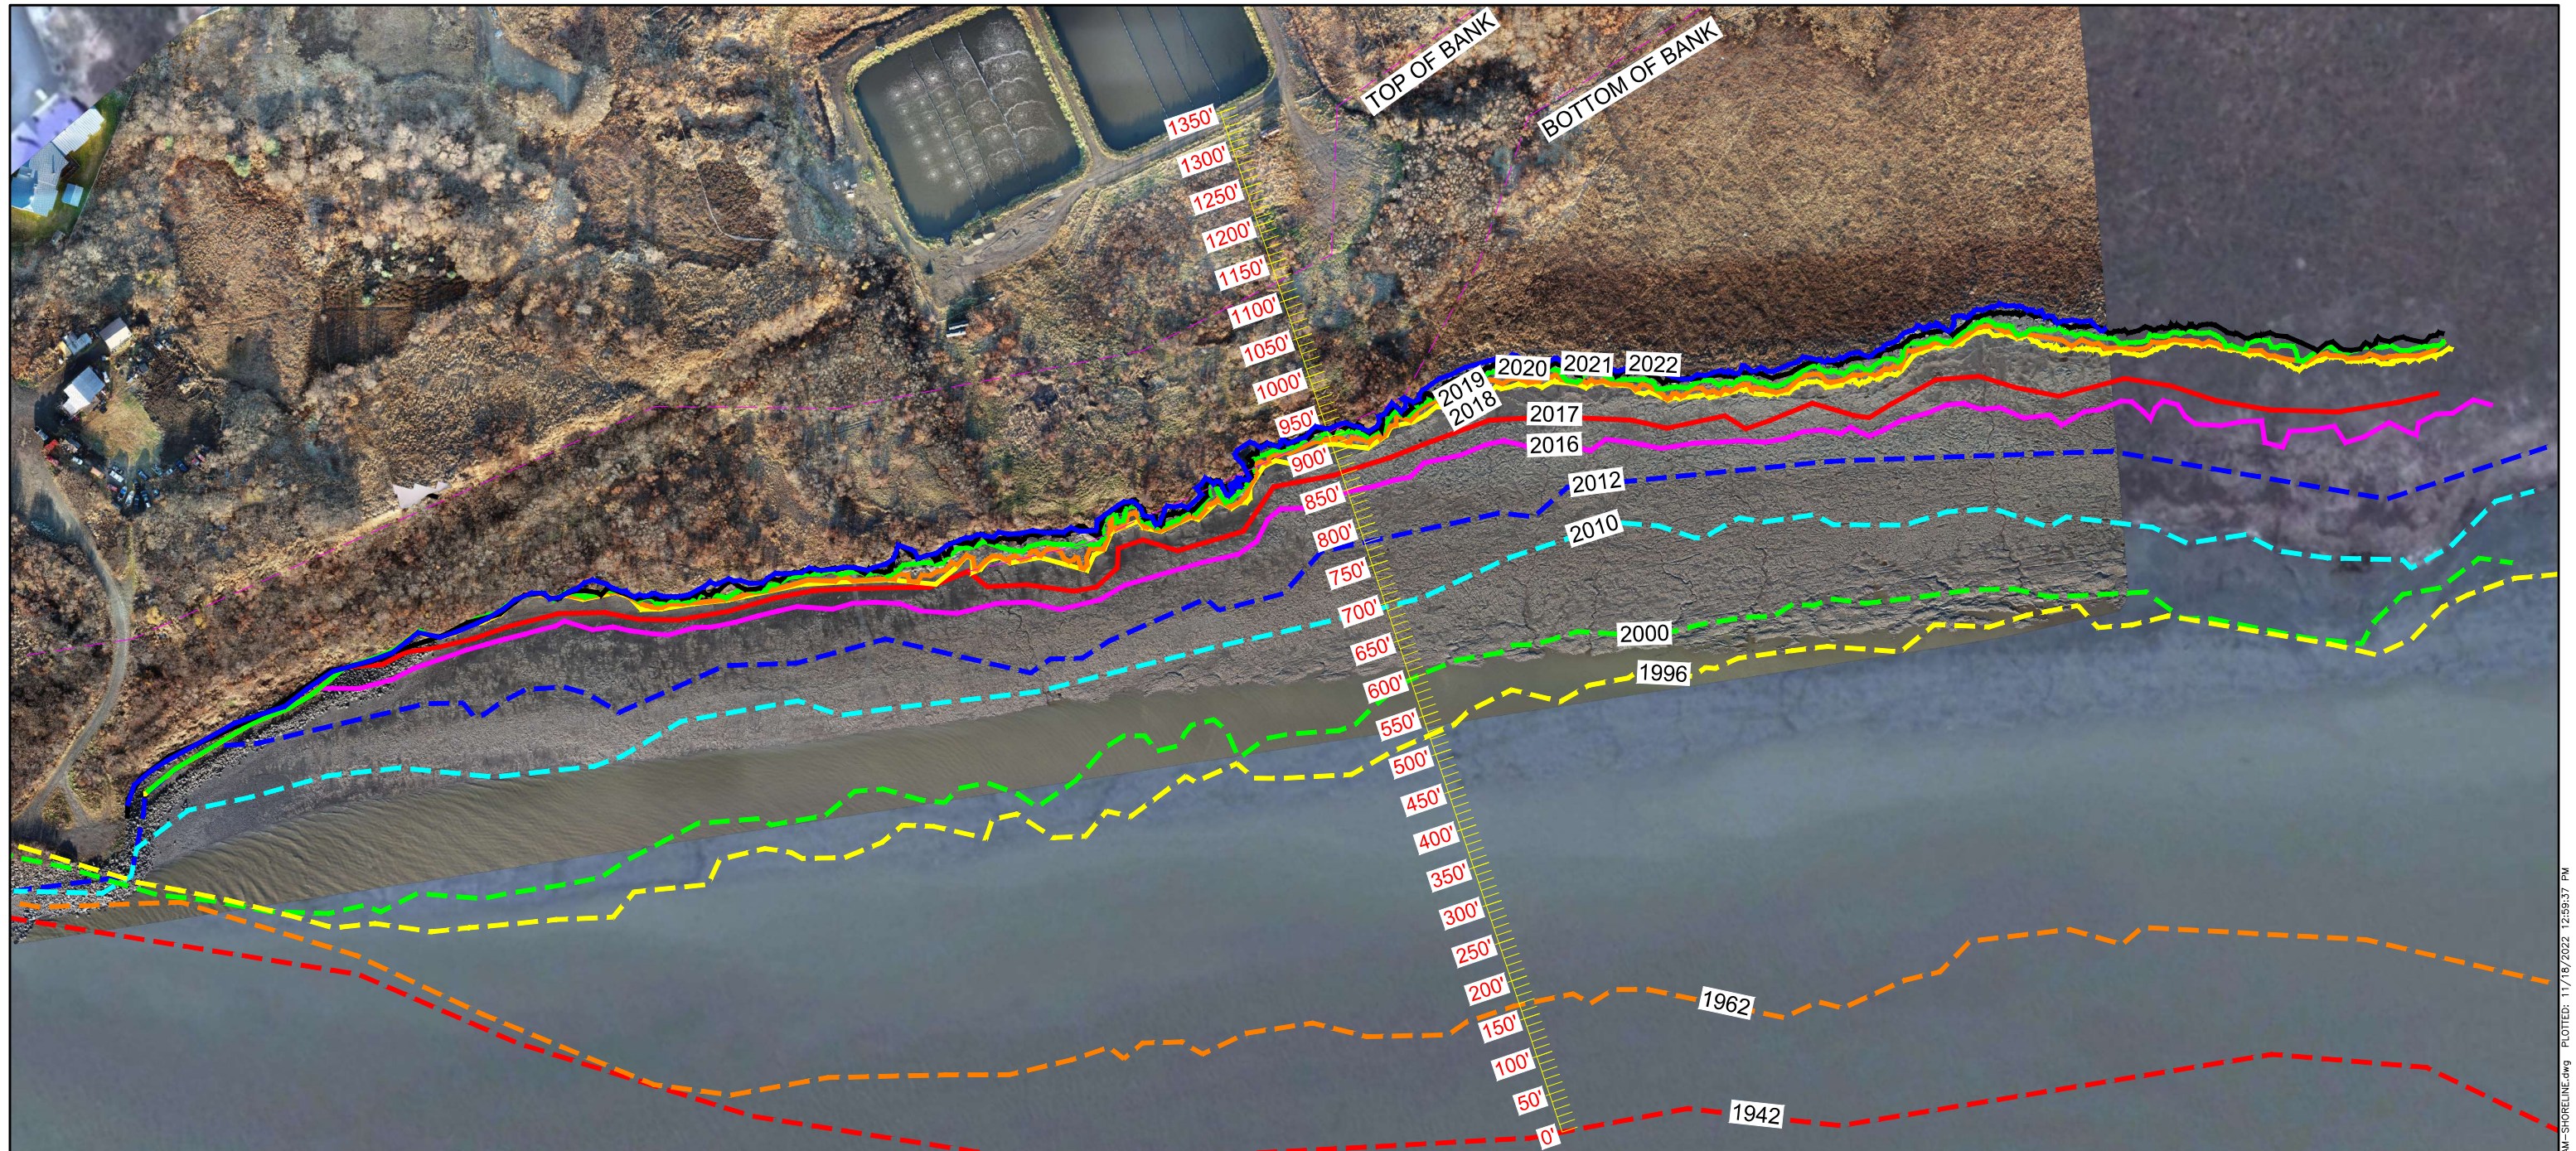
1. 2016 THROUGH 2022 SHORELINE AND TOP OF BANKS ARE BASED ON FIELD SURVEYS PERFORMED BY EDGE SURVEY AND DESIGN, LLC.
2. 2012 TOP OF BANKS ARE BASED ON AN ORTHOPHOTO PROVIDED BY THE CITY OF DILLINGHAM.
3. 2010 TOP OF BANKS ARE BASED ON AN ORTHOPHOTO PROVIDED BY MICROSOFT BING.
4. 2000, 1996, AND 1962 TOP OF BANKS ARE BASED ON AERIAL PHOTOS PROVIDED BY THE CITY OF DILLINGHAM. THESE PHOTOS WERE NOT CORRECTED FOR CAMERA AND TERRAIN DISTORTIONS AND ARE APPROXIMATE.
5. 1942 SHORELINE BASED ON USGS QUADRANGLE SHEET "DILLINGHAM A-7" DATED 1952. THIS MAP NOTES THAT AERIAL PHOTOGRAPHS WERE TAKEN IN 1942.
6. INLAND BANKS ARE BASED ON 2012 AERIAL PHOTO AND ARE APPROXIMATE.
7. BASED ON THE DATA FROM 1942 THROUGH 2022 THE SHORELINE HAS ERODED 930 FEET OR 11.6 FEET PER YEAR.
