Dragnet Drive Closure and Rehab Report

Road Closure Start Date: 5/05/2023 at 9:30pm

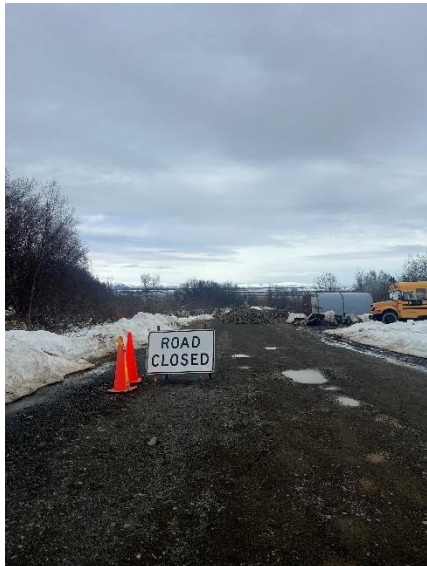
Figure 2 Initial Road closure

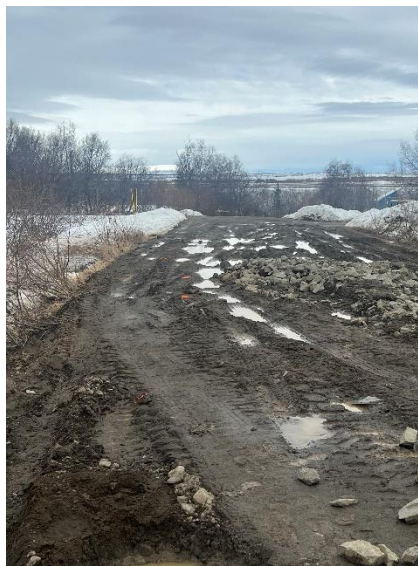
1Road with some shot rock

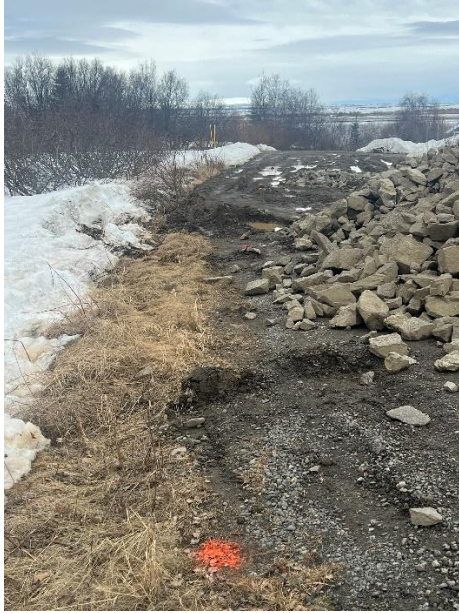
3Road with additional fill

A plan was formulated to run alongside the road and gather up the saturated material and push back into the center of the road to help build the crown (which will help with future drainage) continue to run the larger shot rock down the middle of the road on the lane, then top with the smaller reject material which will help with the settling and final placement of the shot rock. It was agreed that pulling the material back into the center would assist with the crown, and eliminating excess waste of material while rehabbing the road.

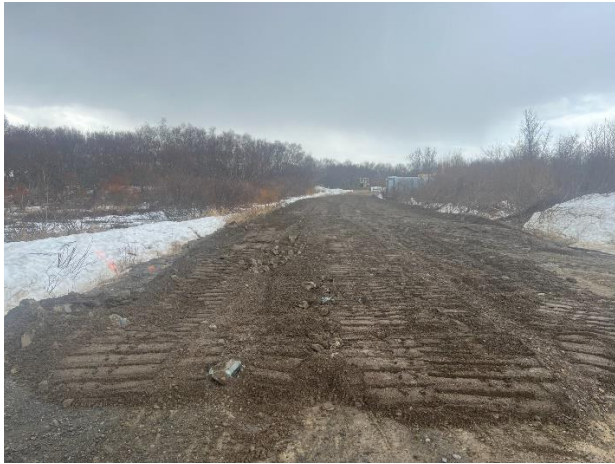
6 Minimal top and widened road

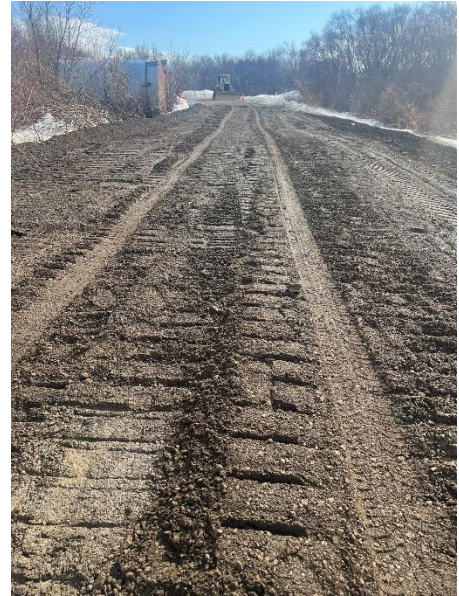
5 Minimal material as top

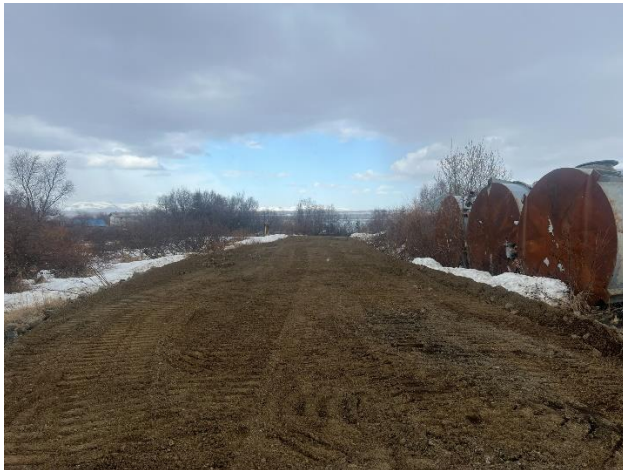
10 Eliminate berm add fines

Planning Department: I recommend building the center of the road to a higher crown while filling in the low spots. Eliminate the excess wasted material that has caused a dam that will prevent drainage. Increase the drainage by clearing and improving the ditching on either side of the road. Create a ditch that drains over the hill but before the guard rail to improve drainage and prevent road wash. Once these items are completed, we should open the road (weight restrictions will still apply by SOA).

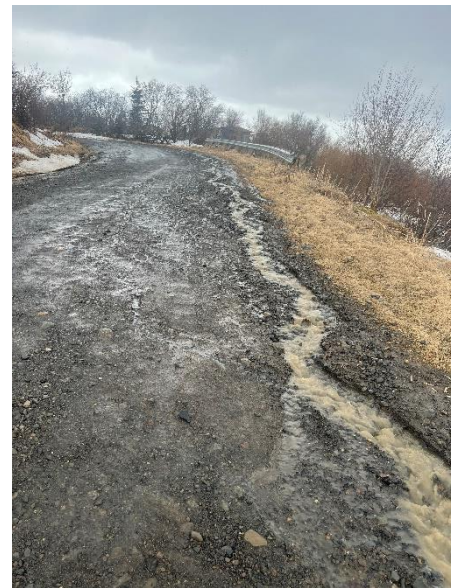
7 Road wash occurring at bottom of hill

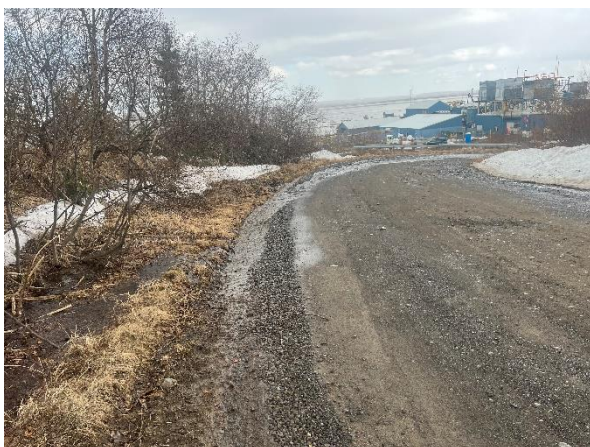
9 Reestablish ditching

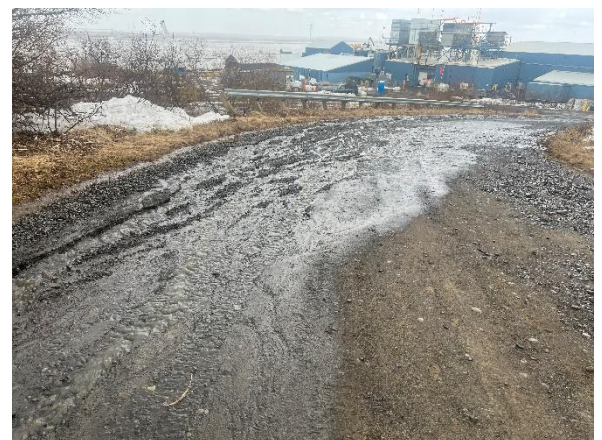
8 Road wash/erosion
