THE BIGGS MUSEUM OF AMERICAN ART EXPANSION

## CITY OF DOVER HISTORIC COMMISSION REVIEW MATERIALS

SELECTIVE REMOVALS AT 15 & 21 THE GREEN

April 11, 2025

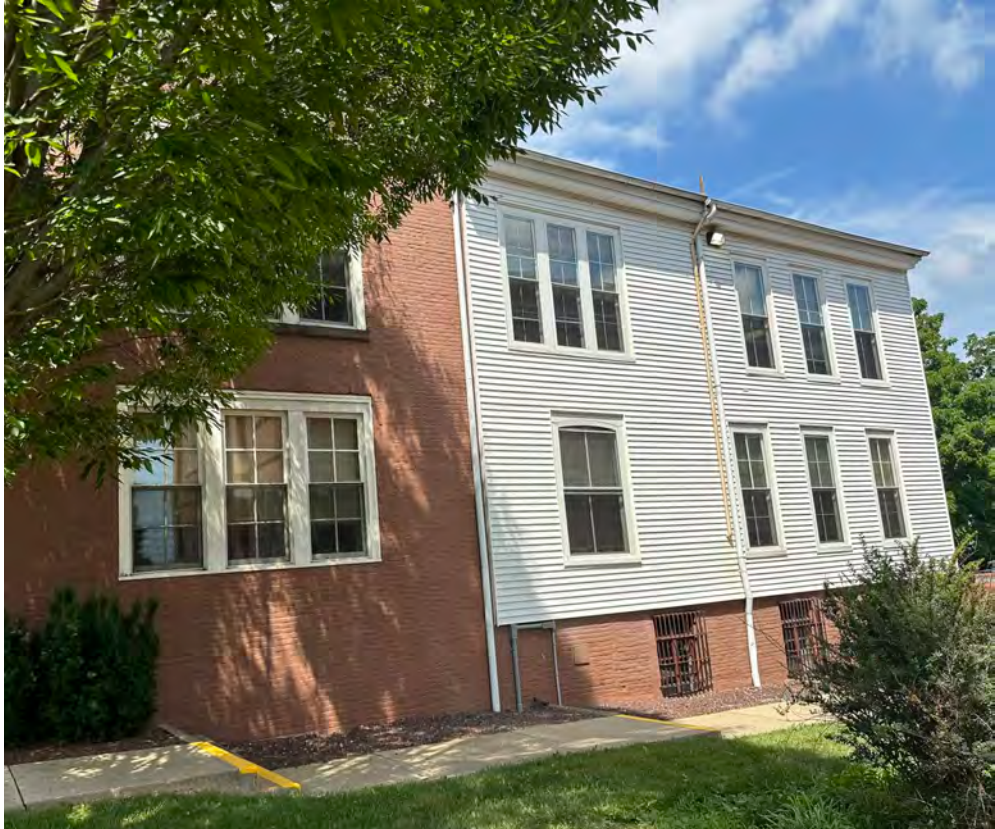
**Figure 2.3.4**  
Existing View of 21 The Green East Elevation with Referenced Rear Addition Recommended for Removal

- **Improper Fire Separation** - The rear addition to 21 The Green is of a different construction system and would require fire separation from the front portion of the building if maintained.

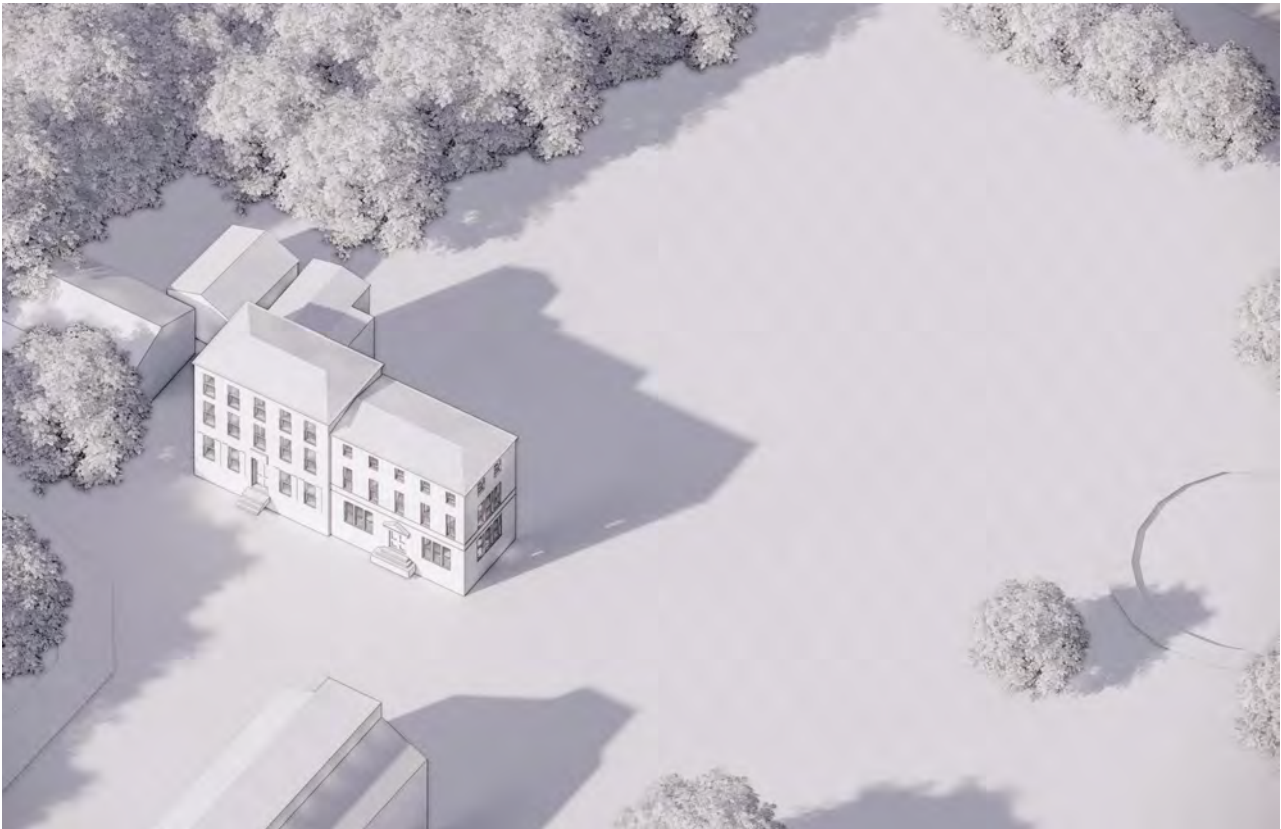
Figure 3.2.1  
1859 Original 15 and 21 The Green Construction

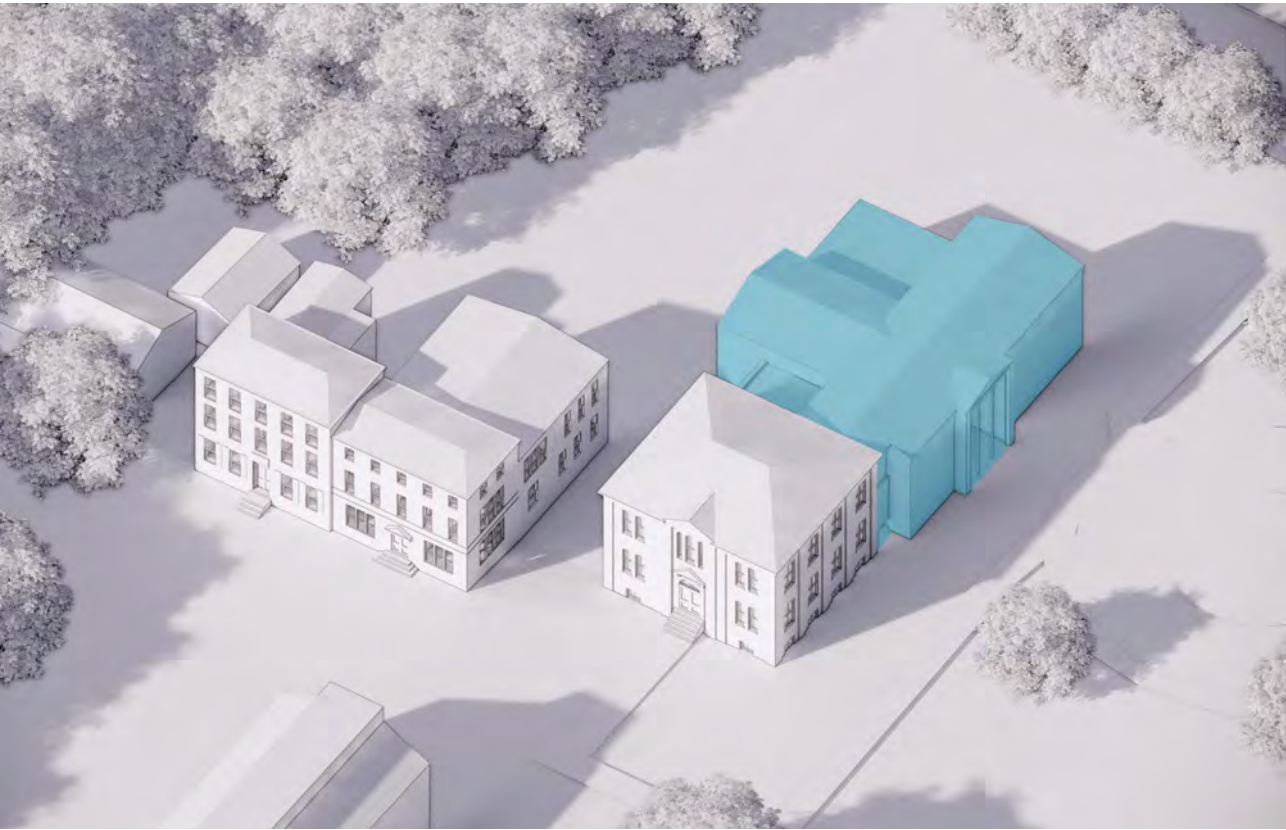
**Figure 3.2.5**  
1990s Addition to the Old County Building to Create the State Visitor Center and Biggs Museum

**1991 Creation of Delaware State Visitor’s Center & The Sewell C. Biggs Museum** – The architecture firm of Homsey Architects, Inc. was hired to create a museum and Delaware state visitor center by adding a new structure to the existing Old County Building. Gredell & Paul served as the structural engineers, with EA Mueller served as Mechanical/ Electrical/Plumbing engineers.

The exterior of the addition to the Old County Building was clad in brick to match the historic building with the exception of the entry that had an aluminum and glass curtain wall at the east façade. To make the addition feasible, a portion of the north side of the Old County Building was removed. Additionally, several new openings in masonry walls of the old structure were cut to accommodate gallery flow.

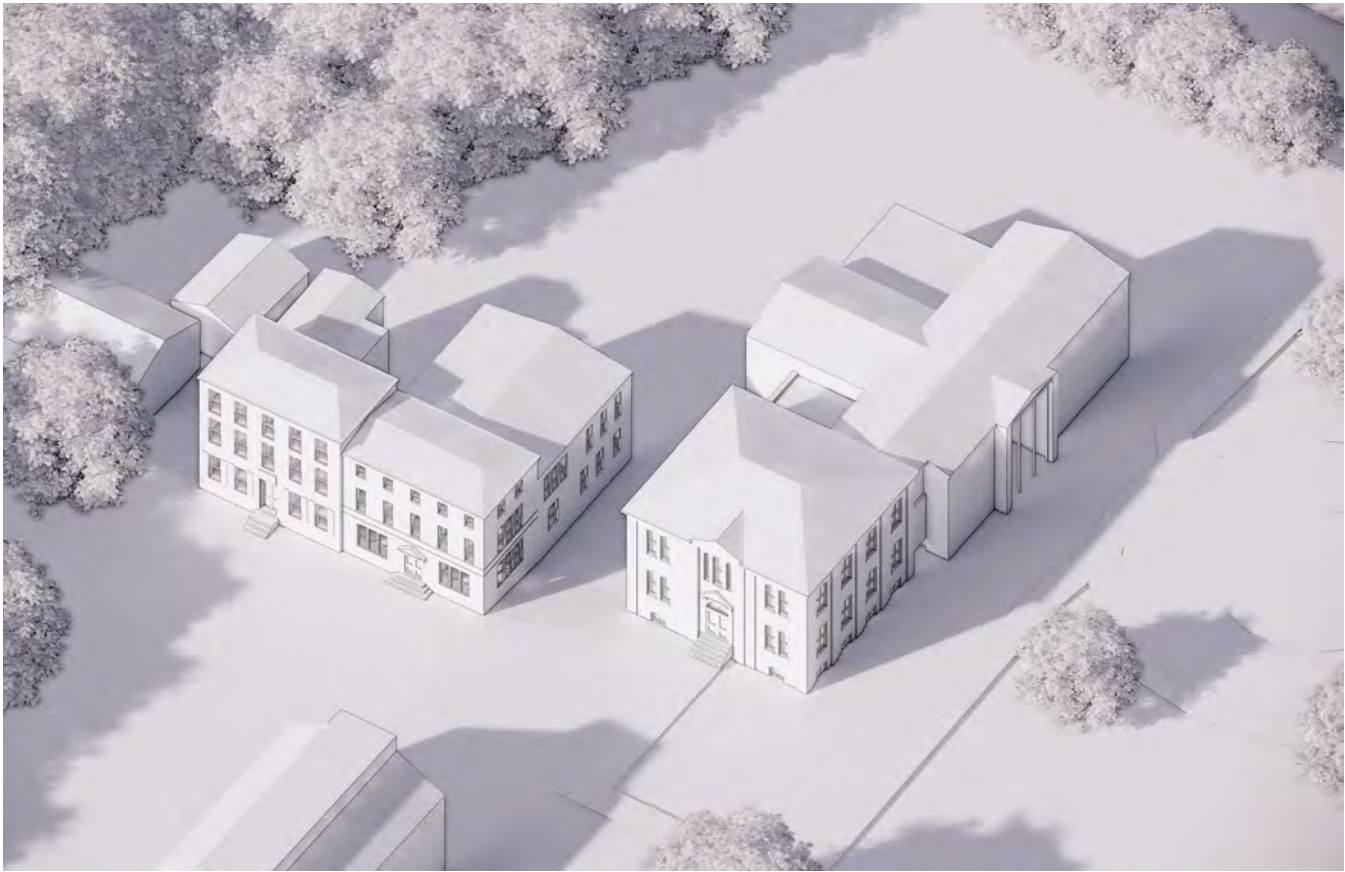
**Figure 4.1.1**  
Axonometric View of Existing Buildings

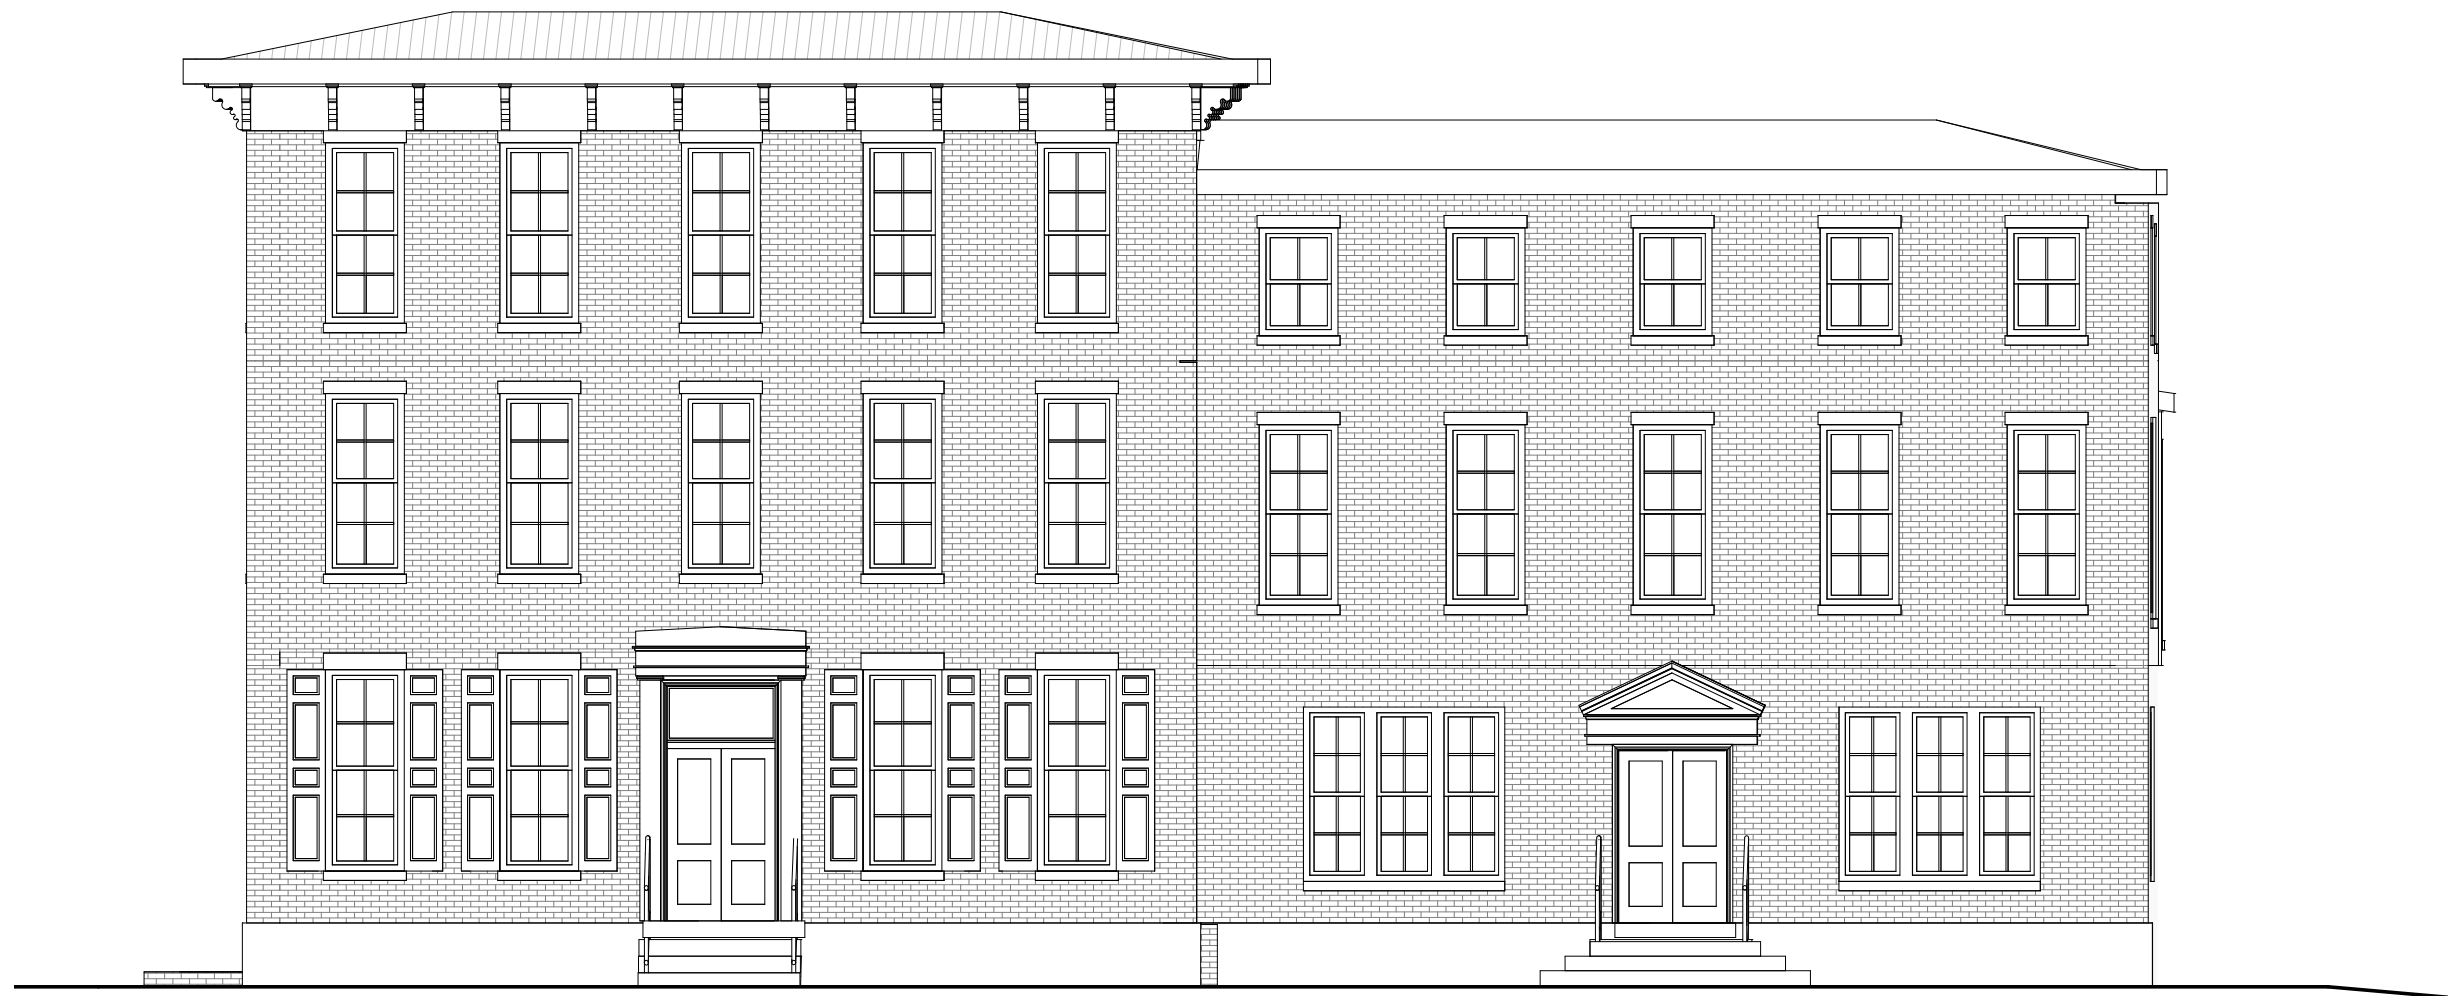
**Figure 4.2.4**  
15 and 21 The Green Front Elevation - Existing Showing That the Rear Addition is Not Visible from The Green

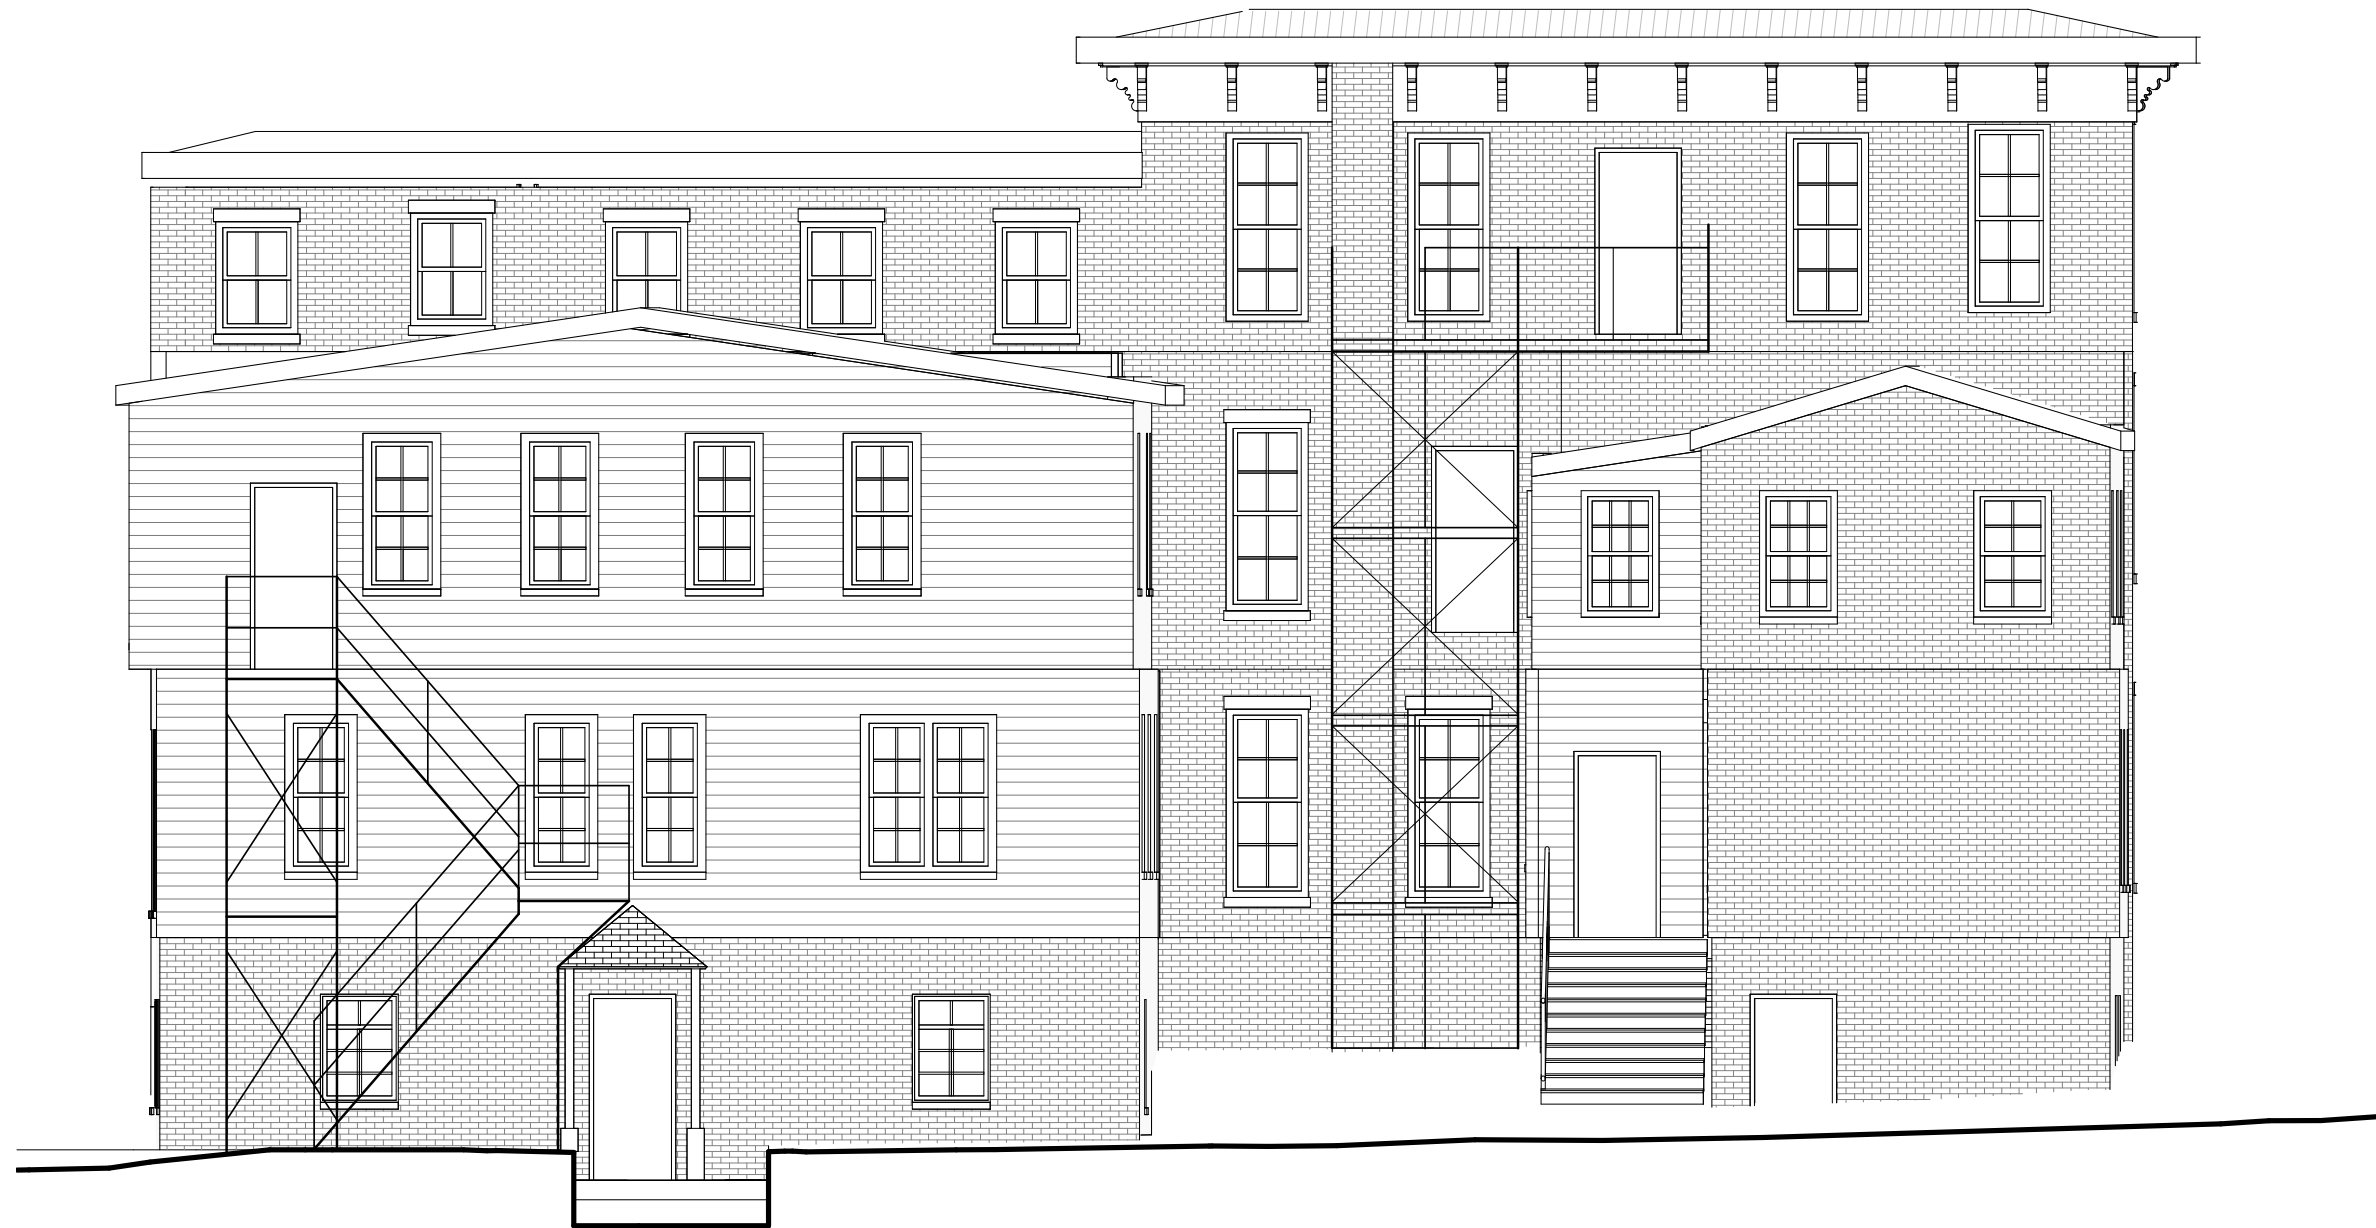
Figure 4.2.5  
15 and 21 The Green Rear Elevation - Existing

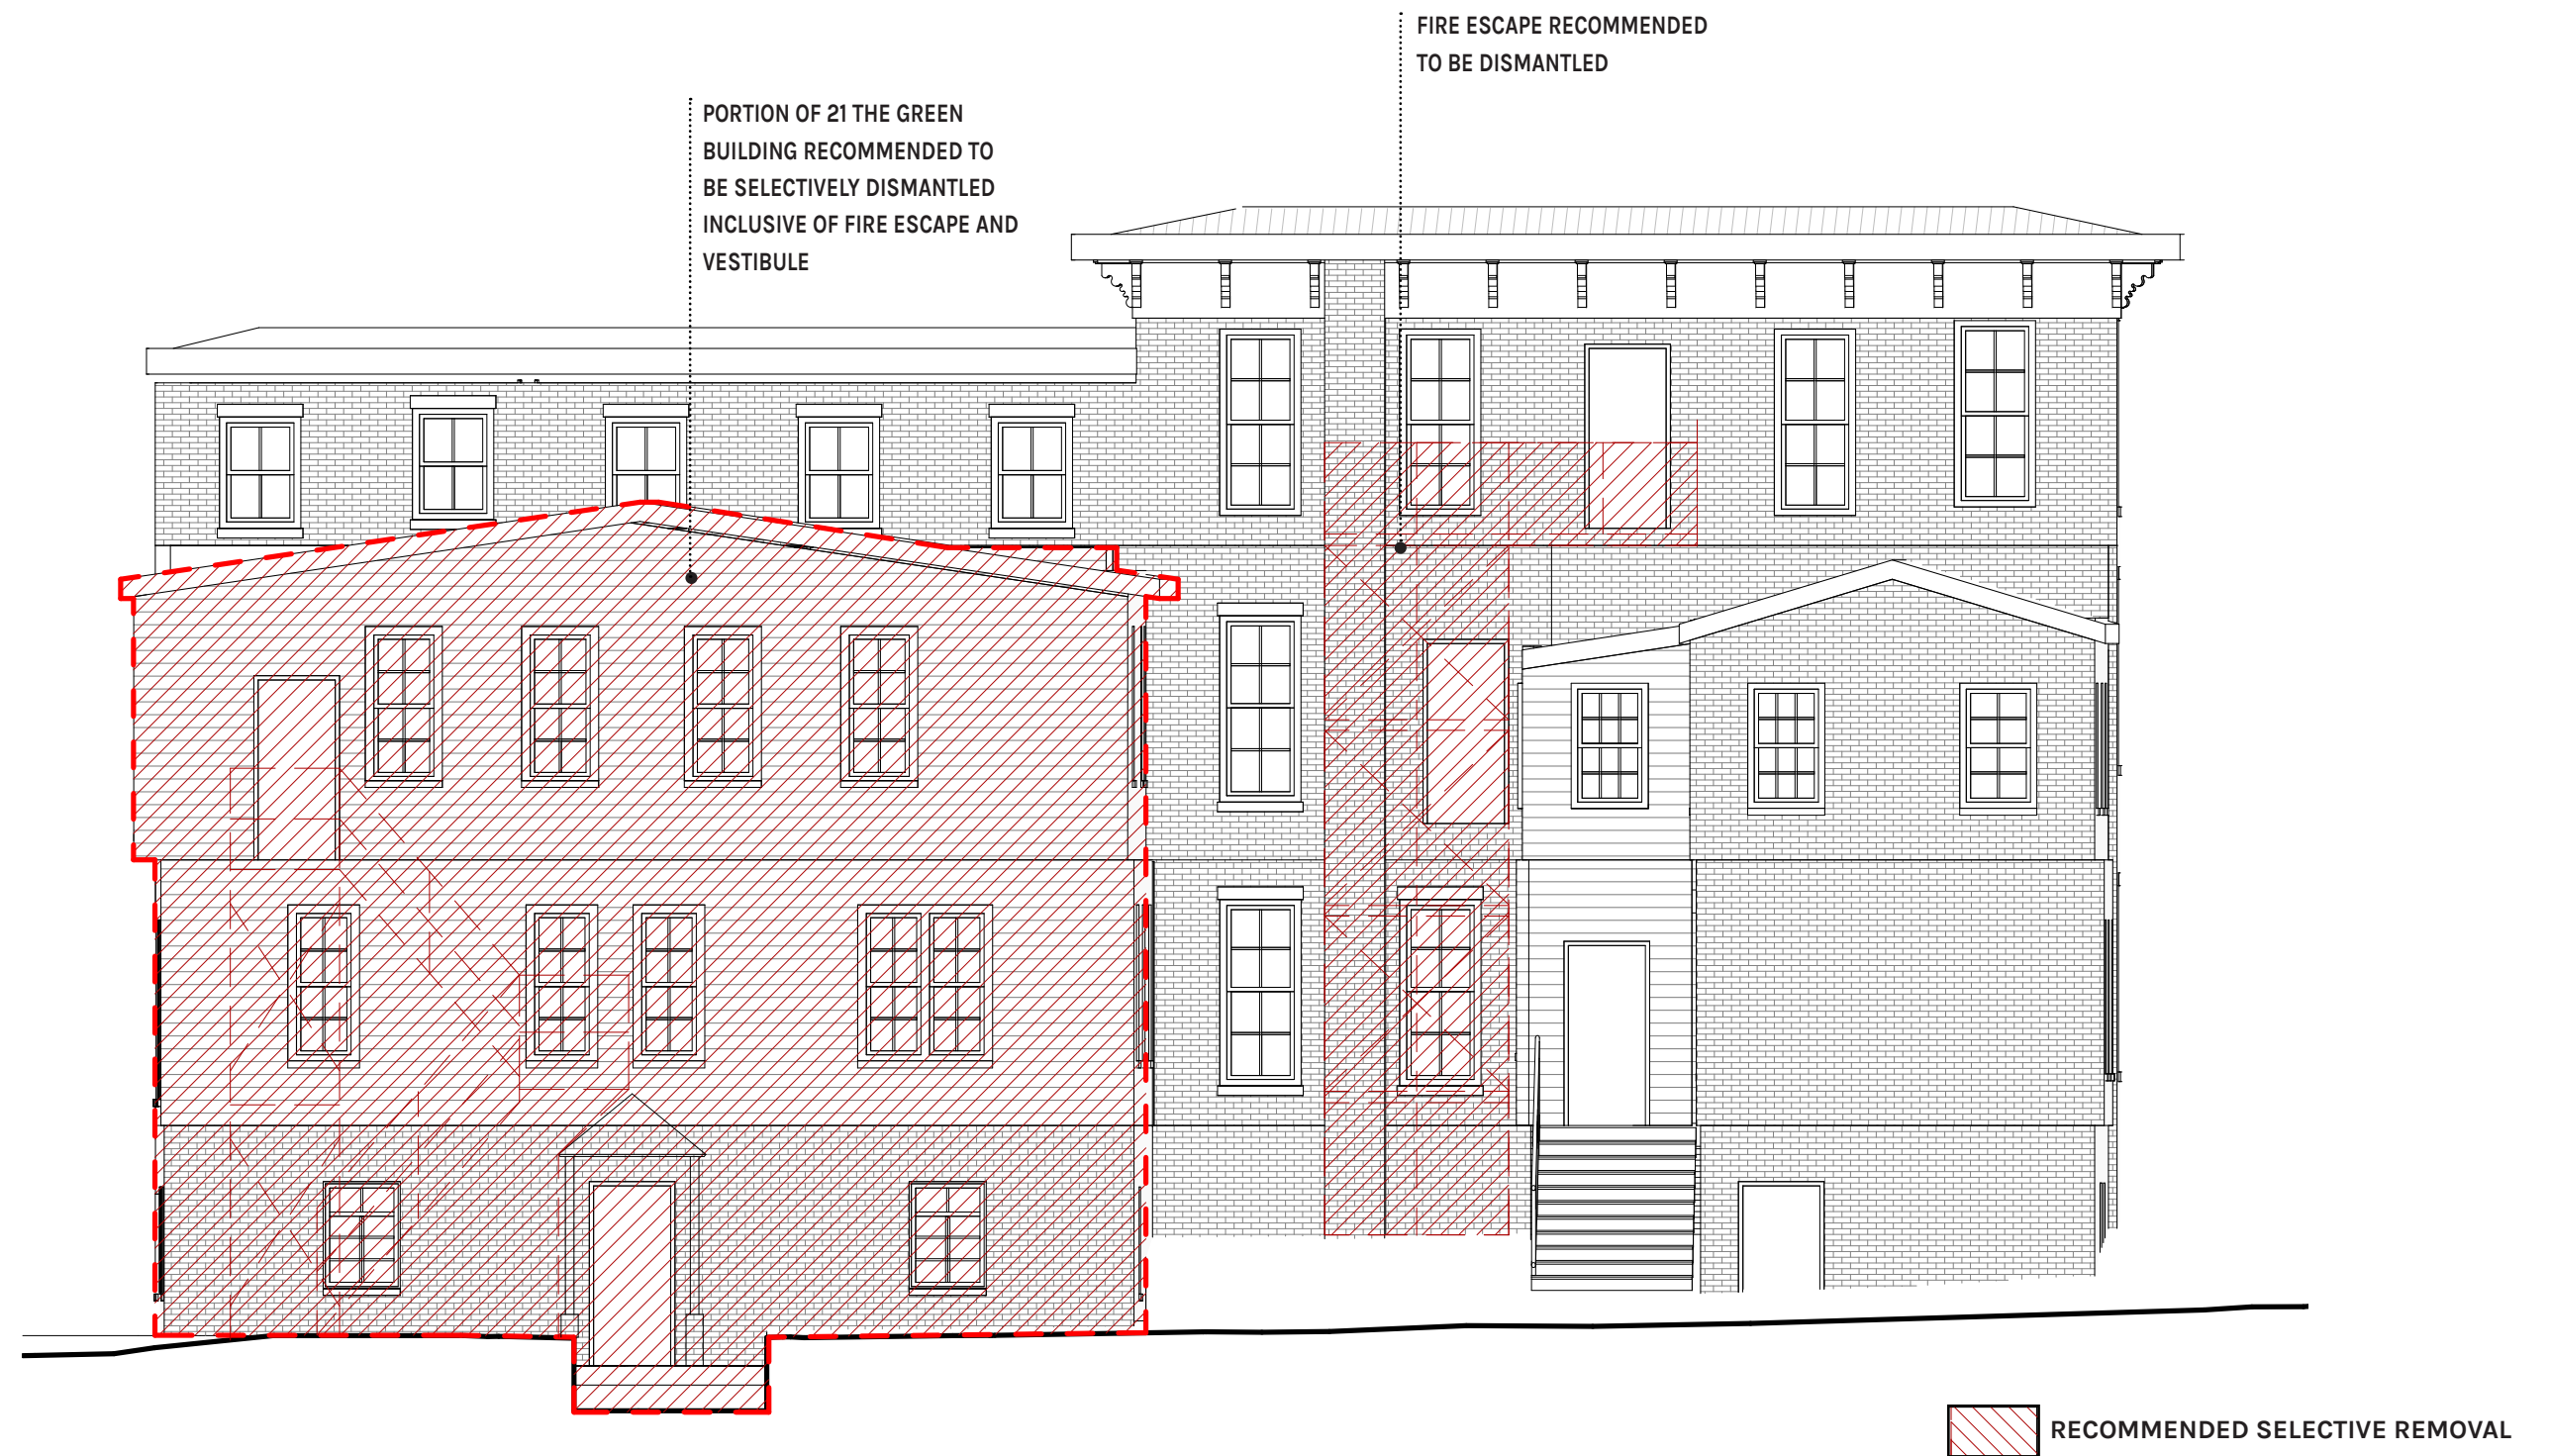
**Figure 4.2.6**  
15 and 21 The Green Rear Elevation - Selective Removal

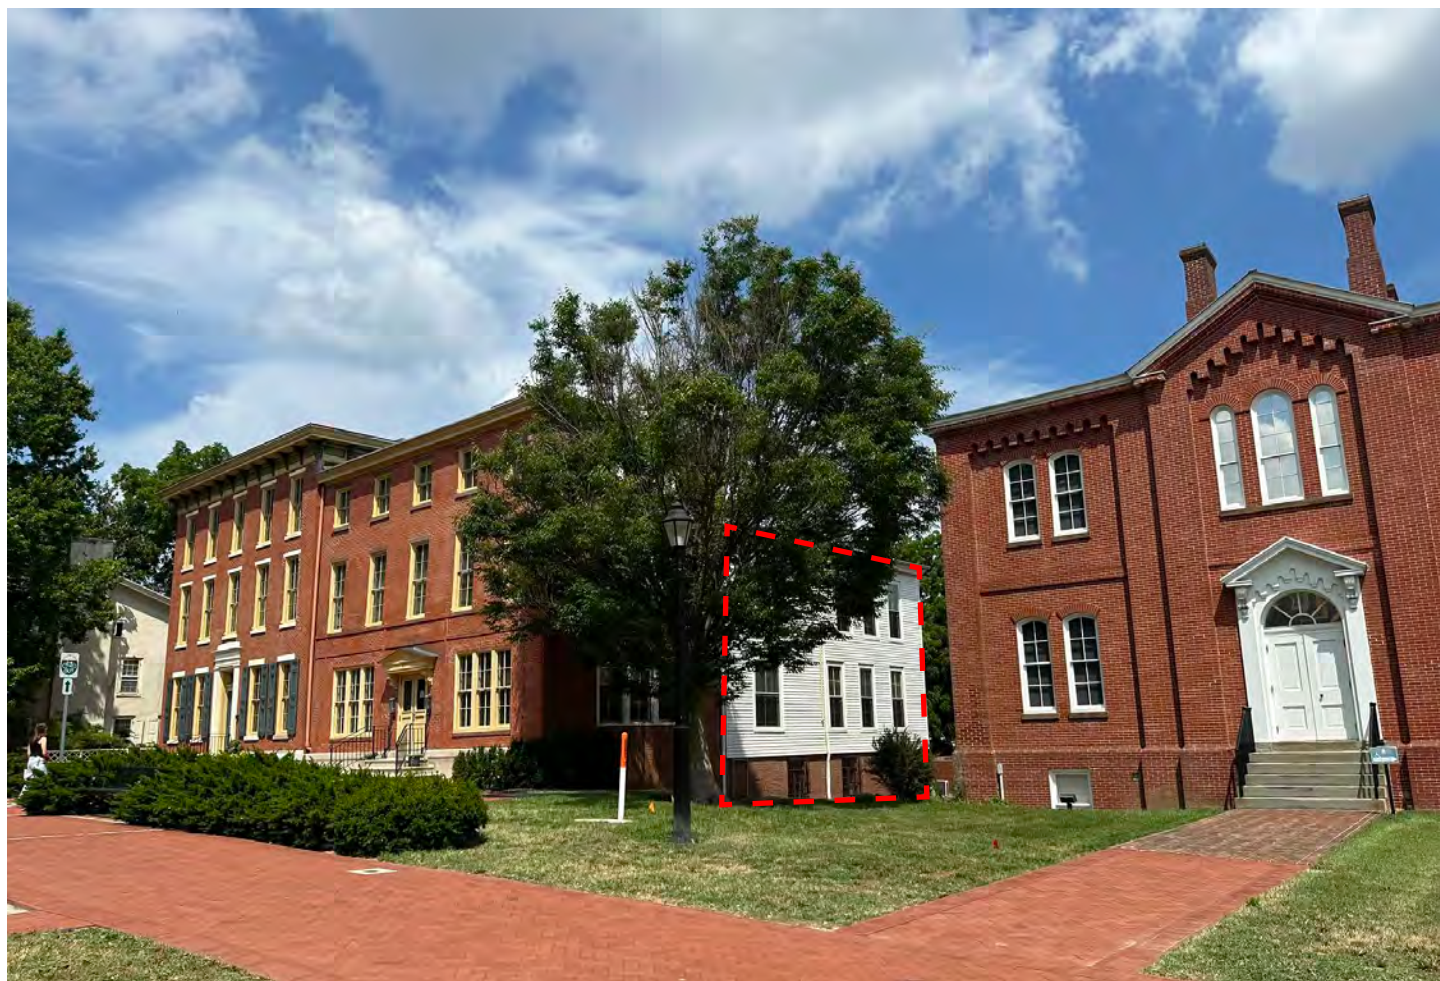
**Figure 4.2.8**  
Existing Southwest View of 15 and 21 The Green and the Old County Building (with Red Outline Demoting Proposed Selective Removal)

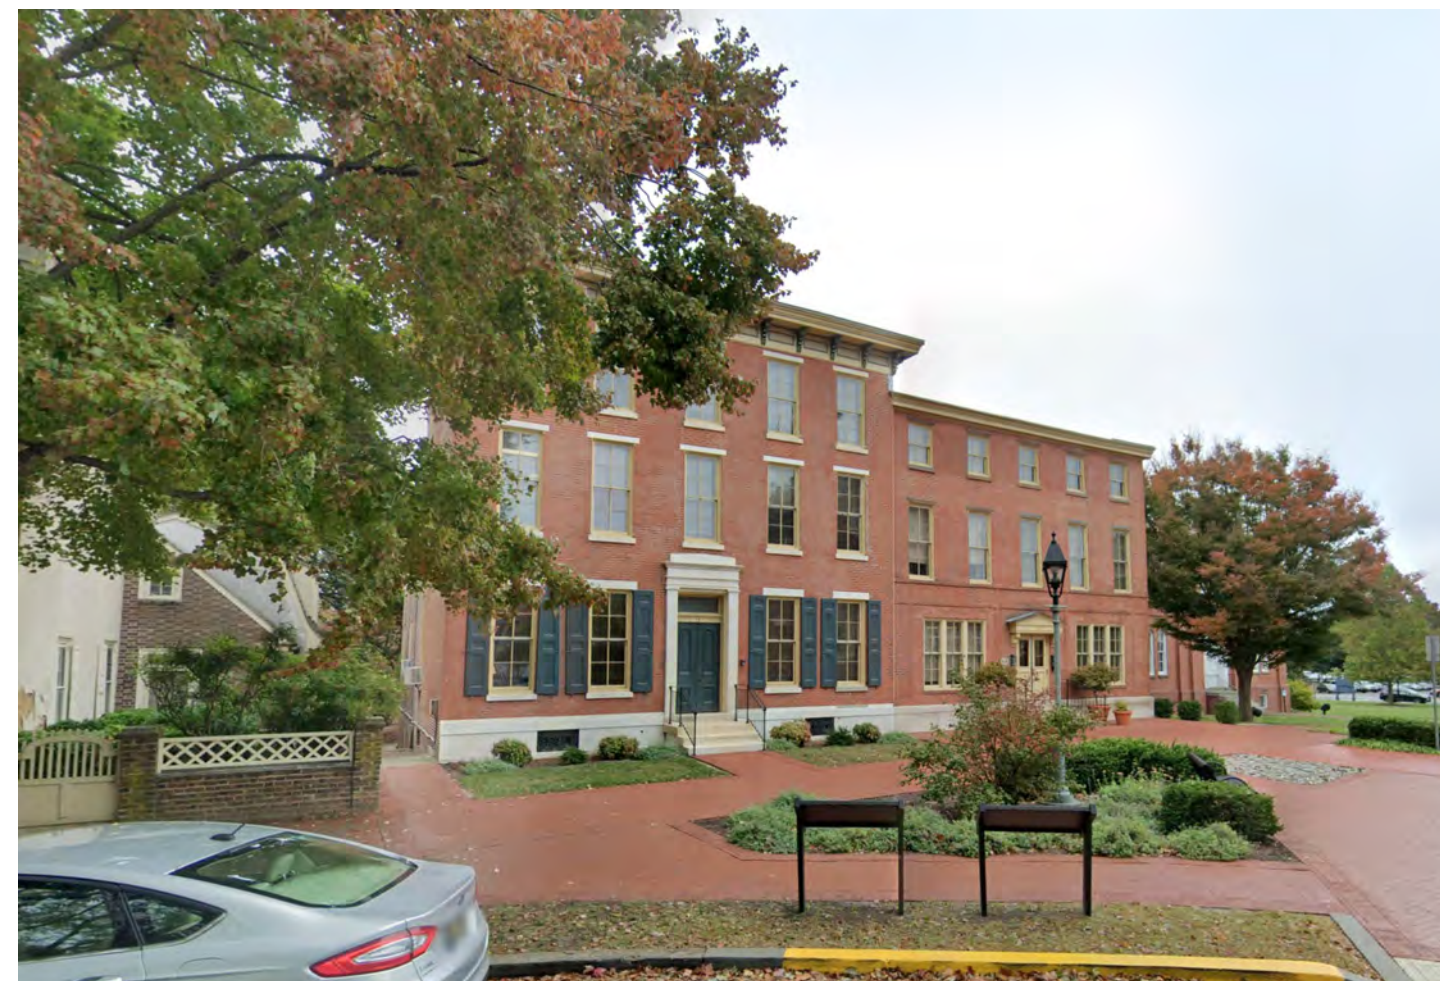
**Figure 4.2.9**  
Existing South View of 15 and 21 The Green (Showing No Impact from The Green of Proposed Selective Removal)

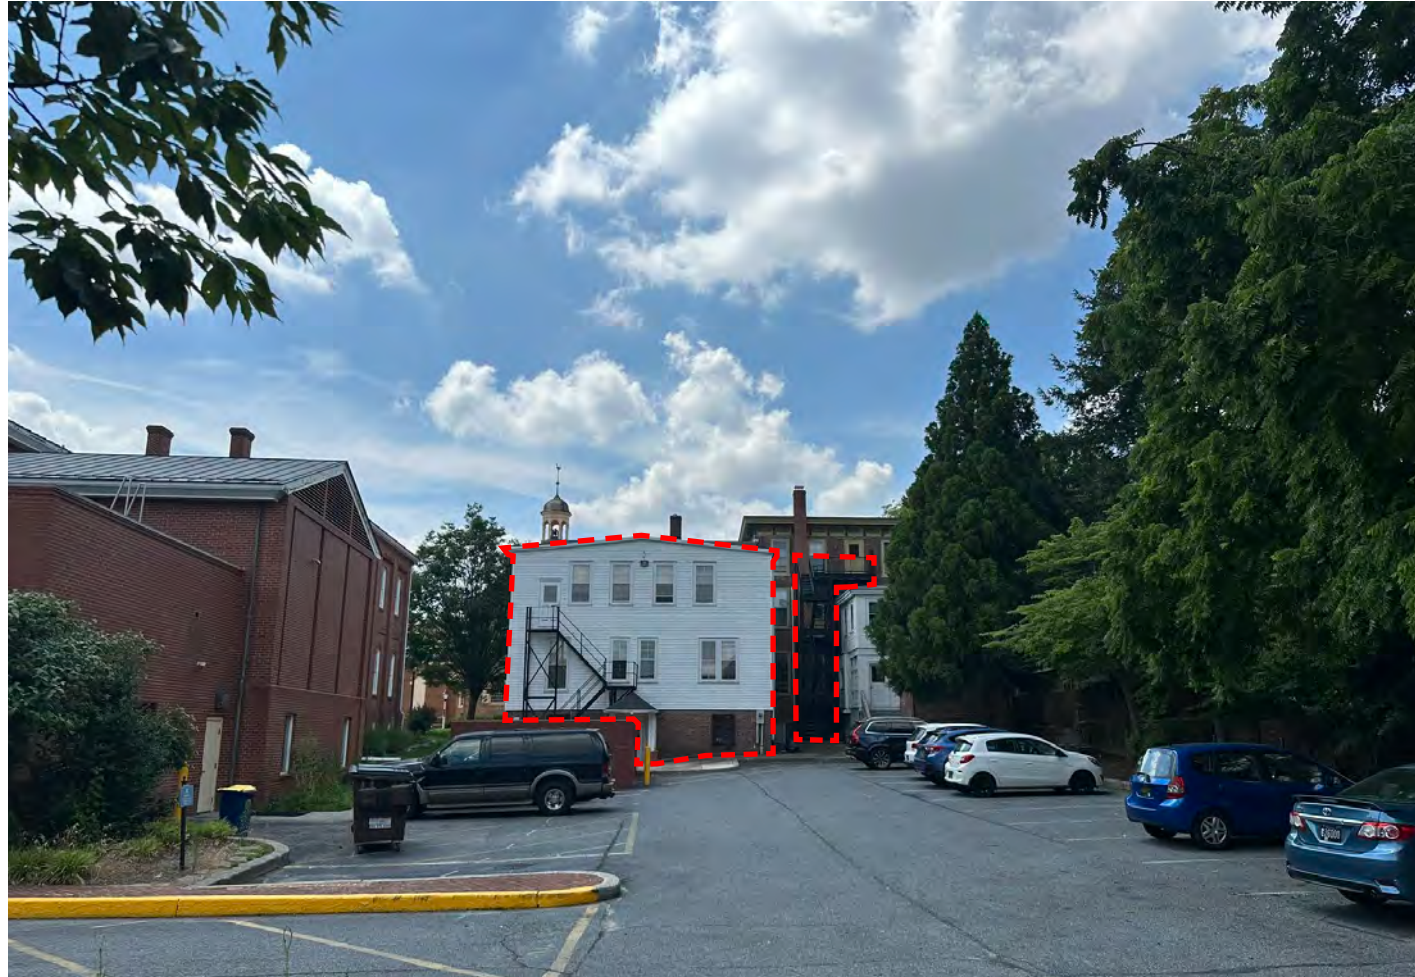
**Figure 4.2.10**  
Existing View from Northern Edge of Existing Parking Lot (Red Outline Denoting Proposed Selective Removal)
