Old Fitzhugh Road Local Historic District Resurvey Historic Resources Survey Report

Project Limits: Old Fitzhugh Road Historic District

City: Dripping Springs

Submitted By: Post Oak Preservation Solutions LLC

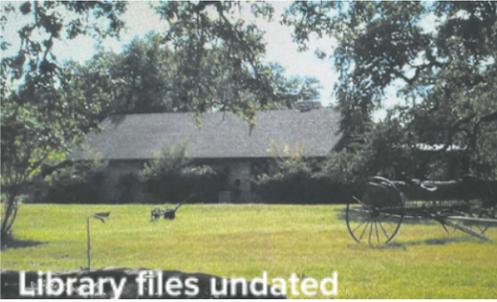
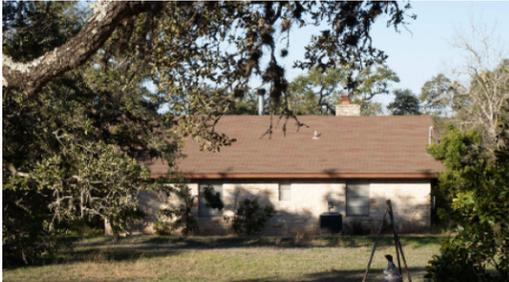
HISTORIC NAME/ YEAR BUILT/ LAT LONG	HAYS CAD PARCEL ID (2024)/ HHM ID (1988)/ ROARK ID (2014)	HISTORIC USE/ CURRENT USE/ FORM OR STYLE	HISTORIC PHOTO/AERIAL (IF AVAILABLE) OR CURRENT AERIAL	2024 PHOTO (POST OAK)	HISTORIC CONTEXT NOTES*	ALTERATIONS	HHM (1988)/ ROARK (2014)/ POST OAK RECOM.
RESOURCE #1 - 775 OLD FITZHUGH							
Ca. 1970 Davidson House 30.200535, -98.088359	RT110501 1 (Roark)	Domestic/ Single dwelling Ranch

Unnamed source in DS library files states that the original 1954 house burned in 1969 and was rebuilt in 1970. Roark states 1965, CAD lists 1976 with 2008 carport. Property originally belonged to the Stephenson family. Purchased by Nelson W. and Doris Breed Davidson (1952-1980), sold to the Kroll family in the 1980s.	Non-historic roof; c. 2008 carport addition on the west elevation.	N/A (HHM) Medium (Roark) High (POPS)
RESOURCE #2A - 750 OLD FITZHUGH RD							
Ca. 1960 Mulhollen House 30.200084, -98.087956	R17904 2 (Roark)	Commerce/Business Ranch

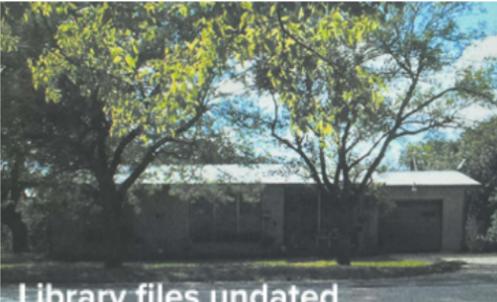
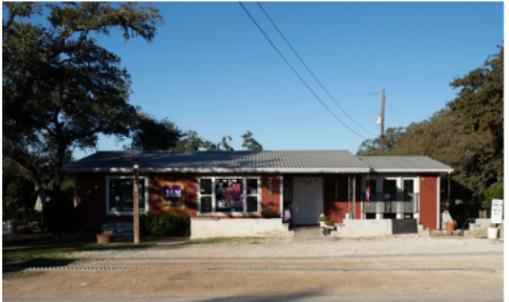
Early property owners include T.L. Maxey (1940s), Mavel Herwig (late 1950s), Jesse Langston, and D.R. Mulhollen (1960-1992). Unnamed source in DS library files states Mulhollen House built in the late 1950s. Waits and Roark give a construction date of 1960, when D.R. Mulhollen purchased the property.	Non-historic roof; c. 2007 rear porch; c. 2016 siding; c. 2016 windows; c. 2016 entry doors; c. 2016 altered garage.	N/A (HHM) Low (Roark) Low (POPS)

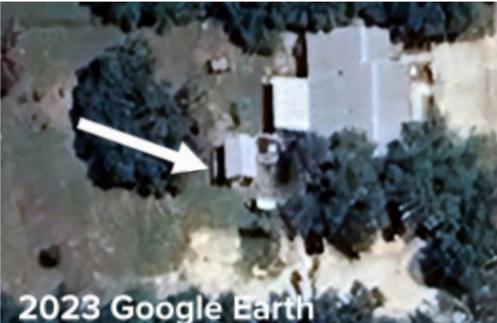
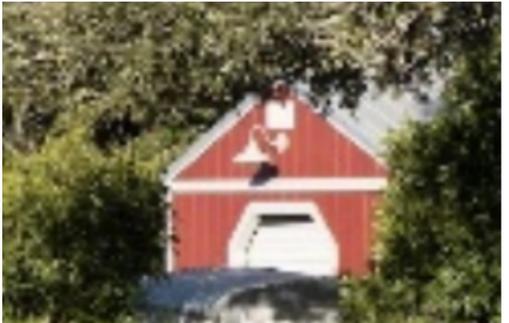
RESOURCE #2B - 750 OLD FITZHUGH RD							
Ca. 2021	R17904 N/A	Commerce/ Secondary structure No style

N/A – Not historic-age	Not historic-age; no alterations noted.	N/A Low (POPS) – Not historic-age

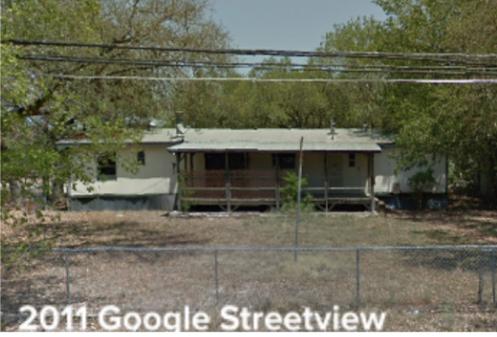
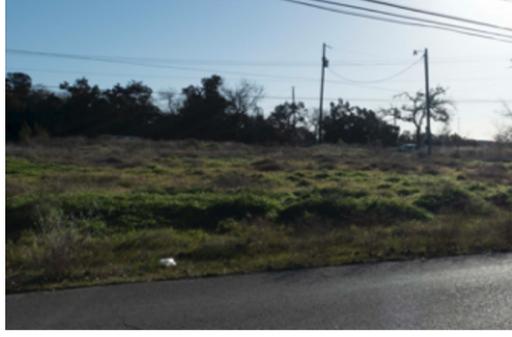
2011 Google Streetview

Vacant lot	Residence demolished ca. 2023	N/A (HHM) N/A (Roark) Low (POPS) – Vacant Lot
RESOURCE #4 - 28485 RR 12							
N/A 30.200286, -98.087351	R17939 N/A	Domestic/Single dwelling Vacant lot

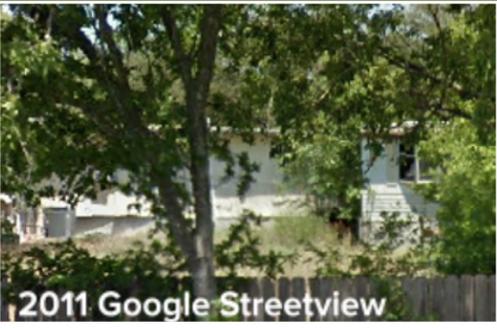
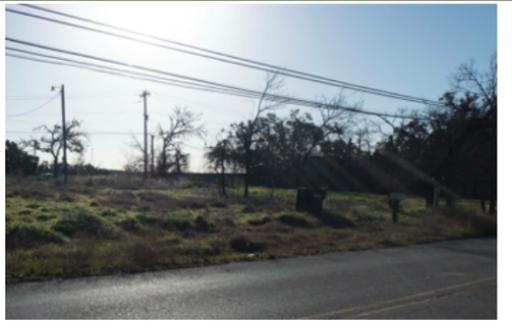
2011 Google Streetview

Originally part of the Nelson M. Davidson property, later conveyed to James R. Hall. Previous owners include L.E. and Mary Dupuy (1970s), Don Dupuy (1980), Bill O'Day (1980s), and the Hudson family (1988-2022). The former residence was demolished ca. 2015.	Residence demolished ca. 2023.	N/A (HHM) N/A (Roark) Low (POPS) – Vacant Lot

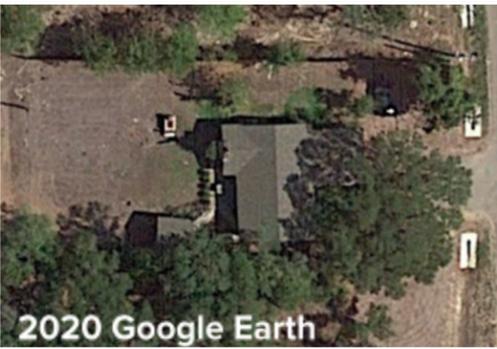
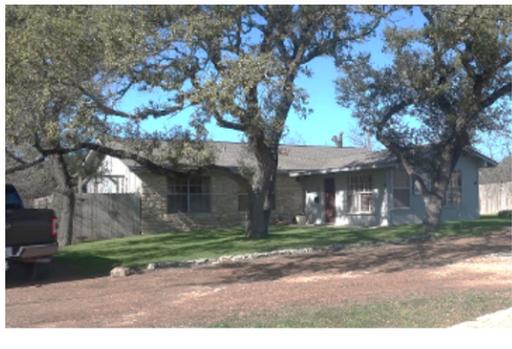
2020 Google Earth

Originally part of the Nelson M. Davidson property, later conveyed to James R. Hall. Previous owners include L.E. and Mary Dupuy (1970s), Don Dupuy (1980), Lowie Edward Walker and Sherly Elayne Walker (1980-1984), sold to Steve and Kay Carter in 1984.	Non-historic windows; c. 2023 wooden pergola added to the west (rear) elevation.	N/A (HHM) Medium (Roark) High (POPS)

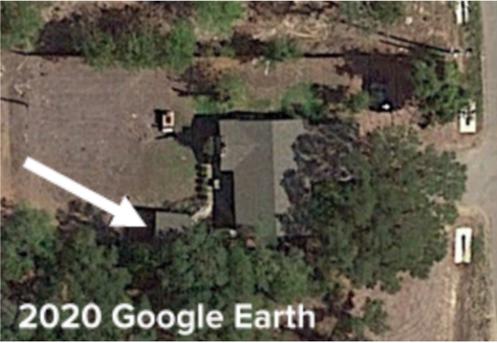
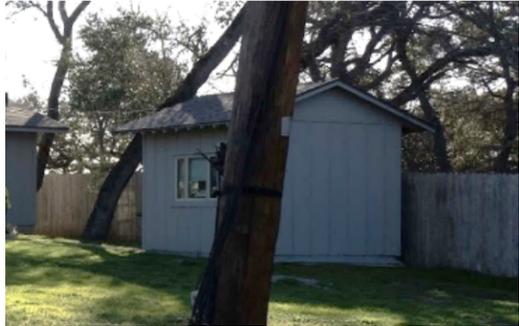
2020 Google Earth

N/A	Not historic-age; no alterations noted.	N/A (HHM) N/A (Roark) Low (POPS) – Not historic-age
RESOURCE #6 - 28101 RR 12							
Ca. 1907 (moved ca. 2015) 30.199564, -98.087335	R17936 N/A	Domestic/Single dwelling Commerce/ Business – Book store National Folk - Gable-Front-&-Wing

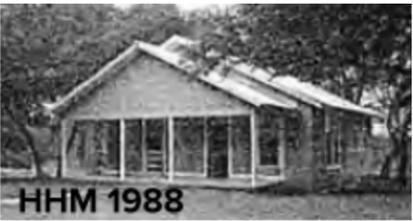
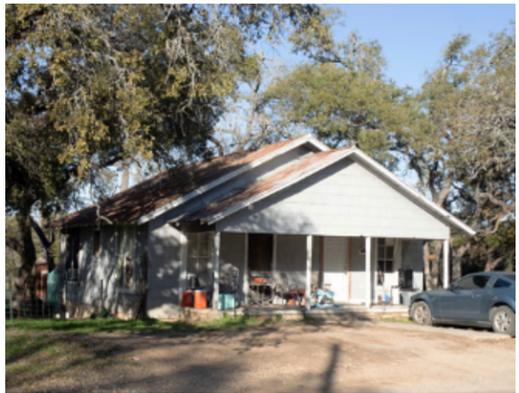
HHM 1988

This property encompasses portions of two lots originally part of P.L. Turner landholdings. This portion of the lot contains the William Allison Roberts House, likely constructed 1945 when the Roberts purchased the property from Turner. Remained in the Roberts family until it was sold to Leslie Renfro in 2011.	Non-original roof; non-original porch posts; c. 2019 entry doors.	Low (HHM) Medium (Roark) High (POPS)

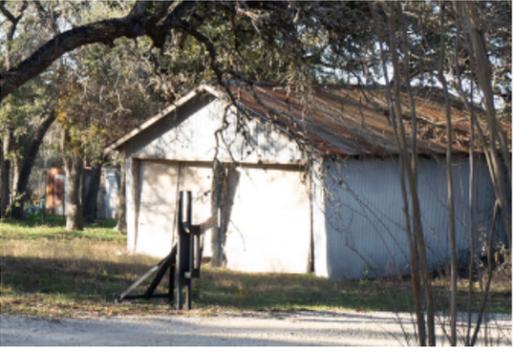
N/A	Non-original roof; non-original siding; non-original doors.	N/A (HHM) Medium (Roark) High (POPS)
RESOURCE #7C - 730 OLD FITZHUGH RD							
Wade and Velma Turner House Ca. 1940 30.199196, -98.087991	R17905/17906 45 (HHM) 4C (Roark)	Domestic/Single dwelling Vernacular Craftsman

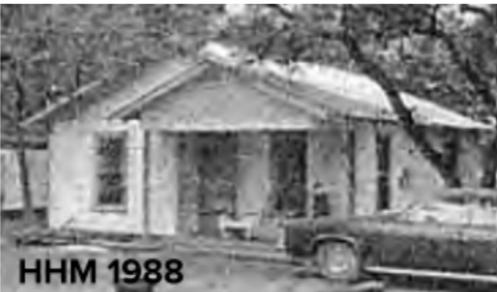
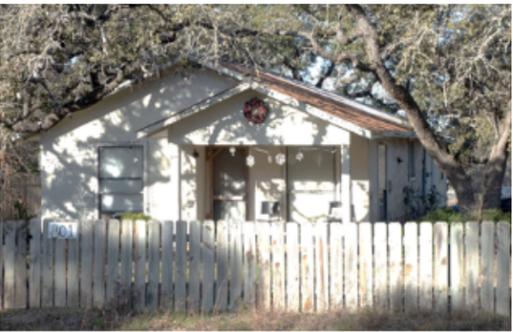
HHM 1988

This was likely the original home of Wade and Velma Turner. Wade was a local stonemason. Noah Edwards purchased a larger tract of land from E.O Wiley . Jr. in 1959 that included this parcel. In 1960 Lupe and Aggie Lerma purchased the lot with the small house from Noah Edwards. They sold property to Benito F. Garza in 1978. Garza's son Ramiro "Ramsey" purchased it in 1997.	Likely non-original siding; likely non-original porch posts.	Low (HHM) Medium (Roark) High (POPS)

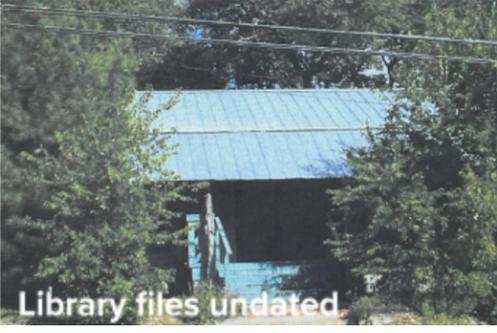
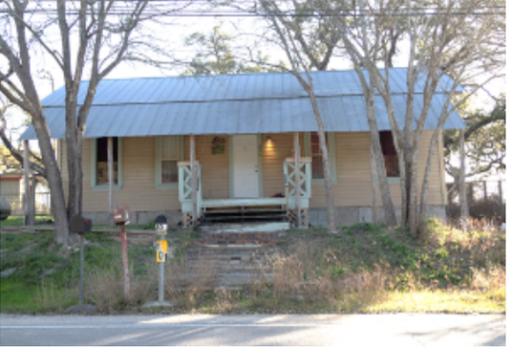
Library files undated

Originally part of the P.L. Turner landholdings that were later sold to C.W. Spillar (1946) and then Nelson M. Davidson (1953) and James R. Hall (1959). Later owners include George and Florence Johnson and their heirs (1971-1996), Billie Jean Parker (1996-2000), and Cheryl Elizondo (2000-2004). Building was moved to its current location.	Some non-original windows; non-original entry door; porch has likely been altered.	N/A (HHM) Medium (Roark) Medium (POPS)

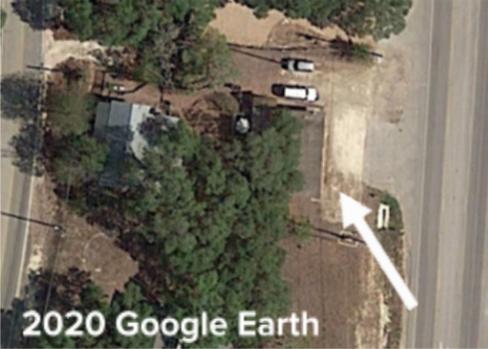
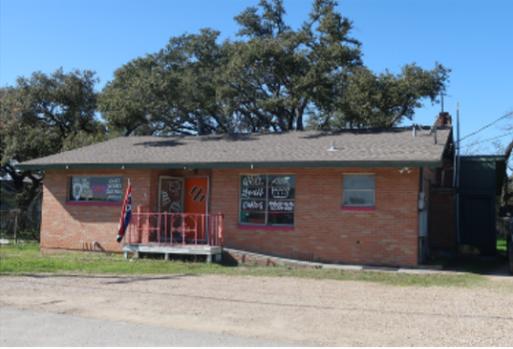
2020 Google Earth

The building was constructed in the 1970s by owner George L. Johnson as a residence following the completion of the new alignment of RR12. Later owners include Jean Parker (1998), Cherly Elizondo (2000), who converted the building to commercial use (Ole Hen House).	Not historic-age; no alterations noted.	N/A (HHM) N/A (Roark) Low (POPS) – Not historic-age
RESOURCE #8C - 650 OLD FITZHUGH RD							
Unknown – likely not historic-age 30.199397, -98.087532°	R17935 N/A	Domestic/Secondary structure No Style

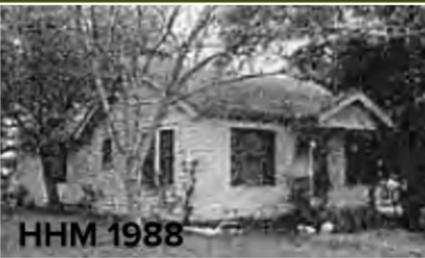
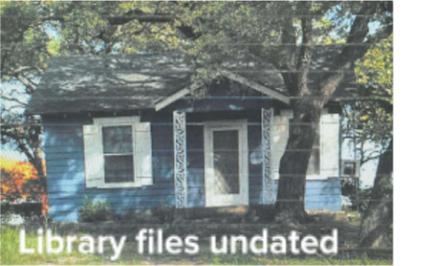
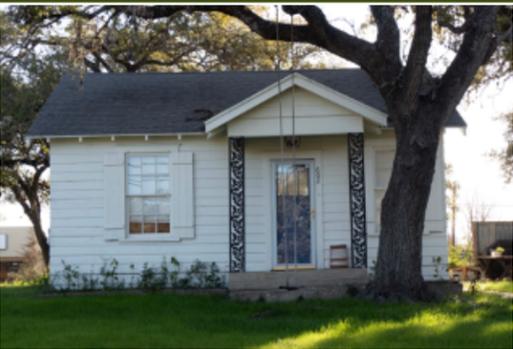
HHM 1988

Unnamed source in DS library files states the house was moved from Austin 1959-1960, confirmed via aerial analysis. Roark lists the construction date as 1940, CAD lists 1950. Property originally part of the P.L. Turner acreage, then to James R. Hall (1959), who moved house to lot for his mother. Later owners include Calvin Knauth, Alice and A.H. Benney (1972-1986), Aileen Gillis (1986-1999), and later members of the Gillis family.	Moved to its current location ca. 1960. Non-original east (rear) addition; non-original siding on east (rear) addition.	Low (HHM) Medium (Roark) High (POPS)

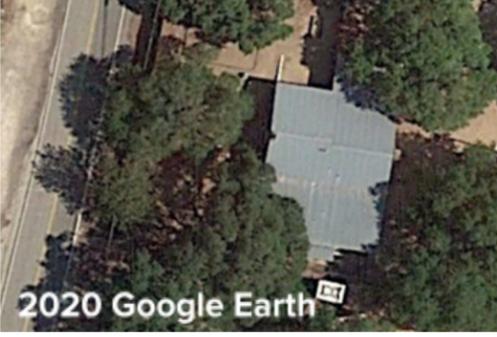
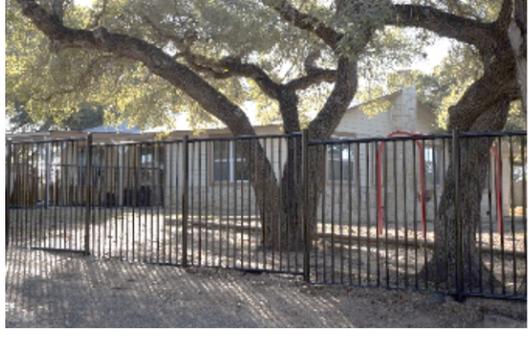
2020 Google Earth

James Hall sold lot to Jonathon Clower in 1962, subsequently built house on lot. Property reverted to Hall in 1963, then sold to John Greiner in 1965, Calvin Knauth in 1966, L.D. and Mary Beth Spears in 1980, then Aileen Gillis in 1985 who converted to daycare.	Non-original canopy; non-original vinyl siding; non-original windows; non-original entry door.	N/A (HHM) Low (Roark) Medium (POPS)
RESOURCE #11A - 601 OLD FITZHUGH RD

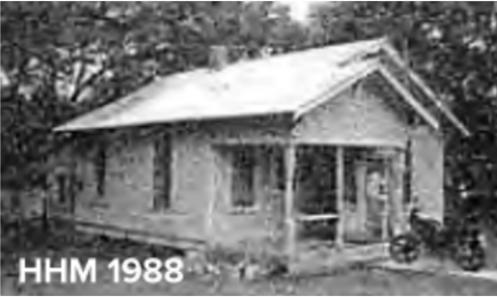
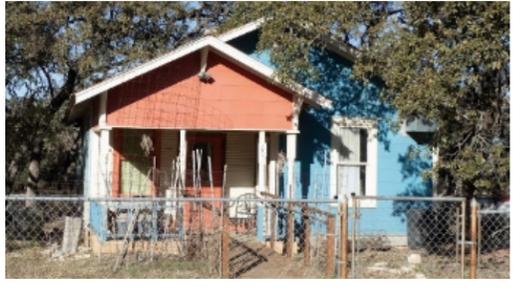
HHM 1988

P.L. Turner homesite, who owned the property until his death in 1956. In 1959 the property was subdivided, and the lot was sold to Noah Edwards, later Raymond and Betty Whisenant (1966). Whisenant family retained property until 2013. Historic masonry gatepost has '1937' etched into concrete curb.	Non-original siding; non-original entry door. Historic wood clapboards extant at porch; historic clapboards may be extant under non-original asbestos siding.	Low (HHM) Medium (Roark) High (POPS)
RESOURCE #11B - 601 OLD FITZHUGH RD							
Ca. 1930 (Roark) 30.198503, -98.088088	R17907 7B (Roark)	Secondary structure/ Shed No style

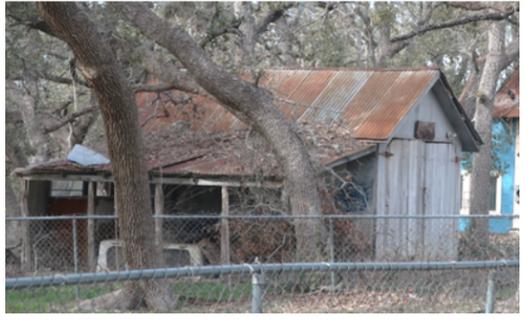
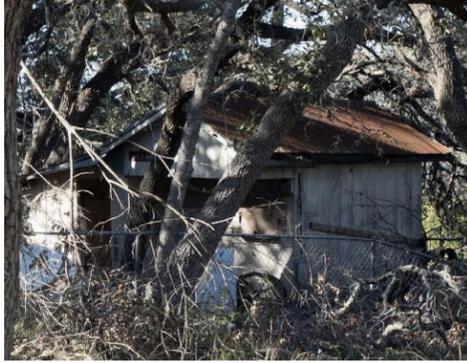
This gable outbuilding with partially unenclosed side room appears to be one of the few remaining domestic or agricultural outbuildings dating to the early twentieth century.	Does not appear to have any substantial alterations, although siding and roof material may have been updated over time.	N/A (HHM) Medium (Roark) High (POPS)

This gable outbuilding with side room appears to be one of the few remaining domestic or agricultural outbuildings dating to the early twentieth century.	Does not appear to have any substantial alterations, although siding and roof material may have been updated over time.	N/A (HHM) N/A (Roark) High (POPS)
RESOURCE #11D - 803 OLD FITZHUGH RD							
Ca. 1960 30.199150, -98.089203	R17903 N/A	Agriculture/ Outbuilding? Possible secondary dwelling

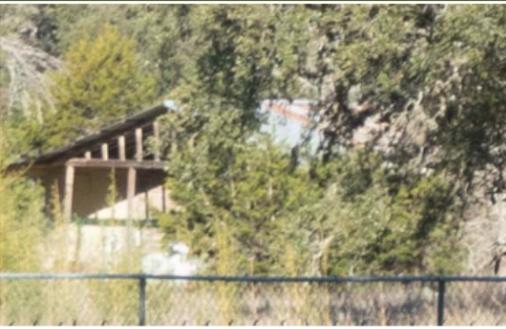
1962 USGS Aerial

This building is not visible from public ROW, however, it appears to be a residence. It is likely the property formerly belonging to Antanacio Boconeagra and Eriberta Garza Boconeagra and Benito Falcon Garza and Florencia Cordoba Garza (per deed V184/P390), who purchased in 1960 and subsequently built a residence.	Unknown, not visible from public ROW. Historic aerial photographs indicate a likely addition on the east elevation.	N/A (HHM) N/A (Roark) High (POPS)

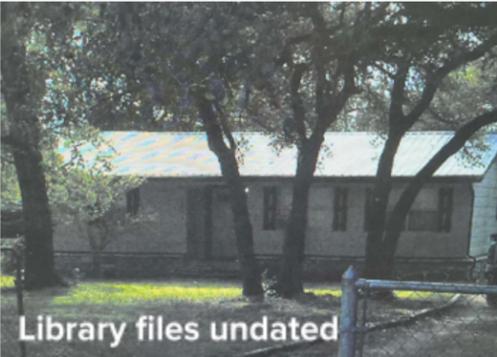
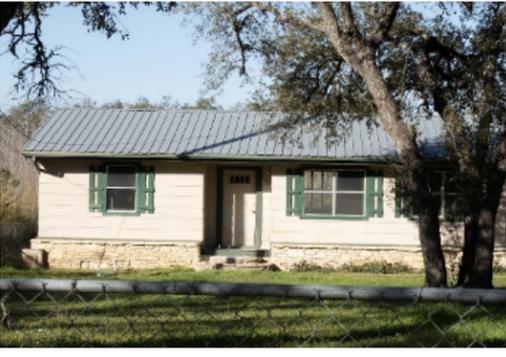
RESOURCE #12 - 575 OLD FITZHUGH RD							
Ca. 1975 George Fry House 30.198343, -98.088446	R17910 N/A	Domestic/Single dwelling Minimal Traditional

Originally part of the P.L. Turner landholdings, it was sold to Vanda Volmering in 1941, who built a house. In 1970 Volmering's heirs sold to the Garcia family. In 1975, George A. Fry purchased the property, the original house was demolished, and a new house constructed. The Fry family still owns the home.	Not historic-age; no alterations noted. Although not yet 50 years old, the building retains excellent integrity from its date of construction, c. 1975.	N/A (HHM) N/A (Roark) Low (POPS) – Not historic-age

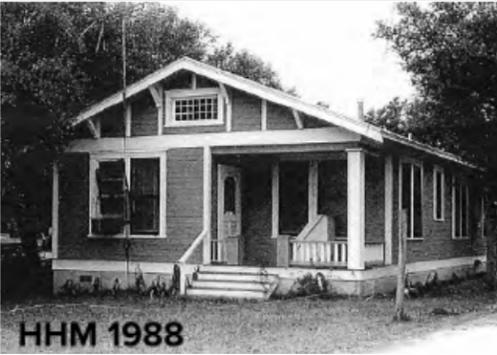
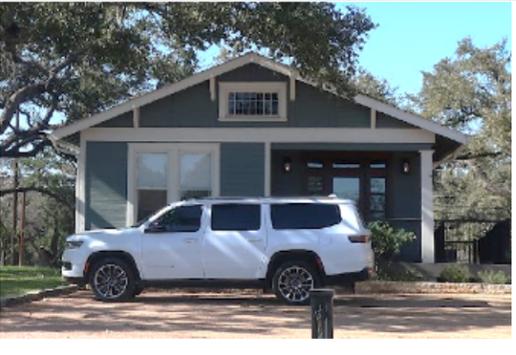
This building does not appear on the 1962 aerial in this location and was likely moved prior to 1983. Previous owners of the property include Fred and Betty Garnett (1969-1971), Lewis C. and Oralia Cruz (1971-1979), and Fay and Zelma F. Jones (1979-2002).	C. 2022, ramp with wood/composite decking and metal railings added along the north elevation leading to the front porch/primary entrance.	Medium (HHM) Medium (Roark) Medium (POPS)

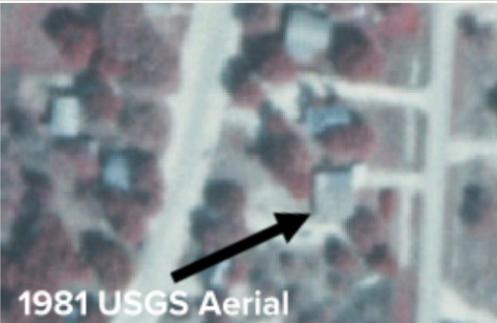
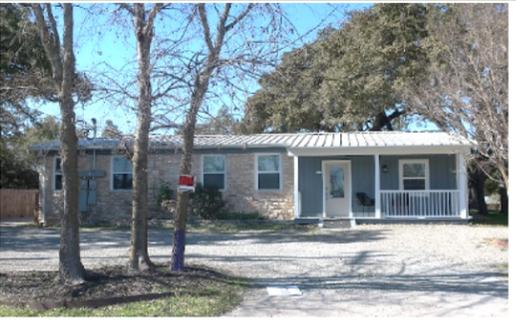
RESOURCE #15 - 700 OLD FITZHUGH RD/ 27951 RR 12							
Ca. 1965 30.198101, -98.087469	R17929 10 (Roark)	Domestic/Single dwelling Commerce/Business – Hair Salon Ranch

Originally constructed as a dwelling. T.B. Porter purchased from James Hall in 1973, sold to Alfred and Carol Chance that year. United Methodist Church purchased in 1975, then sold to Daisy Binkley in 1979. Juanita and Douglas Jernigan purchased in 1980, then sold to Carl Ann and Joseph R Felkel in 1993.	C. 2019, east (rear) elevation garage doors removed and rear porch with secondary entrance added; non-original windows; non-original entry doors.	N/A (HHM) Medium (Roark) Medium (POPS)

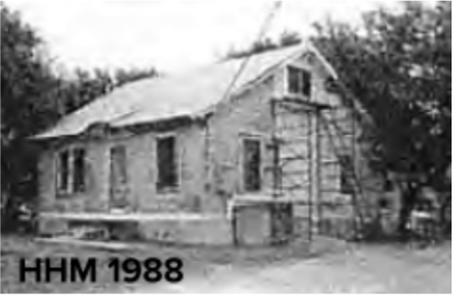
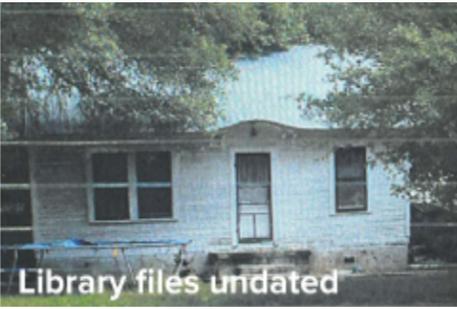
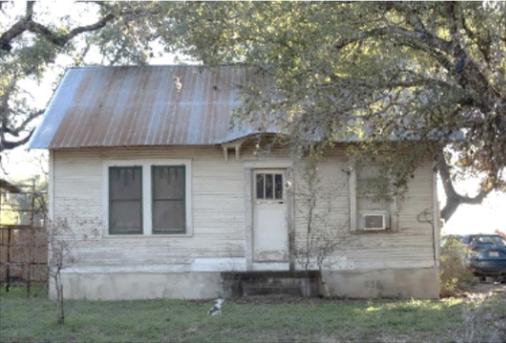
The building was likely moved from Austin and does not appear on the 1962 aerial but does appear on the 1983 aerial. James R. Hall, county surveyor, sold the property to William R. and Bessie Scott in 1973 and the property was later inherited by John Scott Jr, Janie Scott, and Jessie Scott in 2020.	Non-original foundation.	Low (HHM) Medium (Roark) Medium (POPS)
RESOURCE #16B - 560 OLD FITZHUGH RD							
Unknown 30.197739, -98.087670	R17930 N/A	Secondary structure/Shed

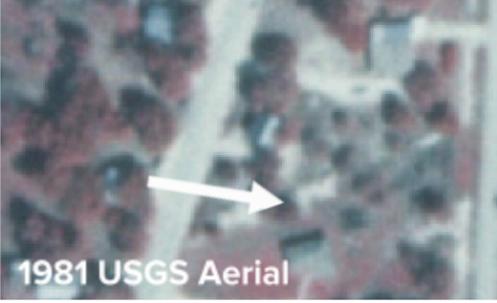
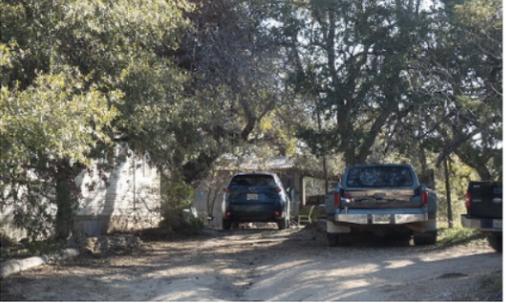
N/A	Non-original siding.	N/A (HHM) N/A (Roark) Medium (POPS)

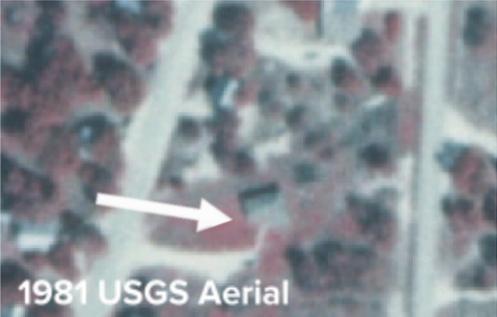
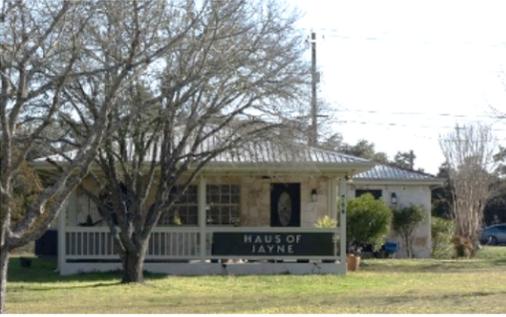
RESOURCE #17A - 766 OLD FITZHUGH RD							
Ca. 1975 30.197485, -98.087766	R17927 N/A	Commerce/Business No style

CAD says 1992 but building appears on 1981 aerial. James Hall sold lot to John L. Barnes in 1971, although later defaulted and property went to FHA. Purchased by H. Alyne Rodgers in 1975, sold to Mac Belk in 1976.	2006, west elevation porch added.	N/A Low (POPS) – Not historic-age

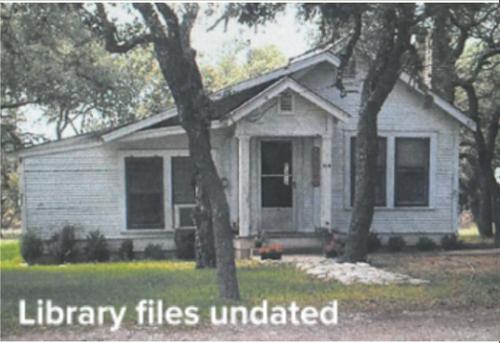
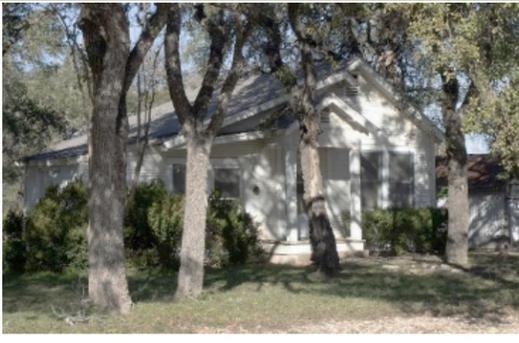
Property was originally part of P.L. Turner landholdings, sold to Jim .H. Howard and Nora Bryant in 1936. The house was likely built shortly after. Property was sold to Clarence Williamson and William McNair in 1949, and then Betty and Charlie Haydon in 1959. The property remained in the Haydon family until 2022.	Historic-age south addition.	Low (HHM) Medium (Roark) High (POPS)
RESOURCE #21B - 519 OLD FITZHUGH RD

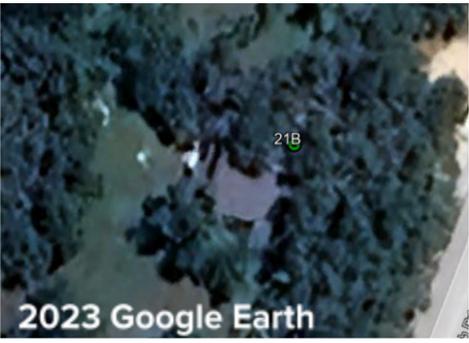
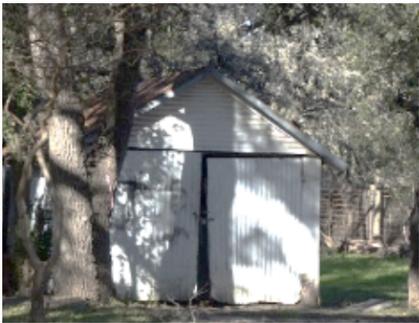
Ca. 1936 30.196866, -98.088792°	R17916 14B (Roark)	Secondary structure/Shed No style

N/A	Non-original roof; non-original siding; non-original doors.	N/A (HHM) Medium (Roark) High (POPS)
RESOURCE #22A - 515 OLD FITZHUGH RD							
Jesse E. Ragland House 1941 (Waits) 30.196589, -98.088948	R17917 51 (HHM) 16 (Roark)	Domestic/Single dwelling Vernacular Craftsman

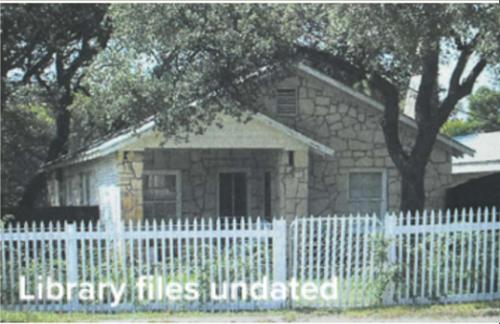
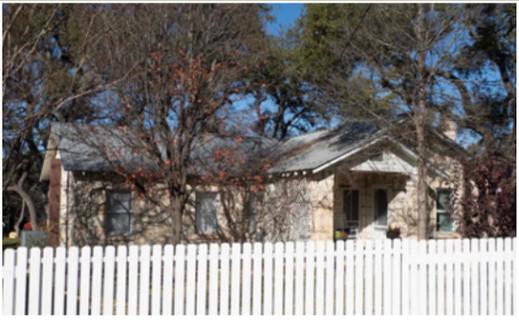
P.L. Turner sold this property to J. and Nora Howard in 1936. They subdivided the lot and sold this portion to Jesse E. Ragland in 1941. The Ragland's owned the property until 1970 when they sold to Eddie W. Needham. Needham sold to Sherri Lynne Johnson (later Bennett) in 1996.	Addition on south elevation; non-original roof; non-original windows.	Low (HHM) Medium (Roark) High (POPS)

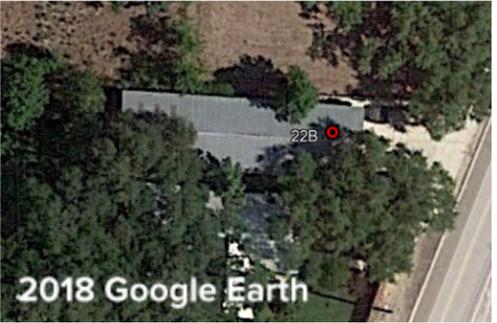
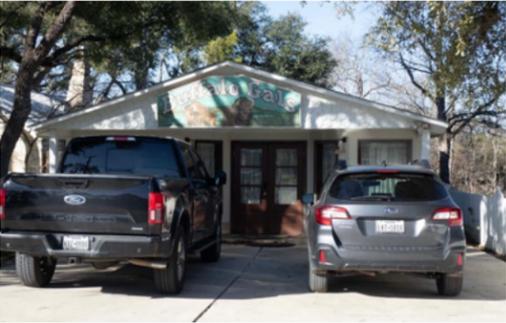
N/A - Unknown. Waits states that Mrs. Sherri Lynne Bennett established an upholstery business "in a building next to her house" in 1993 but does not specify if the building was constructed at that time.	Unable to confirm presence on historic aerials due to dense tree cover although appears evident in 1985. Does not appear to have been surveyed by Roark in 2014. Limestone veneer and piers added c. 2016; vinyl gable shingles added c. 2019.	N/A (HHM) N/A (Roark) Low (POPS)

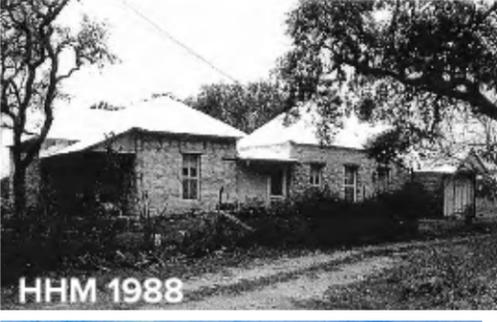
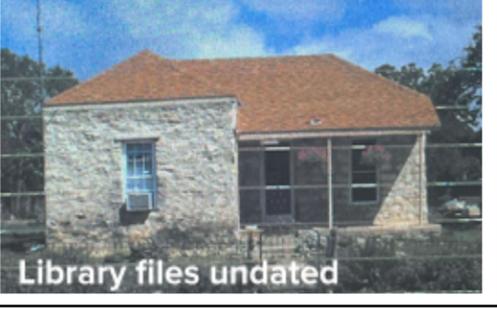
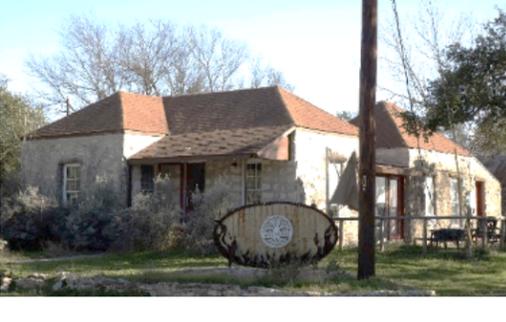
Built by John T. Spaw, originally with wood siding, using lumber from the old Middlebrook school and church. Spaw added stones personally hauled from Creek Road at a later time. The building remained in the Spaw family, inherited by subsequent generations, until it was sold in 2002.	Stone veneer added during period of significance; non-original vinyl windows; non-original porch roof.	Medium (HHM) Medium (Roark) High (POPS)

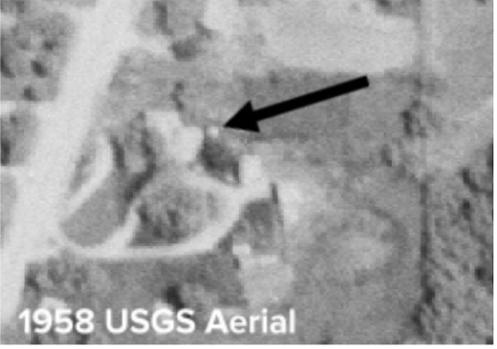
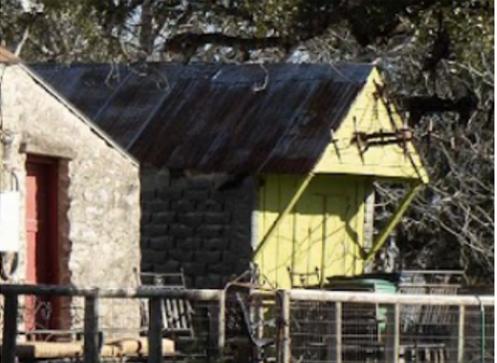
According to the 2014 Roark survey, this is the last remaining smokehouse located within the survey area. Roark did not assign the resource a survey number.	It appears the resource may have some replacement siding, but it was difficult to view from the public ROW.	N/A (HHM) N/A (Roark) High (POPS)
RESOURCE #23C - 400 OLD FITZHUGH RD							
Unknown – possibly historic-age 30.196387, -98.088356	R17925 N/A	Secondary structure/Shed No style

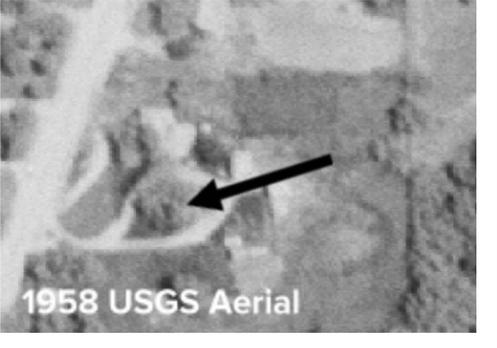
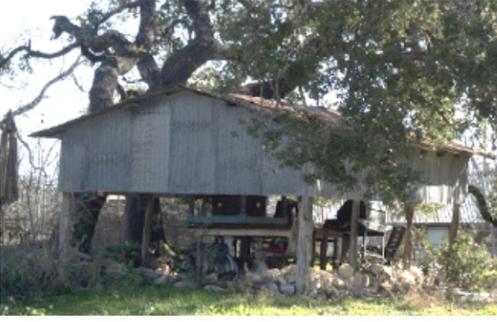
Unable to confirm presence on historic aerials due to dense tree cover. Does not appear to have been surveyed by Roark in 2014.	No apparent alterations.	N/A (HHM) N/A (Roark) High (POPS)

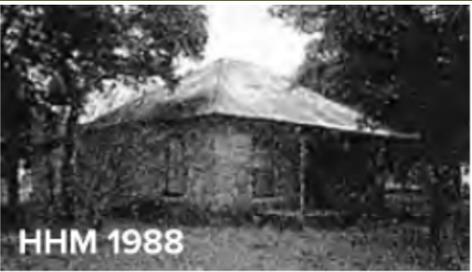
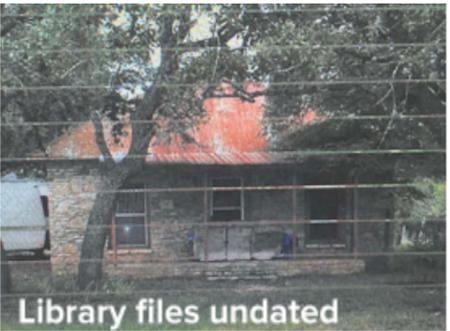
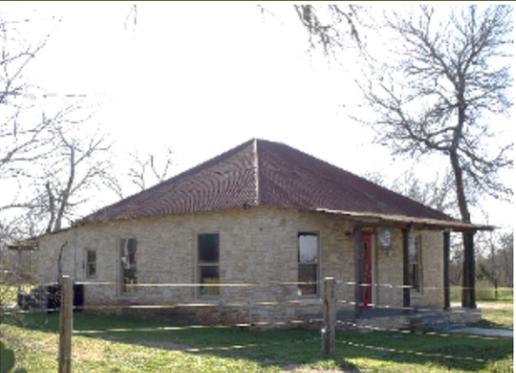
RESOURCE #27A - 310 OLD FITZHUGH RD							
1923 (Waits) 30.195692, -98.088820	R17923 61 (HHM) 18 (Roark)	Domestic/Single dwelling- Industry/ Communications Business/Bar National Folk - Pyramidal

Around 1923, Samp McLendon built this small house north of his 1912 house (Resource 31A) and moved the telephone switchboard there. Ila Mae Horner and her husband Wallace moved into the house and Ila Mae took over as switchboard operator, a position she held for 37 years (until 1960). In 1962 James O. Roberts purchased the building and added the rock veneer at that time. The property later passed to Mary Alice Roberts (1998), Alsia Ferrer (2015), and was rehabilitated as the Dog 'N' Bone business ca. 2019.	C. 1962, exterior stone veneer installed; c. 2019, rehabilitated and converted to commercial use. The gravel drives and parking lot, which cover a significant portion of the parcel, somewhat detract from the integrity of setting and the feeling/association of a rural landscape.	Low (HHM) Medium (Roark) High (POPS)* Potentially individually eligible

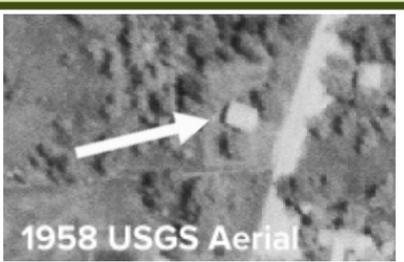
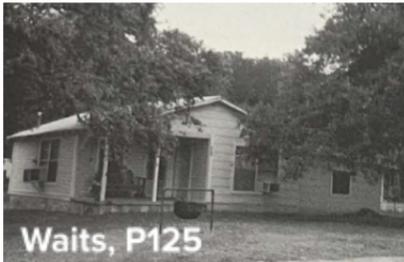
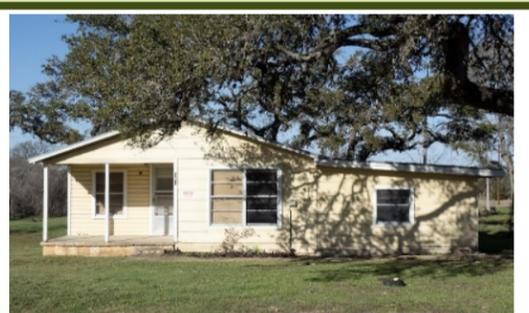
RESOURCE #28 - 301 OLD FITZHUGH RD

P.L. Turner sold to W.A. and Ila Mae Horner in 1930. A house was constructed on the property in 1950, later home to their daughter Minnie. Minnie Horner provided ice to the community from the 1920s through 1950s and kept an icehouse in a small insulated wood building downtown. Mrs. Horner also sold milk, cream, and butter, and often would sell her goods from her Model T coupe. The Horners sold the property to Virgil and Bonnie Prescott, and it remained in their family until 2018 when it was sold to Barbara Jannard.	Possibly historic-age addition on north elevation; non-original aluminum lap siding.	N/A (HHM) Medium (Roark) High (POPS)
---	--------------------------	---	---	---	--	--	--

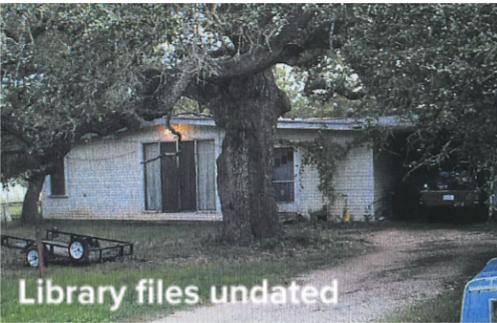
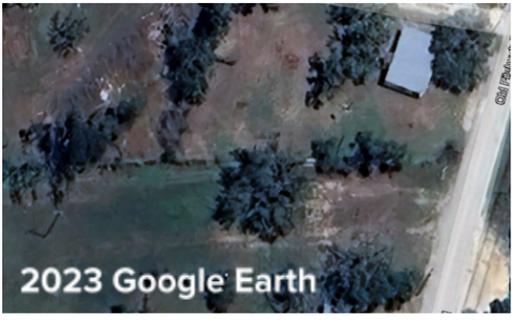
2023 Google Earth	Formerly part of I.V. and Katie Davis tract, later went to son Bradley Davis who built the home in 1964. Davis owned the property until 1998, then sold to Dennis and Mary Kyle.	Residence demolished ca. 2015.	N/A (HHM) Low (Roark) Low (POPS) – Demolished

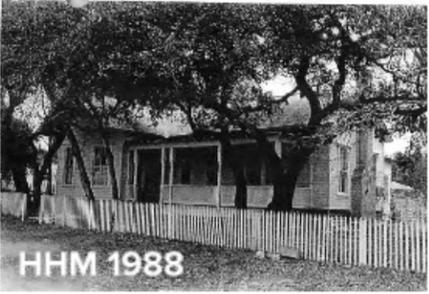
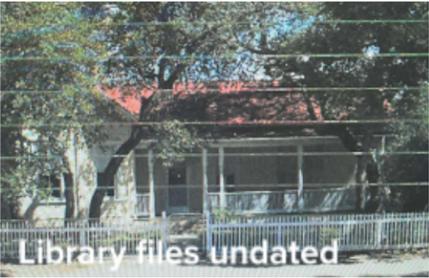
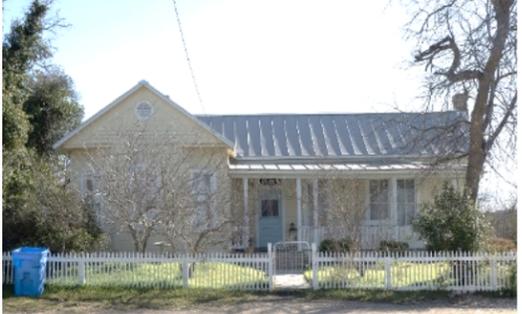
RESOURCE #31A- 250 OLD FITZHUGH RD							
W.S. McClendon House and Telephone Exchange Ca. 1912 30.195130, 98.088955	R121424 62 (HHM) 22 (Roark)	Domestic/Single dwelling- Industry/ Communications Folk Victorian

W. S. "Samp" McLendon home built 1912 with a unique angled room in projecting front gable to house telephone switchboard. The only L-plan dwelling remaining in the city (per HHM). Restored in 1995 by Charlie Haydon.	C. 2003, east elevation addition; non-historic windows; non-historic front door.	High (HHM) High (Roark) High (POPS)* Possibly individually eligible

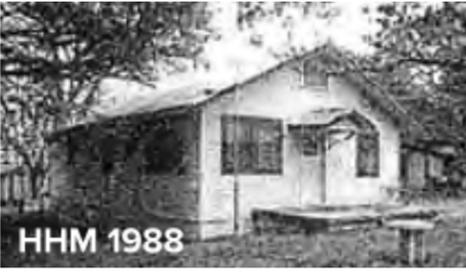
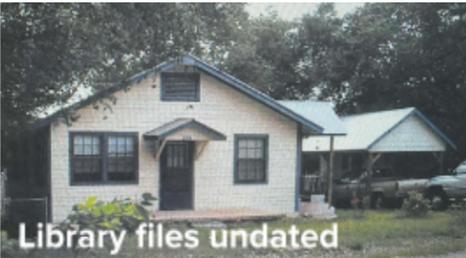
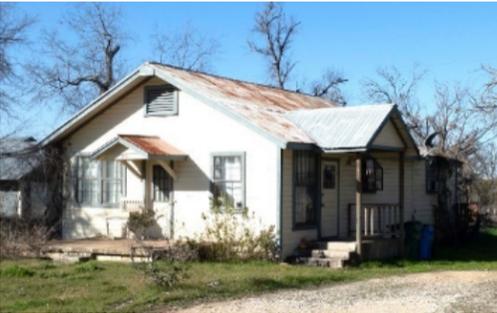
Originally part of the I.V. and Katie Davis tract, subdivided and sold to JW Butler in 1949. Walter and Gertrude Clayton purchased in 1951 and built home. Stayed in Clayton family until sold to James and Martha Flaherty in 1980s, then Richard and Katherine Wright, Tim Wright, and Maureen Casedy (1994).	Non-original windows; non-original front door; possible historic-age rear addition and side porch on north elevation.	Low (HHM) Low (Roark) High (POPS)

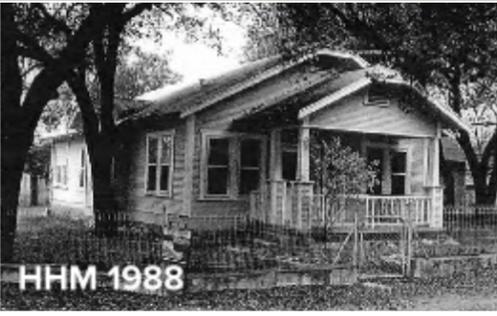
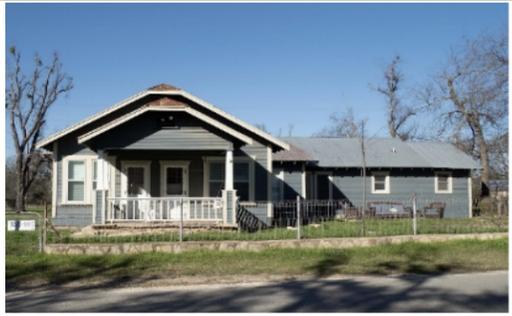
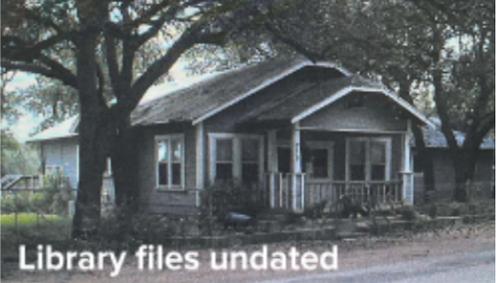
RESOURCE #33A - 215 OLD FITZHUGH RD

Built by local carpenter (per HHM). Katie Davis dismantled the main portion of the ca. 1902 home directly south to construct the residence. Roark gave the building a high preservation priority rating due it being one of the few “traditional family farms that were once common within the study area.” Waits states Katie Davis never lived in the house but rented it out.	C. 1980, north ell addition; non-historic front doors.	Medium (HHM) High (Roark) High (POPS)
	54 (HHM) 24A (Roark)	Craftsman

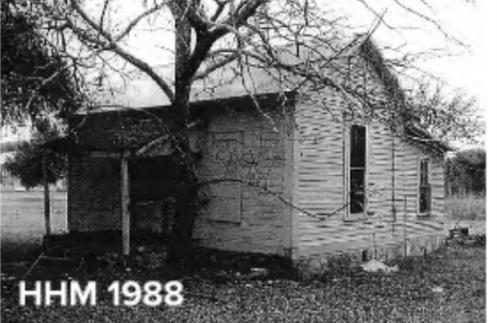
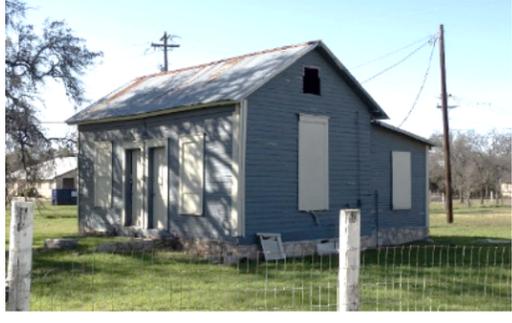
I.V. and Katie Davis House 1916 (Addition - Waits) 30.194424, -98.089560	R17921	Domestic/Single dwelling

Waits stated this was a two-room 1916 addition to the original 1890s house. The main building was torn down in 1941, and Bradley Davis used the addition for storage. Roark assigned a high preservation priority rating due its role as one of the few “traditional family farms that were once common within the study area.”	Loss of the main portion of the house occurred during the period of significance. Additional alterations include replacement front doors and concealed windows.	Medium (HHM) High (Roark) High (POPS)
	55 (HHM) 24B (Roark)	Secondary structure/Storage National Folk

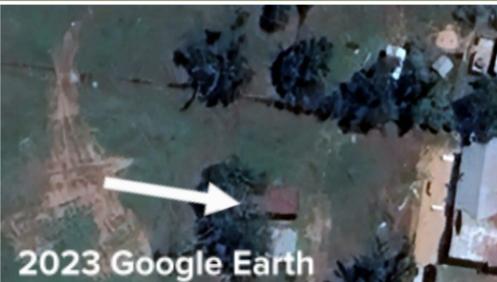
RESOURCE #33C - 215 OLD FITZHUGH RD

Although one of the few remaining agricultural outbuildings in the study area, the building was constructed ca. 1970 and does not have associations with the early development of the property.	No alterations noted.	N/A (HHM) N/A (Roark) Low (POPS)
	N/A	No style

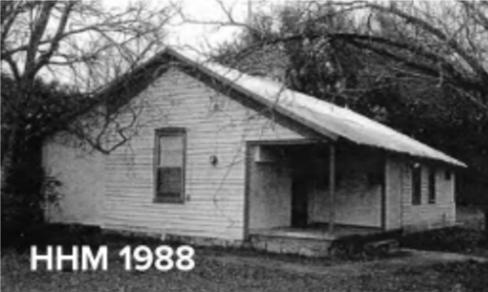
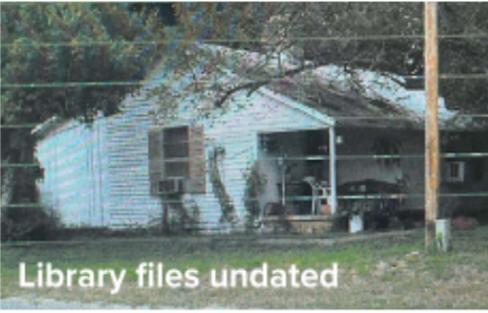
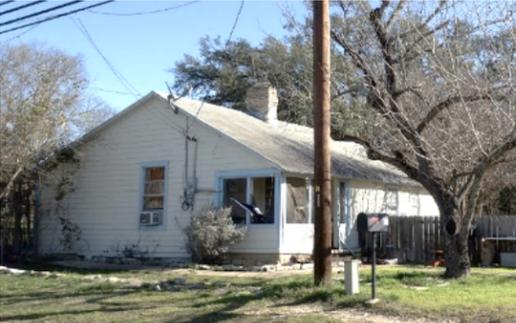
<p>Unnamed DS library source claims this is the I.C.P. McLendon House built in 1884 which later housed the telephone exchange until his son Samp built a new house at 115 OFR in 1912. The McLendon family sold the property to O.V. Stubbs in 1921. Subsequent sales of the property include to J.E. Spaw in 1925, I.D. Hedges in 1934, D.W. Crenshaw in 1936, O.J. Bean in 1937, John W. Ireland in 1957, and Bessie Ireland Scott in 1971.</p> <p>Roark refers to the home as the Patton house, although deed records do not suggest he ever owned the property. If the source material is accurate, this is one of the oldest remaining homes in the district.</p>	Post-1988, infilled front porch; non-original aluminum lap siding; non-original window and door surrounds.	Medium (HHM) Low (Roark) High (POPS)

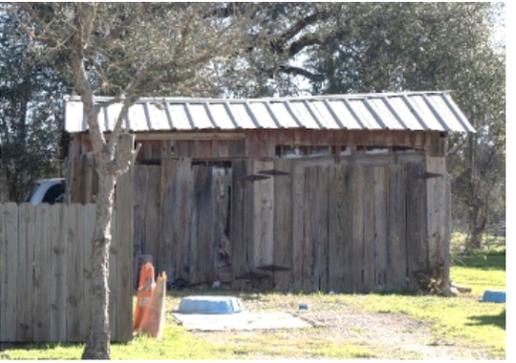
One of the few remaining historic-age outbuildings associated with early twentieth century development.	Replacement roof; non-original wood plank doors cover what appear to be historic wood doors with glazing.	N/A (HHM) Medium (Roark) High (POPS)

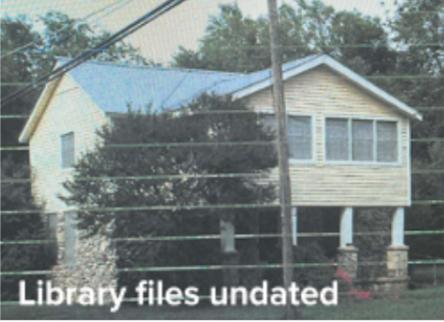
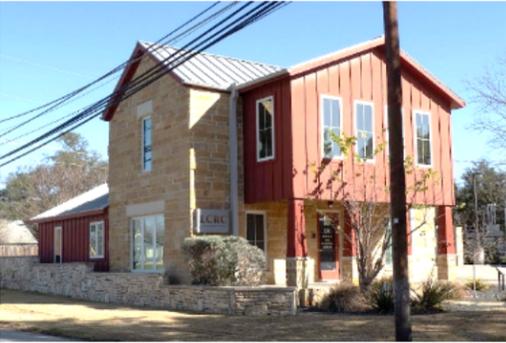
RESOURCE #37A- 102 OLD FITZHUGH RD

<p>In 1881, W.T. Chapman platted the townsite, and the Austin-Fredericksburg Road (roughly present-day Mercer Street) was the main commercial core of the community. That year the first school opened, Dripping Springs Academy, and Chapman constructed a two-story boarding house across Fitzhugh Road to house students. The building was later converted to a residence, and was remodeled several times throughout the twentieth century, most recently ca. 2016 when the entire exterior, and likely interior, was substantially altered.</p>	<p>Original building was remodeled and extensively altered beyond recognition c. 2016. Current structure retains similar form and massing, but materials and proportions have been changed. Current structure is unrecognizable as an historic 1881 boarding house and residence.</p>	<p>Low (HHM)</p> <p>Low (Roark)</p> <p>Low (POPS) – Altered</p>

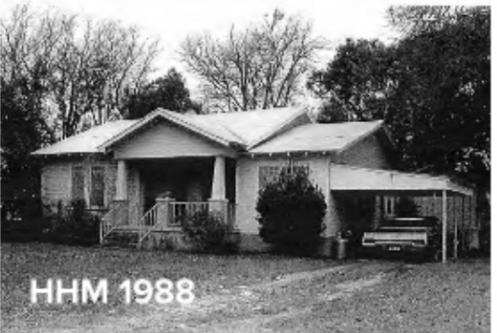
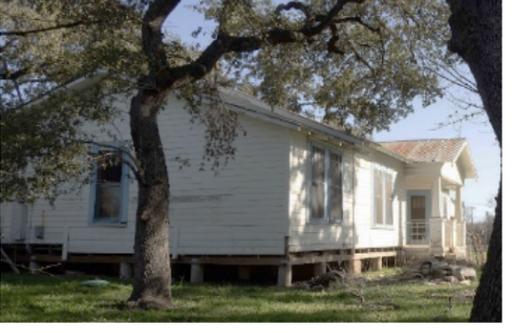
Originally part of John Short Addition, eventually sold to I.C.P. McLendon, then John R. Hamilton (1886), R.H. Haines (1899), J.B. Middlebrooks (1906), and W.L. Dye (1916). D.W. Crenshaw and wife purchased in 1925, demolished old structure, built new home. In 1941 Crenshaw family sold to J.E. Spaw. Remained in Spaw family until ca. 2011. Roark calls this residence the Dye/Logan house although this appears incorrect.	Possible early alterations prior to 1930; non-historic carport on north elevation; non-original porch railings; c. 2016, historic foundation removed and replaced with concrete piers.	Medium (HHM) Medium (Roark) High (POPS)

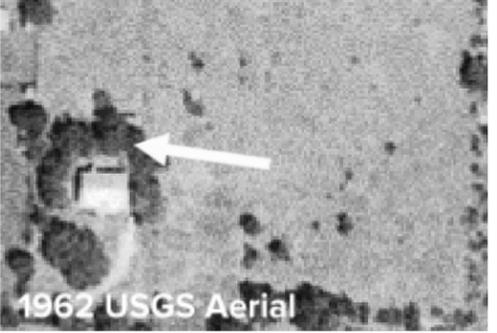
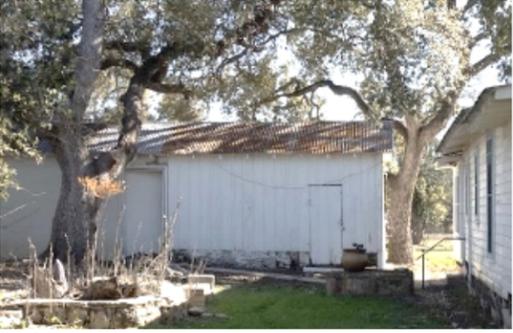
RESOURCE #38B - 100 OLD FITZHUGH RD							
Ca. 1925 30.193847, -98.088626	R17947 N/A	Domestic/Secondary structure No style

Associated with 1920s Crenshaw homestead and subsistence farm/ranch. One of the few parcels within the district that still engages in small-scale agriculture.	No significant alterations noted.	N/A High (POPS)

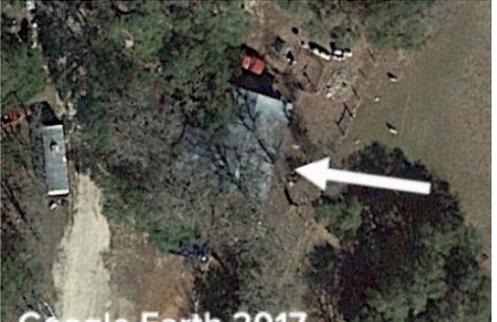
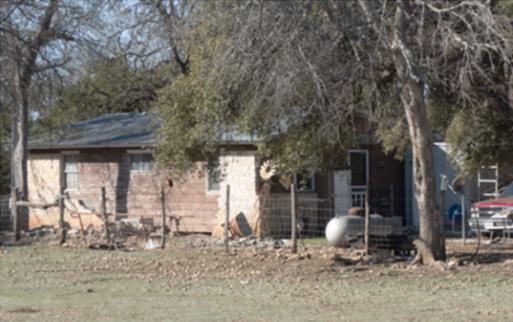
RESOURCE #40A - 380 MERCER ST							
Garza Ranch Ca. 1965 30.193979, -98.090547	R17897 N/A	Domestic/Single dwelling No style

Property ownership of this parcel was difficult to discern; it appears it was inherited by W.S. Chapman's widow who conveyed it to her daughter Fannie Coopwood in 1918. Coopwood sold to W.S. Garnett, Sr. and W.S. Garnett, Jr. (deed mentions a well, an old barn) in 1935, then by Garnett's heirs to Mary Lou Haster in the 1950s, Epifanio and Francisco Garza in 1960, and Richard and Rosa Garza in 1974. This residence was likely constructed by members of the Garza family.	Much of the masonry veneer is in disrepair and is crumbling from the building's exterior. There appears to be a shed roof addition on the north elevation.	N/A High (POPS)

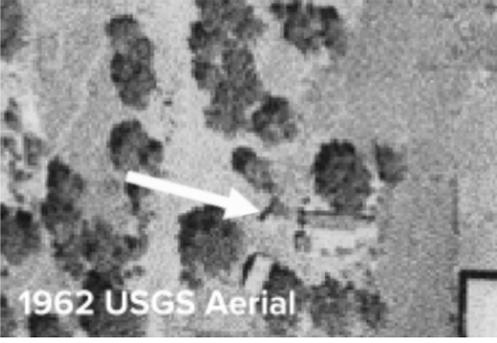
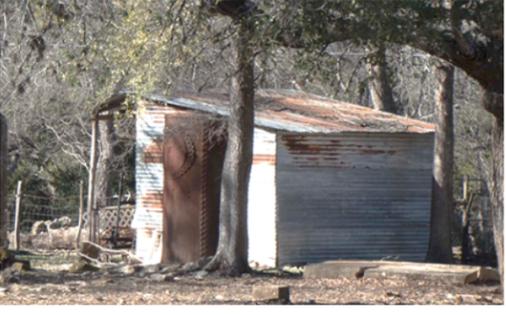
See Resource 40A.	No significant alterations noted.	N/A High (POPS)

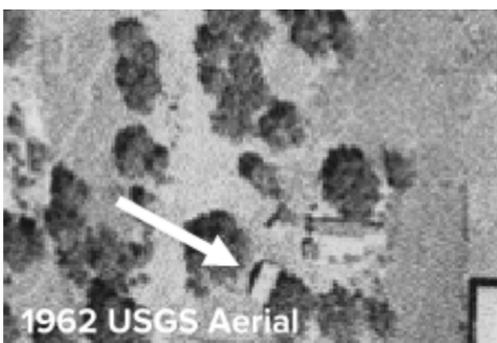
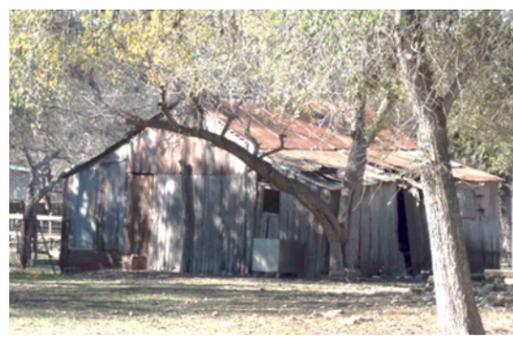
See Resource 40A. Likely constructed during the Garnett family ownership.	No significant alterations noted, some missing roof material.	N/A High (POPS)
RESOURCE # 40F - 380 MERCER ST							
Ca. 1940 30.194509, -98.090745	R165789/R17897 N/A	Object/Ruin

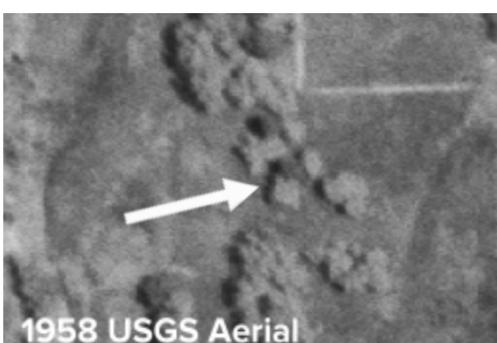
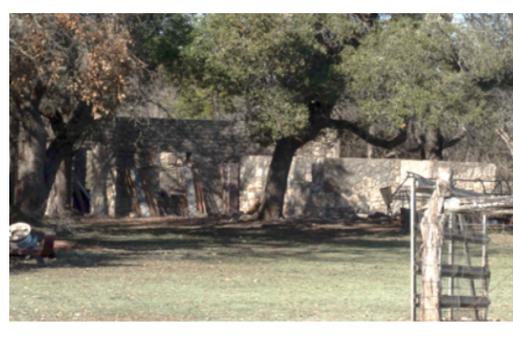
See Resource 40A. This may be a remnant of the old Garnett family home/property. Sketch map in <i>Clear Springs, Limestone Ledges</i> indicates the presence of "rock pens" on the Garnett property, so it is also possible this historically served an agricultural or ranching purpose.	Limestone walls of a former structure, possibly a residence. Structure no longer has a roof, doors, or windows.	N/A High (POPS)

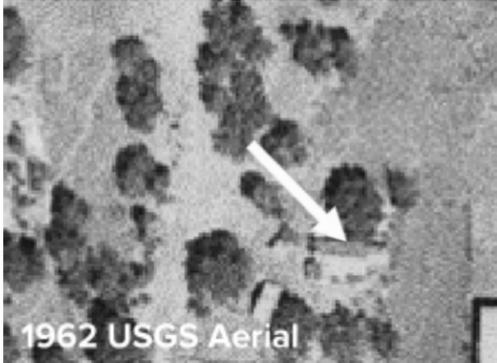
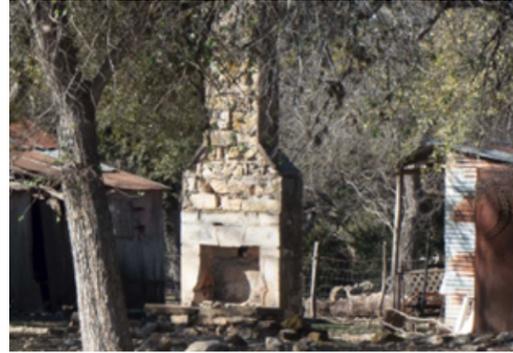
RESOURCE # 40G - 380 MERCER ST

See Resource 40A. This may be a remnant of the old Garnett family home.	This limestone chimney is all that remains of a former residence on the property.	N/A High (POPS)
--	-------------------	-------------	--	---	---	---	------------------------
