Old Fitzhugh Road Local Historic District Resurvey Historic Resources Survey Report

Project Limits: Old Fitzhugh Road Historic District

City: Dripping Springs

Submitted By: Post Oak Preservation Solutions LLC

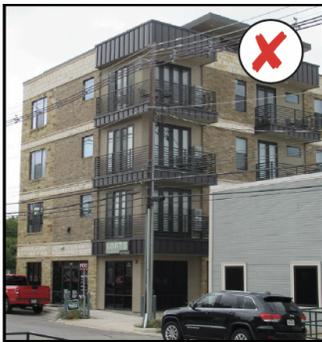
The height of this building is incompatible with the Heritage District.

2. A larger building should be broken into “modules” that are similar in scale to the width of buildings on the blockface. Street-facing elevations should have sufficient facade relief and interruption every 25-70 feet or so to provide visual interest. They should use three-dimensional design elements throughout the entire building facade.

3. Use design elements and material variation to reduce the scale of the building when they align with elements found on adjacent historic buildings.
4. Buildings should be one-to-two stories tall in order to maintain the traditional range of building heights.

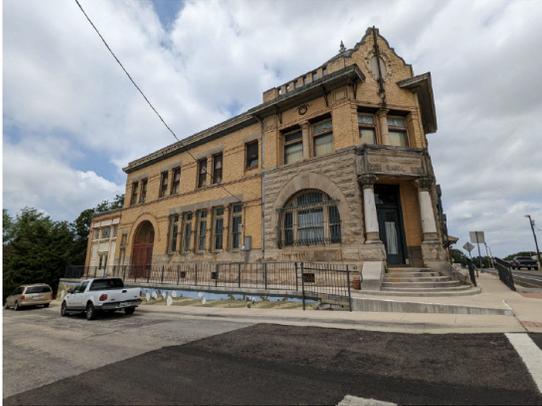
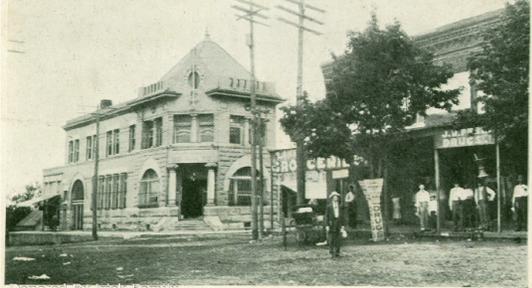
100 NORTH WASHINGTON

Historic function: Housed the Farmers and Merchants Bank until 1929 and never reopened as a bank.
Current function: Residence on second story
Current conditions: Largely unchanged since original construction. Unpainted stone exterior. Retains historic wood windows with leaded glass transoms and decorative first-story grills.

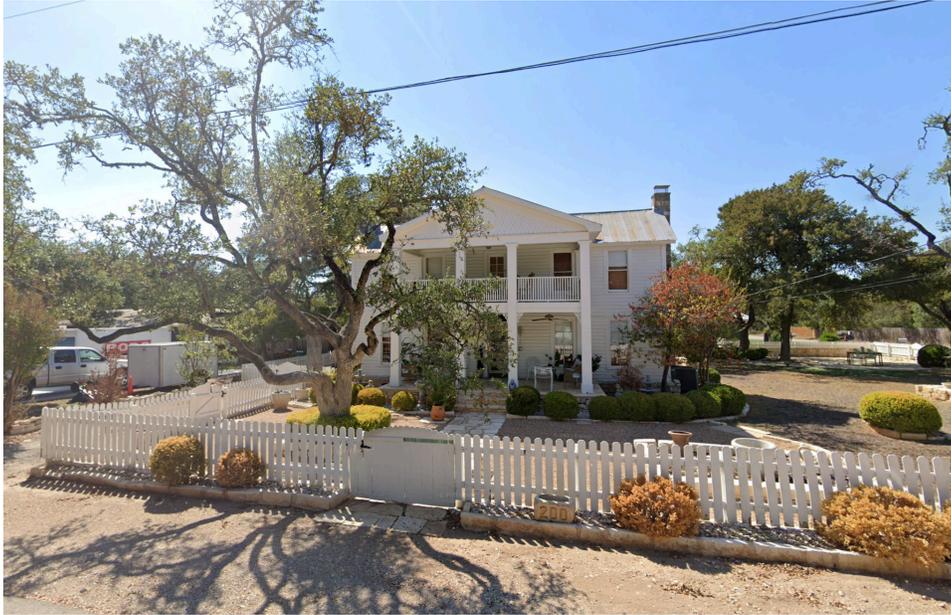
Jones House
Google Street View 2023

The Jones House, located within the Hays Street Historic District at 200 Bluff Street, may be individually eligible at the state or federal level as a local example of late nineteenth century residential architecture. While it has lost original integrity of setting as a farmstead surrounded by agricultural land, it otherwise retains good integrity.

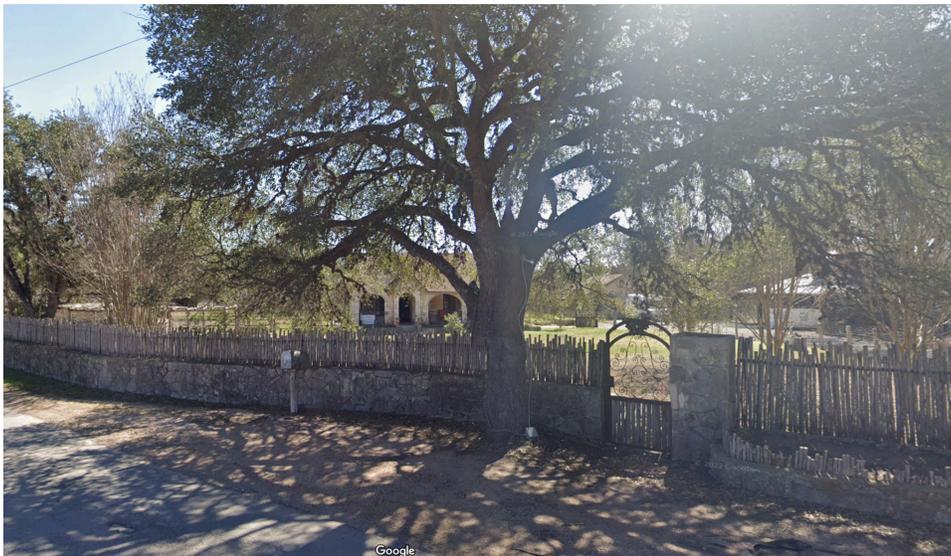
Will Crow House
Google Street View 2022

The Will Crow House, located within the Hays Street Historic District at 103 Creek Road, may be individually eligible at the state or federal level as a local example of 1930s field-stone bungalow architecture and for its association with the Milk House Springs.
