RE: Results of Pavement reconnaissance and recommendations for alleyway between Whitaker and Tedford Lanes, Sierra Manor Townhomes, Fallon, Nevada

Summit Engineering is pleased to present the following results of pavement reconnaissance and subsequent recommendations for the alleyway repaving between Whitaker and Tedford Lanes, north of the Sierra Manor Townhomes, in Fallon, Nevada.

**RECOMENDATIONS MAP FOR
SIERRA MANOR TOWNHOMES
FALLON, NV**

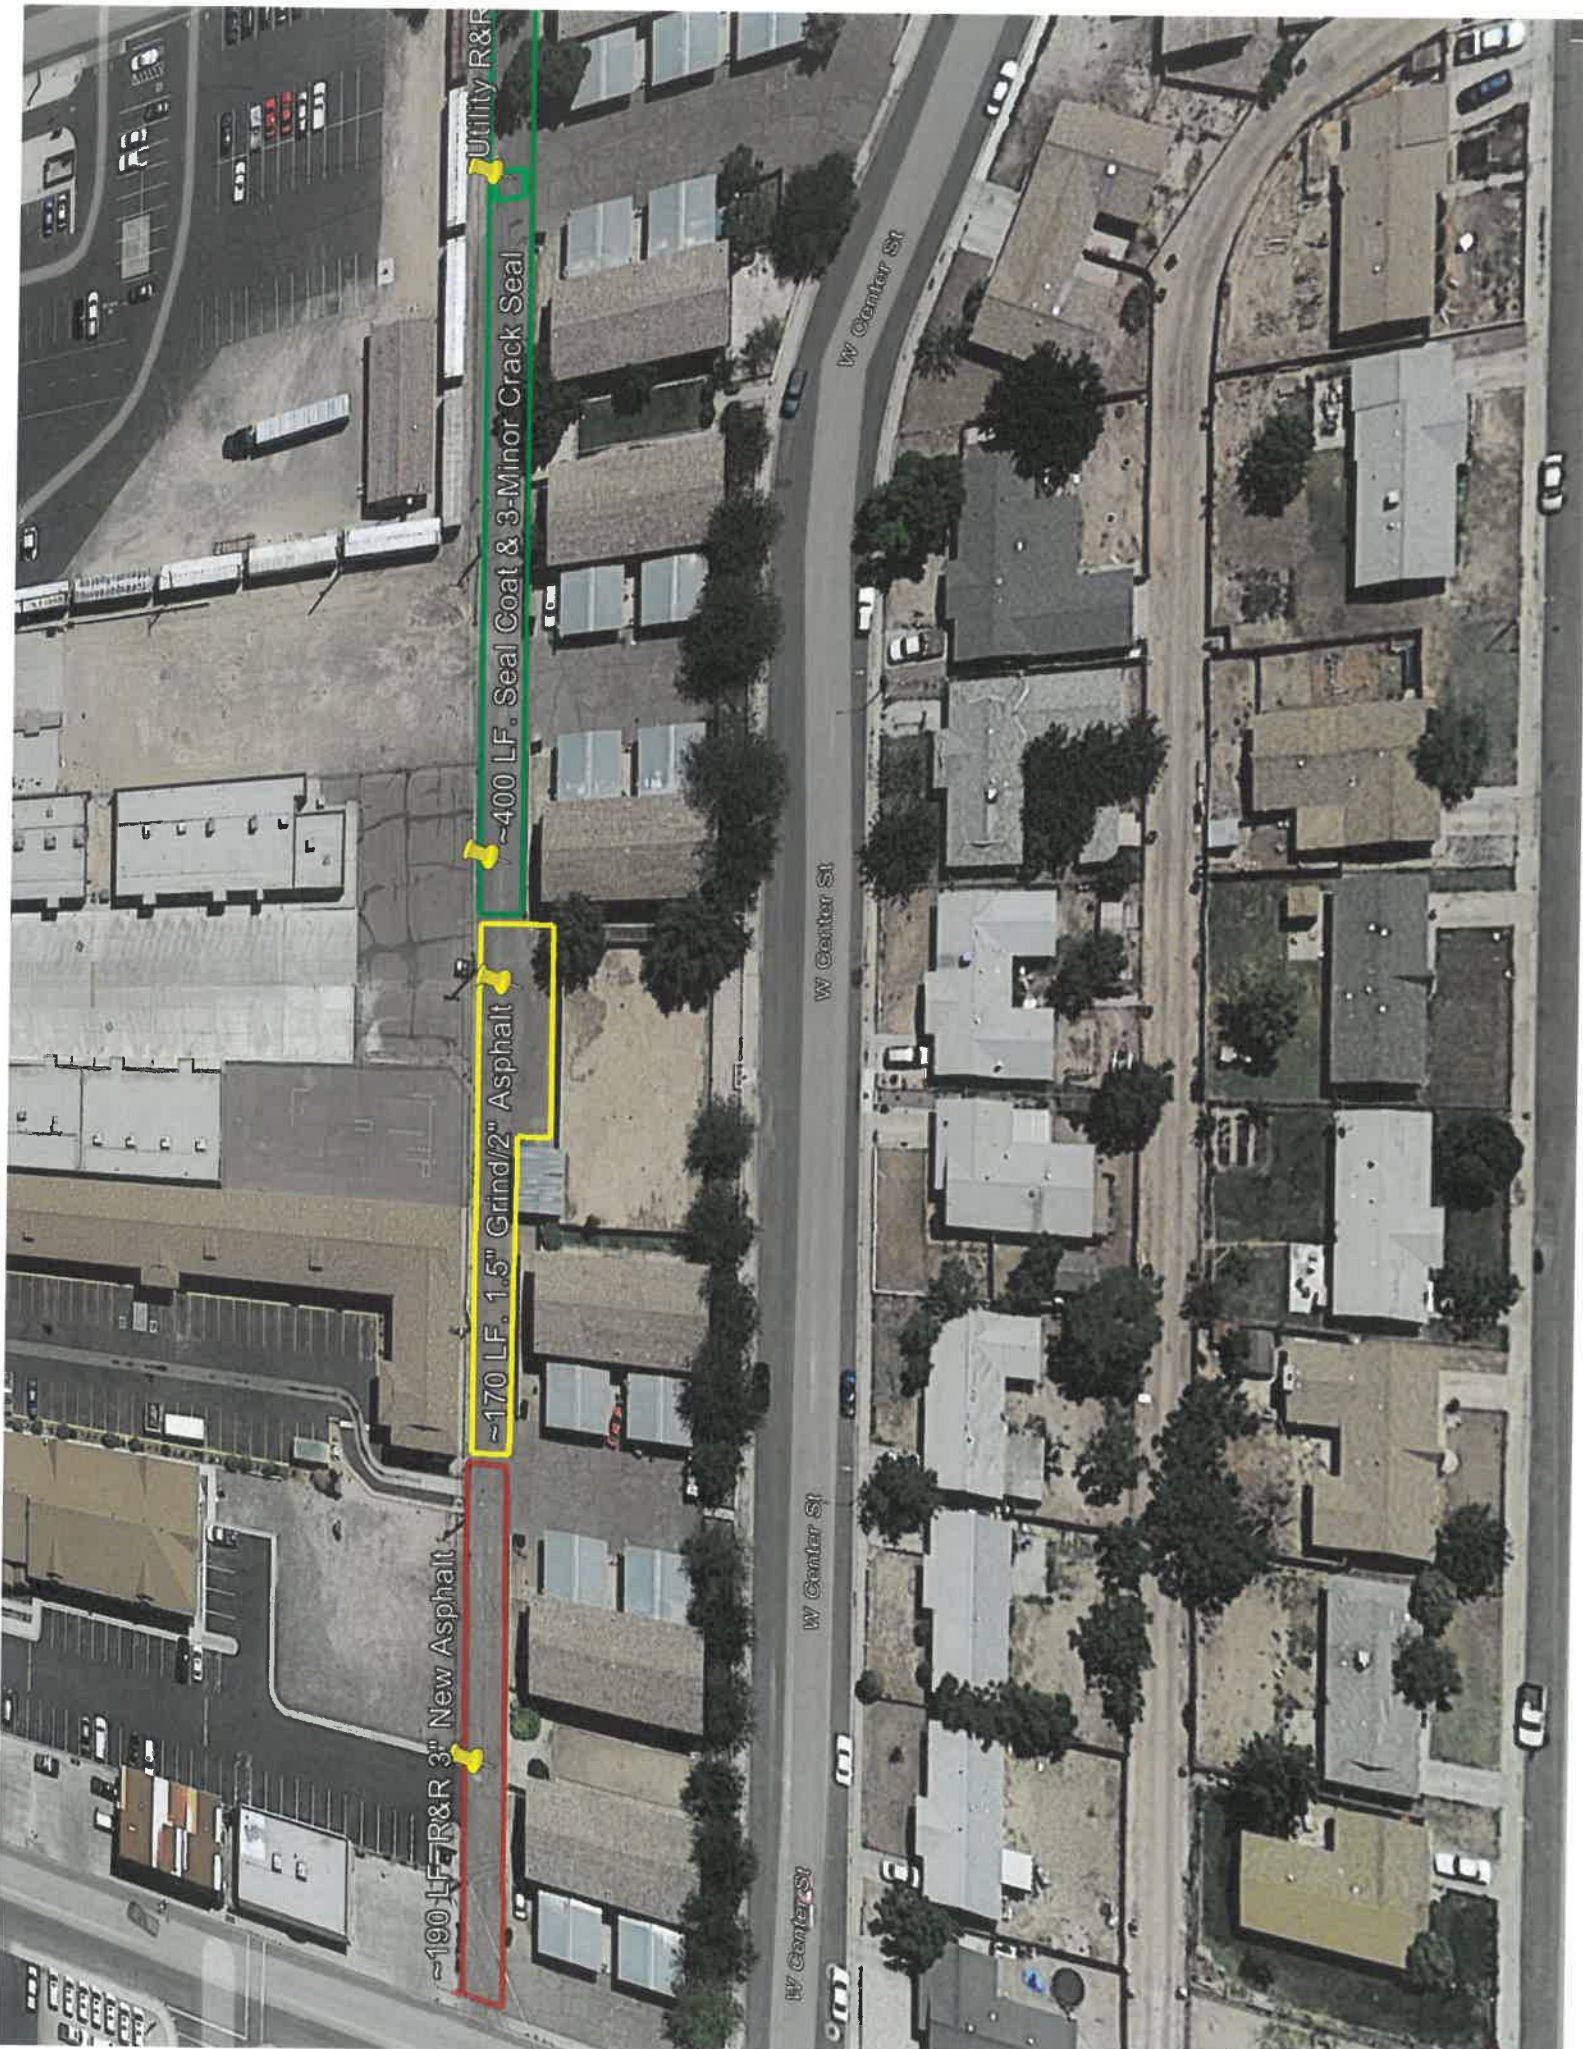
~190 LF R&R 3" New Asphalt

~170 LF. 1.5" Grind/2" Asphalt

~400 LF. Seal Coat & 3-Minor Crack Seal

Utility R&R

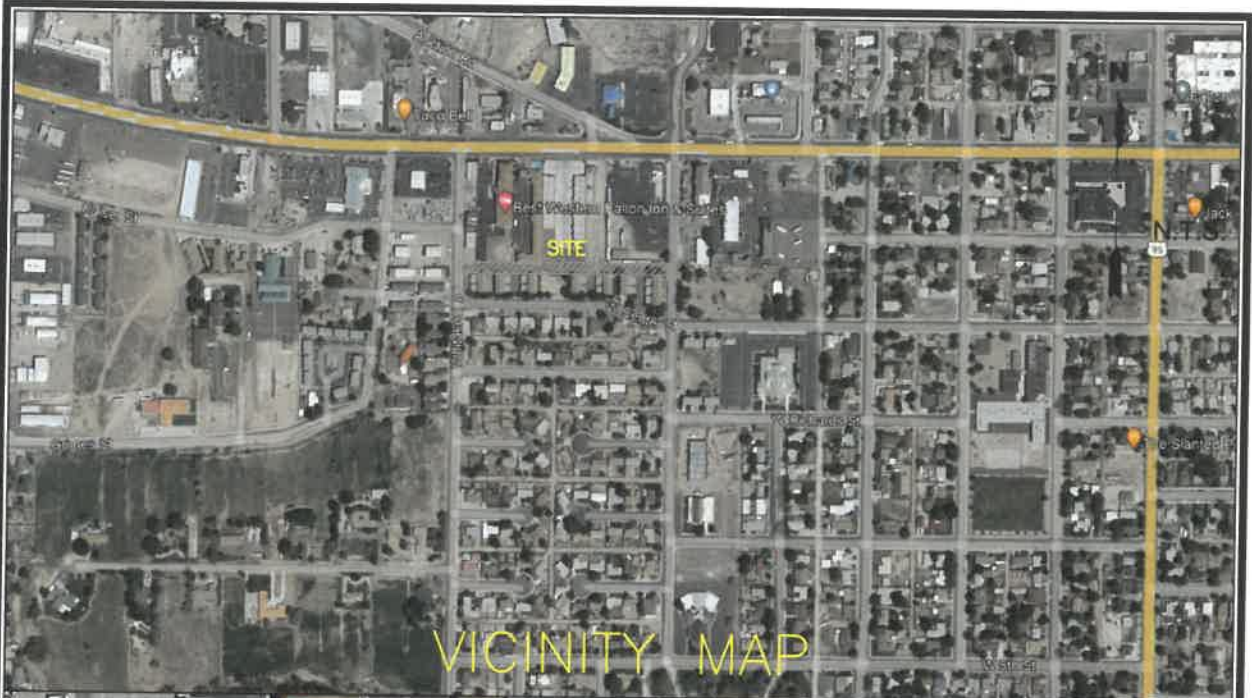
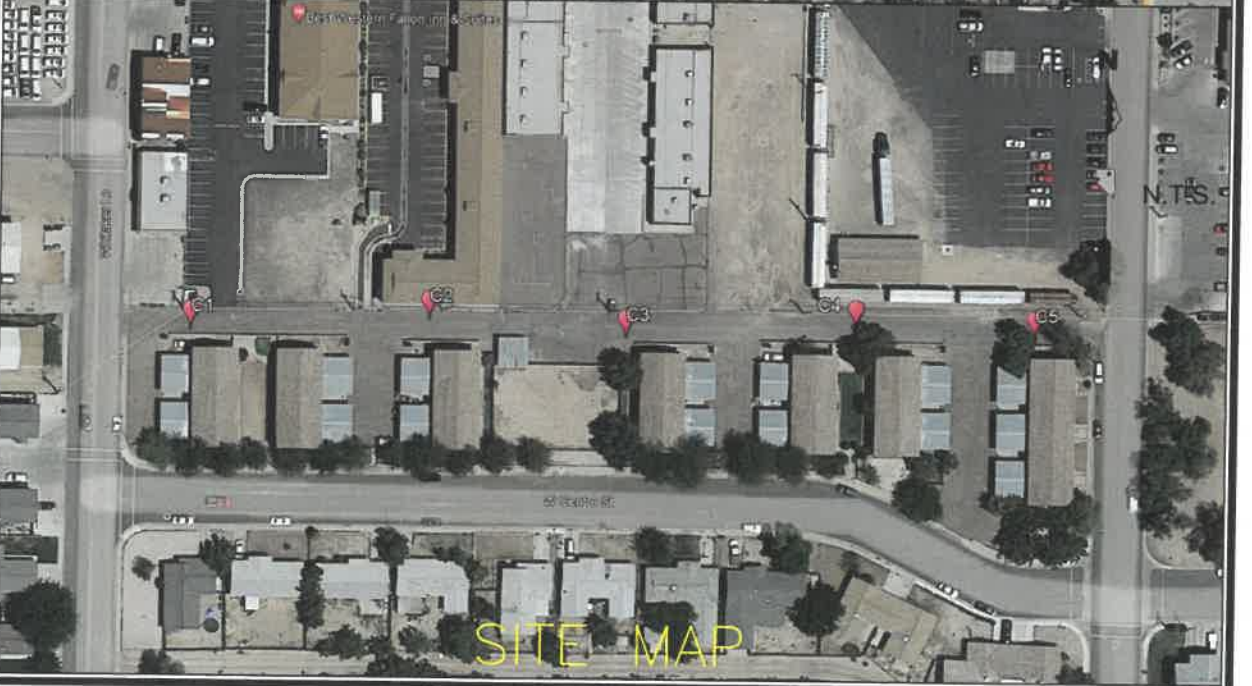
**SITE/VICINITY MAP FOR
SIERRA MANOR TOWNHOMES
FALLON, NV**

- FULL AC REPLACEMENT
- GRIND & OVERLAY
- SURFACE SEALING

Due to the highly degenerated condition, the immediate roughly 190' of existing asphalt immediately east of Whitaker Lane should be removed and replaced (indicated in red on page 2). Underlying base may remain, but should be scarified and recompact to 95% max dry density based on an ASTM 1557 Modified Proctor. The adjacent 'middle' roughly 170' of alley should receive a 2" grind and overlay (indicated as yellow on page 2). The remaining roughly 400 LF of alley, west of Tedford Lane, is newer asphalt with little to no signs of deterioration, may remain in place, with only crack sealing performed, notably 3 expansion cracks running the full width of the alley. A roughly 400sf area where previous sawcut and utility work had been performed and alley has settled, roughly 80' west of the east end of the alley, should receive asphalt removal and replacement, following recommendations above (red section at east end, page 2). The entire length of the alley should receive surface sealing after all remediation work has been completed.
