## Folsom City Council Staff Report

<b>MEETING DATE:</b>	2/10/2026
<b>AGENDA SECTION:</b>	Old Business
<b>ITEM TITLE:</b>	Resolution No. 11543 - A Resolution Authorizing the City Manager to Approve an Additional Contingency in the Amount of \$2,803,450 from the Water Operating Fund (Fund 520) for the Agreement (Contract No. 174-21 24-052) with Euro Style Management for the Construction of the Tower Tank Rehabilitation Project (Project WA2402) and Appropriation of Funds
<b>FROM:</b>	Utilities Department

**Project: Folsom Tower Tank Rehabilitation**

### **RE: Foothills Tank No. 2 – Detailed Roof Structural Inspection Report**

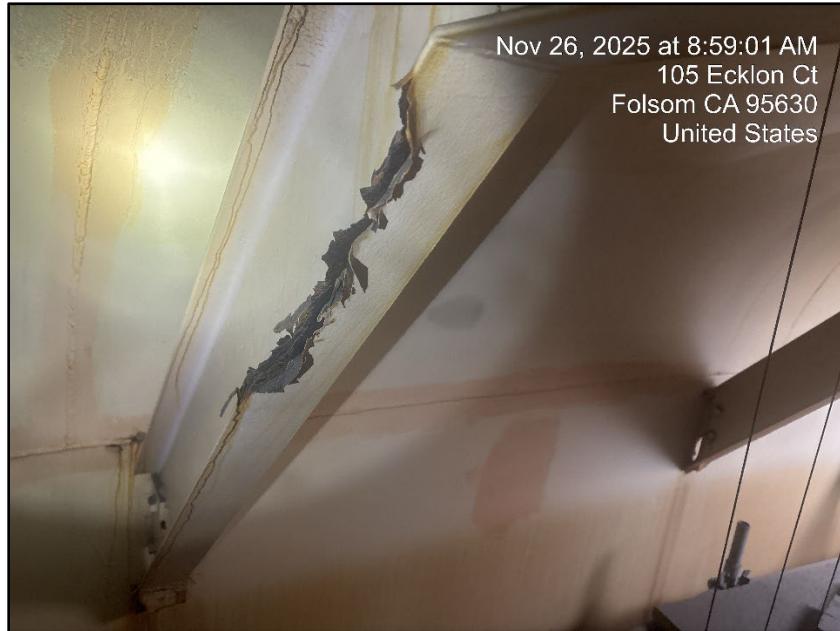
1. Photo No. 1 – Tower Tank steel rafter cantilever leg bottom showing bottom flange deterioration, corrosion and paint coating failure

- Structural Modifications (approximate extra cost of \$223,000).
  - Replacement of additional 23 rafters (approximate extra cost of \$200,000).
  - Removal of 282 flat bars (approximate extra cost of \$43,000).

- Removal of Bid Item No. 12 - Replacement of twenty (20) rafter braces (approximate credit of \$69,000).
  - Install 439 rafter braces (approximate extra cost of \$380,000).

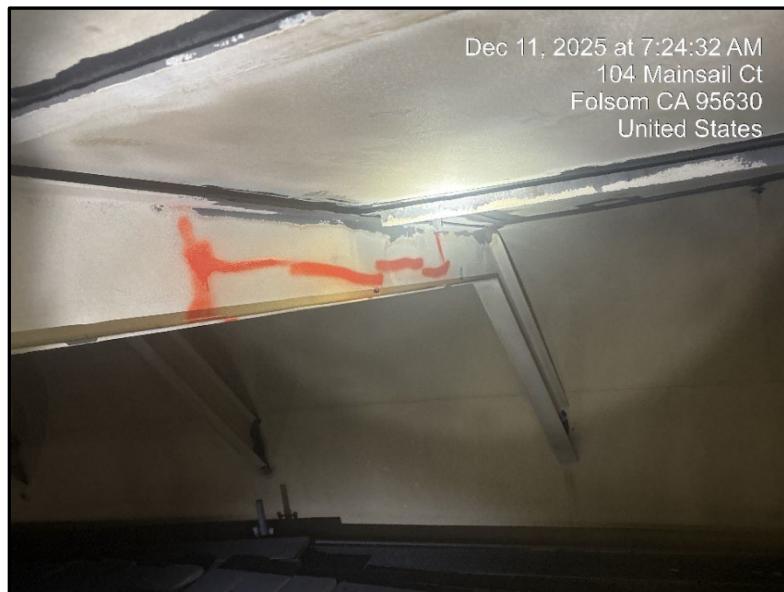
2. Photo No. 2 – Tower Tank steel rafter top flange deterioration and corrosion (top flange compromised for length of orange paint shown along the web of the steel I-beam)

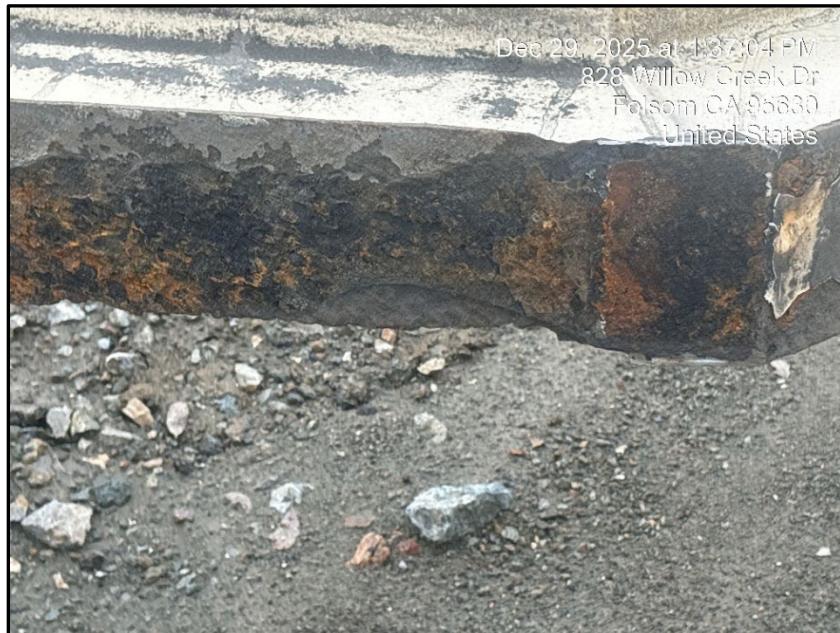
3. Photo No. 3 – Tower Tank steel rafter after removal from Tower Tank showing top flange corrosion and loss of steel material

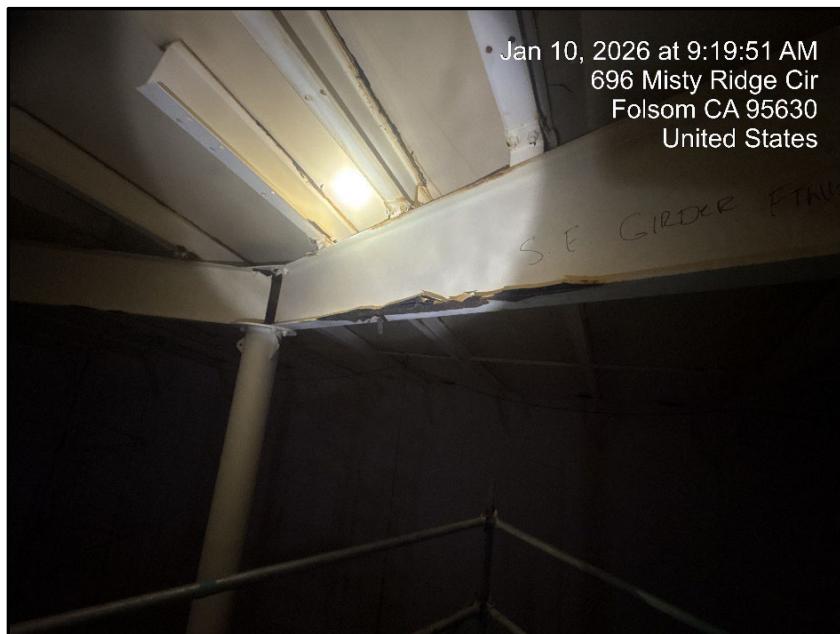
4. Photo No. 4 – Foothills No. 2 south-east steel girder bottom flange damage and loss of material (4-Ft in length)

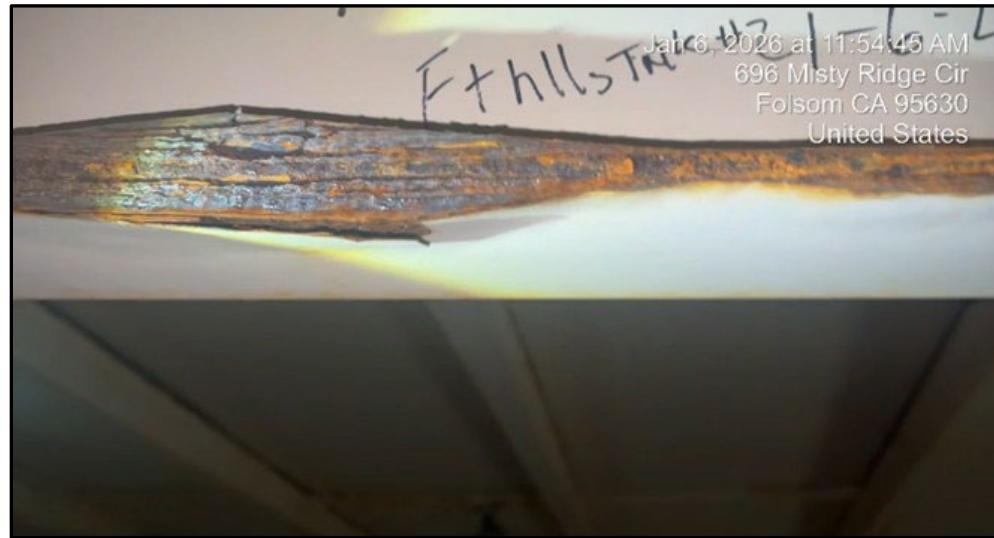
5. Photo No. 5 – Foothills No. 2 northern steel girder bottom flange showing deterioration, corrosion and loss of steel material

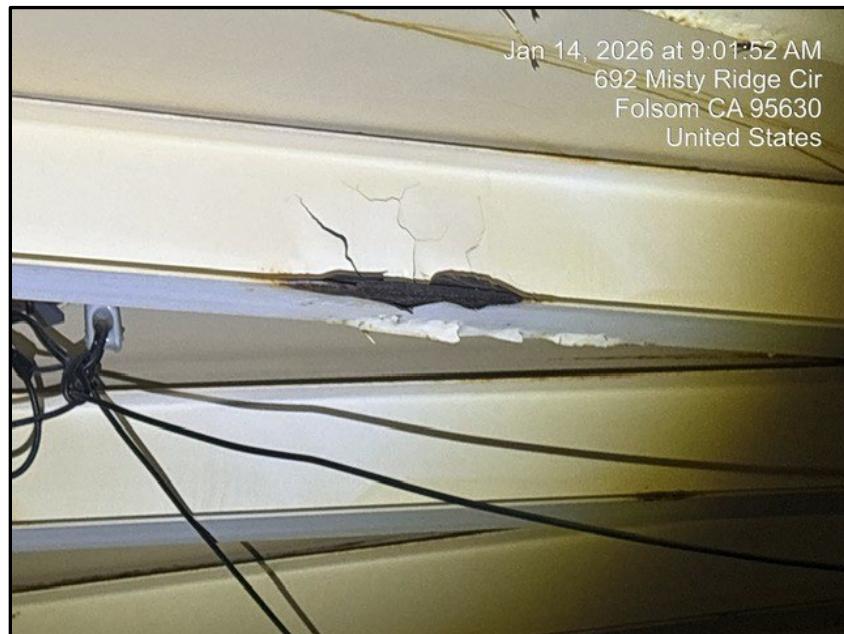
6. Photo No. 6 – Foothills No. 2 – steel rafter bottom flange deterioration and corrosion (various locations)

- Replacement of 60 of 64 outer rafters (94%) (approximate extra cost of \$496,800).
- Replacement of 21 of 32 inner rafters (66%) (approximate extra cost of \$126,000).
- Blasting and Coating all steel above the water-line (approximate extra cost of \$252,000).
- Installation of 376 braces (approximate extra cost of \$300,800).
- Rehabilitation of 6 of the 7 girders (approximate extra cost of \$21,000).
- Replace center cone support with halo (approximate extra cost of \$59,600).

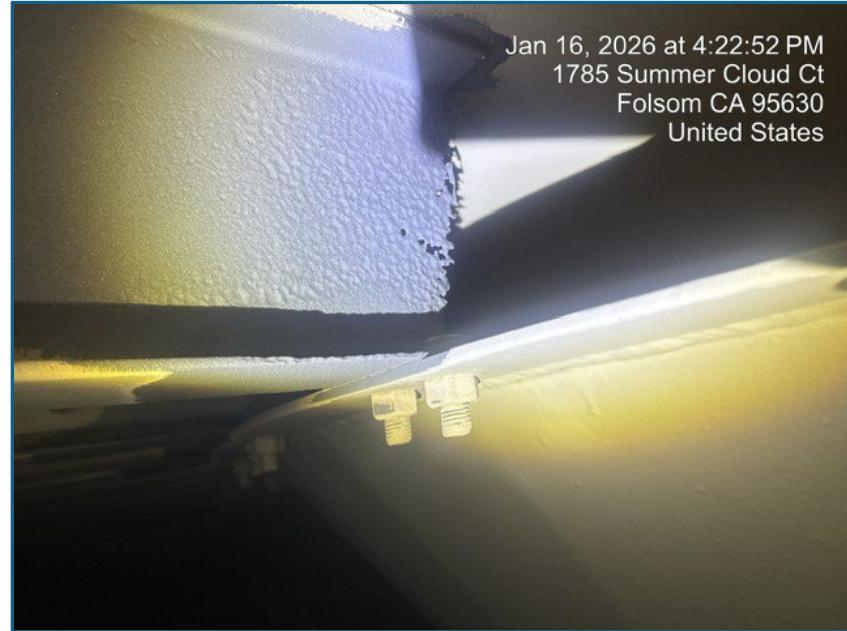
7. Photo No. 7 – Foothills Tank No. 2 rafter end at crows nest (center support) showing loss of coating, corrosion and loss of steel material

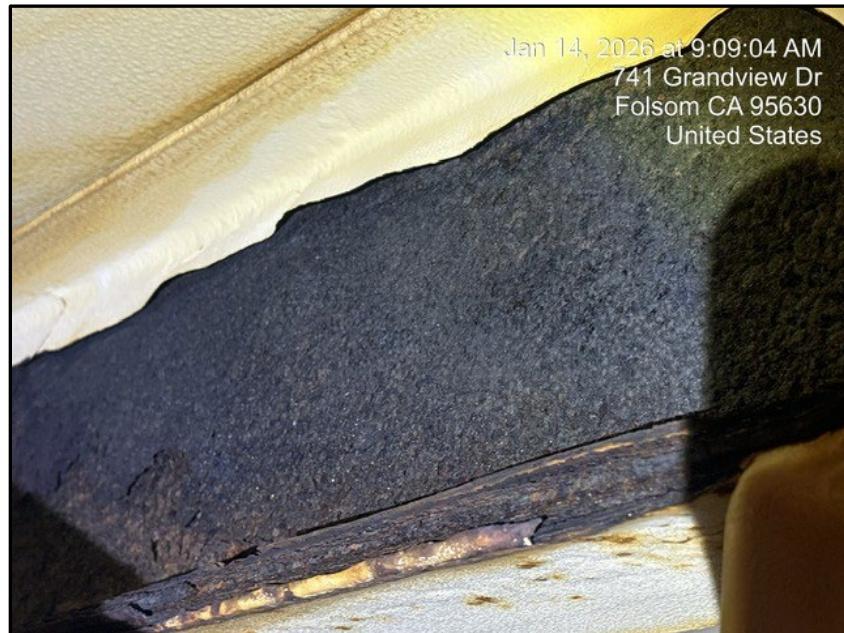
8. Photo No. 8 – Significant rafter deterioration and loss of material showing pitting and corrosion and loss of paint coating.

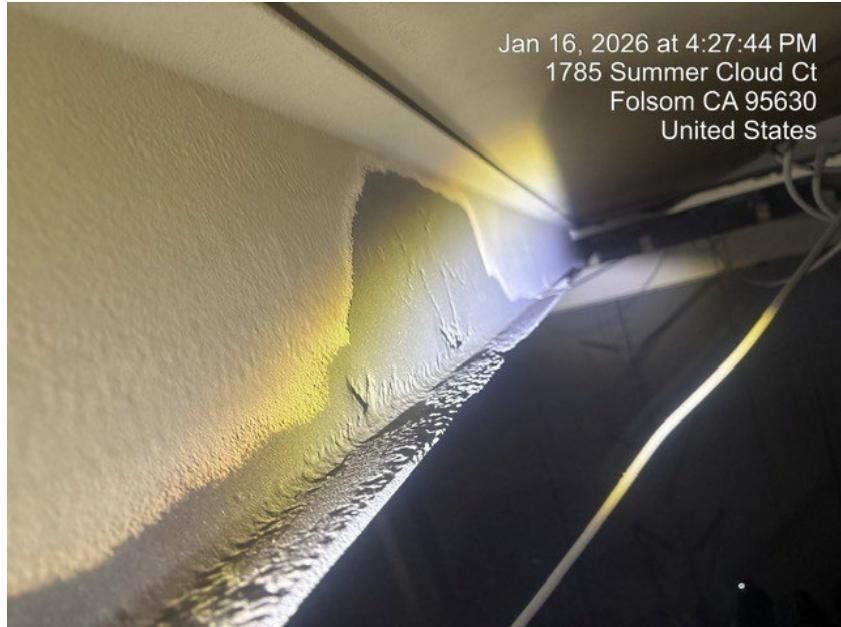
9. Photo No. 9 – Foothills Tank No. 1 rafter bottom flange corrosion

- Anticipate replacement of 64 of 64 outer rafters (100%) (approximate extra cost of \$529,920).
- Anticipate replacement of 26 of 32 inner rafters (81%) (approximate extra cost of \$156,000).
- Anticipate blasting and coating all steel above the water-line (approximate extra cost of \$252,000).
- Anticipate installing 376 braces (approximate extra cost of \$300,800).
- Anticipate rehabilitating all 7 girders (approximate extra cost of \$25,000).
- Replace center cone support with halo (approximate extra cost of \$59,600).
- Full dance floor scaffolding (approximate extra cost of \$130,000).
- Interior spot repair below the waterline (approximate extra cost of \$30,000).
- Interior/Exterior overflow modification (approximate extra cost of \$21,760).
- Exterior center vent rehabilitation (approximate extra cost of \$25,000).
- Other ancillary work (approximate extra cost of \$19,920).

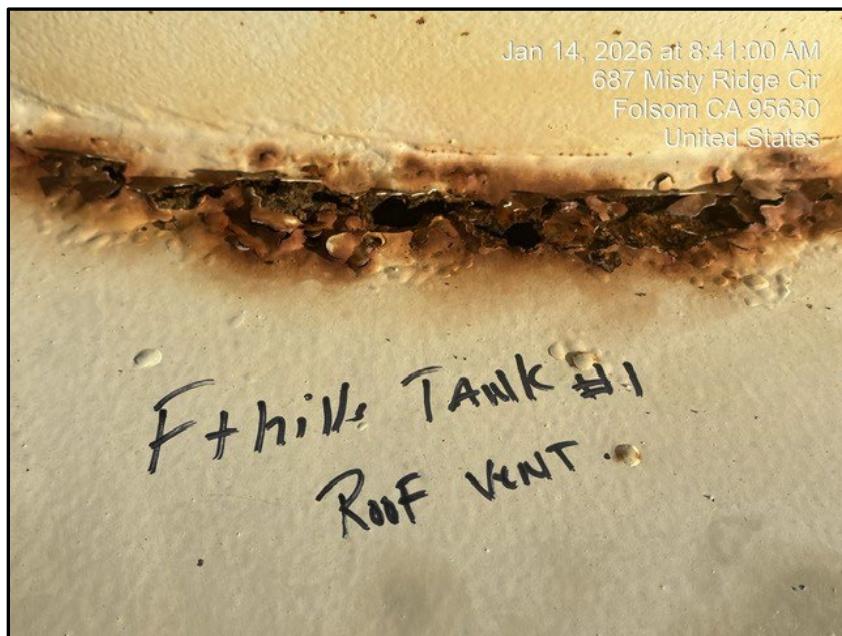
10. Photo No. 10 – Foothills Tank No. 1 roof vent corrosion and loss of steel material

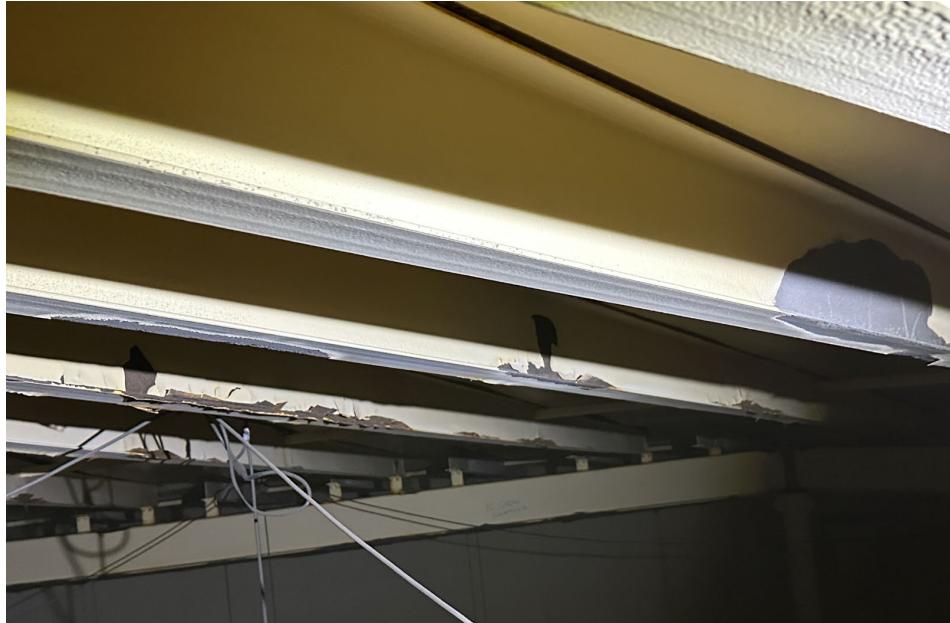
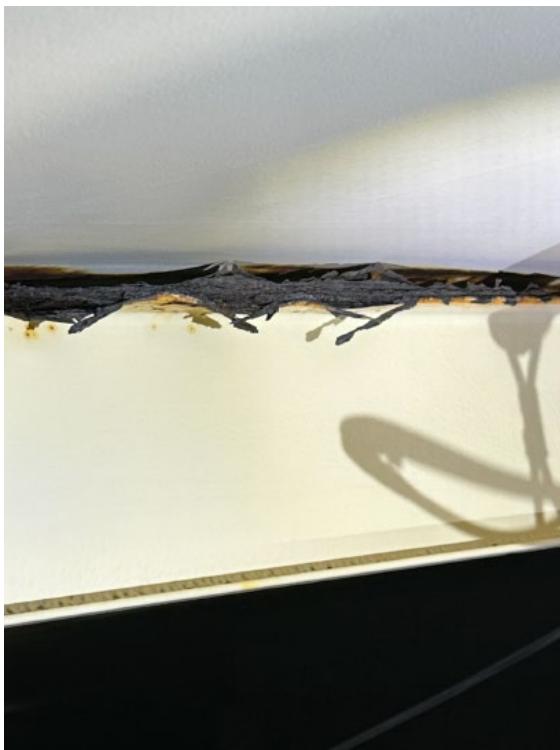
Significant corrosion damage was observed on a substantial number of the radial beams. A total of approximately 61 beams exhibit deterioration beyond economical repair and require complete replacement:

The flanges show the most severe section loss, compromising the beams' flexural capacity. Photographic documentation (see attached images) clearly shows advanced corrosion with significant metal loss on the flanges.

W8x10 Beam Deterioration

**Recommendation: Replace all 61 deteriorated beams with new W8×10 sections. Ensure proper surface preparation per SSPC-SP standards and specify appropriate coating systems for potable water tank interiors. Paint all new and existing structural steel and roof plates above the water line.**

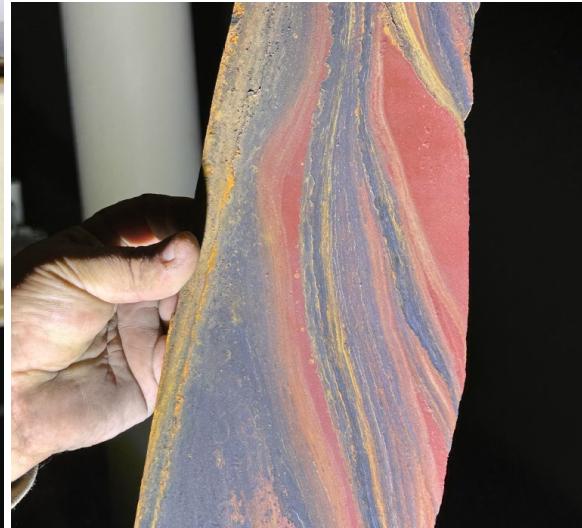
The corrosion pattern and paint failure characteristics suggest the deterioration resulted from inadequate surface preparation and/or inappropriate coating materials during the original construction. Evidence indicates the following contributing factors:

- Poor adhesion between primer and steel substrate, evidenced by widespread delamination
- Potential use of water-based primer incompatible with the service environment

W8x10 Top Flange CorrosionPaint Showing Primer Debonded from Steel

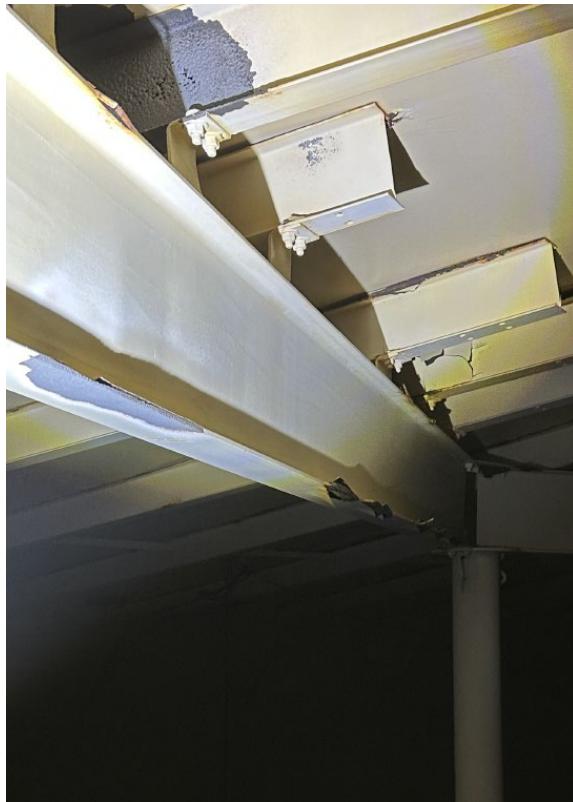
Six of the seven W16×26 circumferential girders exhibit localized corrosion damage requiring structural repair (see attached images). The majority of deterioration occurs on the bottom (tension) flanges, with the damage concentrated in discrete areas rather than distributed along the full member length.

W16x26 Girder Flange Corrosion

Repair Strategy: Cover plate reinforcement provides the most practical and economical solution for restoring the lost section capacity. The specific repair requirements vary based on damage location relative to the support points:

- Repair required when flange area loss exceeds 20%
- Install 3/8-inch × 6-inch steel cover plates
- Extend plates minimum 12 inches beyond damaged area each direction
- Fillet weld plates to both sides of bottom flange and across the end per AWS D1.1 standards

- Repair required when flange area loss exceeds 5%
- Install 3/8-inch × 6-inch steel cover plates using same detailing as above

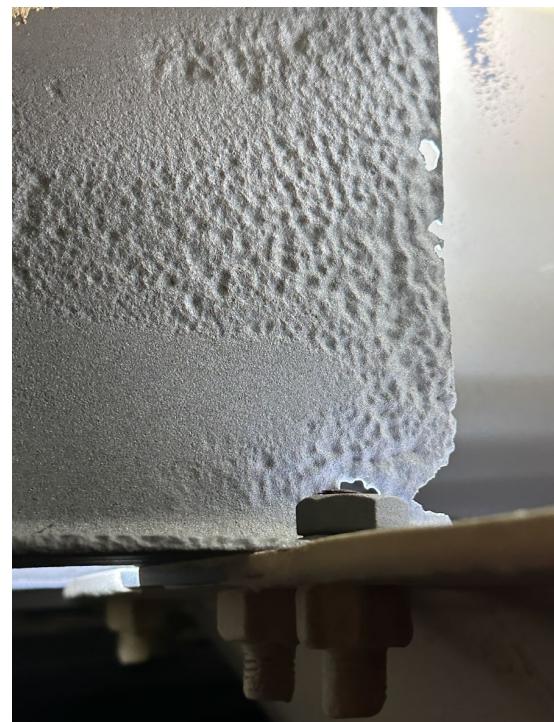
Multiple beam webs at the central support exhibit corrosion damage requiring reinforcement (see attached images). Many of these deficiencies will be addressed through the replacement of deteriorated radial beams as previously described. For beams being retained in place with damaged web connections, vertical stiffener plates will be required to restore shear transfer capacity at the support.

**Design Deficiency:** The existing "crows nest" center support consists of an inverted plate steel cone structure positioned directly below the roof vent opening. It is supported by a single steel column. This configuration creates a significant operational problem: the enclosed cone limits adequate air circulation into and out of the tank interior. Limited air exchange occurs only through the narrow gaps between radial beams, resulting in poor ventilation that likely contributed to the accelerated corrosion observed throughout the structure.

W8 Beam at Center Support

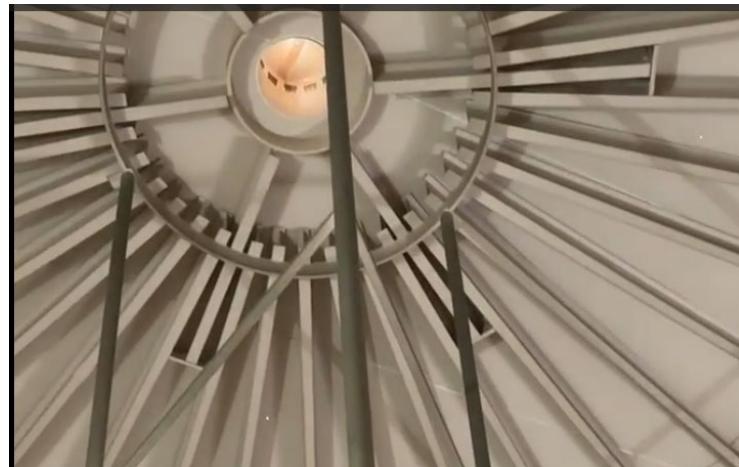
New Halo Type Support

**Optional Recommendation:** Replace the existing solid cone structure with an open "halo beam" support system (see attached images). This would consist of a circular steel beam supported by radial columns, allowing unrestricted air flow while maintaining equivalent structural support for the radial beams. This modification will:

- Significantly improve air circulation and ventilation
- Reduce moisture accumulation on steel surfaces
- Extend the service life of protective coatings
- Minimize future corrosion and maintenance requirements
