# Folsom City Council Staff Report

<b>MEETING DATE:</b>	6/25/2024
<b>AGENDA SECTION:</b>	Consent Calendar
<b>SUBJECT:</b>	Resolution No. 11218 – A Resolution to Declassify Four Landmark Trees within the Joint Powers Authority Landmark Grove to Allow for Removal as Part of the Sacramento Regional Transit Light Rail Modernization 15 Minutes to Folsom Project
<b>FROM:</b>	Community Development Department

**Arborist Report**  
**SacRT Folsom Light Rail Modernization Double Track**  
**Project (v4) – Addendum 1**

## **SacRT Folsom Light Rail Modernization Double Track Project (v4)**

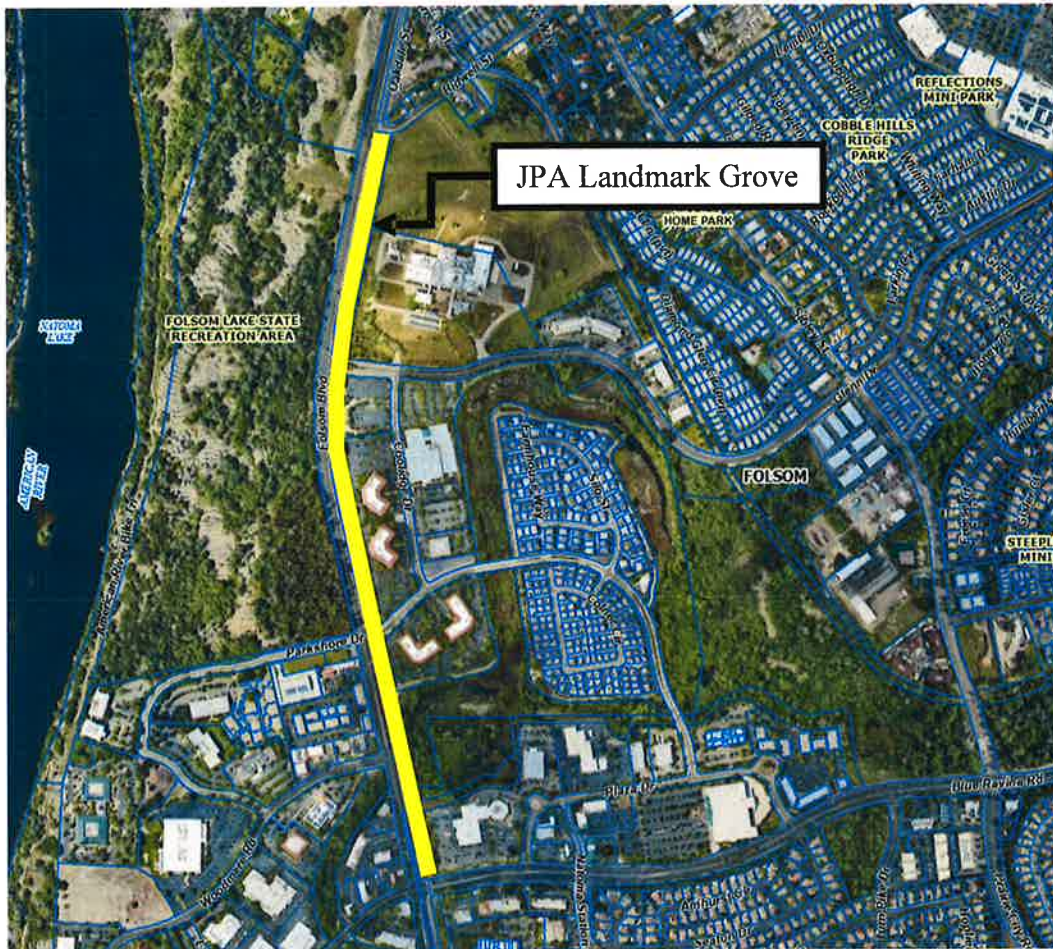
*Aerial image illustrating the location and span of the Joint Powers Authority (JPA) Landmark Grove, which traverses along the east edge of Folsom Blvd between Blue Ravine Rd and Bidwell St.*

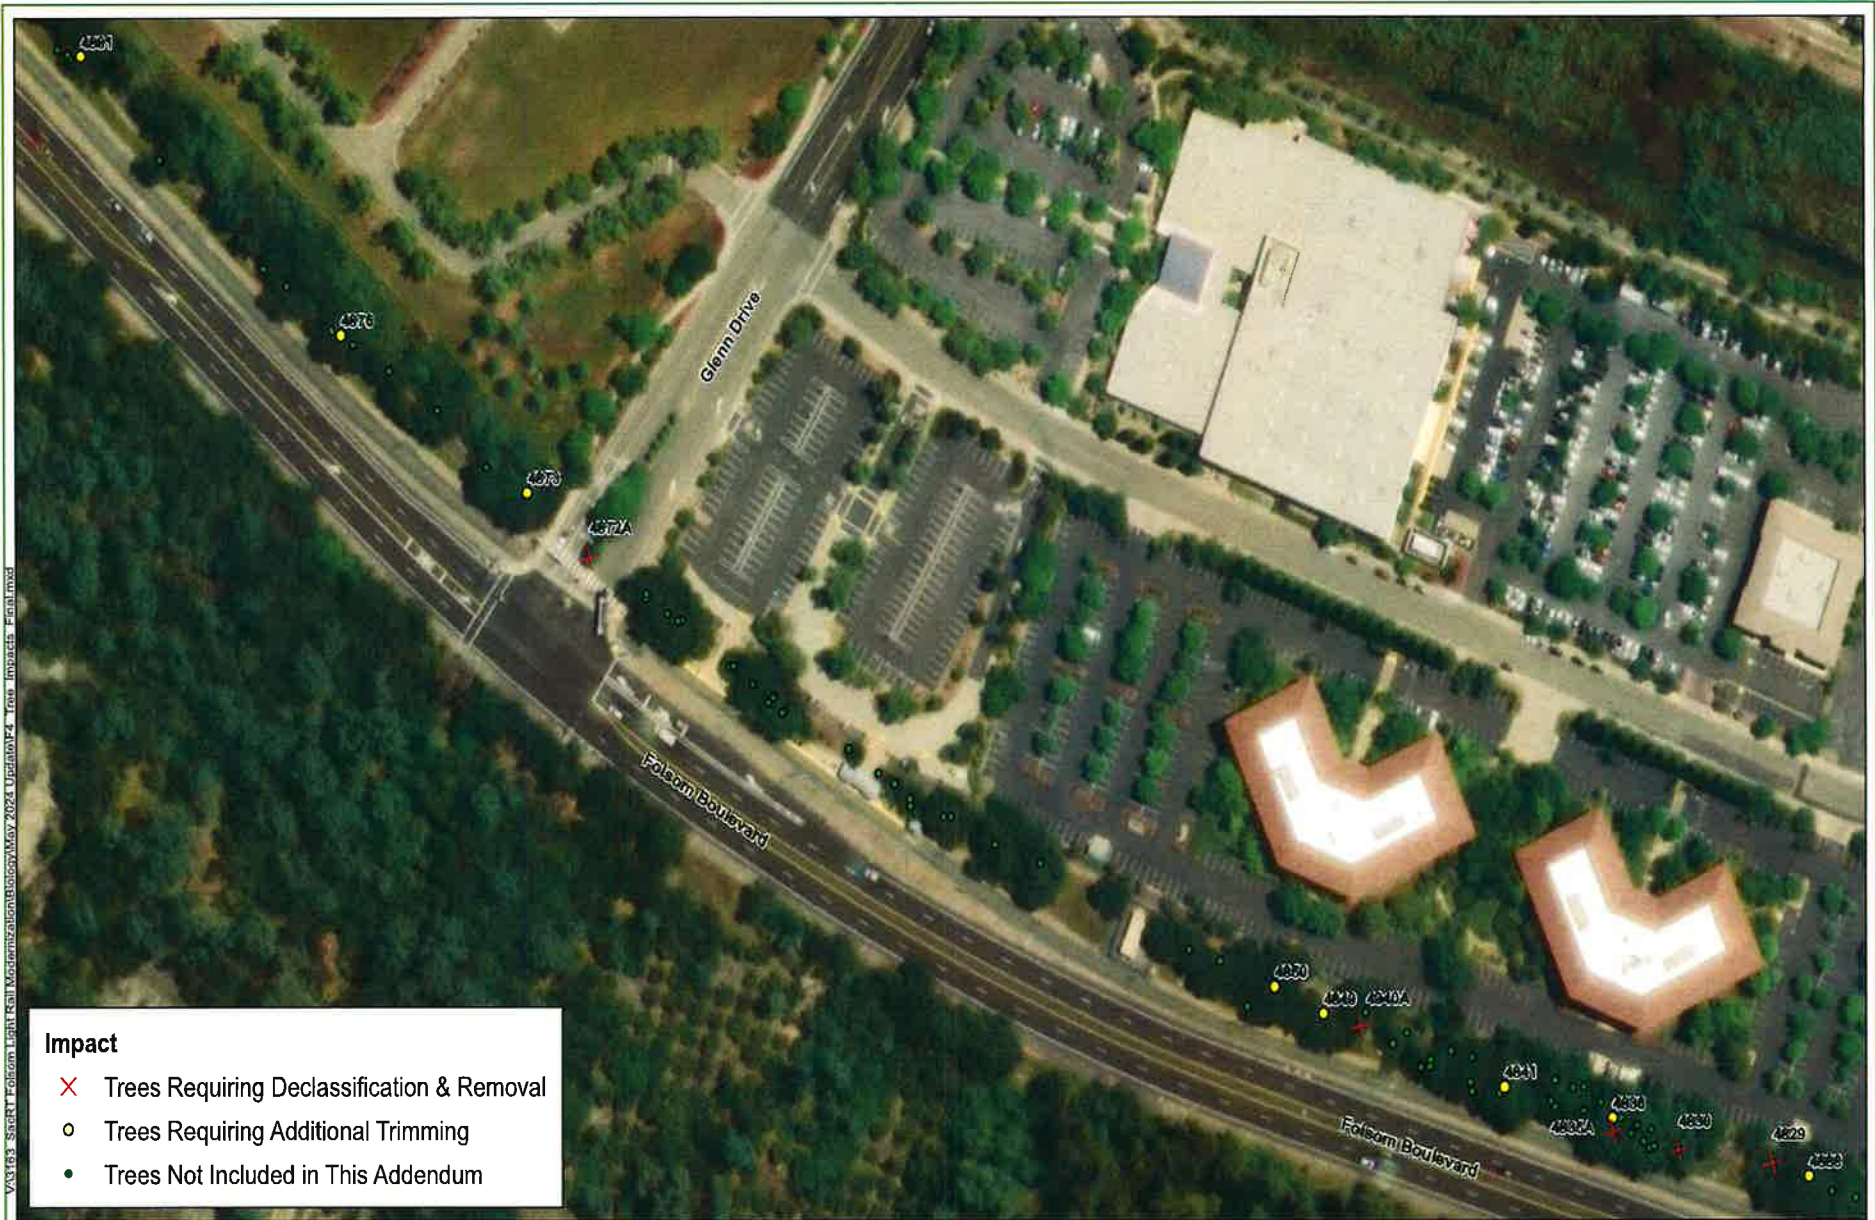
V:\163\_SacRT\_Folsom\_Light\_Rail\_Modernization\GIS\Map\_04\04\_Tree\_Impacts\_Final.mxd

Tag #	Species	Extrapolated DSH	Health Rank	Replacement Ratio	DSH Replacement Requirement
4829	Interior live oak	20	Good	1:1	20
4830	Valley oak	11	Good	1:1	11
4835A	Interior live oak	1	Good	1:1	1
4872A	Crepe Myrtle	5	Good	1:1	5
4940A	Valley oak	3	Good	1:1	3

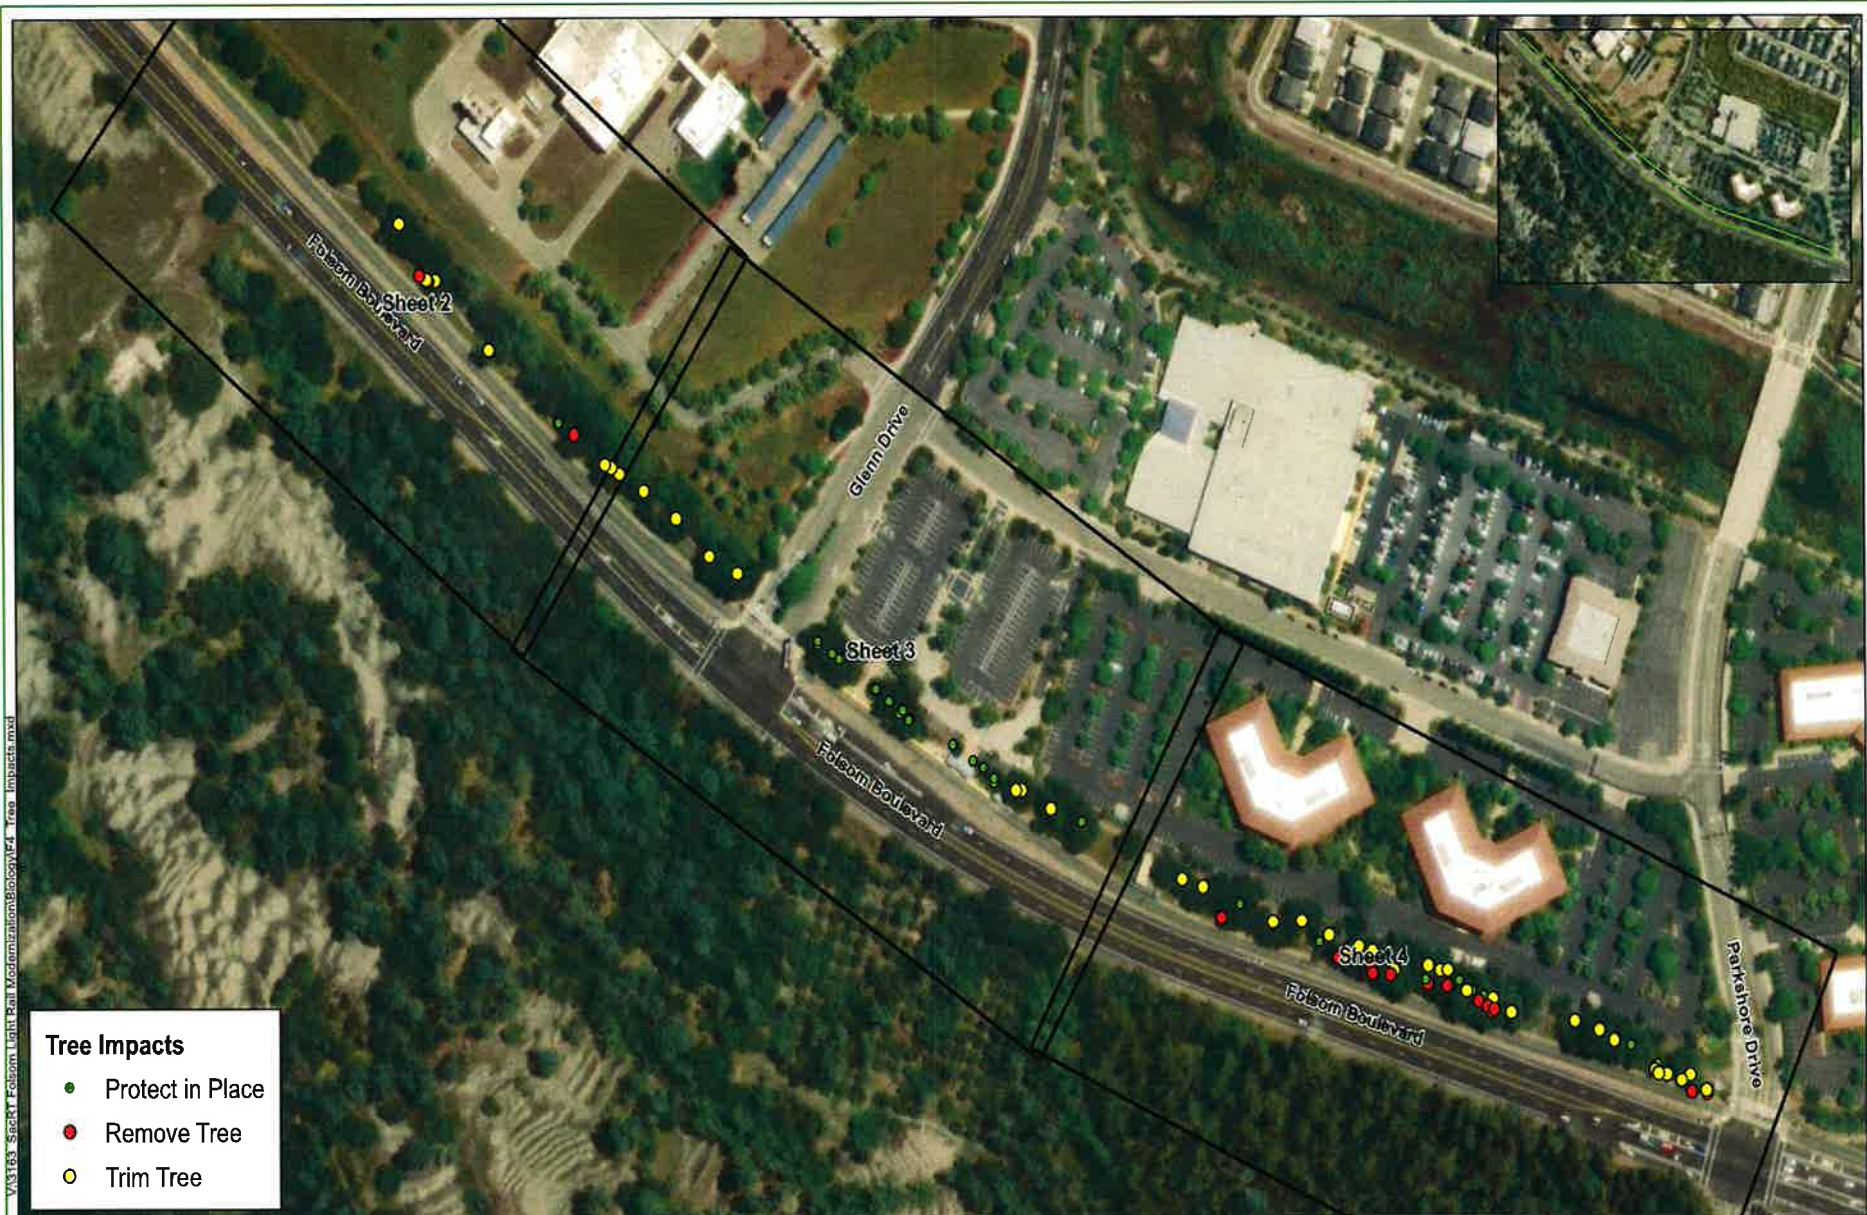
**Figure 3**  
**Tree Impacts Map**  
 Sheet 1 of 4  
 SacRT Folsom Light Rail  
 Modernization Double Track Project

**Tree Impacts**

- Protect in Place
- Remove Tree
- Trim Tree

All trees found within the project area were in either good or fair health at the time of the survey except for three Interior Live Oaks (#4853, #4863 and #4992). The locations of all trees found within the project area are shown on Figure 3.

Of the 85 trees found within the Project Area, 18 must be removed and 39 must be trimmed. All 57 affected trees are in conflict with either permanent project features or access requirements during construction. The location of trees that will be impacted by the project are shown on Figure 4. Tree Impacts. The remaining trees are located far enough away from proposed improvements that they can be protected in place for the duration of construction and will not need to be trimmed or removed.

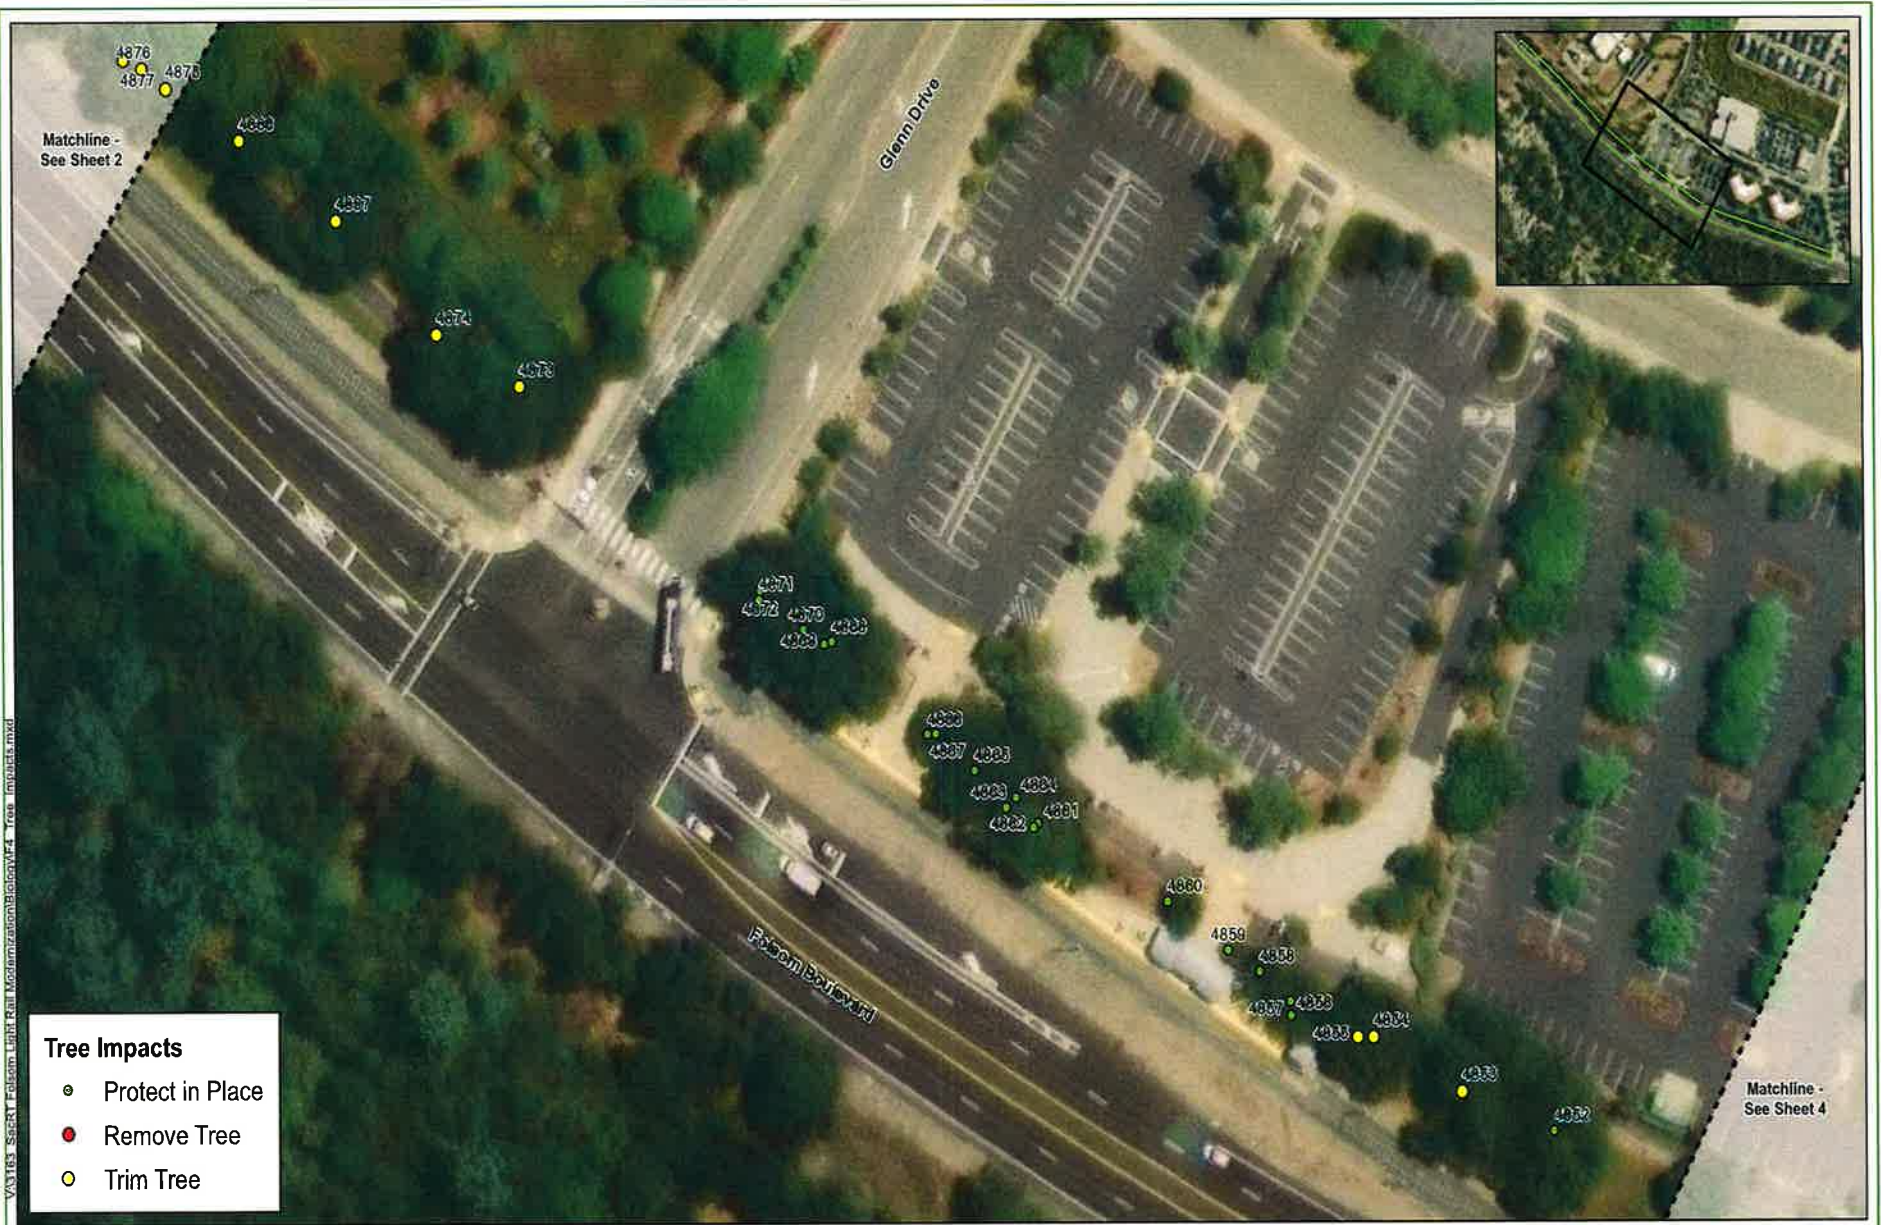
**Figure 3**  
**Tree Impacts Map**  
 Sheet 3 of 4  
 SacRT Folsom Light Rail  
 Modernization Double Track Project

**Tree Impacts**

- Protect in Place
- Remove Tree
- Trim Tree

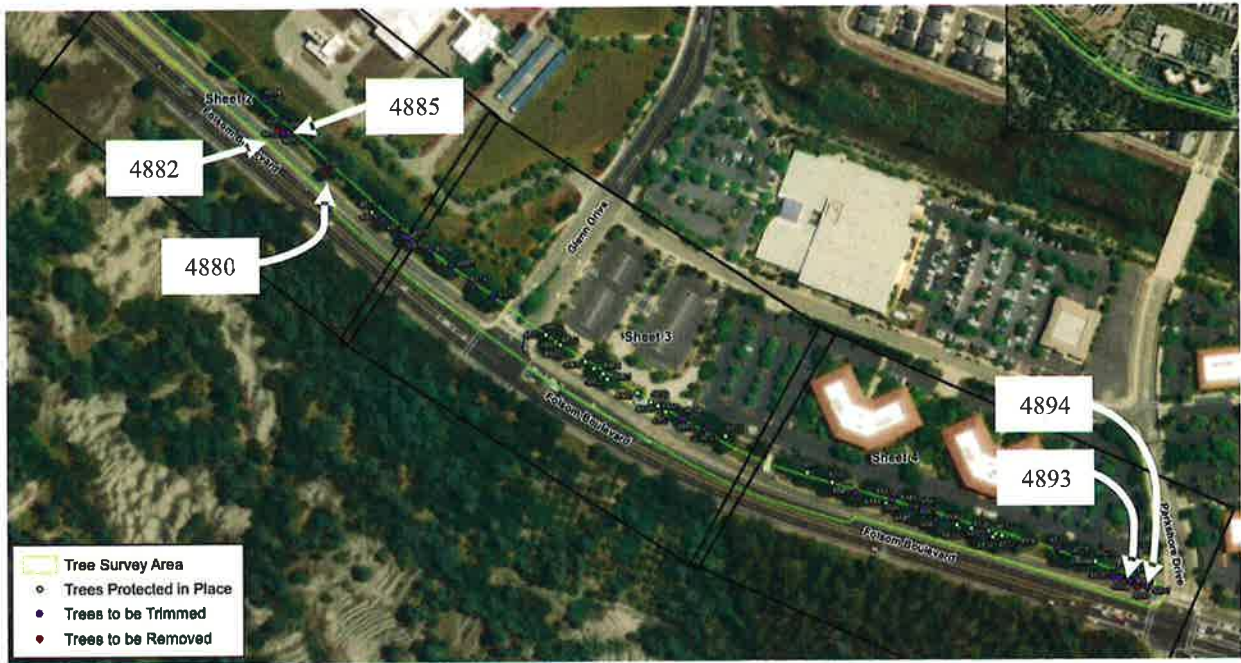
**Exhibit A**  
**Site Map**

*Annotated excerpt from the arborist report prepared by Dokken Engineering calling out the five oaks proposed for declassification*

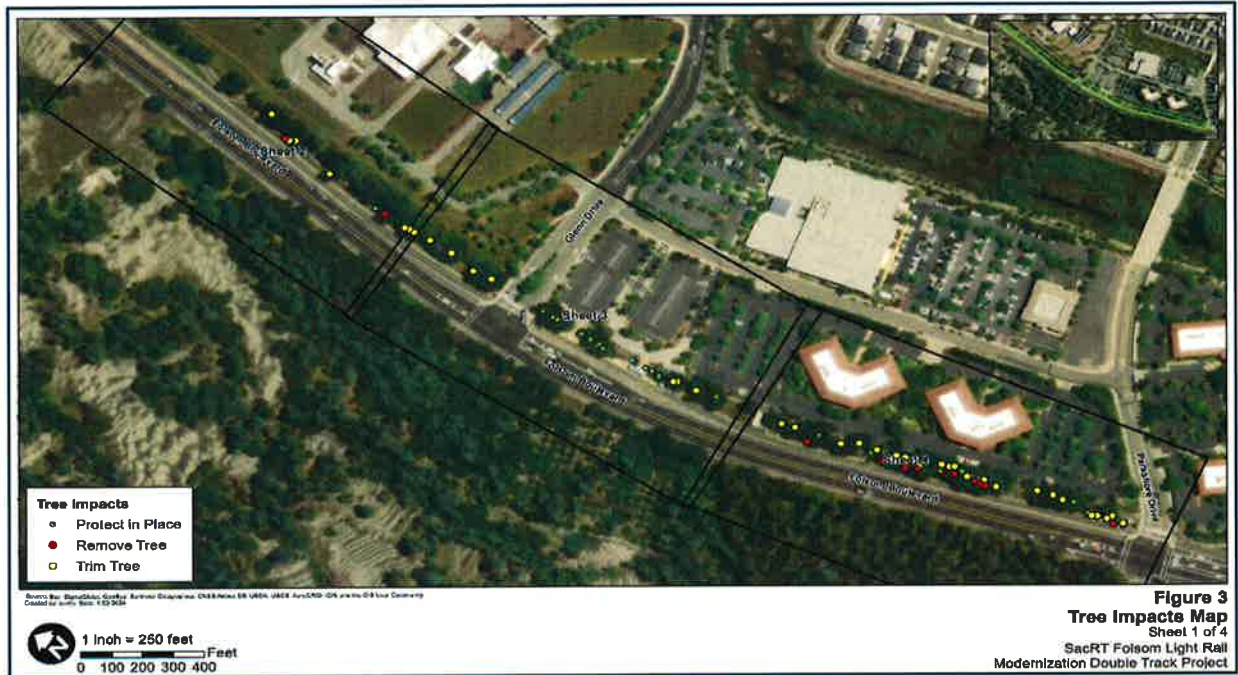
**Exhibit A**  
**Site Map and Tree Removal Table**

*Excerpt from the arborist report prepared by Dokken Engineering illustrating the locations of the thirteen trees proposed for declassification.*
