Folsom City Council Staff Report

MEETING DATE:	1/23/2024
AGENDA SECTION:	New Business
SUBJECT:	Resolution No. 11159 – A Resolution to Declassify Five Landmark Trees within the Joint Powers Authority Landmark Grove to Allow for Removal as Part of the Sacramento Regional Transit Light Rail Modernization 15 Minutes to Folsom Project
FROM:	Community Development Department

Arborist Report SacRT Folsom Light Rail Modernization Double Track Project (v3)

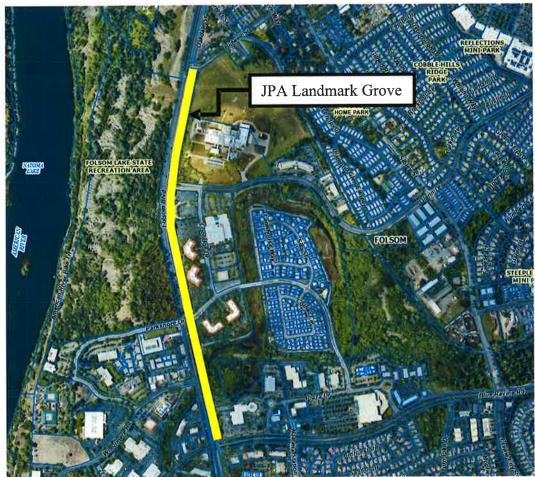
Aerial image illustrating the location and span of the Joint Powers Authority (JPA) Landmark Grove, which traverses along the east edge of Folsom Blvd between Blue Ravine Rd and Bidwell St.

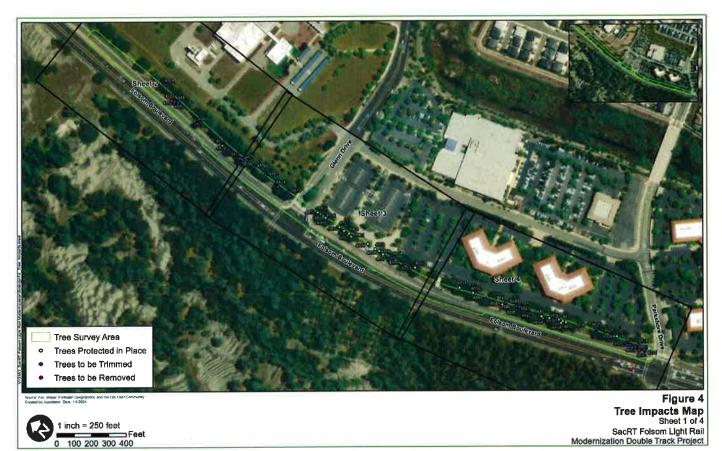
Excerpt from the arborist report prepared by Dokken Engineering showing proposed tree work prescriptions within the JPA Landmark Grove to accommodate the planned light rail improvements

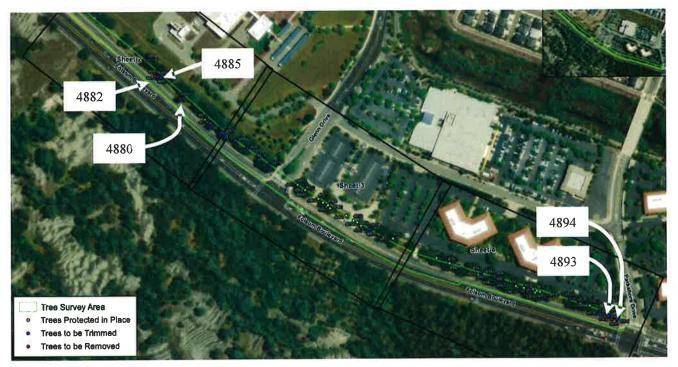
Exhibit A Site Map

Annotated excerpt from the arborist report prepared by Dokken Engineering calling out the five oaks proposed for declassification

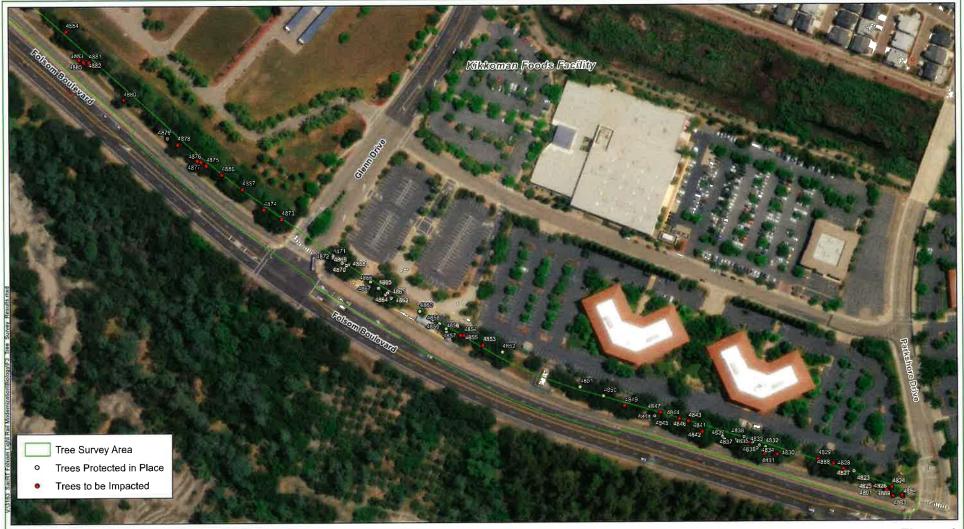
1 inch = 200 feet Feet 0 100 200 300 400 **Figure 3 Tree Survey Results** SacRT Folsom Light Rail Modernization Double Track Project

All trees found within the project area were in either good or fair health at the time of the survey except for two Interior Live Oaks (#4853 and #4863). The locations of all trees found within the project area are shown on Figure 3. Tree Survey Results.

Per conversations with the City Arborist, it was discovered that all trees within the JPA right-ofway along Folsom Boulevard between Bidwell Street and Blue Ravine were designated as a Landmark Grove by the City Council. Landmark trees may not be removed without prior declassification by the City Council. This includes every tree in the survey. In addition to the Native Oak Tree species reported above, an additional 7 interior live oaks and 1 valley oak with less than 6-inch DSH were included in the survey and are subject to Landmark tree provisions. A total of 67 trees were surveyed in the study area.

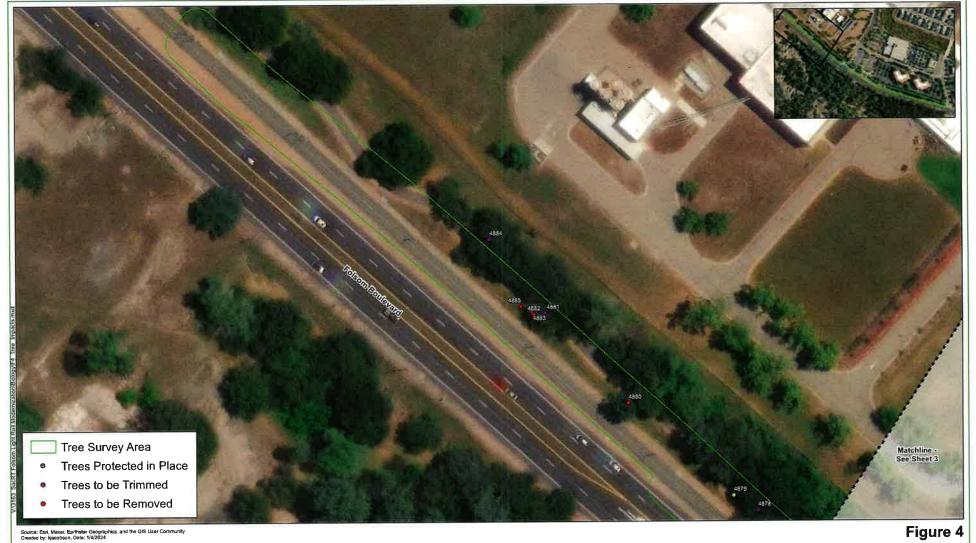
Tree Impacts Map
	1 inch = 83 feet				Sheet 2 of 4
	- 03 leet				SacRT Folsom Light Rail
0	100	200	300	400	Modernization Double Track Project

The location of trees that will be impacted by the proposed project are shown on Figure 4. Tree Impacts. The remaining trees are located far enough away from proposed improvements that they can be protected in place for the duration of construction and will not need to be trimmed or removed. Details on tree trimming and justifications for tree removals are included on the following pages.

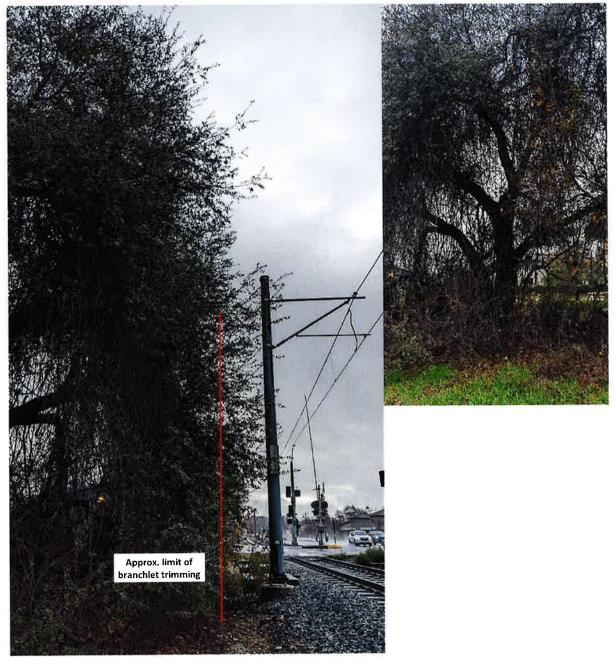
Tree 4824, Interior Live Oak, 18+29 Inches

Tree 4824 is a large 2-stemmed tree rooted outside of the project footprint but ends of branches that lean towards the construction area will need to be trimmed to allow for vehicle access and equipment clearance. Proposed trimming includes multiple branchlets less than 1 inch in diameter. The canopy above catenary pole height overhangs the area needing trimming, so no canopy area will be affected. The trimming is not expected to affect the long-term health of the tree.

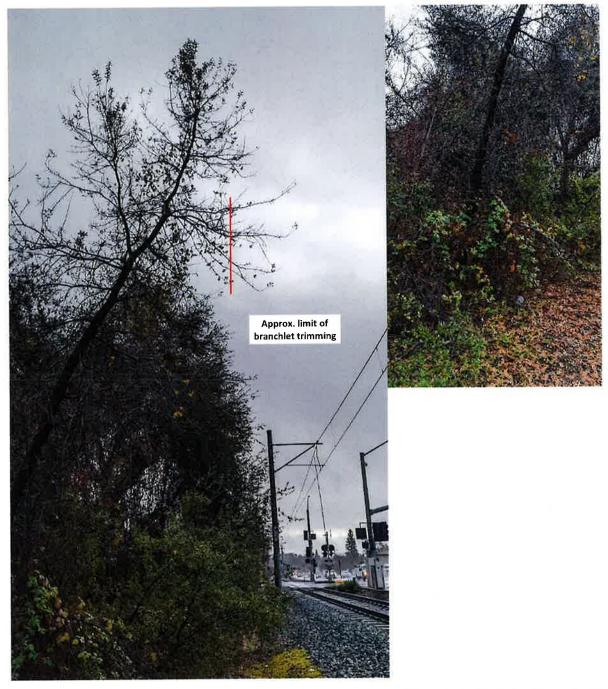
Tree 4826, Valley Oak, 7 Inches

Tree 4826 is rooted outside of the project footprint but ends of branches that lean towards the construction area will need to be trimmed to allow for vehicle access and equipment clearance. Proposed trimming includes approximately 5 branchlets less than 1 inch in diameter. The canopy above catenary pole height overhangs the area needing trimming, so no canopy area will be affected. The trimming is not expected to affect the long-term health of the tree.

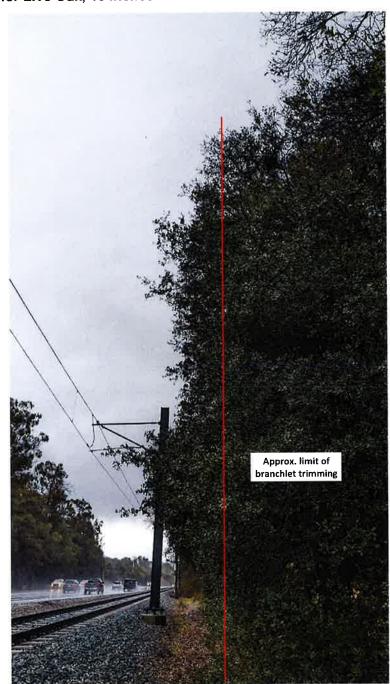
Tree 4828, Interior Live Oak, 15 Inches

Tree 4828 is rooted outside of the project footprint but ends of branches that lean towards the construction area will need to be trimmed to allow for vehicle access and equipment clearance. Proposed trimming includes 5 lateral branches of 1–2-inch diameter and multiple branchlets less than 1 inch in diameter. Trimming will remove approximately 5% of the canopy and is not expected to affect the long-term health of the tree.

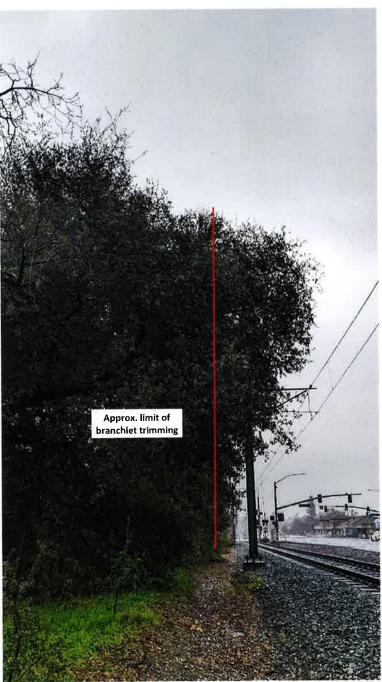
Tree 4829, Interior Live Oak 20+4 Inches

Tree 4829 is rooted outside of the project footprint but ends of branches that lean towards the construction area will need to be trimmed to allow for vehicle access and equipment clearance. Proposed trimming includes 3 lateral branches of 2-3-inch diameter and a few branchlets less than 1 inch in diameter. Trimming will remove approximately 10% of the canopy and is not expected to affect the long-term health of the tree.

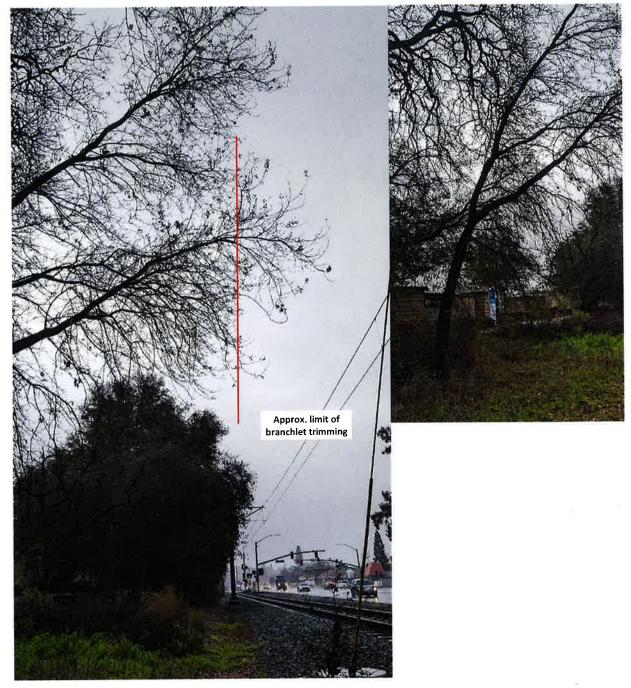
Tree 4830, Valley Oak, 11 Inches

Tree 4830 is rooted outside of the project footprint but ends of branches that lean towards the construction area will need to be trimmed to allow for vehicle access and equipment clearance. Proposed trimming includes a few branchlets less than 1 inch in diameter. The canopy above catenary pole height overhangs the area needing trimming, so no canopy area will be affected. The trimming is not expected to affect the long-term health of the tree.

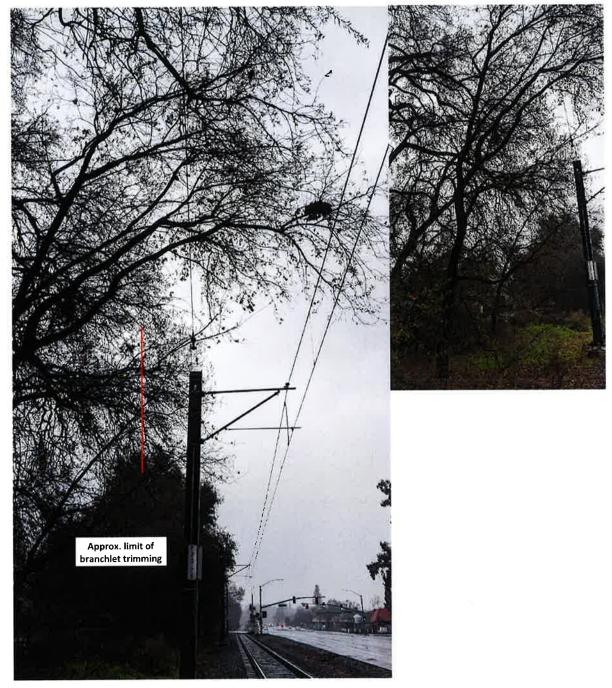
Tree 4831, Valley Oak, 14 Inches

Tree 4831 is rooted outside of the project footprint but ends of branches that lean towards the construction area will need to be trimmed to allow for vehicle access and equipment clearance. Proposed trimming includes 3 lateral branches of 1-2-inch diameter. The canopy above catenary pole height overhangs the area needing trimming, so no canopy area will be affected. The trimming is not expected to affect the long-term health of the tree.

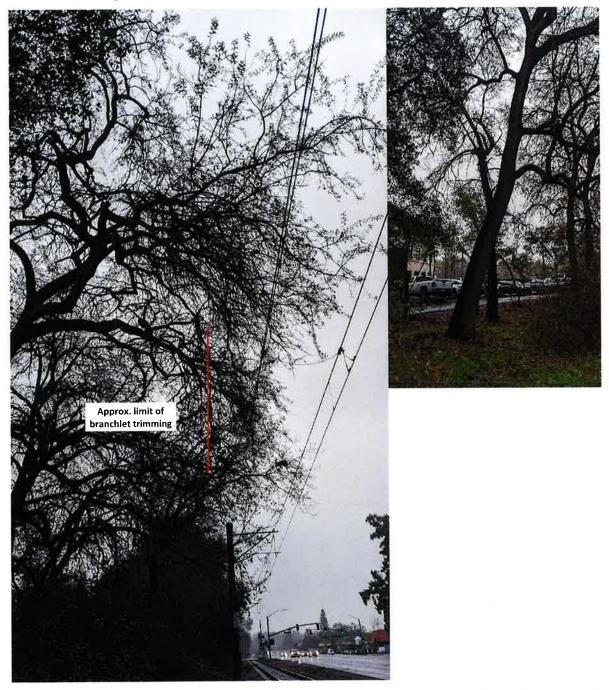
Tree 4836, Valley Oak, 31 Inches

Tree 4836 is rooted outside of the project footprint but ends of branches that lean towards the construction area will need to be trimmed to allow for vehicle access and equipment clearance. Proposed trimming includes 4 lateral branches of 1-2-inch diameter. The canopy above catenary pole height overhangs the area needing trimming, so no canopy area will be affected. The trimming is not expected to affect the long-term health of the tree.

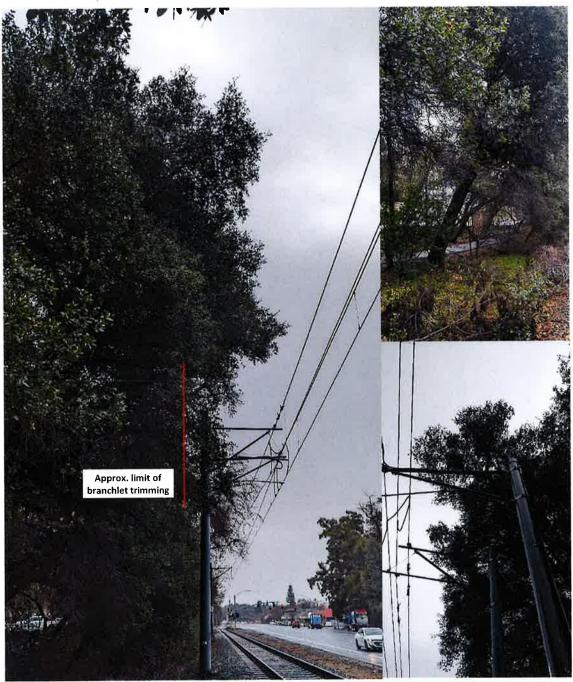
Tree 4841, Interior Live Oak, 28 Inches

Tree 4841 is rooted outside of the project footprint but ends of branches that lean towards the construction area will need to be trimmed to allow for vehicle access and equipment clearance. Proposed trimming includes 4 lateral branches of 1-inch diameter. The canopy above catenary pole height overhangs the area needing trimming, so no canopy area will be affected. The trimming is not expected to affect the long-term health of the tree.

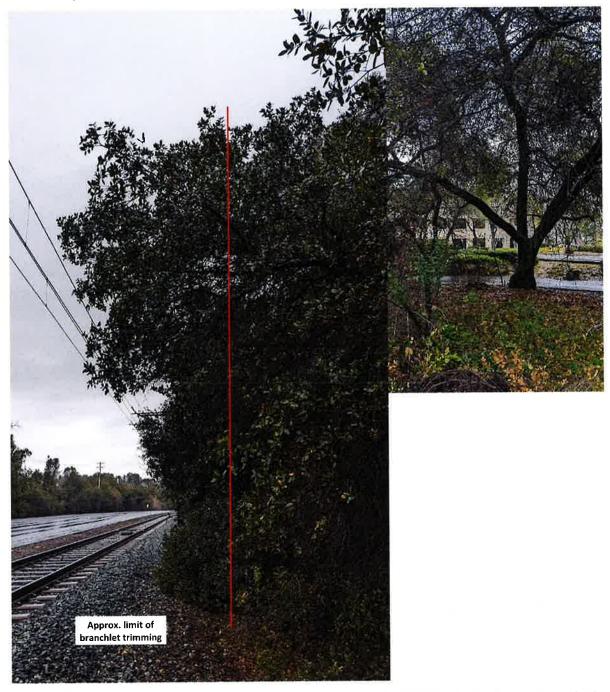
Tree 4843, Interior Live Oak 20+22 Inches

Tree 4843 is rooted outside of the project footprint but ends of branches that lean towards the construction area will need to be trimmed to allow for vehicle access and equipment clearance. Proposed trimming includes one lateral branch of 3-inch, two of 2-inch, and two of 1-inch diameter, plus multiple branchlets less than 1 inch in diameter. Trimming will remove approximately 10% of the canopy and is not expected to affect the long-term health of the tree.

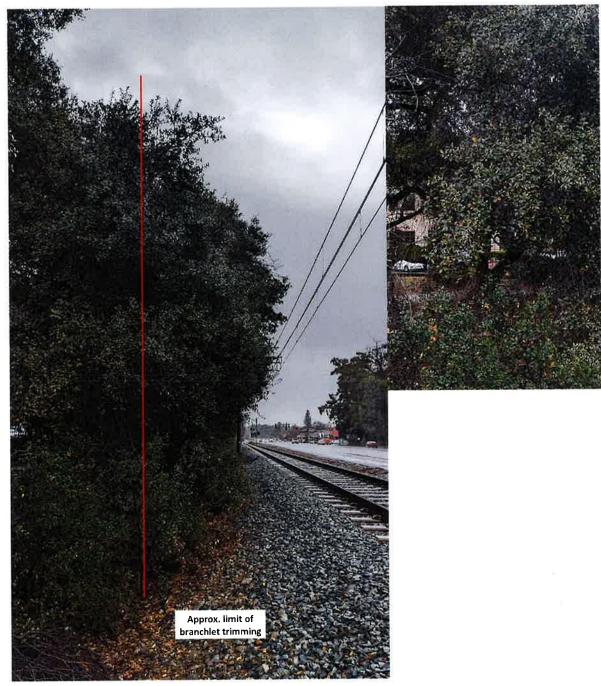
Tree 4844, Interior Live Oak, 27+23 Inches

Tree 4844 is rooted outside of the project footprint but ends of branches that lean towards the construction area will need to be trimmed to allow for vehicle access and equipment clearance. Proposed trimming includes one lateral branch of 4-inch, two of 2-inch, and four of 1-inch diameter, plus multiple branchlets less than 1 inch in diameter. Trimming will remove approximately 10% of the canopy and is not expected to affect the long-term health of the tree.

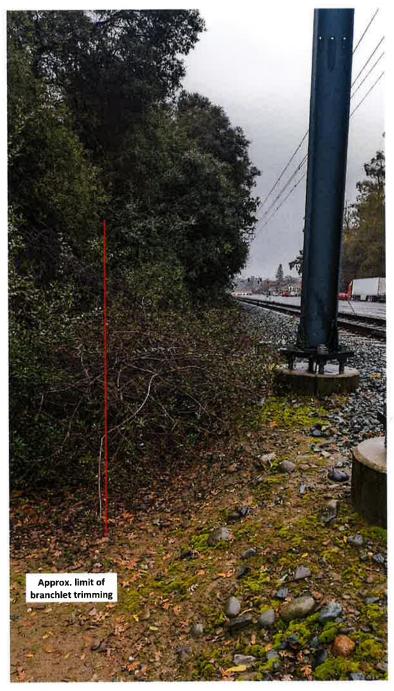
Tree 4847, Interior Live Oak, 11+16 Inches

Tree 4847, in poor health, is rooted outside of the project footprint but ends of branch that extends into the construction area near to the ground will need to be trimmed to allow for vehicle access and equipment clearance. Proposed trimming includes multiple branchlets less than 1 inch in diameter. The canopy above catenary pole height overhangs the area needing trimming, so no canopy area will be affected. Trimming will remove approximately 5% of the canopy and is not expected to affect the long-term health of the tree.

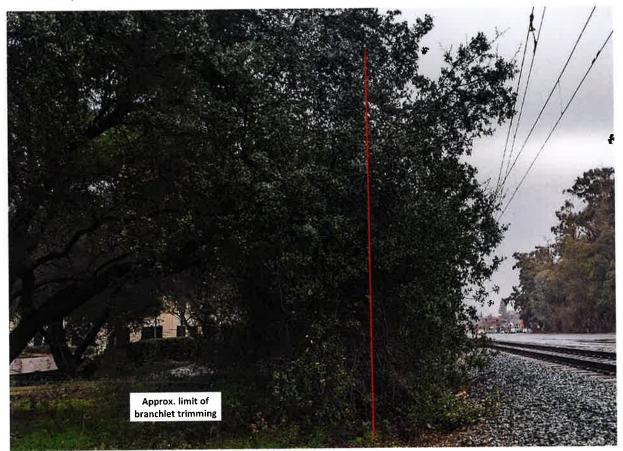
Tree 4849, Interior Live Oak, 21+21+19 Inches

Tree 4849 is rooted outside of the project footprint but ends of branches that lean towards the construction area will need to be trimmed to allow for vehicle access and equipment clearance. Proposed trimming includes one lateral branch of 3-inch, two of 2-inch, and six of 1-inch diameter, plus multiple branchlets less than 1 inch in diameter. Trimming will remove approximately 10% of the canopy and is not expected to affect the long-term health of the tree.

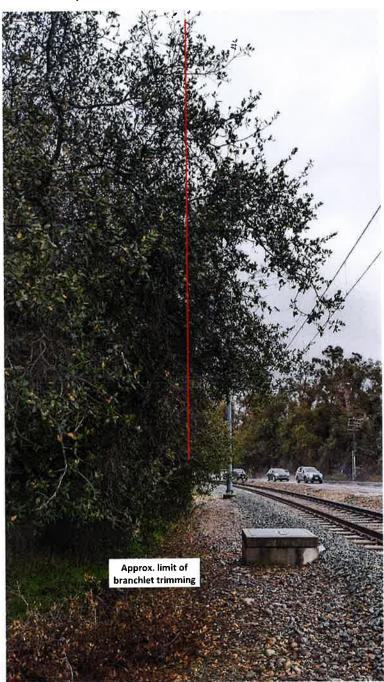
Tree 4853, Interior Live Oak, 17+8+9+9+13+8+12+10+4+8+13+14+4+12 Inches

Tree 4853, in poor health, is rooted outside of the project footprint but ends of branches that lean towards the construction area will need to be trimmed to allow for vehicle access and equipment clearance. Proposed trimming includes one lateral branch of 3-inch, one of 2-inch, and nine of 1-inch diameter. Trimming will remove approximately 10% of the canopy and is not expected to affect the long-term health of the tree.

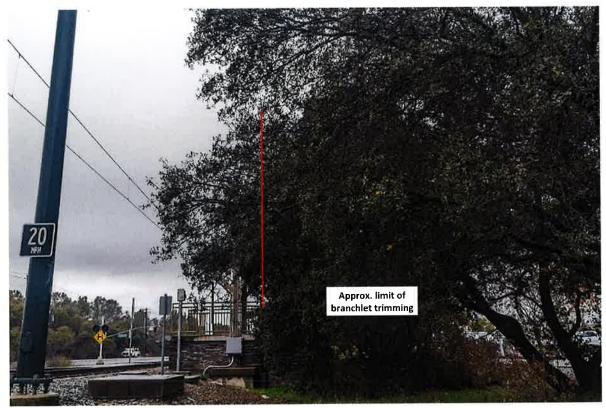
Tree 4854, Interior Live Oak, 11+14 Inches

Tree 4854 is rooted outside of the project footprint but ends of branch that extends into the construction area near to the ground will need to be trimmed to allow for vehicle access and equipment clearance. Proposed trimming includes three lateral branches of 2-inch, and seven of 1-inch diameter. Trimming will remove approximately 10% of the canopy and is not expected to affect the long-term health of the tree.

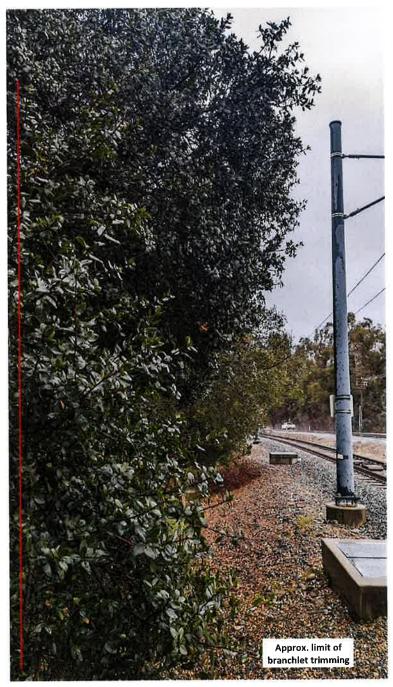
Tree 4855, Interior Live Oak, 13+6+11+8+9+4 Inches

Tree 4855 is rooted outside of the project footprint but ends of branches that extend into the construction area will need to be trimmed to allow for vehicle access and equipment clearance. Proposed trimming includes four lateral branches of 2-inch and five of 1-inch diameter, plus multiple branchlets less than 1 inch in diameter. Trimming will remove approximately 10% of the canopy and is not expected to affect the long-term health of the tree.

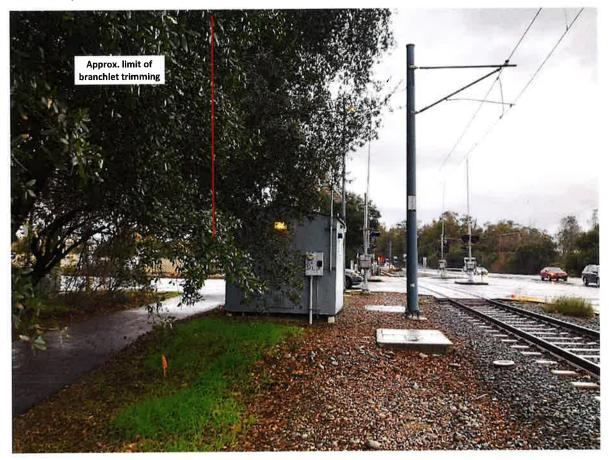
Tree 4873, Interior Live Oak, 37 Inches

Tree 4873 is rooted outside of the project footprint but ends of branches that extend into the construction area will need to be trimmed to allow for vehicle access and equipment clearance. Proposed trimming includes one lateral branch of 3-inch, five of 2-inch and four of 1-inch diameter. Trimming will remove approximately 10% of the canopy and is not expected to affect the long-term health of the tree.

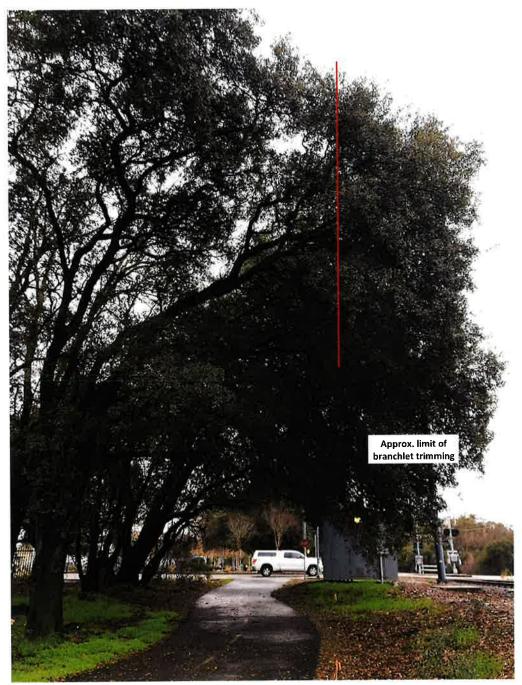
Tree 4874, Interior Live Oak, 28 Inches

Tree 4873 is rooted outside of the project footprint but ends of branches that extend into the construction area will need to be trimmed to allow for vehicle access and equipment clearance. Proposed trimming includes one lateral branch of 5-inch, three of 3-inch, ten of 2-inch and four of 1-inch diameter, plus multiple branchlets less than 1 inch in diameter. Trimming will remove approximately 30% of the canopy and is not expected to affect the long-term health of the tree.

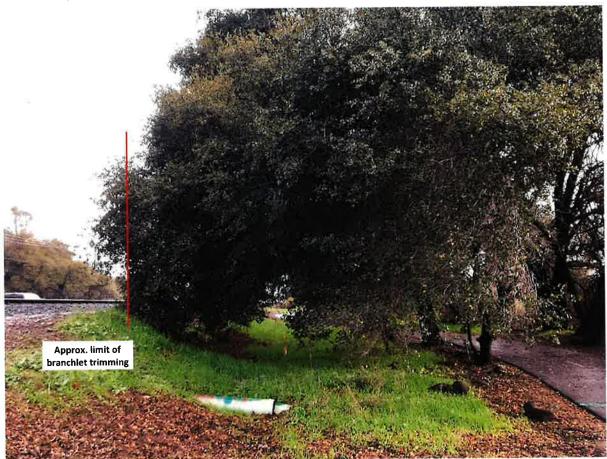
Tree 4875, Interior Live Oak, 10 Inches

Tree 4875 is rooted outside of the project footprint but ends of branches extending into the construction area will need to be trimmed to allow for vehicle access and equipment clearance. Proposed trimming includes a few branchlets less than 1 inch in diameter. Trimming will remove less than 5% of the canopy and is not expected to affect the long-term health of the tree.

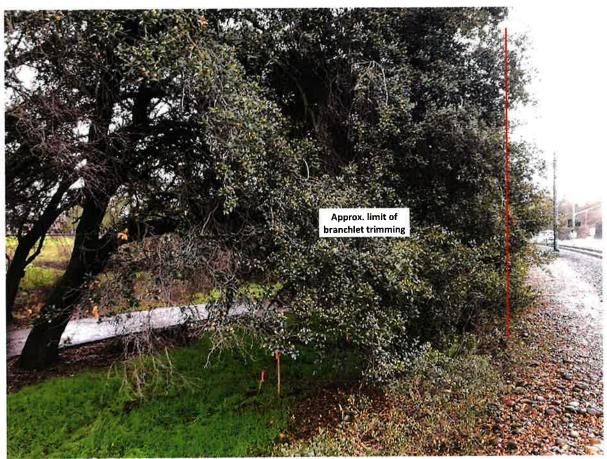
Tree 4876, Interior Live Oak, 23 Inches

Tree 4876 is rooted outside of the project footprint but ends of branches extending into the construction area will need to be trimmed to allow for vehicle access and equipment clearance. Proposed trimming includes multiple branchlets less than 1 inch in diameter. Trimming will remove approximately 5% of the canopy and is not expected to affect the long-term health of the tree.

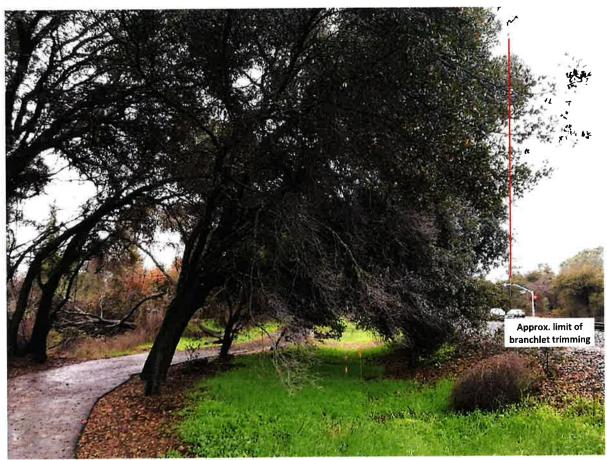
Tree 4877, Interior Live Oak, 11 Inches

Tree 4877 is rooted outside of the project footprint but ends of branches extending into the construction area will need to be trimmed to allow for vehicle access and equipment clearance. Proposed trimming includes multiple branchlets less than 1 inch in diameter. Trimming will remove approximately 5% of the canopy and is not expected to affect the long-term health of the tree.

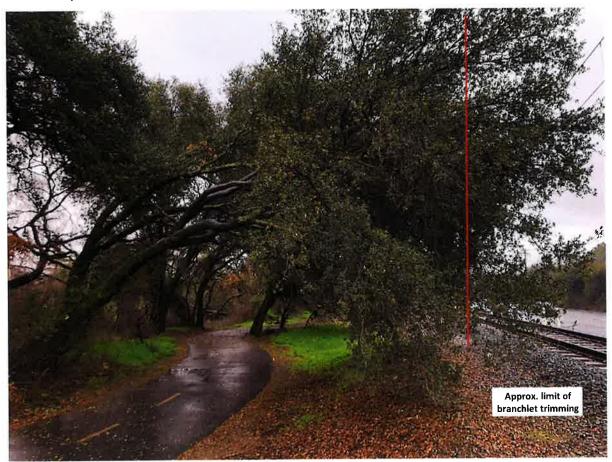
Tree 4878, Interior Live Oak, 16 Inches

Tree 4878 is rooted outside of the project footprint but ends of branches that extend into the construction area will need to be trimmed to allow for vehicle access and equipment clearance. Proposed trimming includes three lateral branches of 2-inch diameter plus multiple branchlets less than 1 inch in diameter. Trimming will remove approximately 30% of the canopy and is not expected to affect the long-term health of the tree.

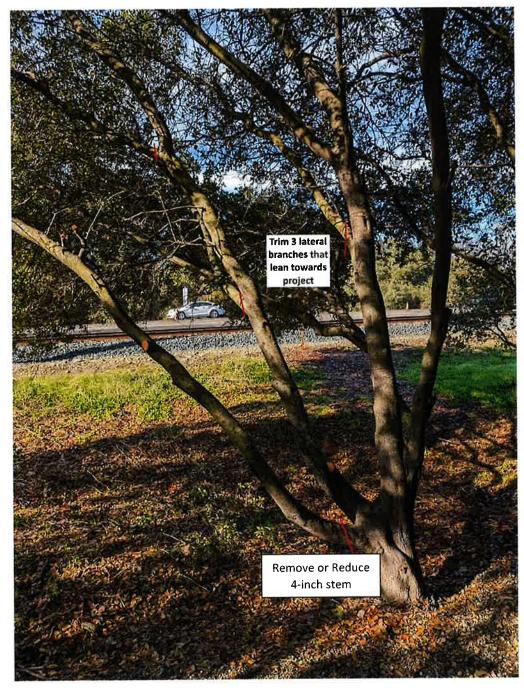
Tree 4881, Interior Live Oak, 6+5+4+4 Inches

Tree 4881 is rooted outside of the project footprint but branches that lean towards the construction area will need to be trimmed to allow for vehicle access and equipment clearance. Proposed trimming includes one 4-inch stem and three lateral branches between 2 and 3 inches in diameter totaling approximately 20% of the total canopy and is not expected to affect the long term health of the tree.

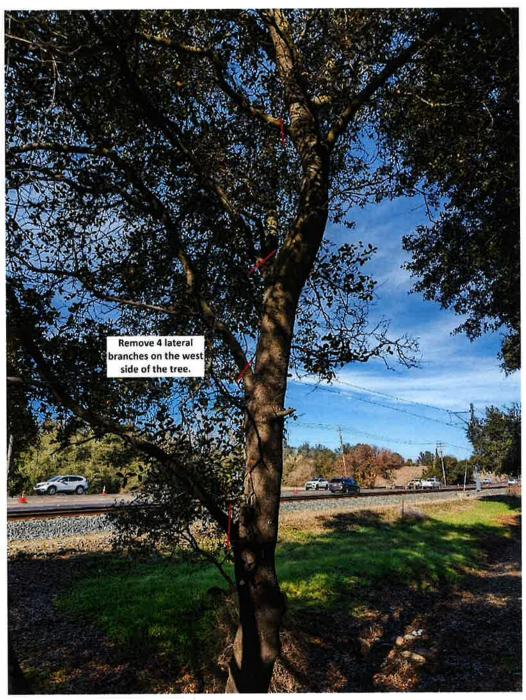
Tree 4883, Interior Live Oak, 11 Inches

Tree 4883 is rooted outside of the project footprint but branches that lean towards the construction area will need to be trimmed to allow for vehicle access and equipment clearance. Proposed trimming includes removing 4 lateral branches from the main leader. The upper canopy will remain untouched. Pruning will remove approximately 20% of the canopy and is not expected to negatively affect the long-term health of the tree.

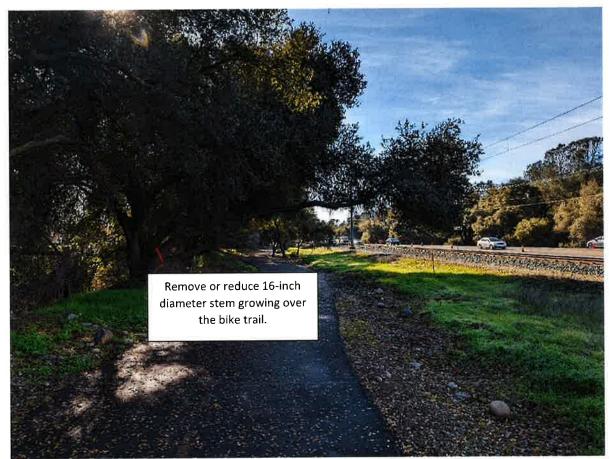
Tree 4884, Interior Live Oak, 24+22+16+16 Inches

Tree 4884 is a large multi-stem tree with one of the stems growing almost horizontally out over the bike trail and into the construction area. This limb needs to be removed or reduced back to a strong lateral to gain vehicle access and clearance for the relocated overhead power lines for the light rail. Removing or reducing this stem will remove approximately 10% of the canopy and is not expected to adversely affect the health of the tree.

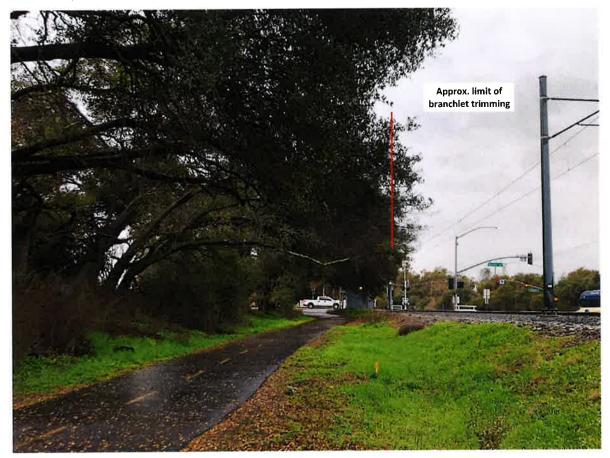
Tree 4886, Interior Live Oak, 20+14 Inches

Tree 4886 is rooted outside of the project footprint but branches that lean towards the construction area will need to be trimmed to allow for vehicle access and equipment clearance. Proposed trimming includes multiple branchlets less than 1 inch in diameter. Trimming will remove less than 5% of the canopy and is not expected to affect the long-term health of the tree.

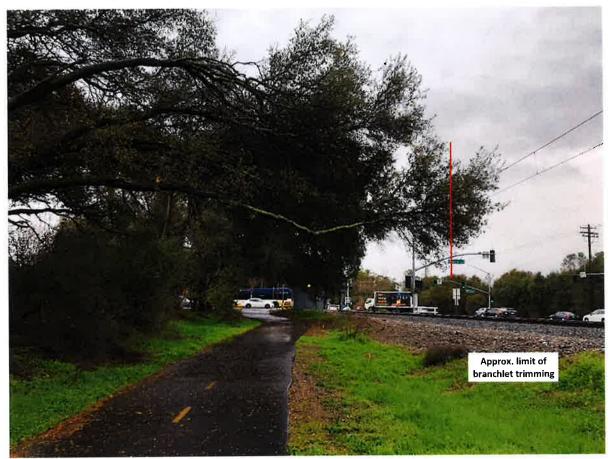
Tree 4887, Interior Live Oak, 13+10 Inches

Tree 4887 is rooted outside of the project footprint but branches that lean towards the construction area will need to be trimmed to allow for vehicle access and equipment clearance. Proposed trimming includes multiple branchlets less than 1 inch in diameter. Trimming will remove less than 5% of the canopy and is not expected to affect the long-term health of the tree.

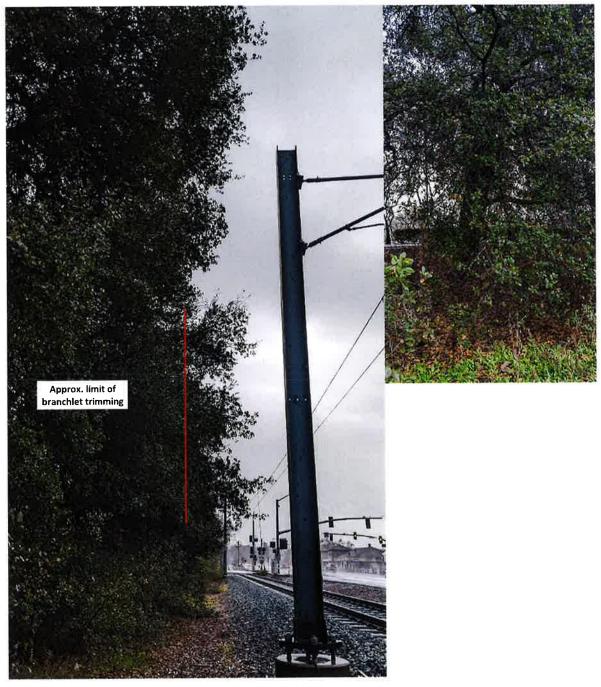
Tree 4888, Interior Live Oak, 38 Inches

Tree 4888, located towards the southern end of the project alignment, is rooted outside of the project footprint but ends of branches that extend into the construction area will need to be trimmed to allow for vehicle access and equipment clearance. Proposed trimming includes three lateral branches of 1-inch diameter. The canopy above catenary pole height overhangs the area needing trimming, so no canopy area will be affected. The trimming is not expected to affect the long-term health of the tree.

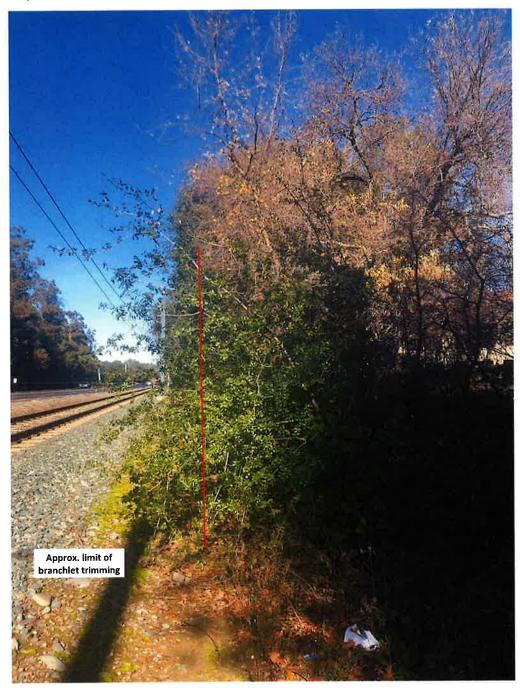
Tree 4889, Interior Live Oak, 3+2 Inches

Tree 4889, located towards the southern end of the project alignment, is a sapling rooted just outside of the project footprint with branches extending into the construction area that will need to be trimmed to allow for vehicle access and equipment clearance. Proposed trimming includes multiple branchlets less than 1 inch in diameter. Trimming will remove approximately 50% of the canopy and is not expected to affect the long-term health of this healthy sapling.

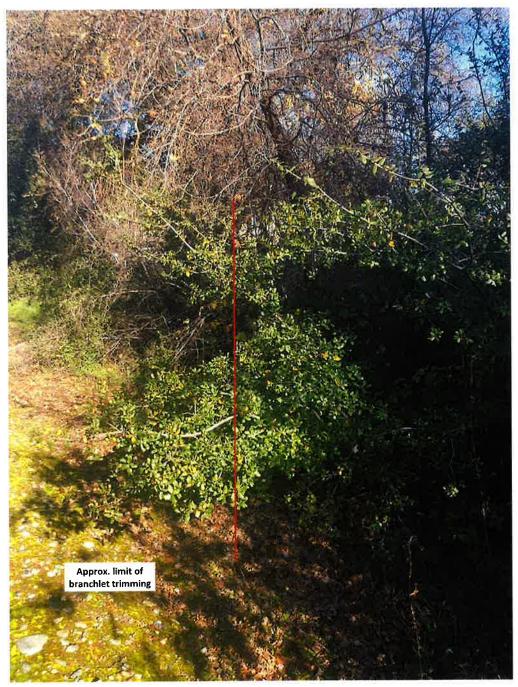
Tree 4890, Interior Live Oak, 1 Inch

Tree 4890, located towards the southern end of the project alignment, is a sapling rooted just outside of the project footprint with branches extending into the construction area that will need to be trimmed to allow for vehicle access and equipment clearance. Proposed trimming includes multiple branchlets less than 1 inch in diameter. Trimming will remove approximately 30% of the canopy and is not expected to affect the long-term health of the tree.

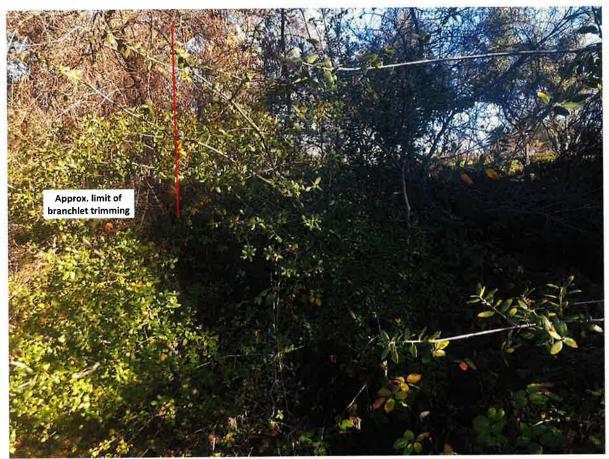
Tree 4891, Interior Live Oak, 1 Inch

Tree 4891, located towards the southern end of the project alignment, is a sapling rooted just outside of the project footprint with branches extending into the construction area that will need to be trimmed to allow for vehicle access and equipment clearance. Proposed trimming includes a few branchlets less than 1 inch in diameter. Trimming will remove approximately 20% of the canopy and is not expected to affect the long-term health of the tree.

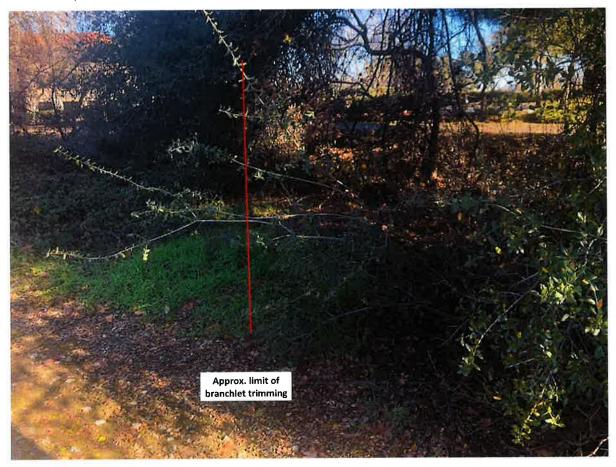
Tree 4892, Interior Live Oak, 1 Inch

Tree 4892, located towards the southern end of the project alignment, is a sapling rooted just outside of the project footprint with branches extending into the construction area that will need to be trimmed to allow for vehicle access and equipment clearance. Proposed trimming includes a few branchlets less than 1 inch in diameter. Trimming will remove approximately 10% of the canopy and is not expected to affect the long-term health of the tree.

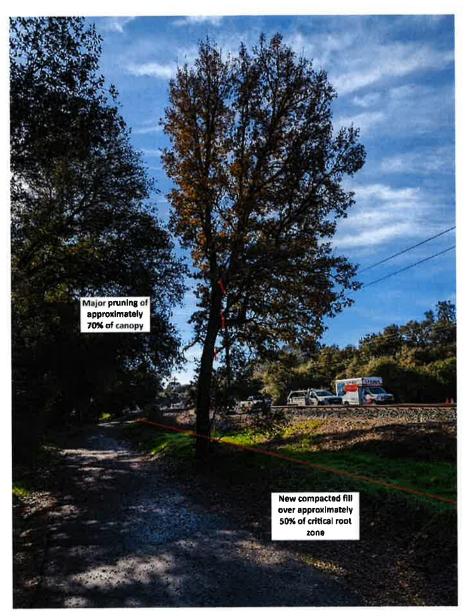
Tree 4880, Blue Oak, 21 Inches

In order to retain tree 4880, SacRT would need to remove approximately70% of the tree crown and grade and compact approximately 50% of the tree's critical root zone. These impacts are far greater than the recommended 25% maximum crown reduction for a single season and recommended 30% maximum critical root zone impact and are likely to cause significant health impacts to the tree. If left in place, the tree may survive for several years but would be at an increased risk of decline and failure. This risk is not acceptable in such close proximity to the light rail overhead powerlines and tracks and SacRT is proposing to remove the tree and pay the in-lieu fee.

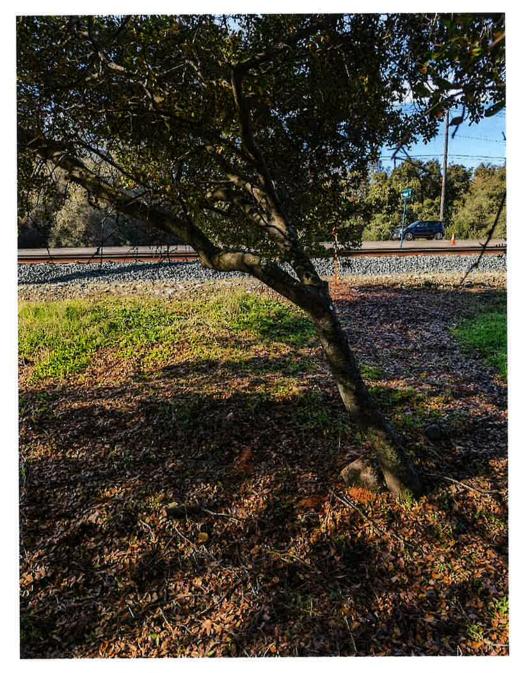
Tree 4882, Interior Live Oak, 7 Inches

Tree 4882 is entirely within the fill slope for the new secondary light rail track and must be removed. Please note, when this tree was surveyed on November 28th, it had three stems, a 7-inch stem, an 8-inch stem, and a 5-inch stem. When the area was re-surveyed on December 22, 2023, it was noted that the 8-inch and 5-inch stems had been removed by someone not affiliated with the SacRT 15-minute light rail project. Numerous other trees along the adjacent bike trail had also recently been trimmed.

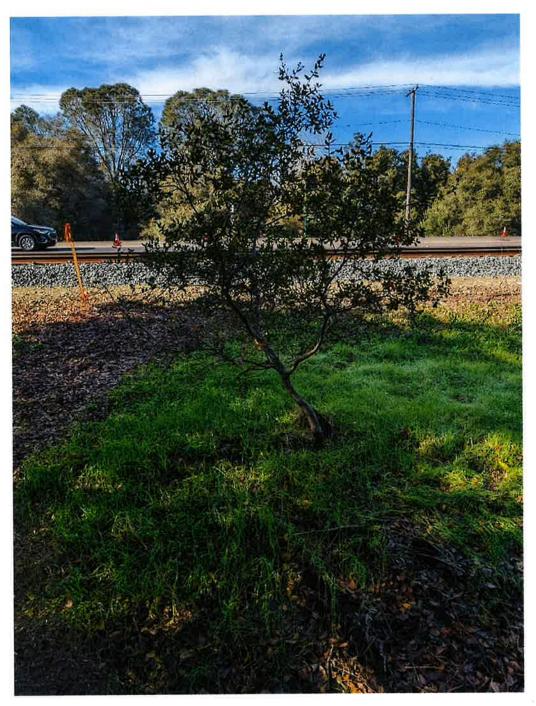
Tree 4885, Interior Live Oak, 1+1 inches

Tree 4885 is entirely within the fill slope for the new secondary light rail track and must be removed.
