Re: Required Correspondence for the purchase and development of 794 Main Street,
Forest Park, GA.

BOUNDARY & TOPOGRAPHIC SURVEY FOR

Phase I Environmental Assessment
794 Main Street
Forest Park, Clayton County, Georgia

RE: Report I for Phase I Environmental Assessment
794 Main Street
Forest Park, Clayton County, Georgia
Project No. GUCAI-25-09531-01

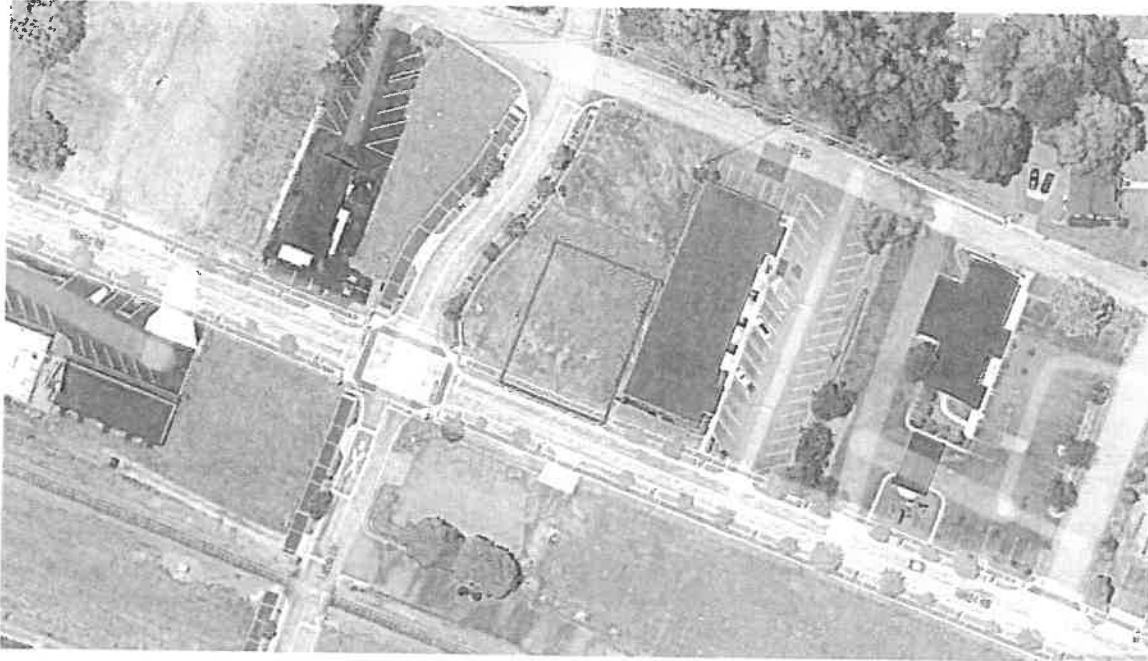
Exhibit 1: Aerial Photograph of the Subject Property

At the time of the site reconnaissance, the Subject Property was vacant, grassed land. Areas surrounding the Subject Property were developed with commercial buildings or were vacant lots. The subject property is bound to the west by North Lake Drive, and to the south by Main Street.

No significant changes to the Subject Property were observed in the subsequent aerial photographs until the 2015 aerial photograph, when the building had been demolished. Since this time, the Subject Property was observed as vacant, grassed land.
