## Staff photos

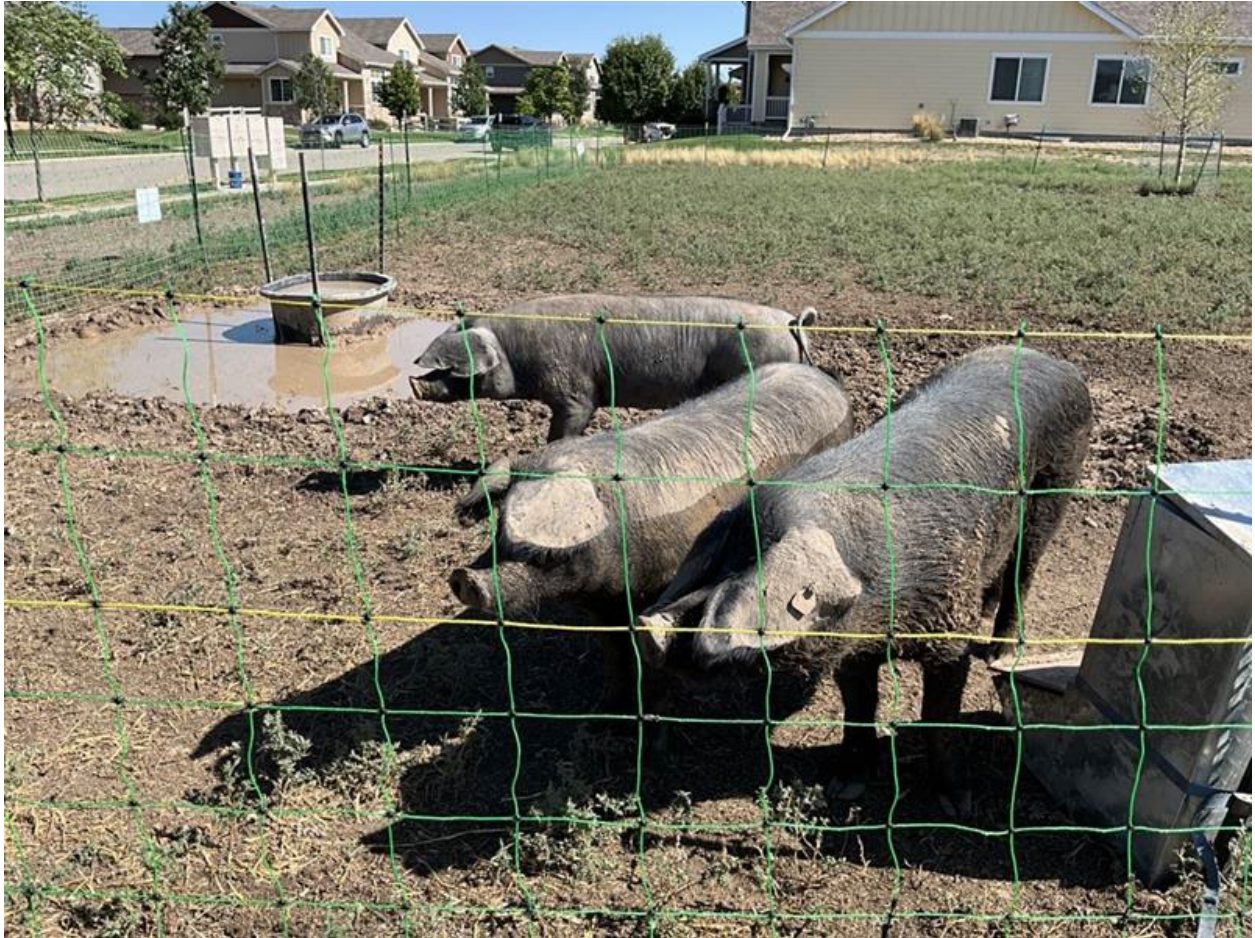
Summer 2025- Pig grazing paddock. Woven mesh electrified fencing, secured water trough and mud wallow and food dispenser shown. Note the exterior perimeter woven wire and t-post fencing.

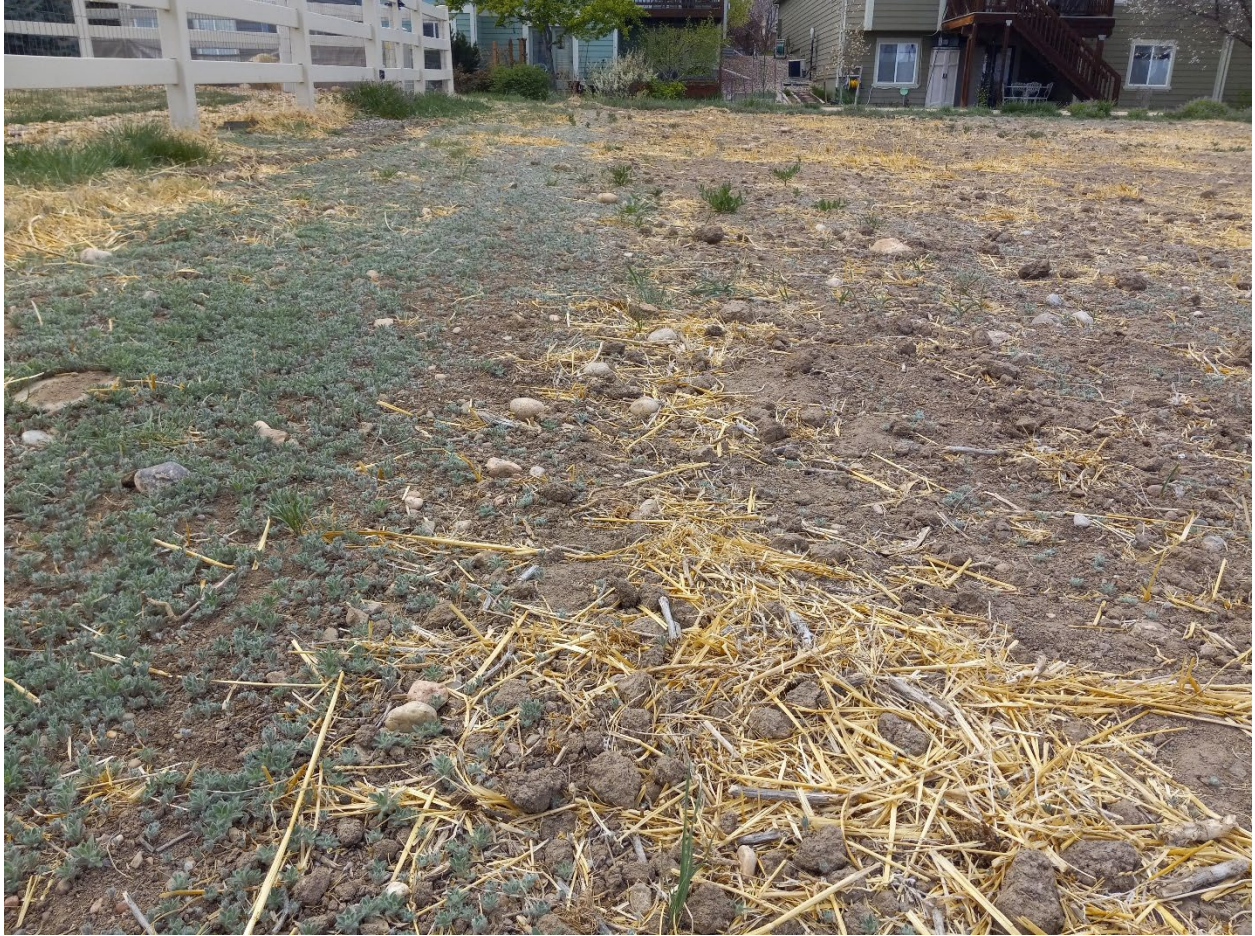
April 2026 – treatment effect of pigs is clearly visible along this old fence line. To the left, many light gray-green kochia seedlings are visible. To the right, few are visible.

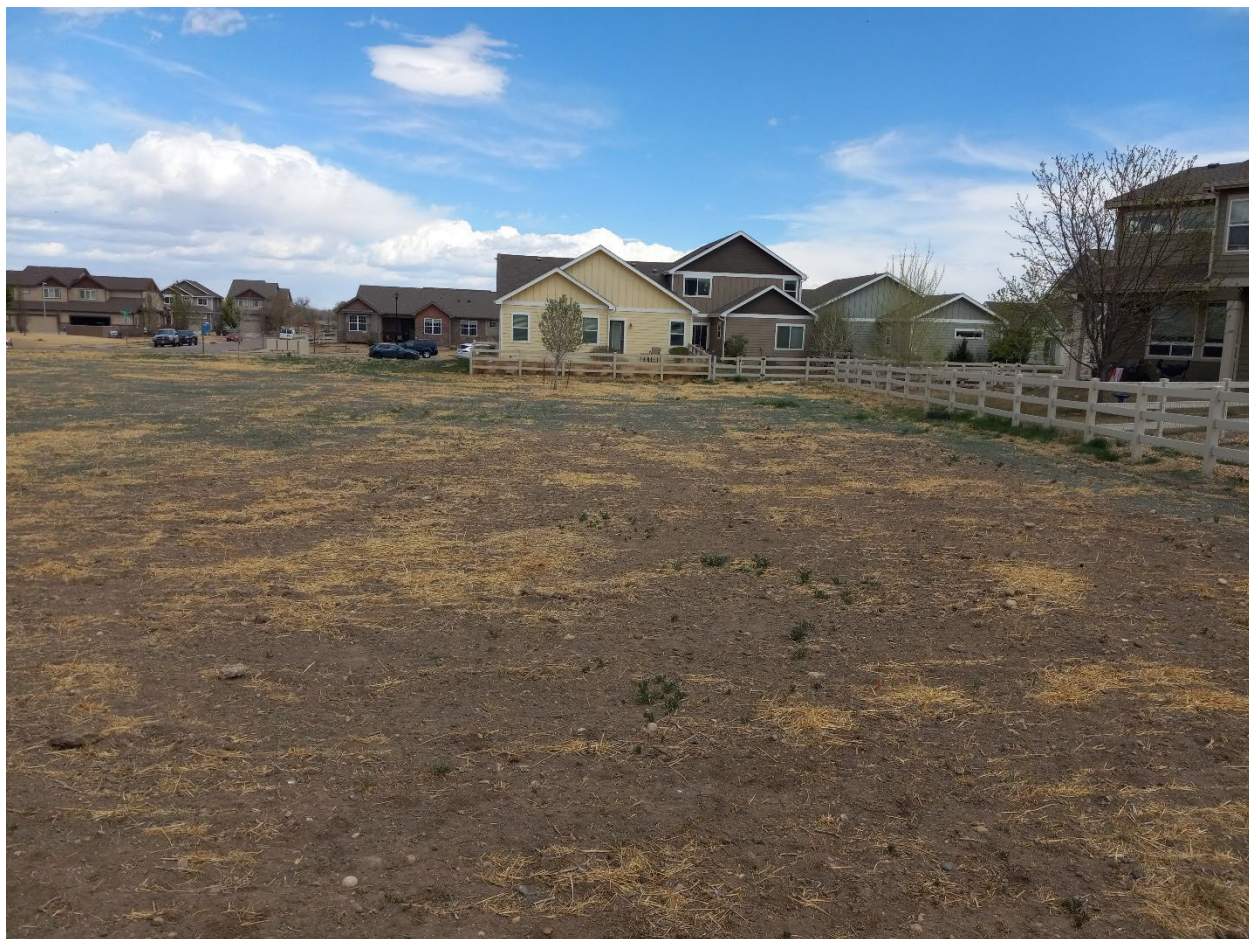
April 2026 – Treatment effect of this paddock is clearly visible the following spring. Light gray-green kochia seedlings are visible in the distance and along the white fence. Few kochia seedlings have germinated in the treated area in the foreground.

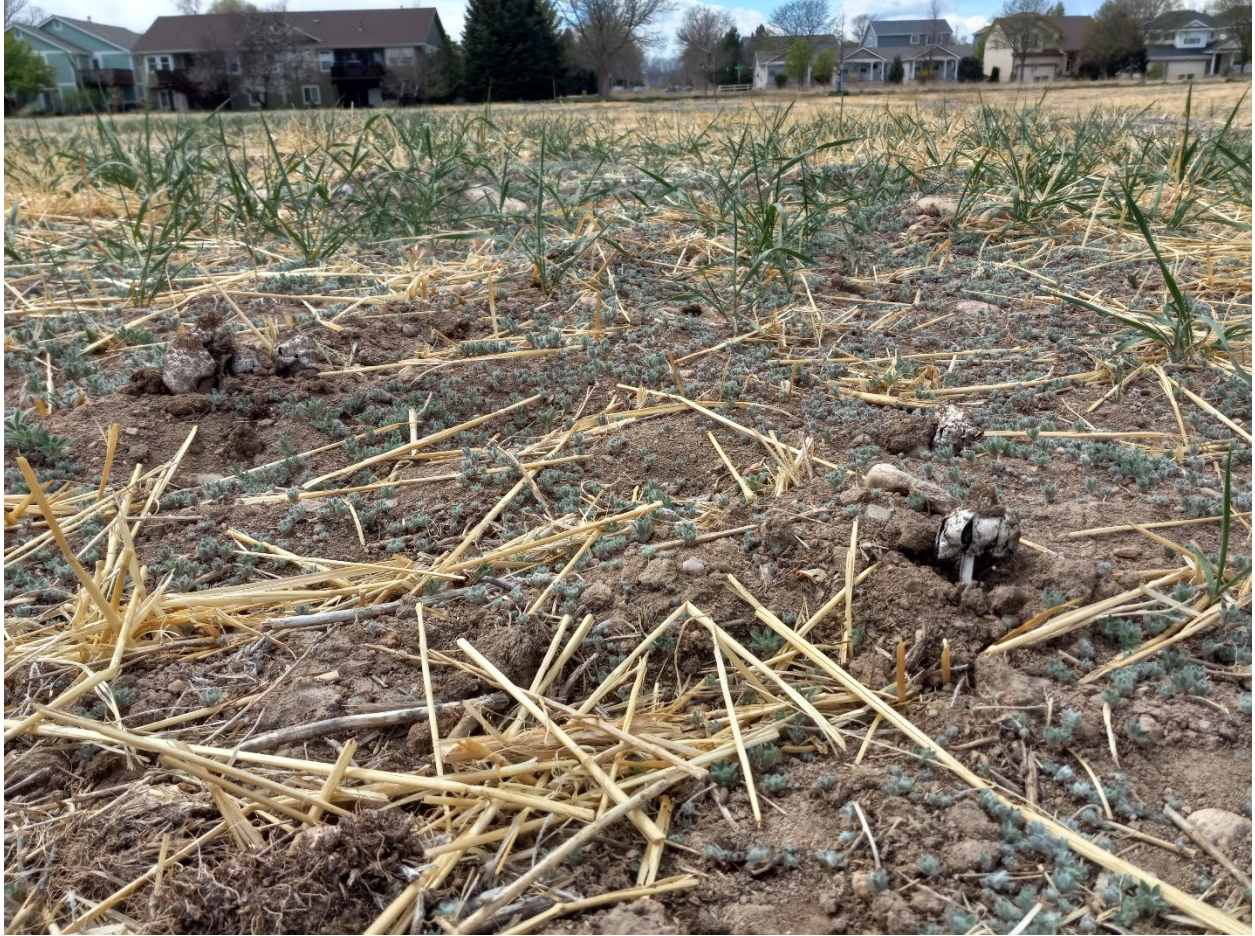
April 2026 – Close up view of the soils in an area that was treated two years prior. Soil permeability is increased. Kochia from the previous untreated season was able to produce seeds that are now germinating. Note the three mushrooms sprouting- a sign of healthy topsoil being created.

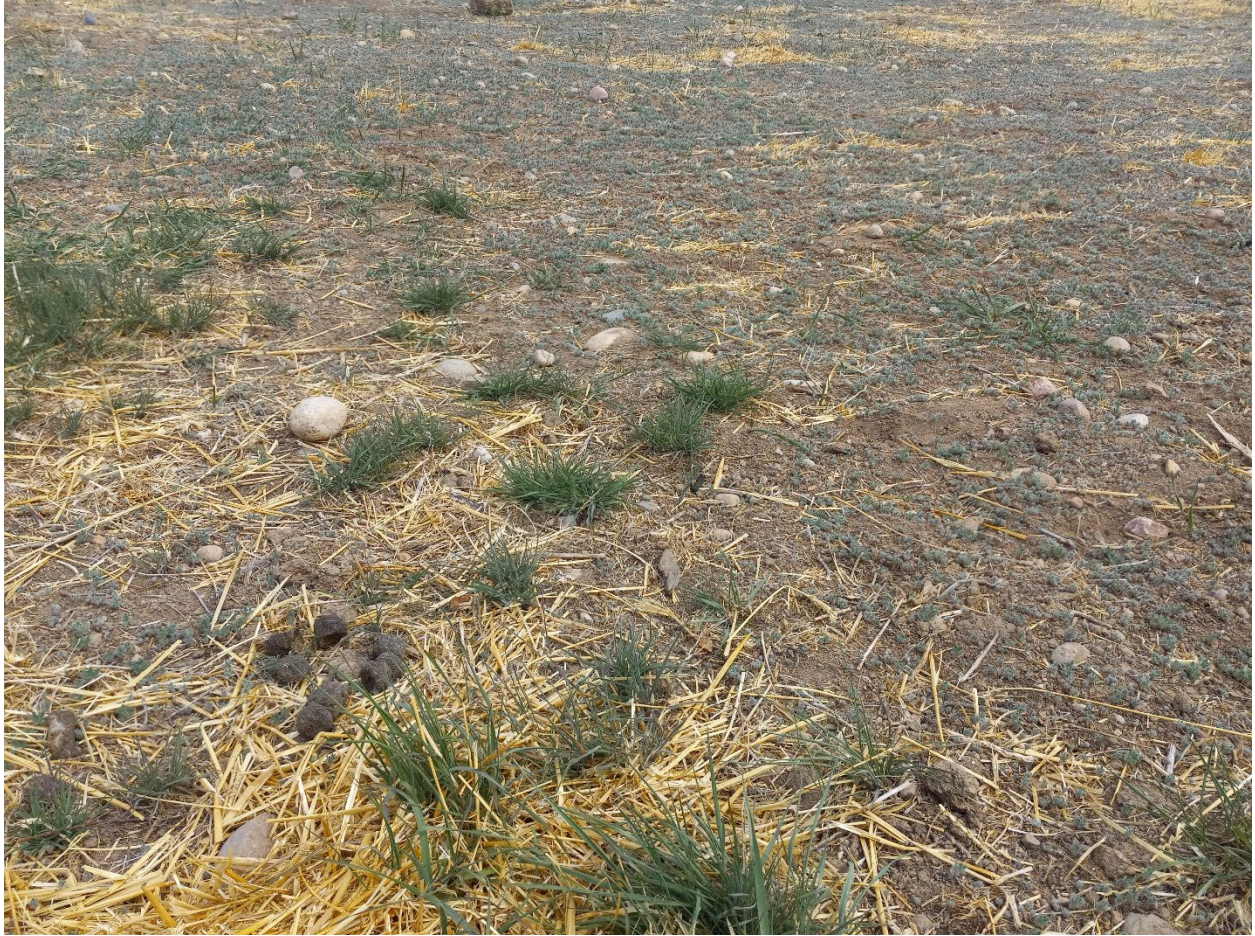
April 2026 – Pigs are not the only animals producing waste at this site. Evidence of dog owners not cleaning up after their pets is clear all over the site.

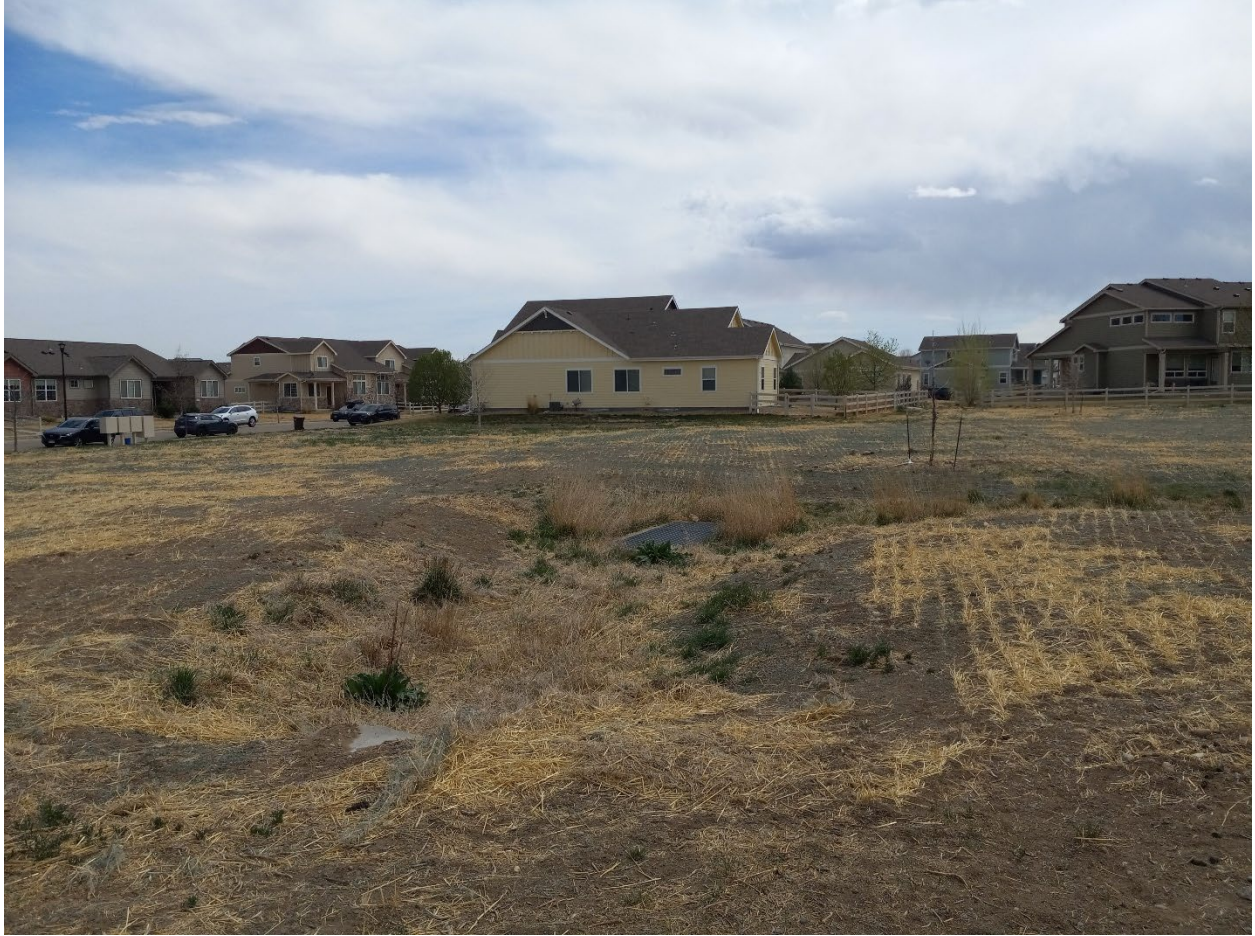
April 2026- view of the stormwater facility immediately to the north of the site. This facility drains to a settling pond and eventually to the Poudre River. The applicant worked closely with staff to develop a plan that would protect stormwater from contamination by the pigs.
