# HUD PHASE I ENVIRONMENTAL SITE ASSESSMENT

Fairview Manor

415 South 4th Street

*July 29, 2026*

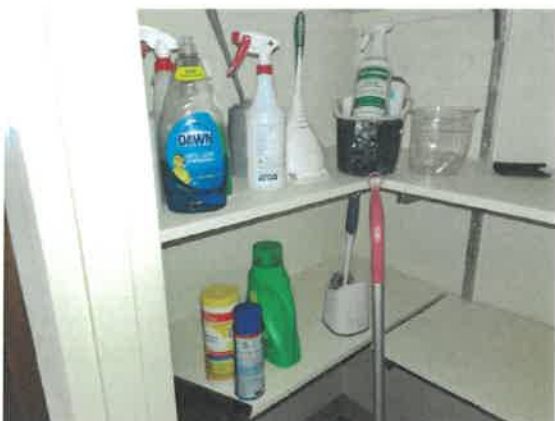
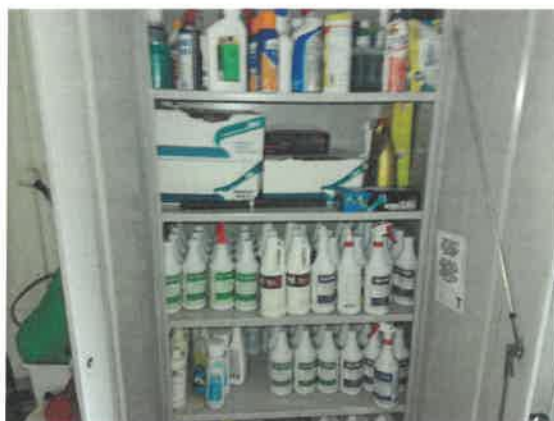
CLEANING SUPPLIES

Review of the hazardous materials use and storage at the subject property did not identify any recognized environmental conditions or environmental concerns with regards to the materials listed in the table above.

- The subject property is not involved in the use of petroleum products; however, the subject property is involved in the use of hazardous materials in the form of routine janitorial and maintenance supplies. The identified materials appear to be properly stored. The materials observed do not appear to pose a hazard to the subject property, provided they continue to be used as designed, are properly handled, and all regulations regarding their use are followed. No further action or investigation is recommended regarding the use of hazardous materials or petroleum products at the subject property.

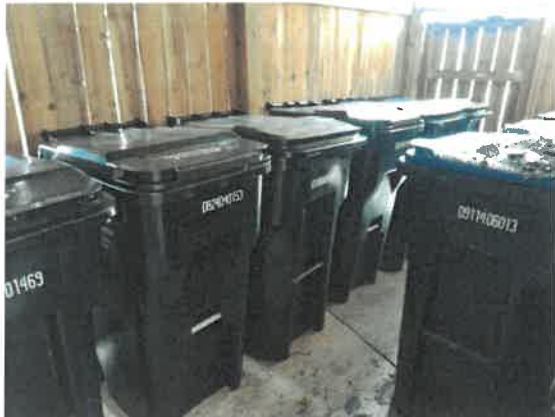
TRASH CONTAINERS

Review of waste storage and disposal information did not identify any recognized environmental conditions or environmental concerns with regards to the wastes listed in the table above.

- The subject property is not involved in the generation, treatment, storage, or disposal of hazardous, medical, or regulated wastes; however, the subject property generates non-hazardous solid and liquid wastes. Generated wastes appear to be stored and disposed of properly. No further action or investigation is recommended regarding wastes at the subject property.

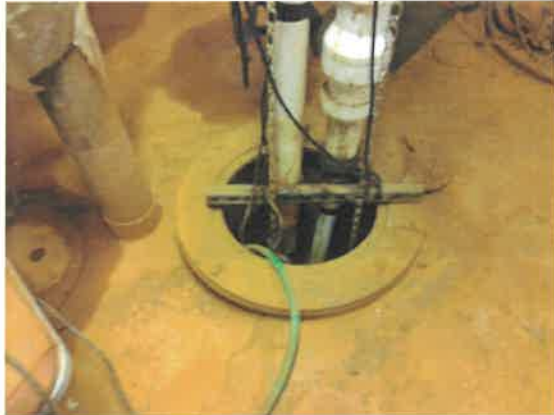
| Environmentally Significant Floor Drains, Sumps, and Pits | | | | | |
|---|---|---|---|---|---|
| Sump | 1 | Sanitary sewer | No | No | Basement |

SUMP PUMP

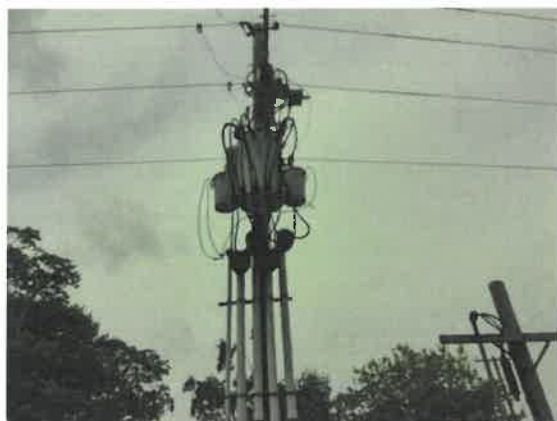
| Oil Cooled Transformers | |
|---|---|
| Conclusion: | Based on the information above, the presence of this equipment does not represent a recognized environmental condition. |

POLE-MOUNTED TRANSFORMERS

- BV identified utility-owned transformers at the subject property that are labeled as "Non-PCB". This equipment appeared to be in good condition with no evidence of leaks. No further action or investigation is recommended regarding the transformers at the subject property.

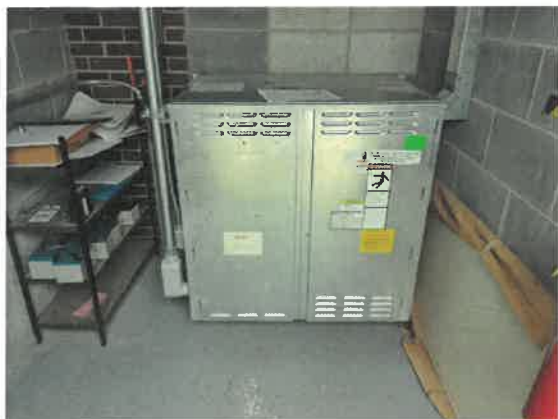
| Hydraulic Elevators | |
|---|---|
| Conclusion: | Based on the information above, the presence of this equipment does not represent a recognized environmental condition. |

ELEVATOR OPERATING EQUIPMENT

- The subject property contains an elevator that uses hydraulic fluid. PCB-containing hydraulic fluid has not been manufactured or used since 1979. Therefore, based on the date of installation, PCB-containing hydraulic fluid is not likely to be found in the elevator operating system. No indication of leakage was observed in the area of elevator operating equipment. The hydraulic elevator unit at the subject property should be periodically inspected for leakage. If leakage is identified, the unit should be repaired and any fluid or fluid-soaked waste disposed of in accordance with applicable federal, state, and local regulations. No further action or investigation is recommended regarding this equipment.
