#### HISTORIC PRESERVATION COMMISSION (HPC)

#### CERTIFICATE OF APPROPRIATENESS APPLICATION

## HISTORIC RESOURCES SURVEY FORM

#### Property #33

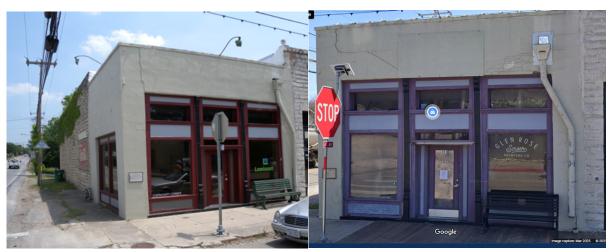
Perhaps the oldest intact commercial building in Glen Rose, the Corner Drug Store Building is a three-bay One-part Commercial Block constructed with ashlar limestone sides and rear and a brick front. The building measures 24 feet 5 inches wide at the front, 25 feet across the rear, and 81 feet long. It has a flat roof in which the front portion drains toward the front and rear slopes to drain toward rear. The stucco-covered brick facade of the building has three bays, the central one containing a wooden single entrance door with glass panel beneath a transom. On either side of the entry are two large fixed plate glass display windows, each beneath its own glass transom. The display window area of the store front is supported on two cast iron upright members marked as having been produced by the Cleburne Foundry Company in Cleburne, Texas. A prominent sheet metal conductor head and downspout on the right front of the building collects and removes rainwater from the front portion of the roof. Historically the front of the building had an iron-rod supported awning that in some years was stabilized by vertical iron pipes. One iron eye remains in the façade from the former awning supports. The northeast side of the building on East Elm Street has two display windows at its northwest end. The rear of the building has a three-bay arrangement as well. It has a central single-door entry with transom flanked by a former sash window on each side that has been enclosed with a wooden covering. The area immediately outside the rear has been developed as a rectangular concrete-floored outdoor patio with a low wooden banister restraint on its three sides. At some time in the 1930s or the early 1940s, the front 19 feet of the building was substantially altered. The northwest front wall and southeast side wall were removed and replaced by brick walls about a foot shorter. Then by the early 1940s this front area was covered with stucco. Again the front part of the building was renovated in 1965. Examination of irregularities in the stonework on the northeast side wall that faces onto East Elm Street shows that this portion of the structure likewise has had multiple additions and changes since its initial construction in the early 1880s. As early as about 1920 this wall has borne painted advertisements, the current one reading "Drink Coca-Cola." After the Corner Drug Store Building ceased to house drug store operations in the 1980s, its interior was modified to house office space and the front awning was completely removed.

Picture from 2010 Resource Survey

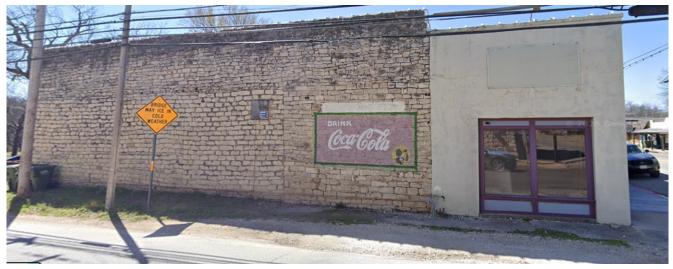
Current Picture 2025

Demolition does not meet the Secretary of the Interiors Standards for Rehabilitation. Demolition contravenes the underlying intent of all the Standards (which are designed to guide appropriate repair, alterations, and additions to historic properties), but most obviously violates:

The owner should explore local grants, tax incentives, or tax abatements for preservation. As a contributing resource in the Glen Rose Historic District, work to the property would be eligible for state and federal tax credits and possibly other grant funding. If the owner does not wish to explore these options then a sale of the building is recommended to an entity that has the time and resources to preserve the building.

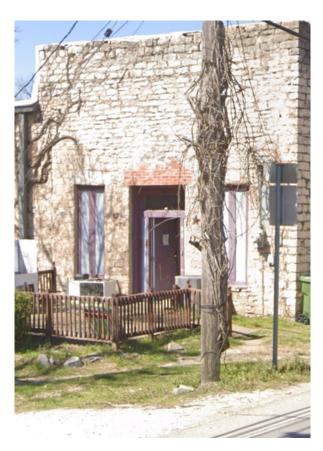
Current Picture 2025
