QUOTATION FORM

Grand Rapids, MN
Eagles Ponds – South Pokegama Ave

BMP Revitalization Scope/Plan

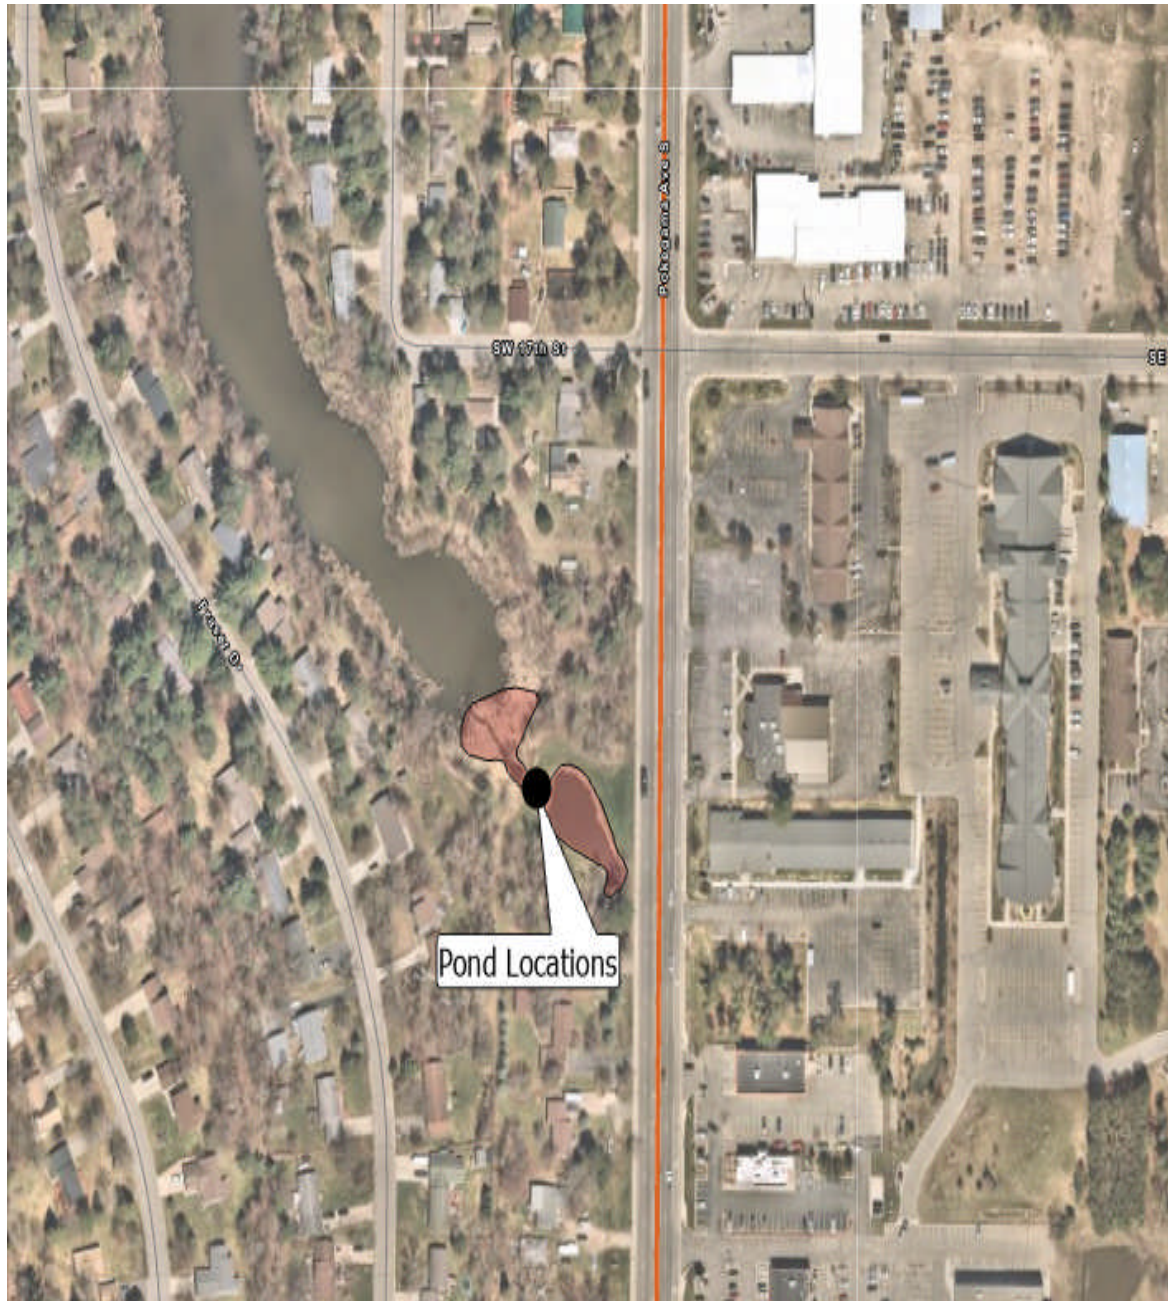
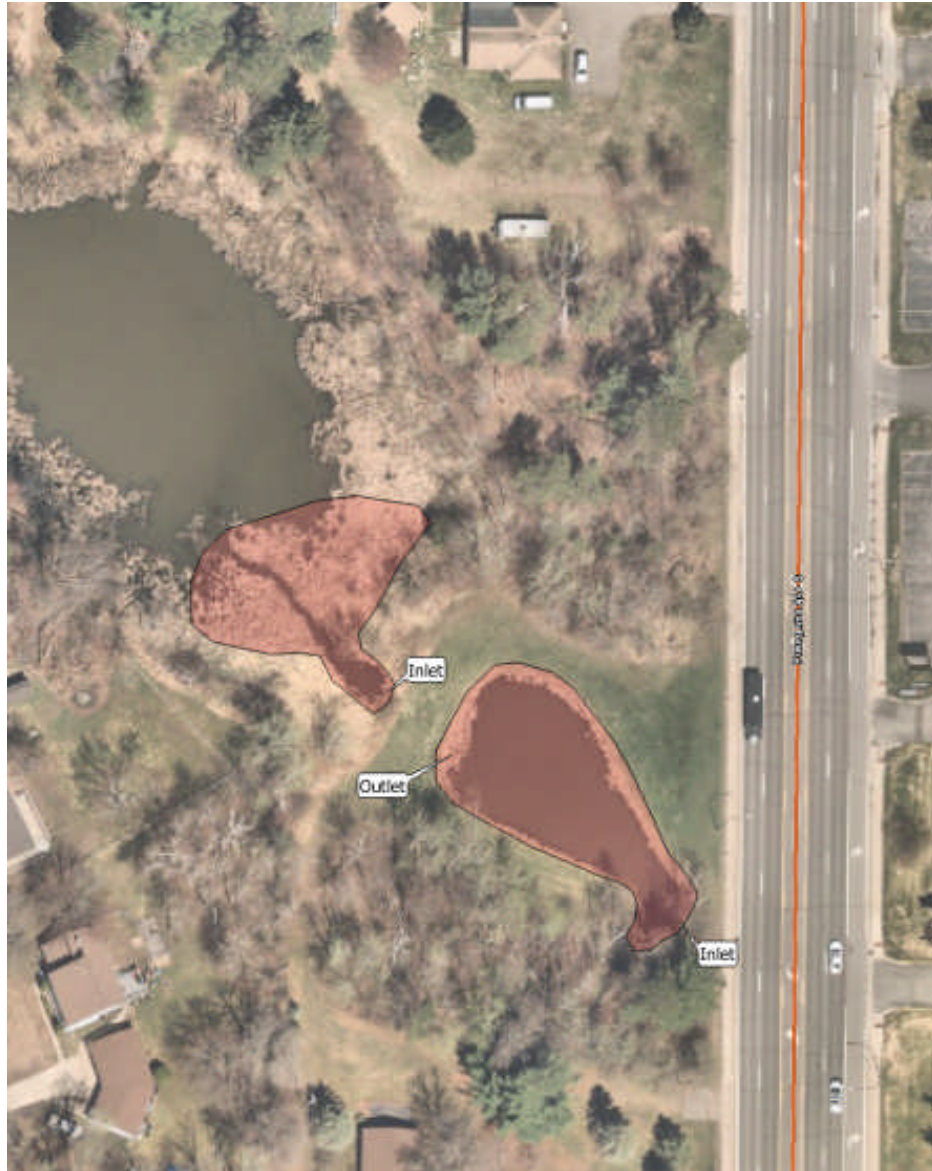
Pond Location

Eagles Pond - west side of S Pokegama Ave

- De-water all loads on site prior to transportation. Excavation area (highlighted in red) is approximately .22 acres (south pond) & .18 acres (north pond).
