# Requirements for Building Cleanout

## Itasca Farm Services Co-op

Project 10004216\_001

## Facility Agricultural Product Inventory

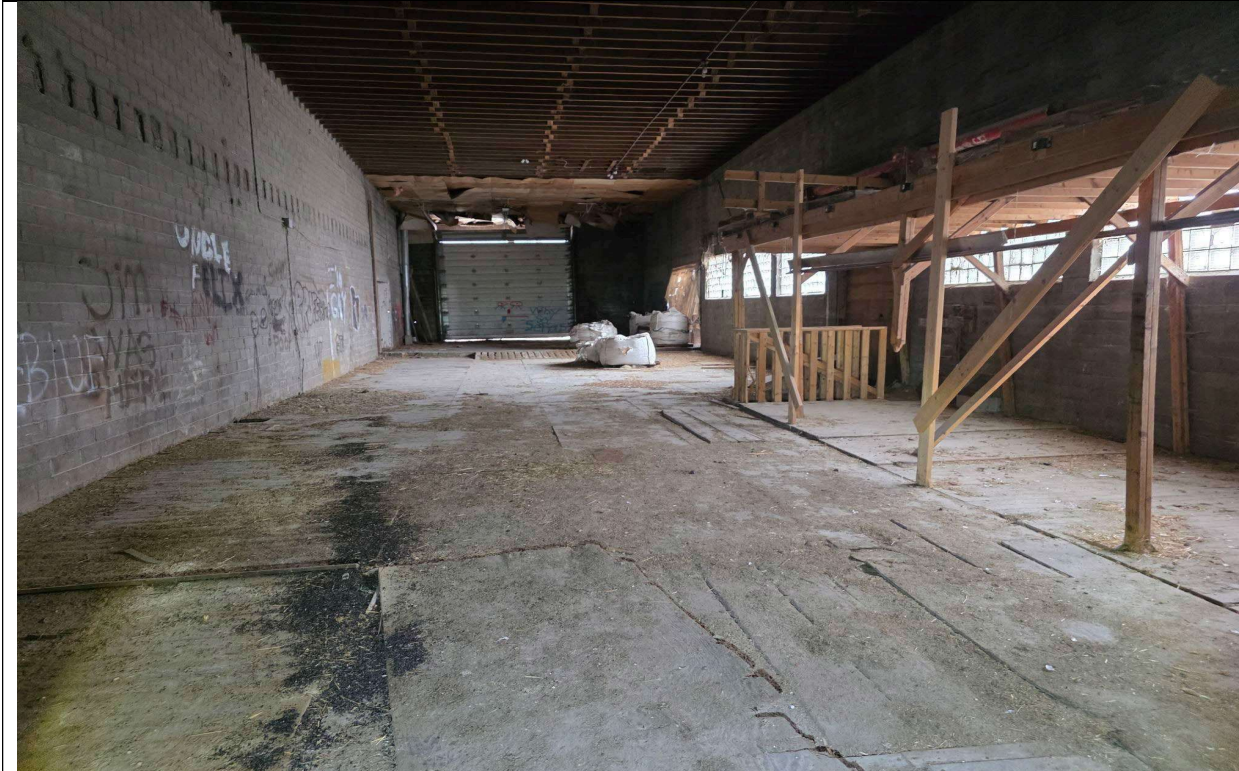
**Photograph 27** Date: April 14<sup>th</sup>, 2026

**Subject:** Interior storage area and drive-through loading and unloading area in the southern portion of the Site building. Eight one-ton bulk bags of fertilizer in the southeast portion of the Site building.

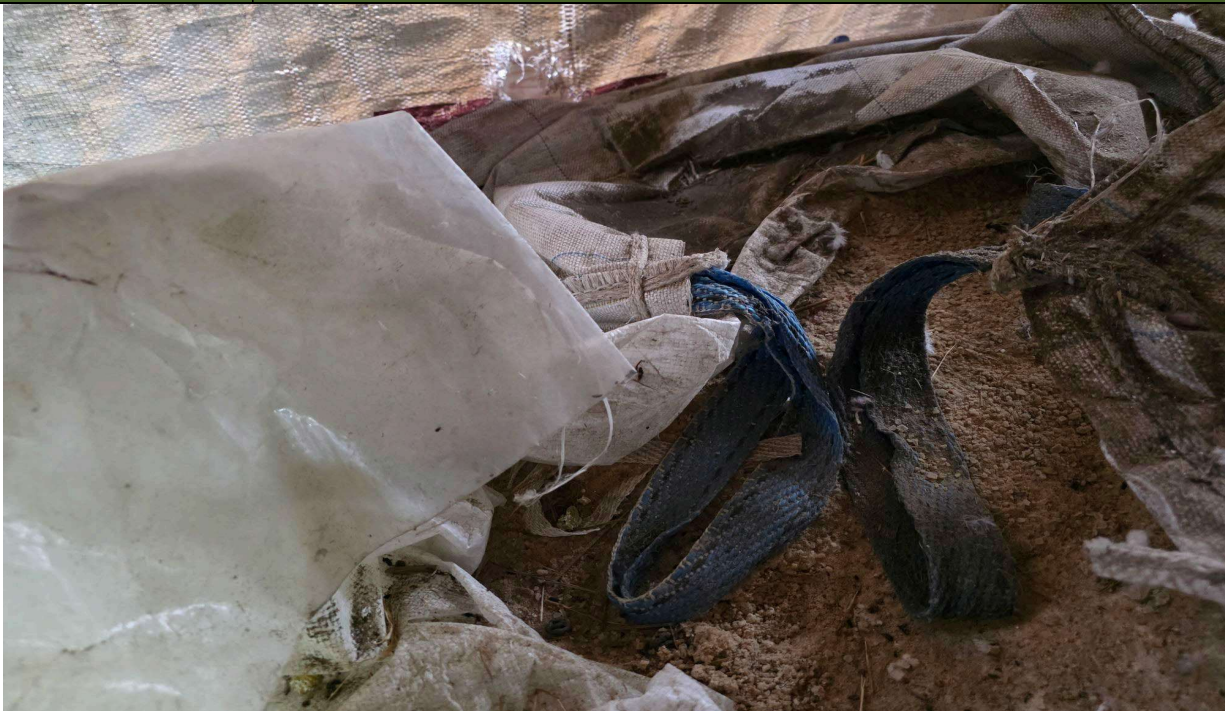
**Photograph 28** Date: April 14<sup>th</sup>, 2026

**Subject:** Contents of one-ton bulk bags in the southeast portion of the Site building.

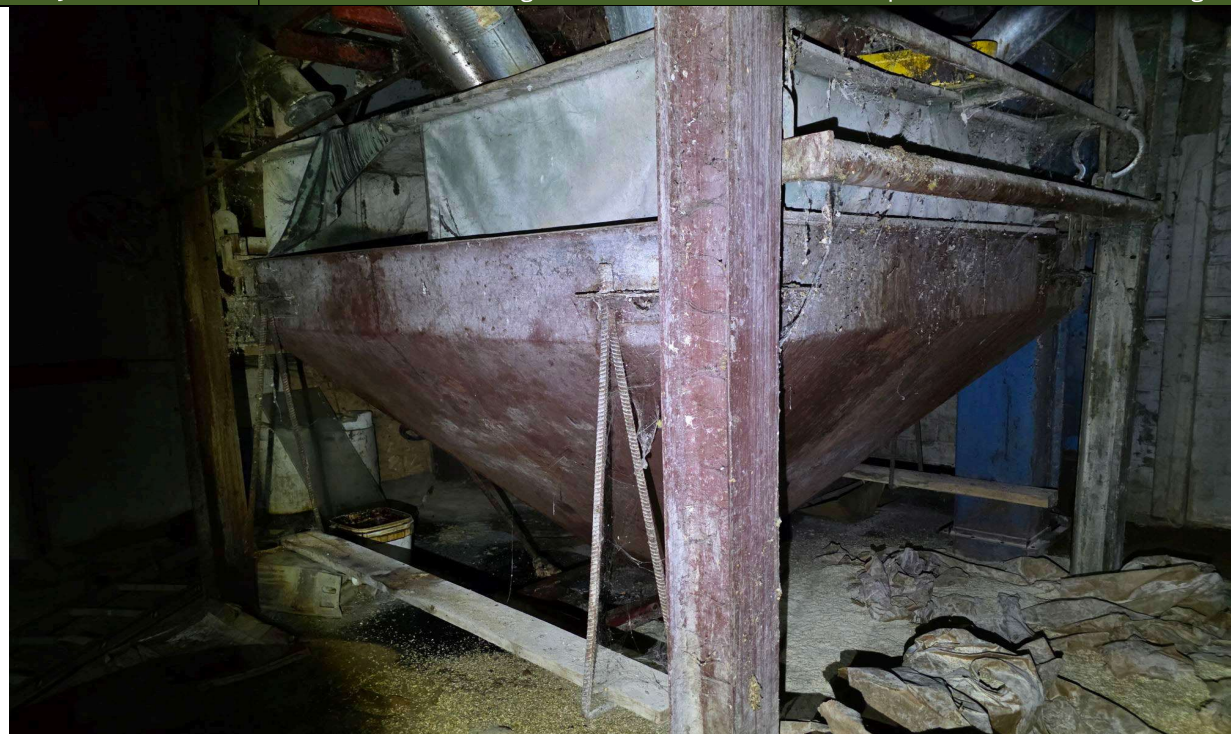
| <b>Photograph 30</b> | Date: April 14 <sup>th</sup> , 2026 |

| <b>Subject:</b> | Seed bag filling area in the eastern portion of the Site building, fed from the grain silos east of the Site building. Staining and various empty bags present. |

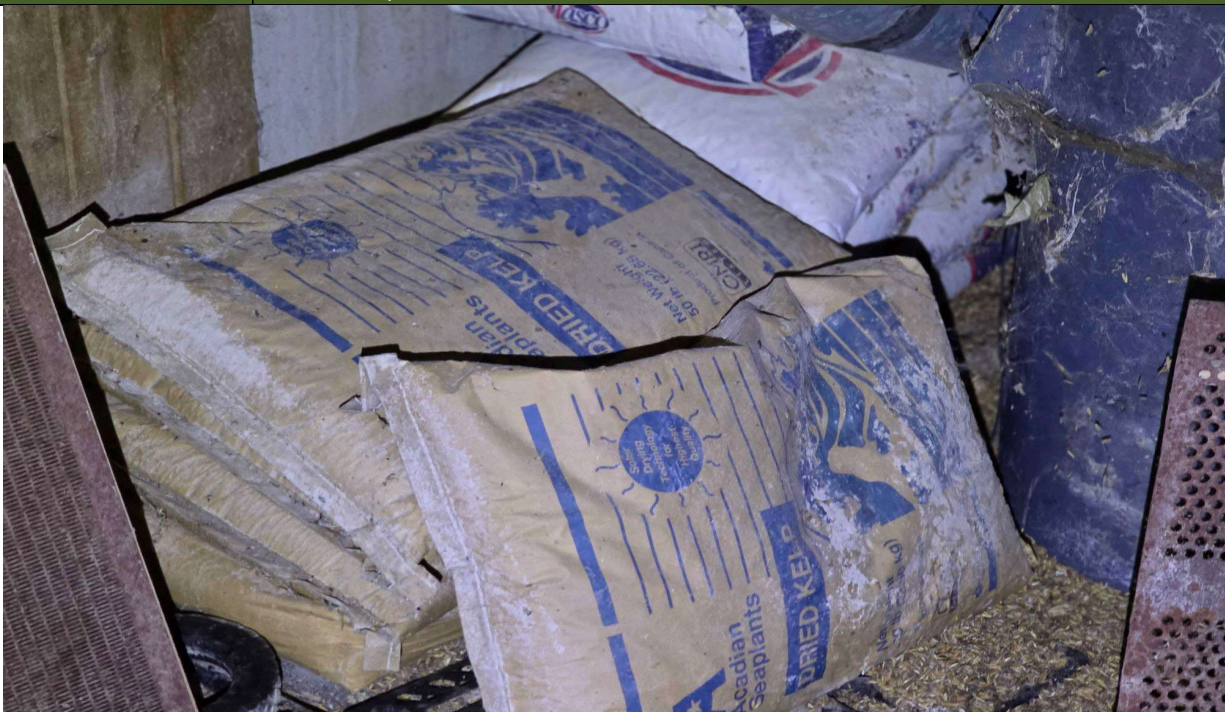
| <b>Photograph 32</b> | Date: April 14 <sup>th</sup> , 2026 |

| <b>Subject:</b> | Five 50-pound bags of dried kelp and five 50-pound bags of Tasco in the seed bag filling area. |

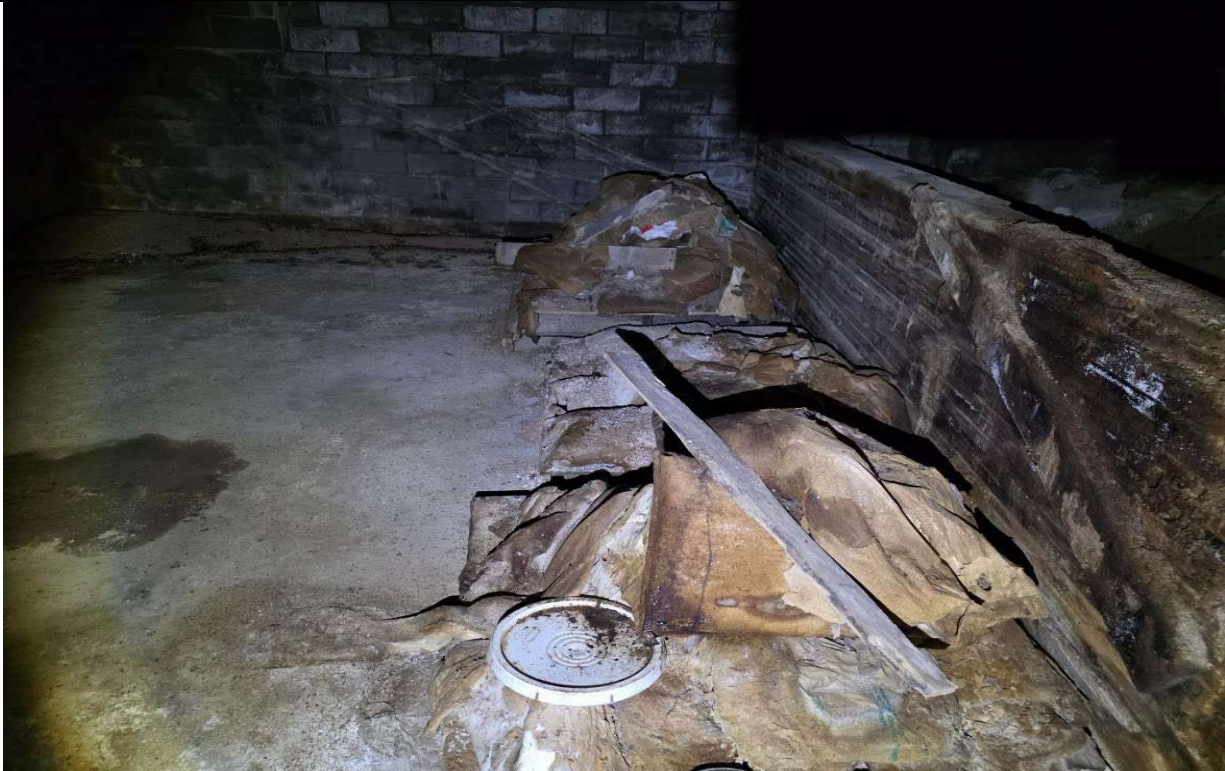
| <b>Photograph 33</b> | Date: April 14 <sup>th</sup> , 2026 |

| <b>Subject:</b> | Approximately 5000lbs of unidentified fertilizer in the northwest portion of the Site building's basement bulk storage area. |

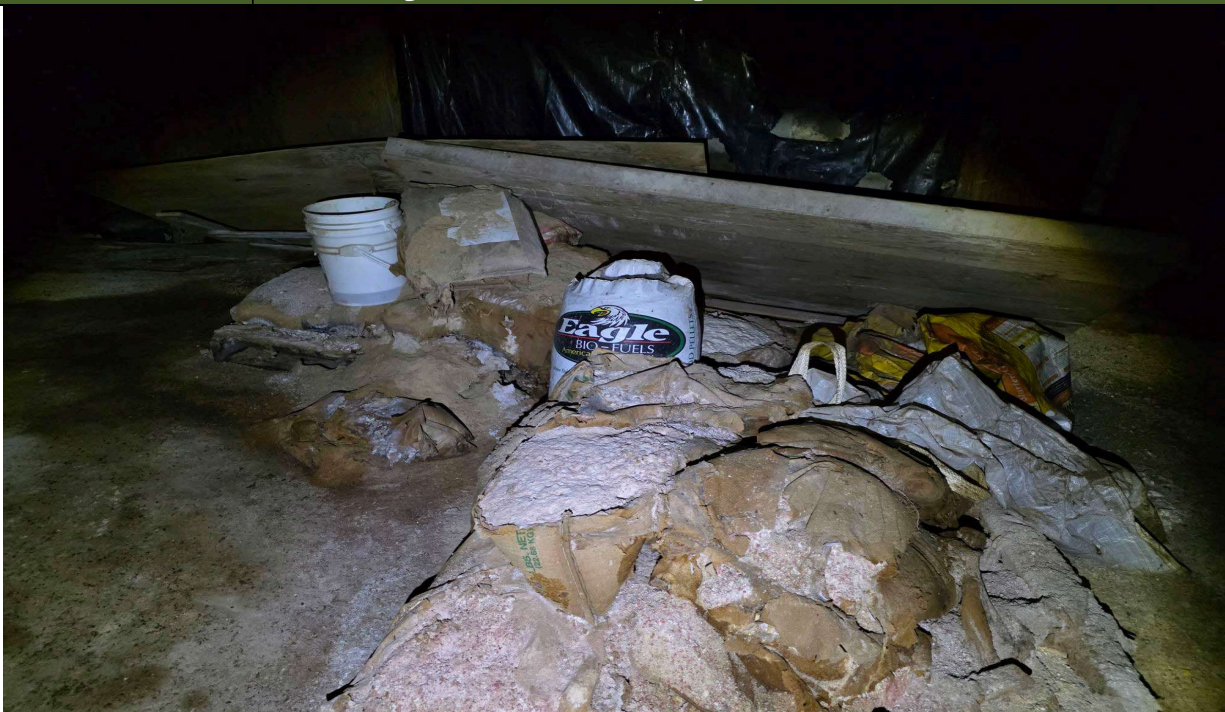
| <b>Photograph 34</b> | Date: April 14 <sup>th</sup> , 2026 |

| <b>Subject:</b> | Approximately 1000lbs of Magnesium oxide, bone meal, and bird seed in the northern portion of the Site building's basement bulk storage area. |

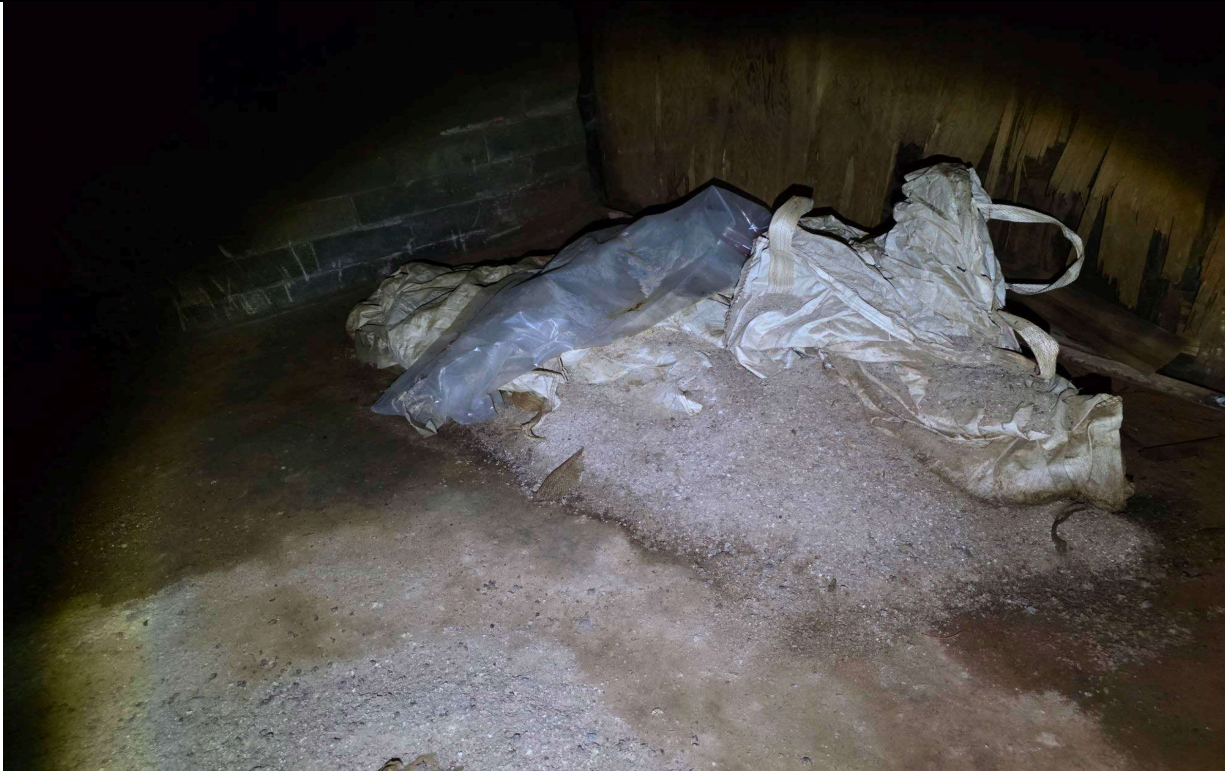
| <b>Photograph 35</b> | Date: April 14 <sup>th</sup> , 2026 |

| <b>Subject:</b> | Approximately 500lbs of unidentified dry fertilizer in the northwest portion of the Site building's basement bulk storage area. |

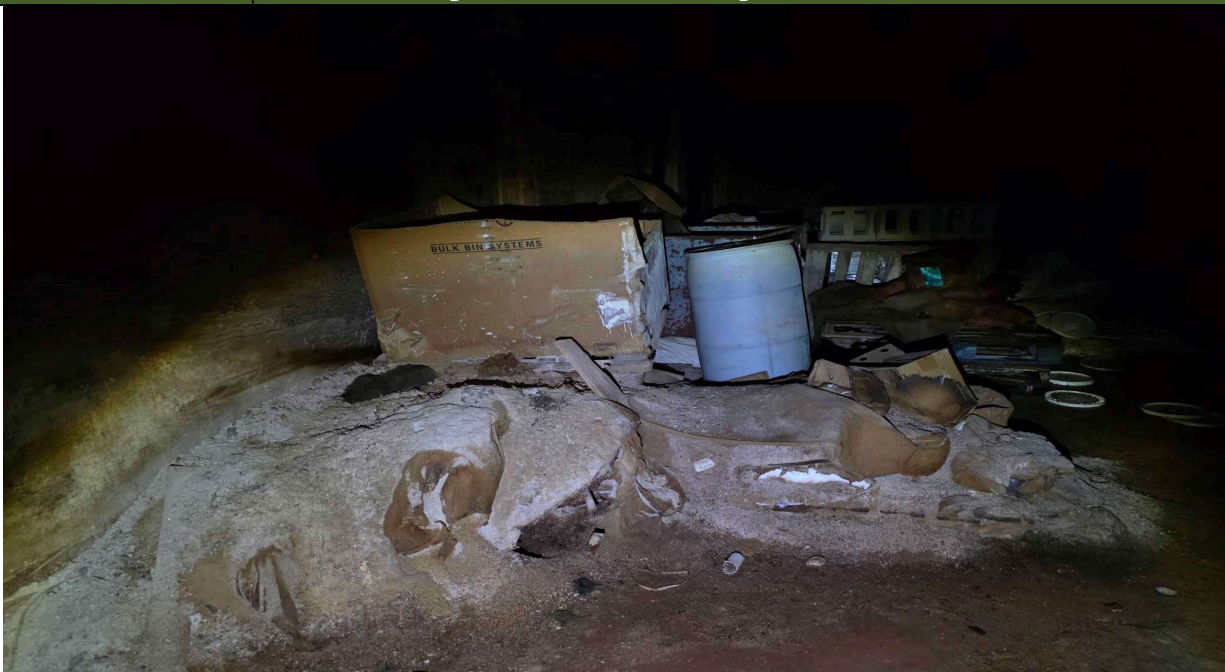
| <b>Photograph 36</b> | Date: April 14 <sup>th</sup> , 2026 |

| <b>Subject:</b> | Approximately 5000lbs of unidentified fertilizer and 5 drums half full of unidentified liquid in the northern portion of the Site building's basement bulk storage area. |

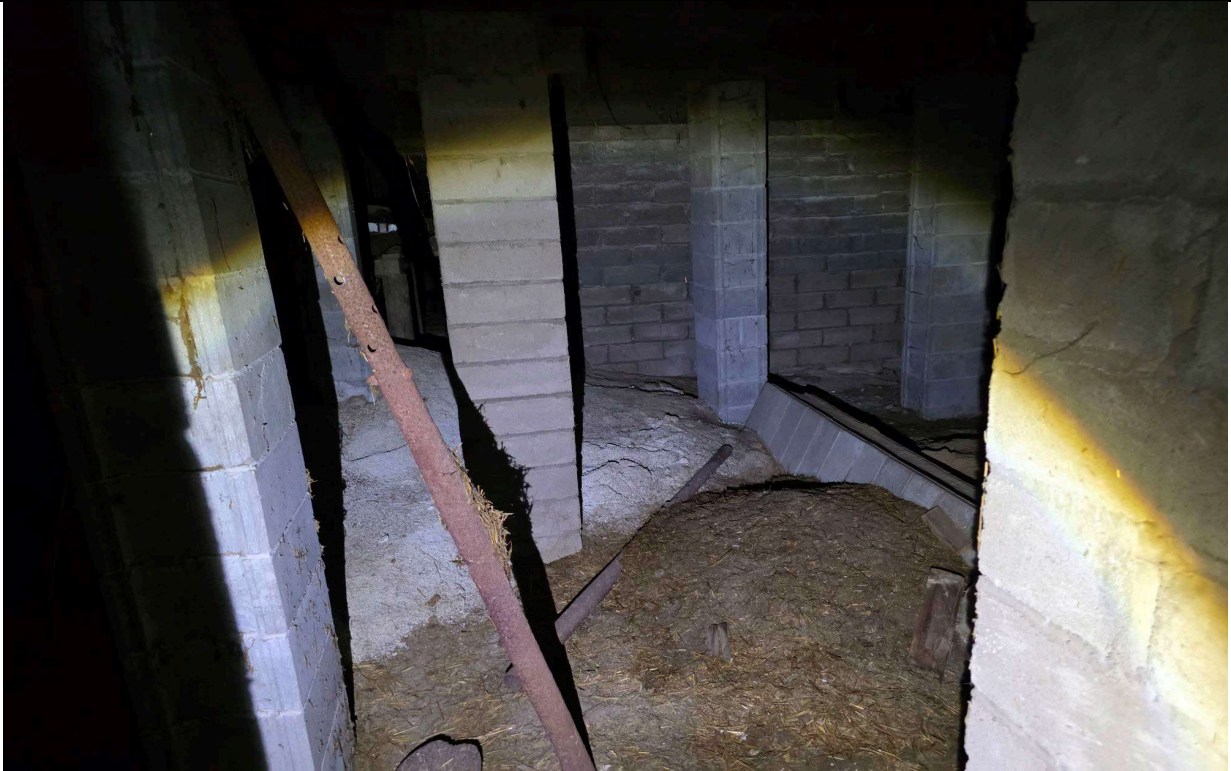
| <b>Photograph 37</b> | Date: April 14 <sup>th</sup> , 2026 |

| <b>Subject:</b> | Dirt floor area with an estimated 20-tons of unidentified fertilizer in the southwest portion of the Site building's basement bulk storage area. |

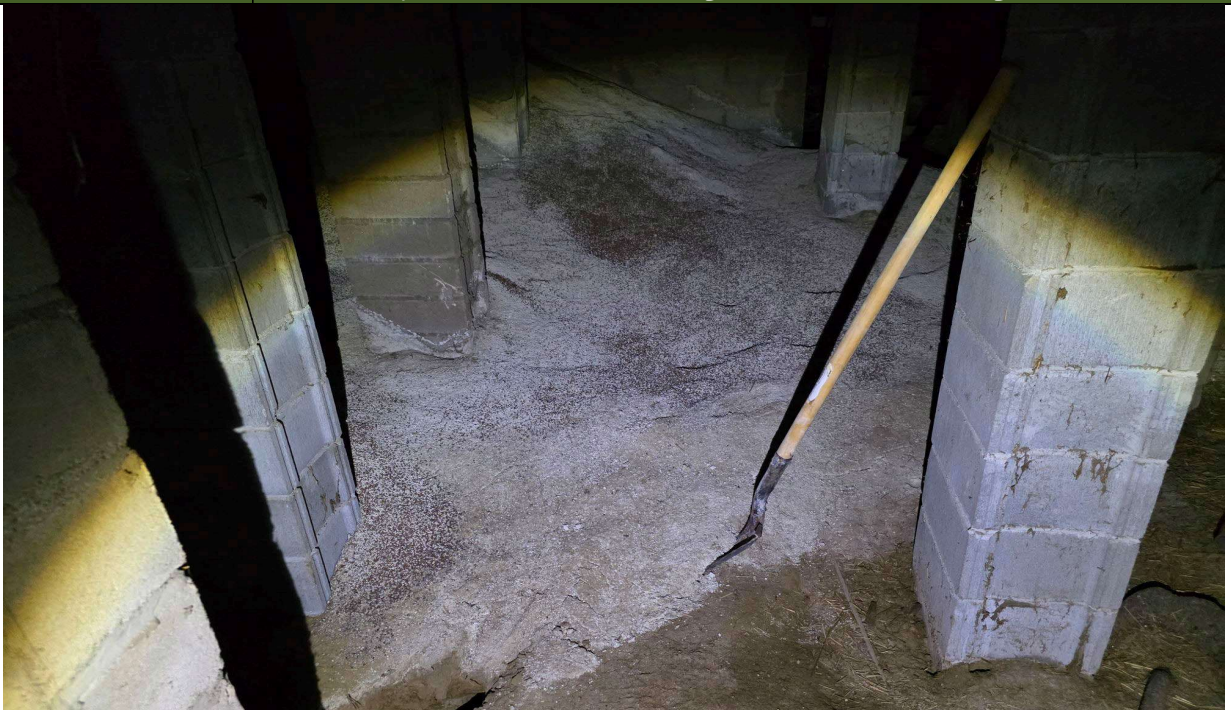
| <b>Photograph 38</b> | Date: April 14 <sup>th</sup> , 2026 |

| <b>Subject:</b> | Dirt floor area with an estimated 20-tons of unidentified fertilizer in the southwest portion of the Site building's basement bulk storage area. |
