603 West Main Street
Demolition of Existing Barn 25BLD-202
Attachment List

Re: Updated Historical Resource Assessment of the 603 West Main Street Barn, Grass Valley,
Nevada County, California 95945

*Resource Name or # (Assigned by recorder) 603 West Main Street Barn

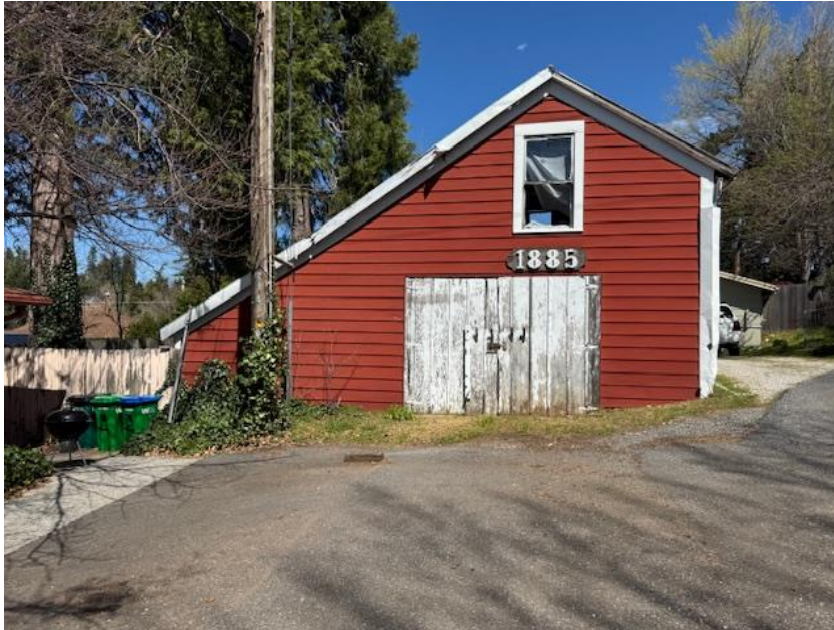
Photograph 1: View looking north at the south elevation of the barn.

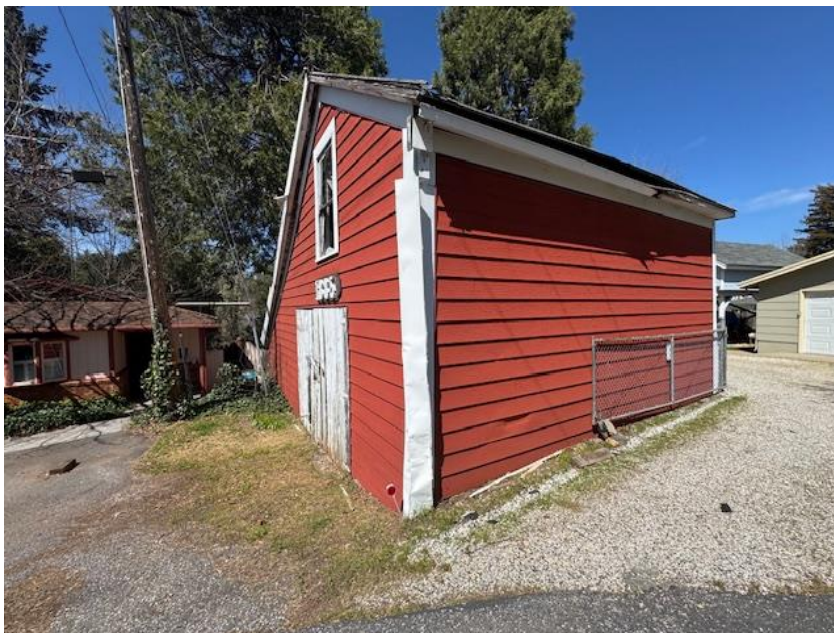
Photograph 2: View looking northwest at the southeast elevation of the barn.
Note that the siding on these two elevations is aluminum clapboards.

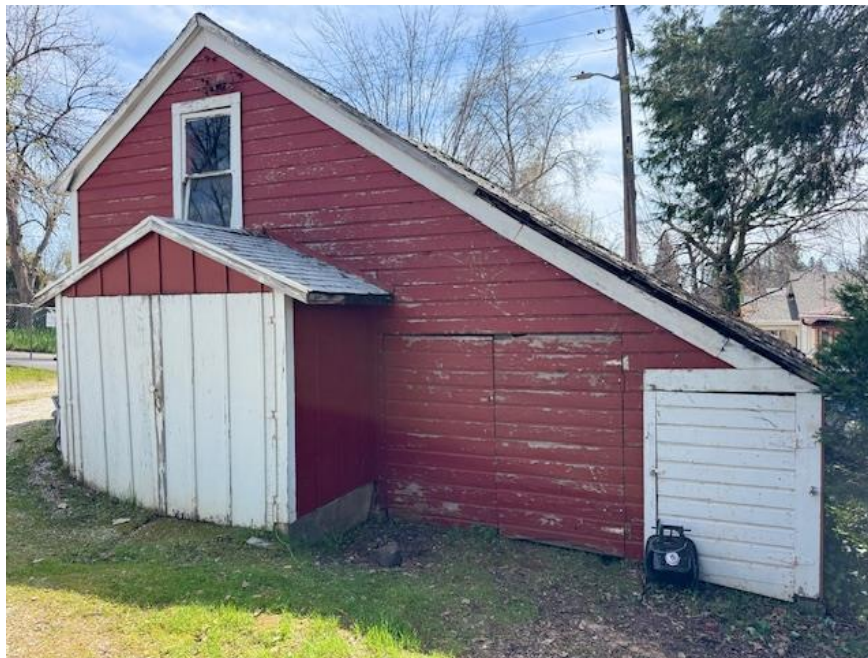
Photograph 4: View looking southeast at the north elevation of the barn.
Note the shiplap siding has been cut and repurposed for the two swinging doors with a new door on the right.

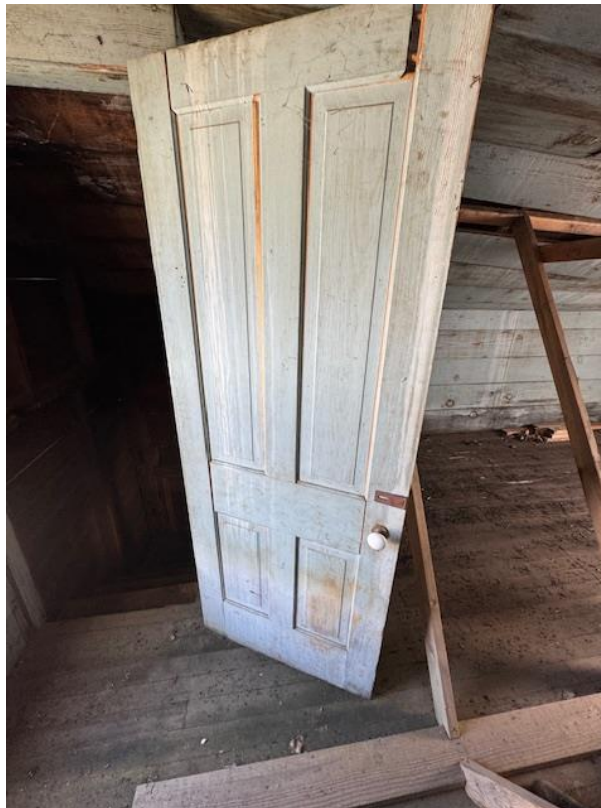
Photograph 9: View of a circa 1880s original door repurposed for the attic.

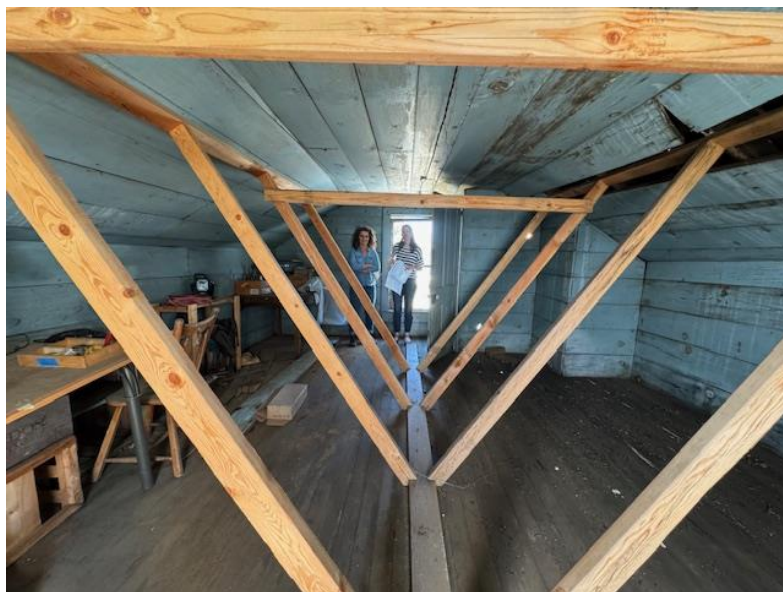
Photograph 10: View of the attic looking north.

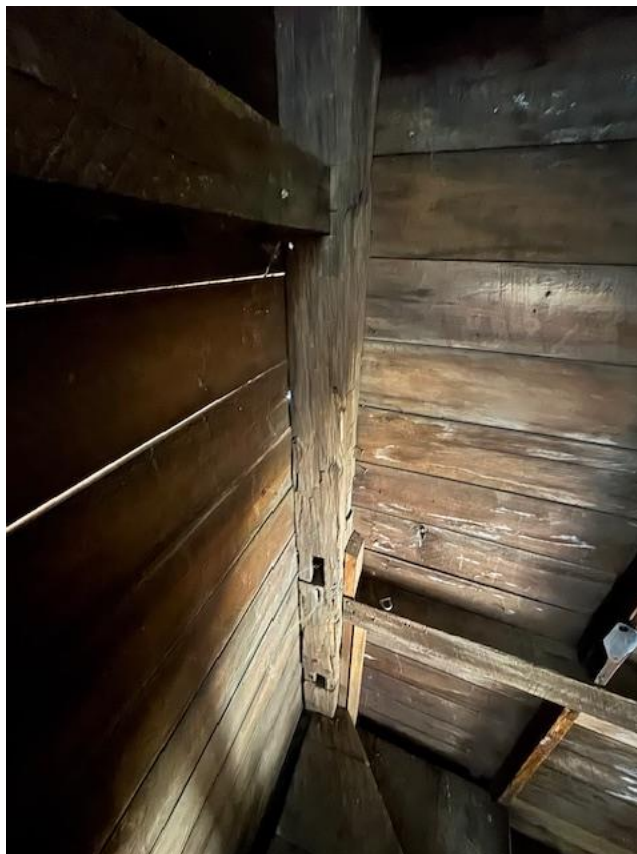
Photograph 11: View looking at the northeast corner of the lower floor wall showing a repurposed mortise and tenon beam.

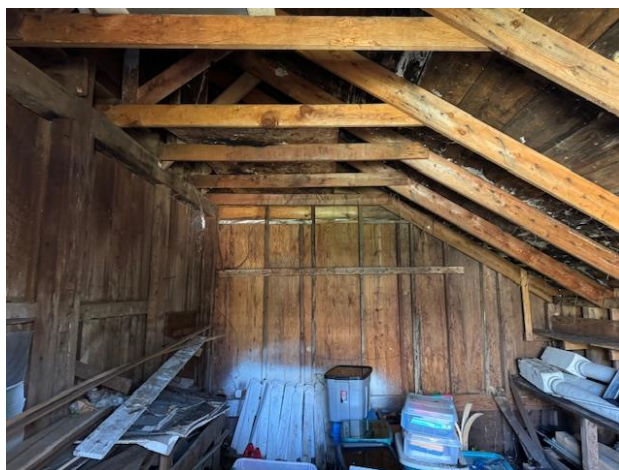
Photograph 12: View looking at the westernmost portion of the barn showing an original mortise and tenon wall on the left and a rebuilt wall on the south and the west.

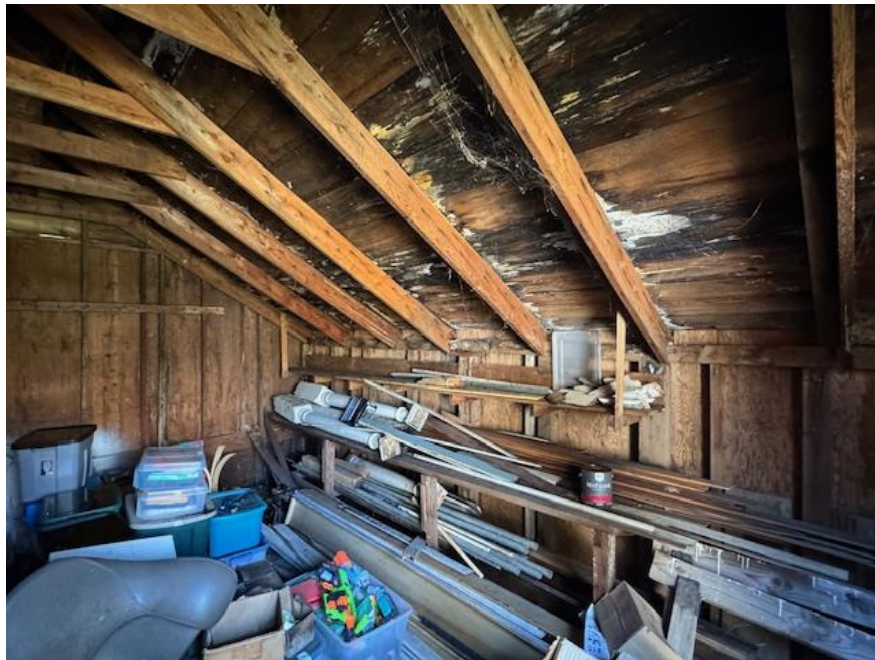
Photograph 13: View of western rebuilt wall and roof rafters.

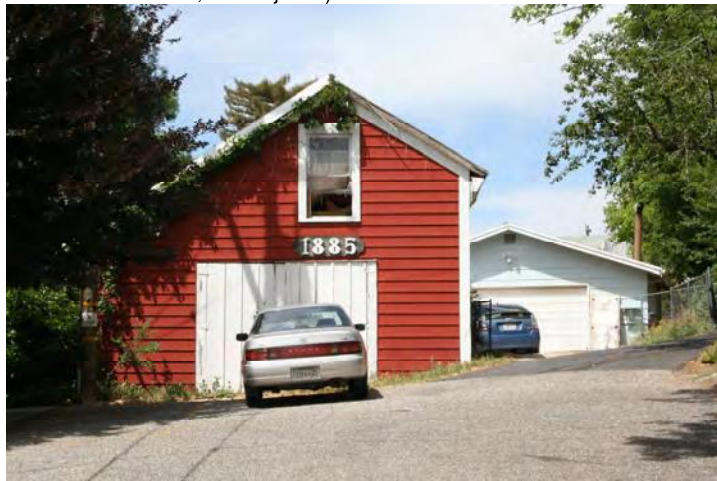
- P5b. Description of Photo:** View looking north at the barn from the end of Pleasant Street.
- *P6. Date Constructed/Age and Sources:** ☒ Historic Circa 1885; Sanborn Fire Insurance Maps, Grass Valley, CA.
