*RE: Wetland Delineation and Jurisdictional Assessment with GPS Survey  
9731 Chilson Commons Circle, Pinckney  
Parcel IDs 15-22-400-023 & -402-900 (partial)  
Hamburg Township, Livingston County, Michigan  
ASTI File No. A25-1834.00*

Figure 1 - Wetland Map

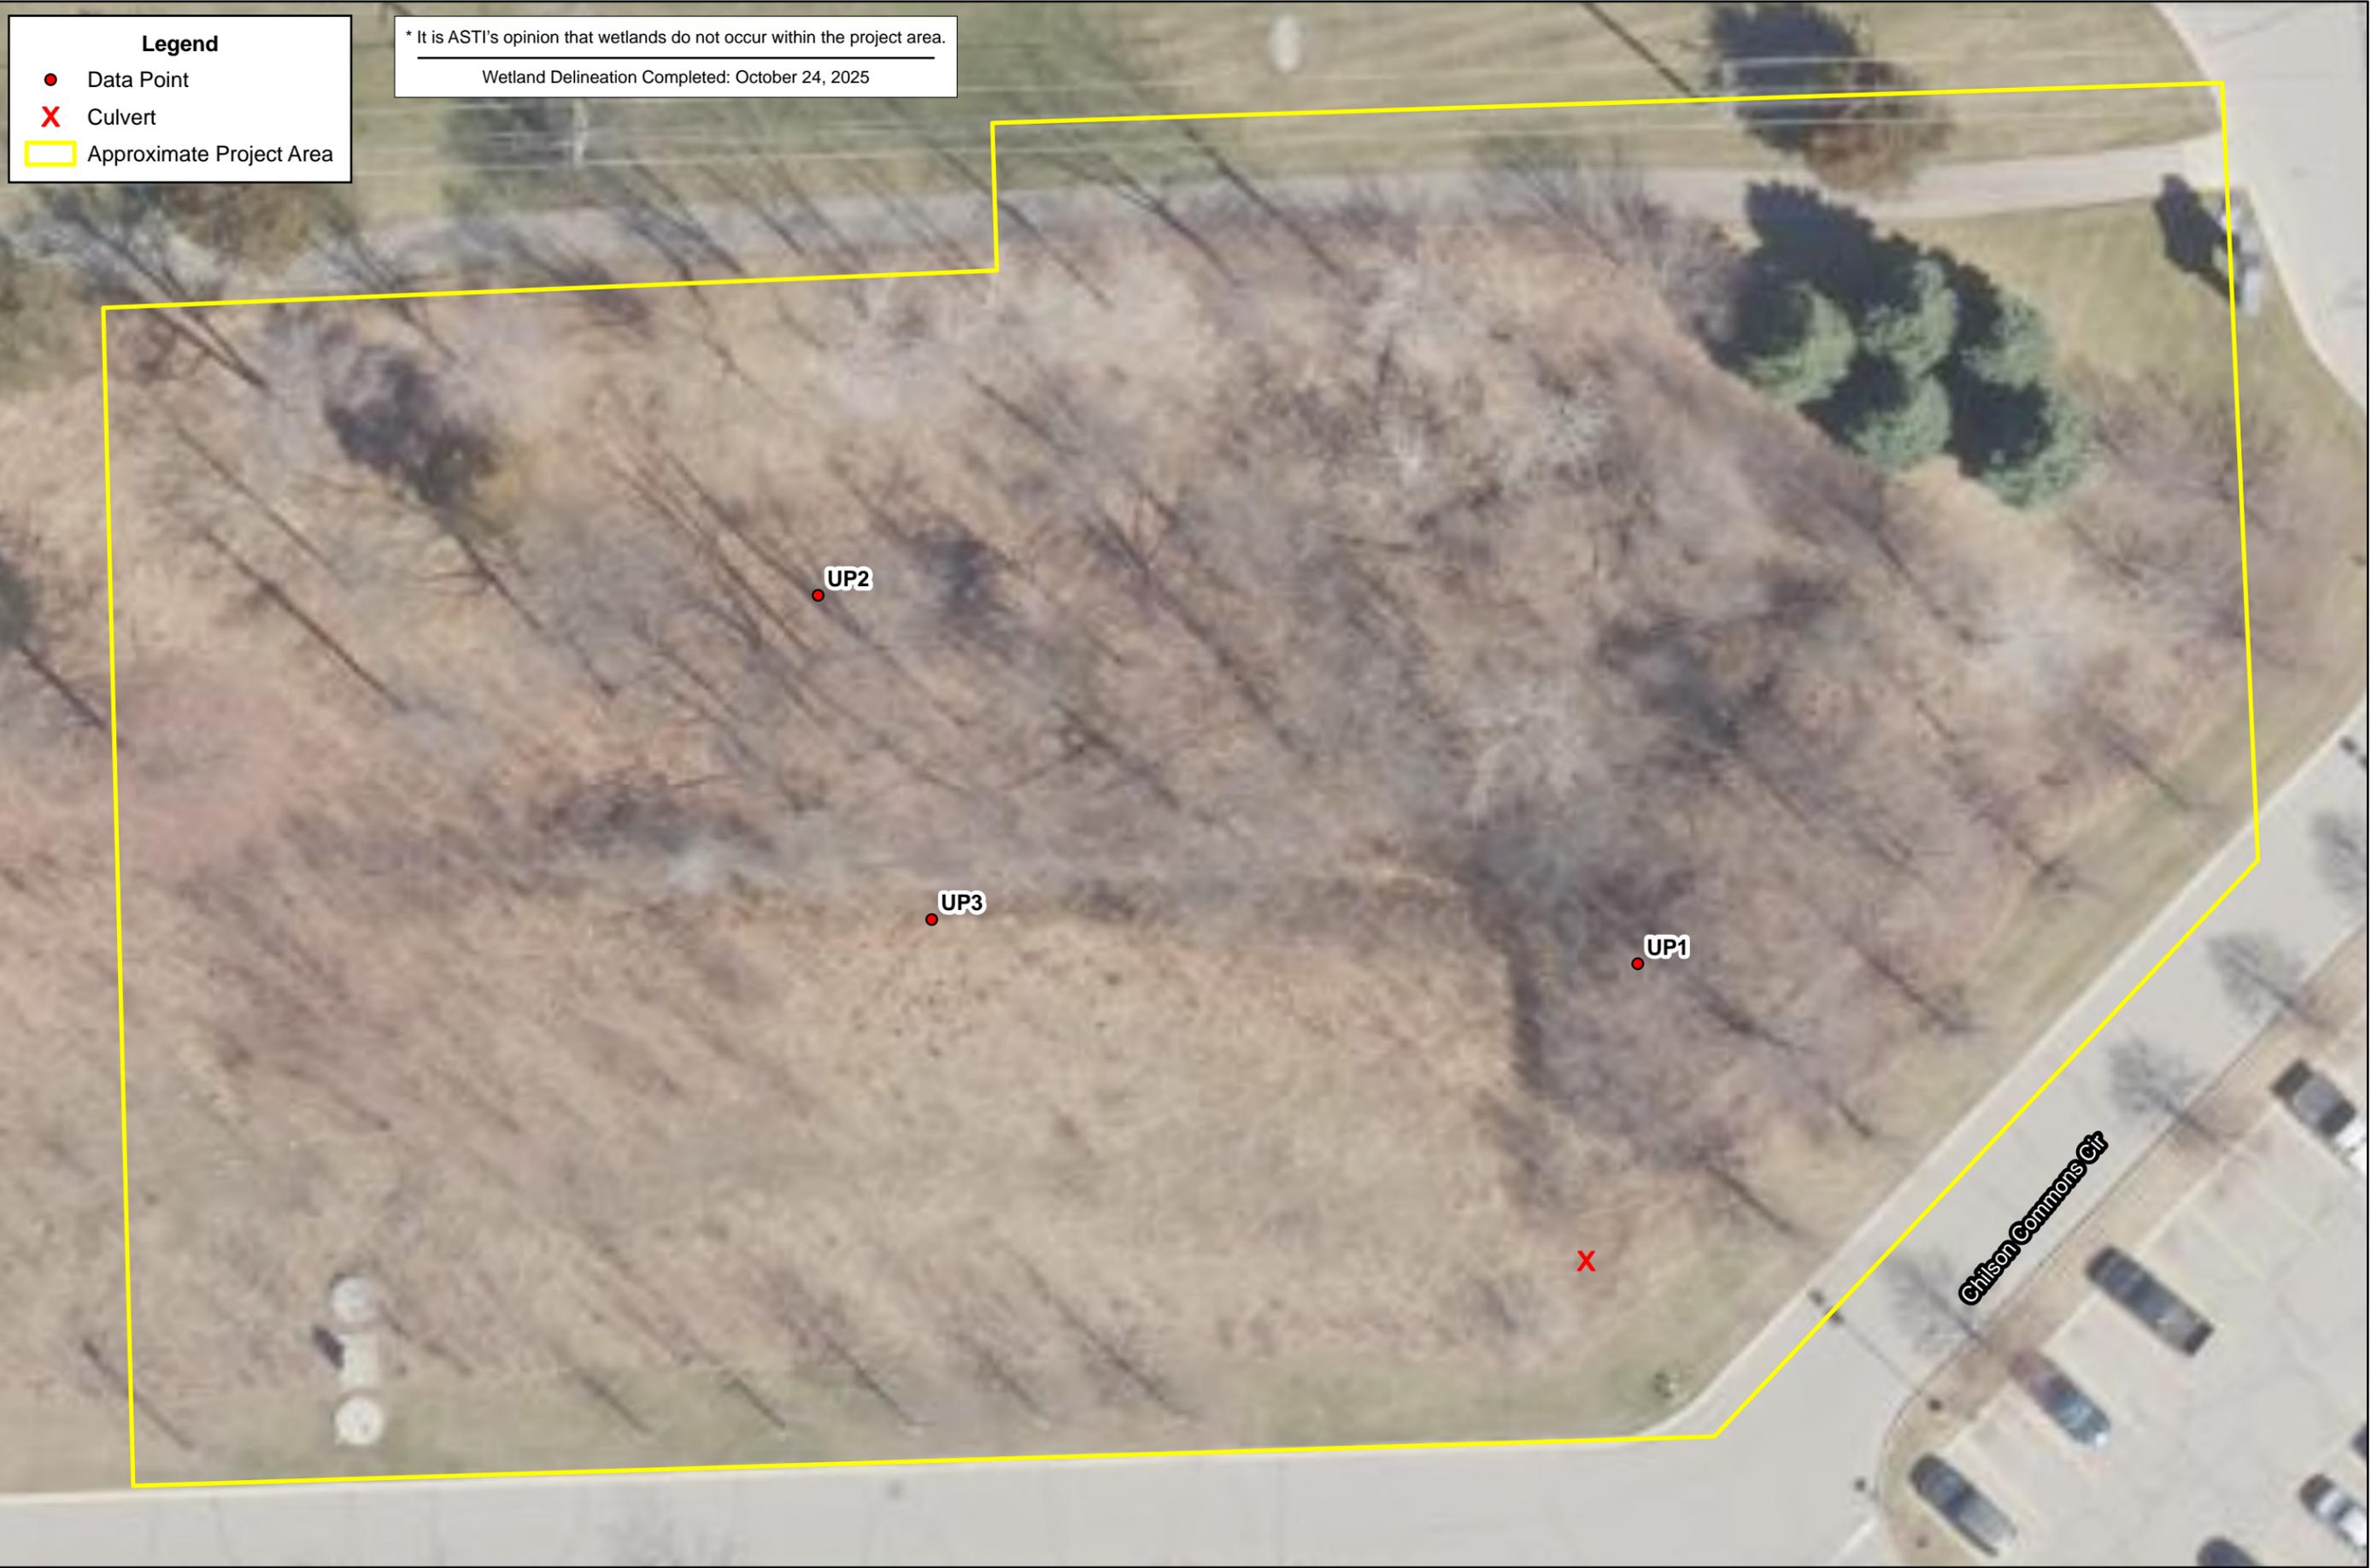
On October 24, 2025, ASTI Environmental (ASTI) conducted a site investigation to delineate wetland boundaries on approximately 1.37 acres of land referenced above and located in Hamburg Township, Livingston County, Michigan (Project Area). No wetlands were found within the Project Area (Figure 1 – *Wetland Map*). Data Points, as depicted on Figure 1, were located using a professional grade, hand-held Global Positioning System unit (GPS).

No wetlands were found within the Project Area. Data recorded for each of the upland data points designated as UP1 through UP3 are summarized below and the GPS-surveyed locations are shown on Figure 1.

These data points were taken within a depression located in the center of the property, which includes a drainage feature lined with riprap. It is assumed that the nearby developments direct stormwater into this area via the culvert located in the southeastern portion of the Project Area. Vegetation is dominated by black cherry (*Prunus serotina*), black oak (*Quercus velutina*), red maple (*Acer rubrum*), Kentucky bluegrass (*Poa pratensis*), common reed (*Phragmites australis*), tall goldenrod (*Solidago altissima*), glossy buckthorn (*Frangula alnus*), tussock sedge (*Carex stricta*), wild strawberry (*Fragaria virginiana*), and yellow sweet clover (*Melilotus officinalis*). Soils were sandy and loamy, and no evidence of wetland hydrology was observed. It is ASTI's opinion that this area is upland.

This area is located on a slope in the northern portion of the Project Area. Vegetation is dominated by black oak, black cherry, cottonwood (*Populus deltoides*), red maple, white willow (*Salix alba*), Kentucky bluegrass, crab grass (*Digitaria ischaemum*), tall goldenrod, and wild strawberry. Soils were sandy, and no evidence of wetland hydrology was observed. It is ASTI's opinion that this area is upland.

\* It is ASTI's opinion that wetlands do not occur within the project area.  
 Wetland Delineation Completed: October 24, 2025
