**APPLICATION FOR A ZONING BOARD OF APPEALS (ZBA)  
VARIANCE/INTERPRETATION  
(FEE \$500 plus \$50 each additional)**

16. If so, state case # and resolution of variance application \_\_\_\_\_
17. Please indicate the type of variance or zoning ordinance interpretation requested:  
Variance to build garage within 50 ft of regulated wetlands, with a variance of 160 sq ft larger than allowed 800 sq ft.

*RE: Wetland Delineation and Jurisdictional Assessment with GPS Survey  
10910 Bob White Beach Road  
Sidwell No. 4715-27-401-037  
Hamburg Township, Livingston County, Michigan  
ASTI File No. 11501*

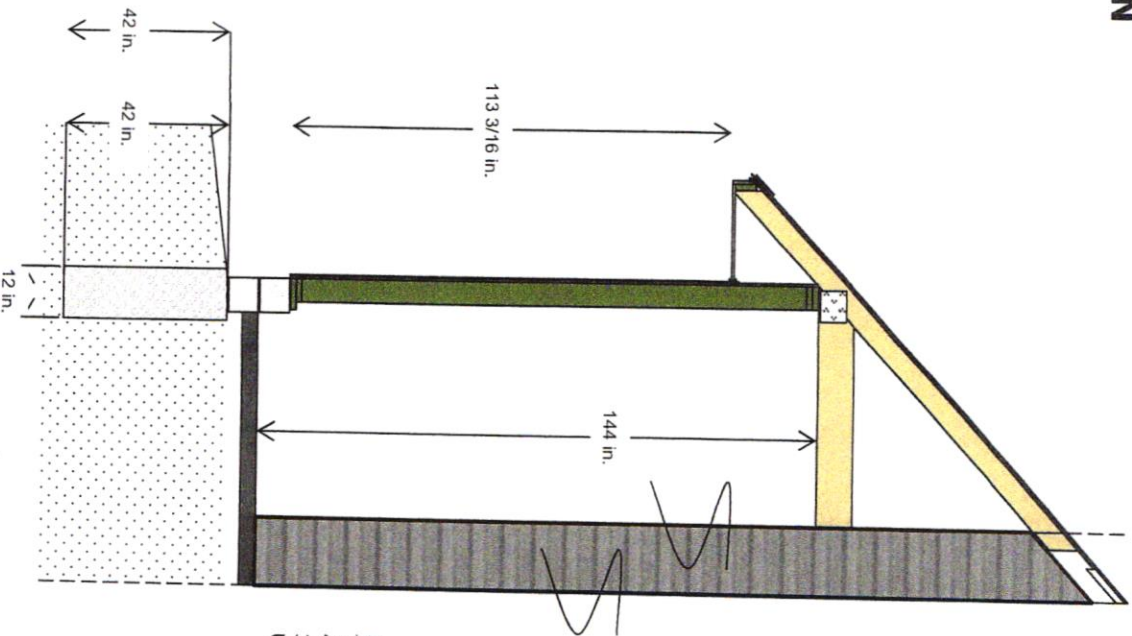
12/12 PITCH TRUSS SYSTEM WITH A STANDARD HEEL  
 (HEEL HEIGHT: 0-7-11 OR 7 11/16 IN.)  
 TRUSS SPACING: 24 IN. O.C.  
 TRUSS LOADING INFORMATION:  
 TCU/TCDL/BCL/BCDL 35-7-0-10  
 TOTAL TRUSS LOADING = 52 P.S.F.  
 BRACE PER TRUSS MANUFACTURERS  
 RECOMMENDATIONS

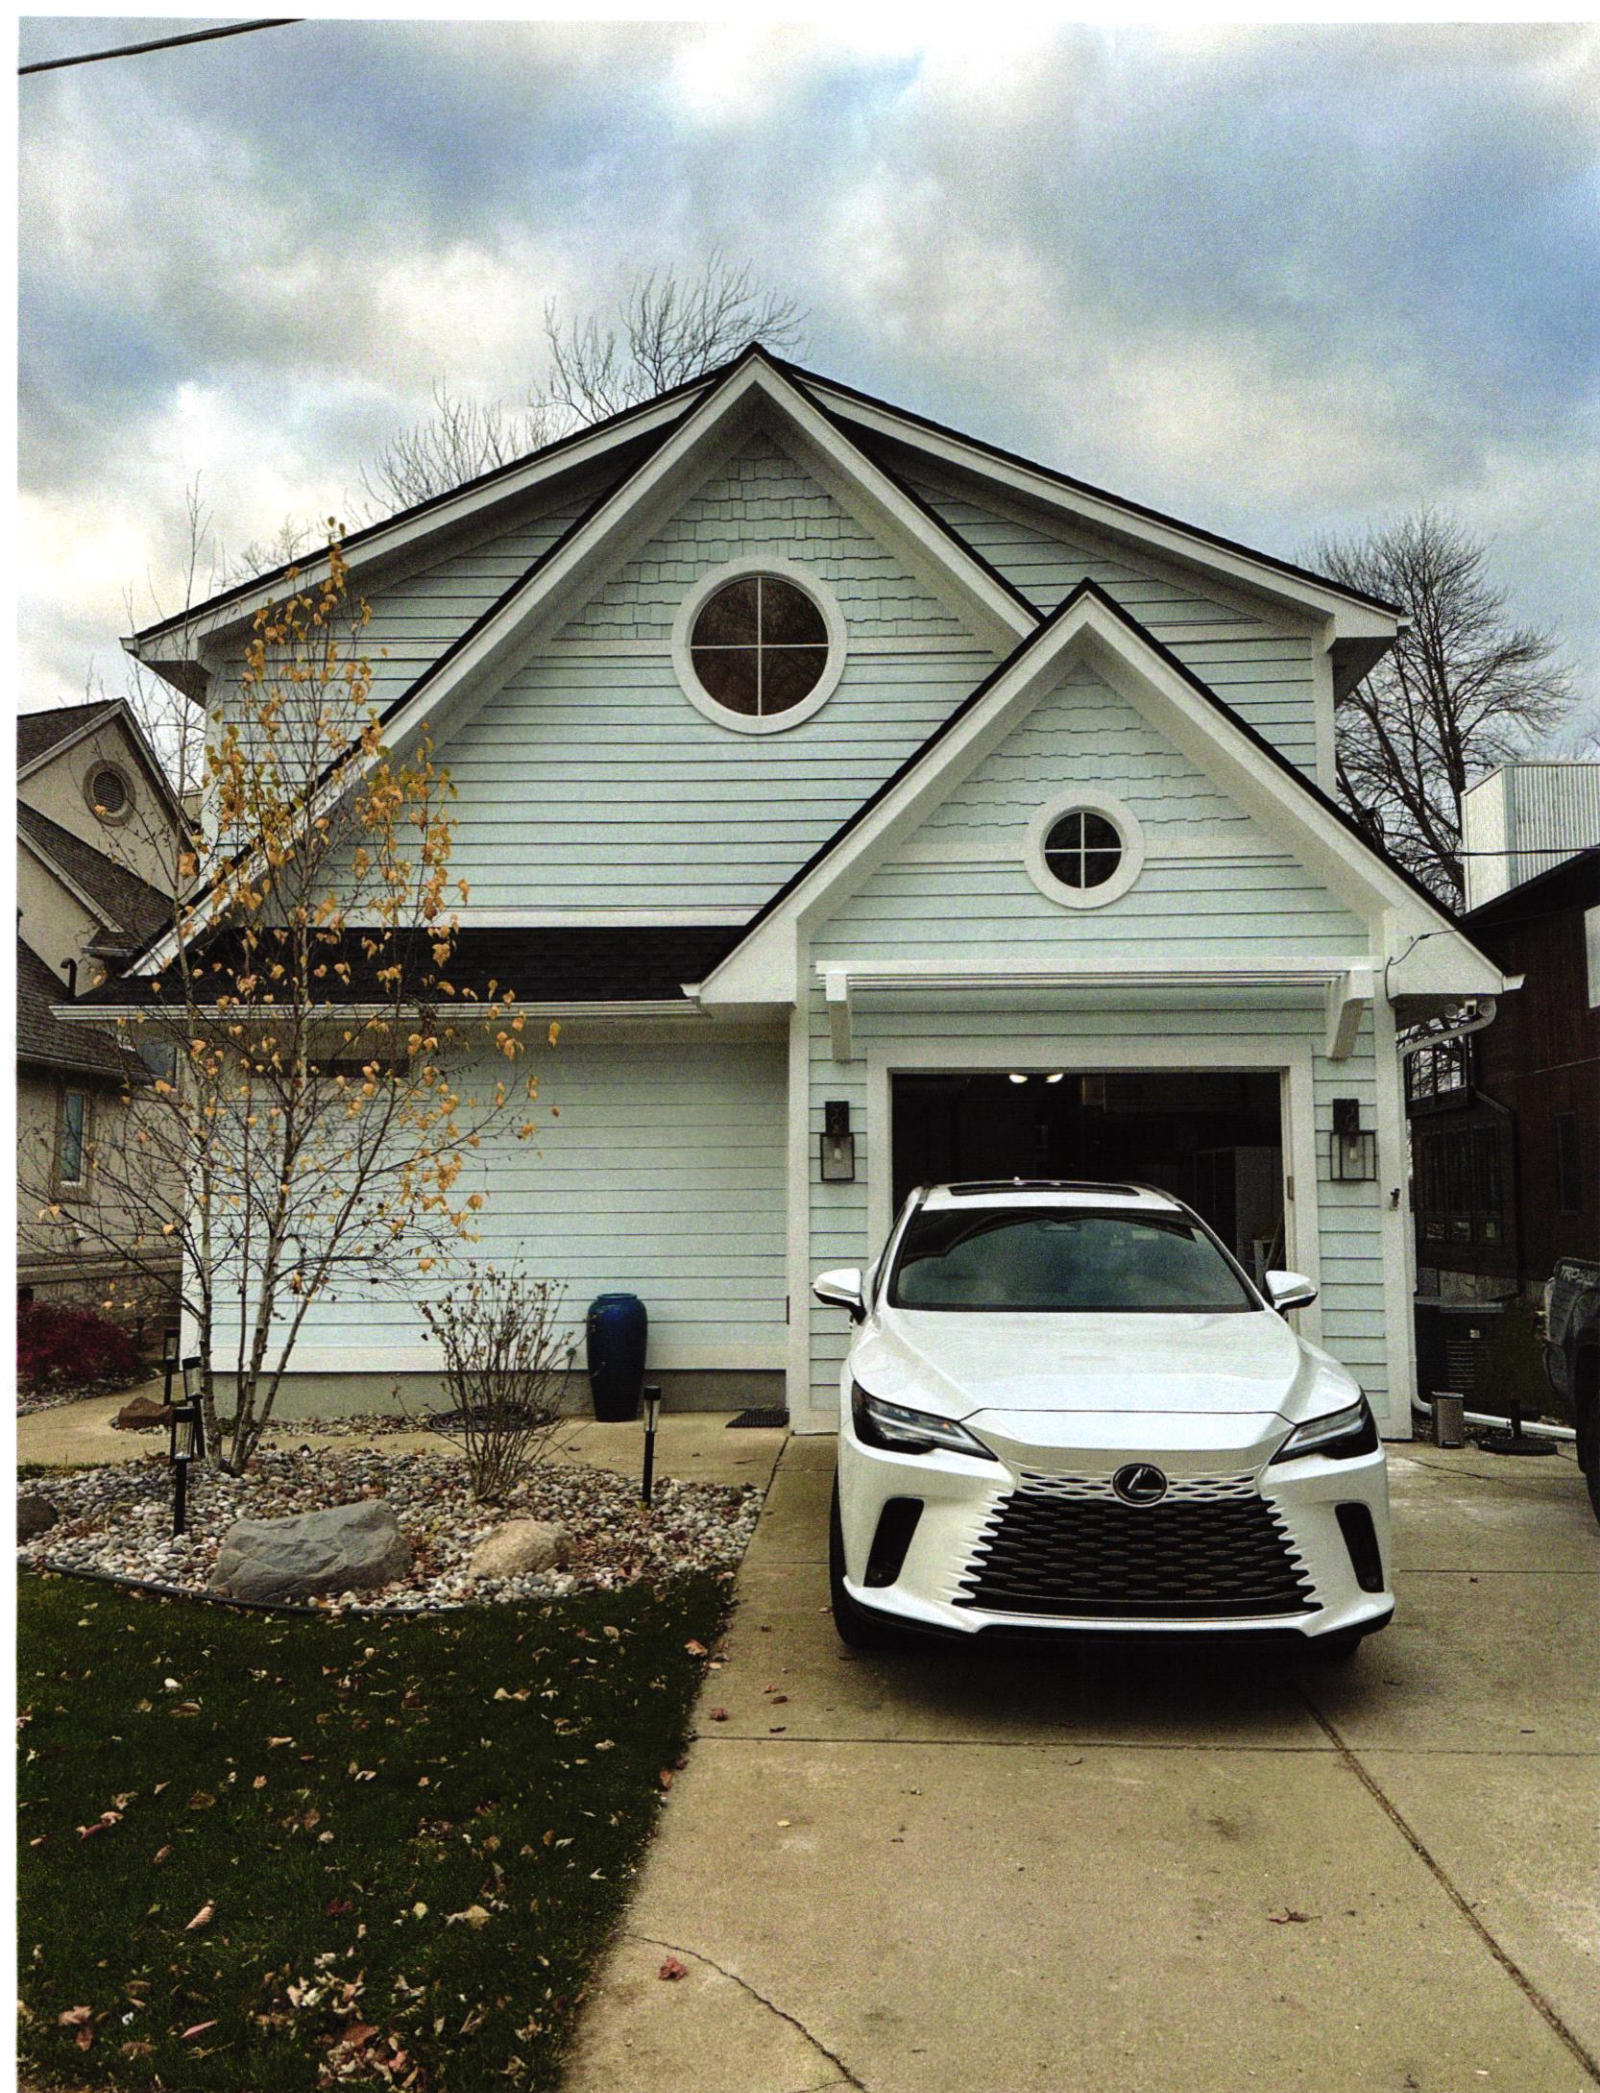
FOUNDATION 1/4" = 1'-0"

INTERIOR FINISHED FLOOR HT. WILL BE 8 IN. BELOW  
 THE TOP OF THE FOUNDATION  
 4 IN. CONCRETE FLOOR W/STRUCTURAL STRENGTH -  
 3500 P.S.I.  
 UNDISTURBED SOIL OR COMPACTED SAND FILL

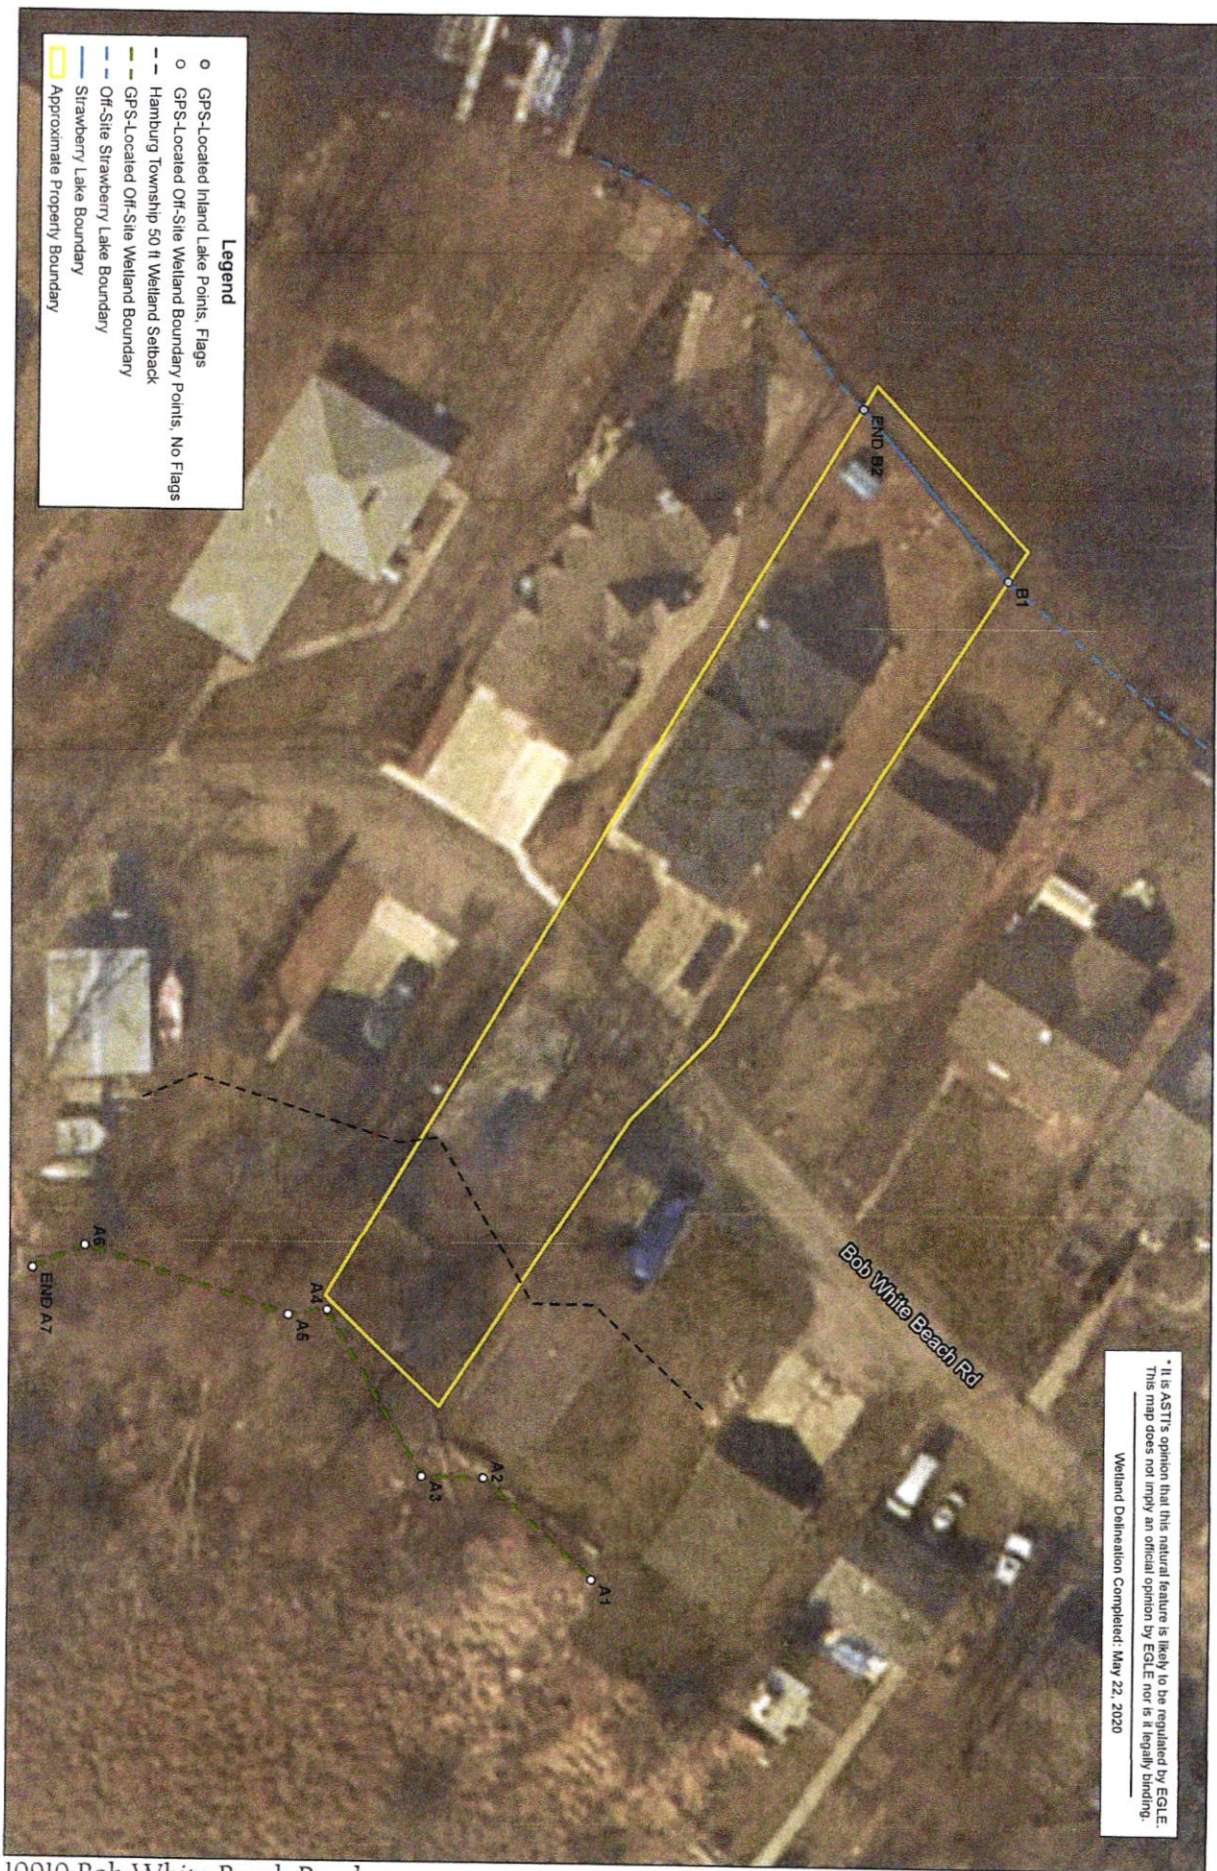
Figure 1 - GPS-Surveyed Wetland Boundaries

Additionally, Hamburg Township requires a 50-foot setback from regulated wetlands per the Hamburg Township Zoning Ordinance, Article 9.9.3, Setback Standards. ASTI has indicated the location of this setback on Figure 1 as it applies to Wetland A.

Attached are Figure 1, which shows the GPS-surveyed inland lake boundaries within the Project Area, adjacent off-site wetland boundaries, and completed US Army Corps of Engineers (ACOE) Wetland Data Forms.

Wetland A is a forested wetland located adjacent to the eastern property boundary line (Figure 1). Dominant vegetation found within Wetland A included silver maple (*Acer saccharinum*), green ash (*Fraxinus pennsylvanica*), and American elm (*Ulmus americana*). Soils within Wetland A were comprised of mucky sands and are considered hydric because the hydric soil criteria of sandy mucky mineral were met. Indicators of wetland hydrology observed within Wetland A included observations of water stained leaves, sparsely vegetated concave surfaces, and saturated soils.

Strawberry Lake = B-1 through B-2

Wetland A = A-1 through A-7
