# DISTRICT 4 ROAD SAFETY AUDIT REPORT

SR-A1A (OCEAN BOULEVARD)

FROM: BOCA HIGHLAND BEACH CLUB

TO: NORTHERN TOWN LIMITS OF HIGHLAND BEACH

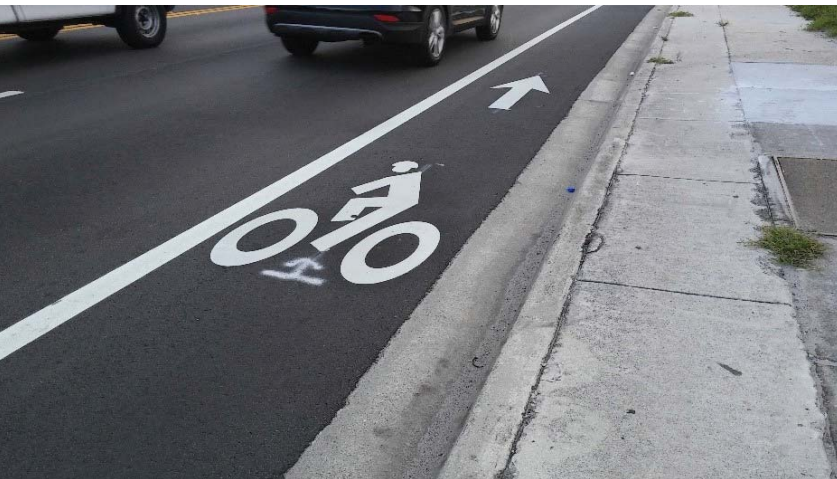
| ID | Location Description: | Spot Observation Overview: | Suggestions for Consideration: |
|---|---|---|---|
| 03 | SR-A1A within Highland Beach | Shoulders are provided throughout Highland Beach but there are no bike lanes | Consider reviewing the feasibility of providing bike lanes or sharrows along SR-A1A in Highland Beach |

Shoulders are provided throughout Highland Beach but there are no bike lanes. Two crashes with bicyclists occurred in the study area in five years. Bicyclists were observed during all field observations and were observed riding along the shoulder or the traffic lanes.

Due to the number of bicyclists using the shoulder and the lanes of SR-A1A, review the feasibility of providing bike lanes along SR-A1A in Highland Beach. If bike lanes are not feasible, it is recommended to stripe sharrows along SR-A1A within Highland Beach. Note that there are no resurfacing projects along this section of SR-A1A scheduled in the next five years per FDOT's Five Year Work Program.

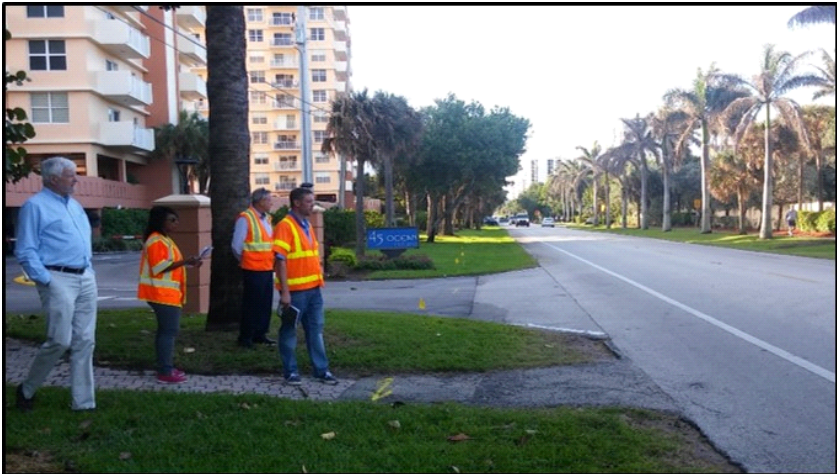
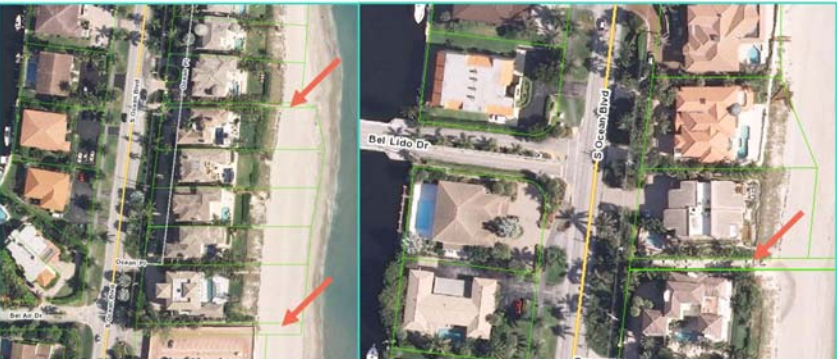
| ID | Location Description: | Spot Observation Overview: | Suggestions for Consideration: |
|---|---|---|---|
| 04 | SR-A1A at 3 unmarked locations | Residents request additional crosswalk locations | No recommendation at this time |

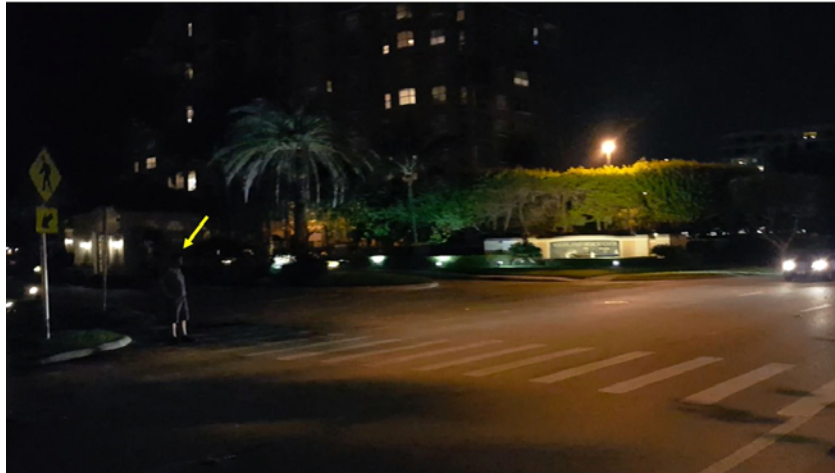
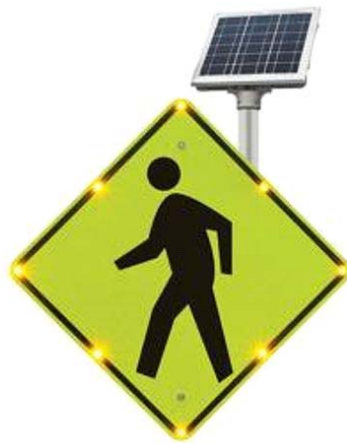
| ID | Location Description: | Spot Observation Overview: | Suggestions for Consideration: |
|---|---|---|---|
| 08 | SR-A1A at Crosswalk 1 at the Boca Highland Beach Club | Pedestrian visibility during dark conditions is low and vehicles observed not stopping for pedestrians | Install "PEDESTRIAN WARNING" (W11-2) signs with LEDs and conduct a before and after compliance review |

The crosswalks have limited lighting and pedestrian visibility is low during dark conditions. Vehicles were also observed not stopping for pedestrians with or without safety vests at the mid-block crosswalks along SR-A1A during all field observations.

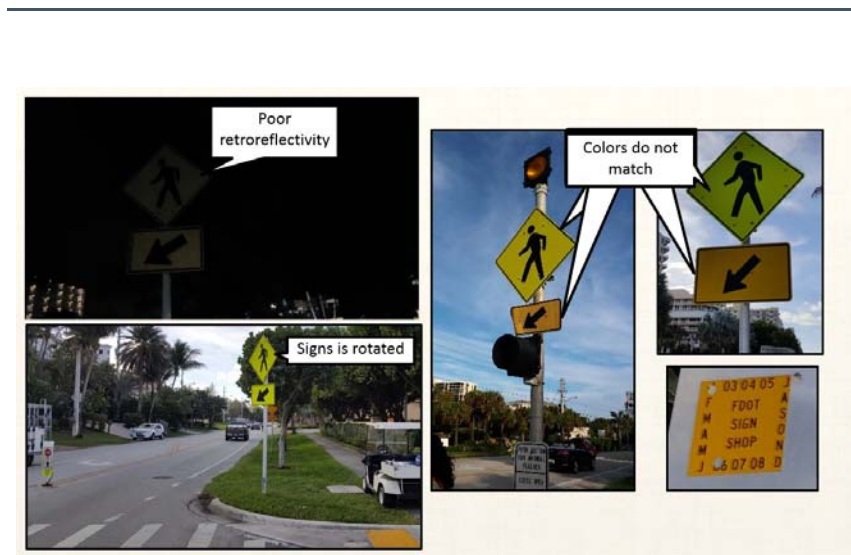
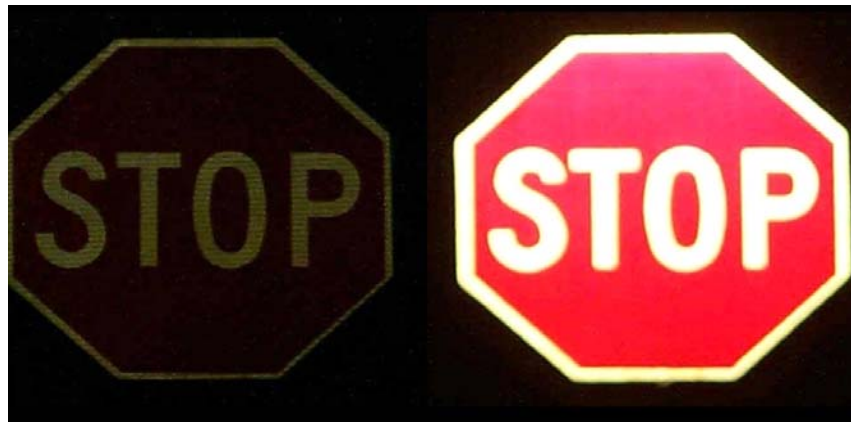
| ID | Location Description: | Corridorwide Observation Overview: | Suggestions for Consideration: |
|---|---|---|---|
| C02 | SR-A1A in Highland Beach | Inconsistent and noncompliant sign colors, rotated sign, poor retroreflectivity | Replace signs as needed |

- During field observations maintenance issues were observed with the signs and include the following:
- "PEDESTRIAN WARNING" (W11-2) signs and the supplemental arrow plaques (W16-7p) signs were not consistent. The signs varied from yellow or yellow-green.
  - The "PEDESTRIAN WARNING" (W11-2) sign and the supplemental arrow plaque (W16-7p) sign at crosswalks #4 was crooked and was not facing southbound traffic.
  - Many of the signs had poor retroreflectivity.
  - The In-Street Pedestrian Crossing signs do not follow the MUTCD as these signs were placed on the shoulder instead of being placed on the center line or on a lane line.

Replace signs that do not have consistent colors, rotate the sign at crosswalk #4, replace signs with poor retroreflectivity, and relocate or remove the In-Street Pedestrian Crossing signs that are on the shoulder. See Appendix B for inventory and recommendations.

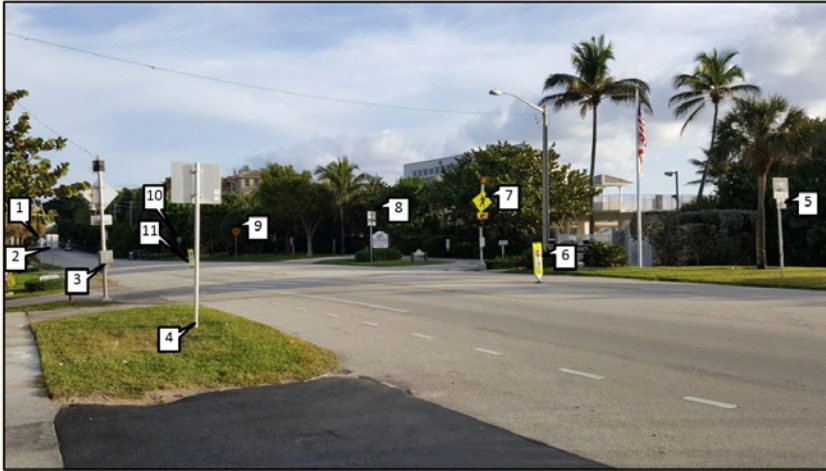
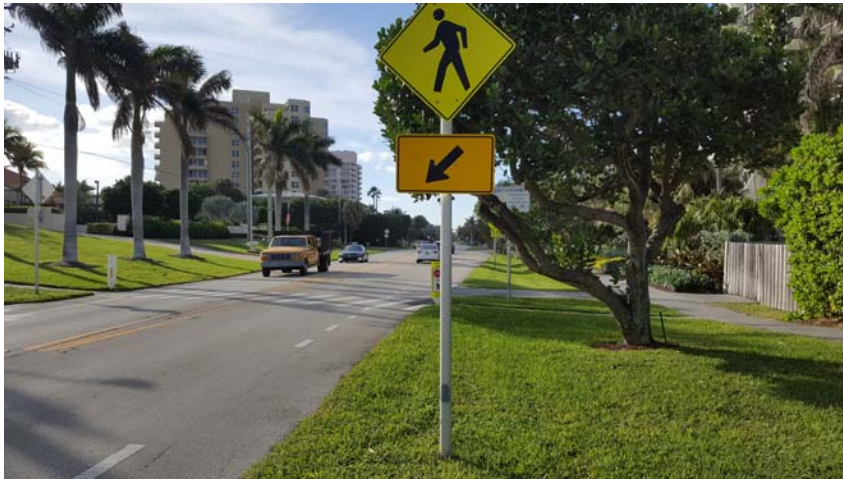
Residents are concerned that there are too many signs along the corridor which may distract drivers of the upcoming 8 mid-block crosswalks.

Conduct a sign inventory to determine which signs could be removed along SR-A1A in Highland Beach.

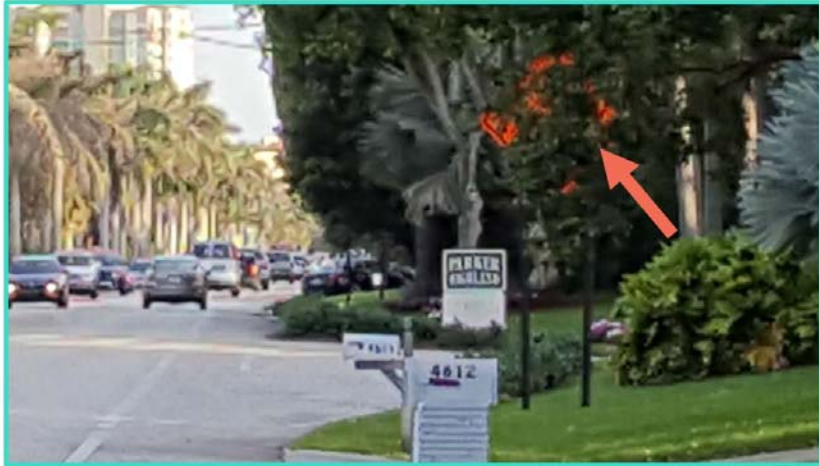
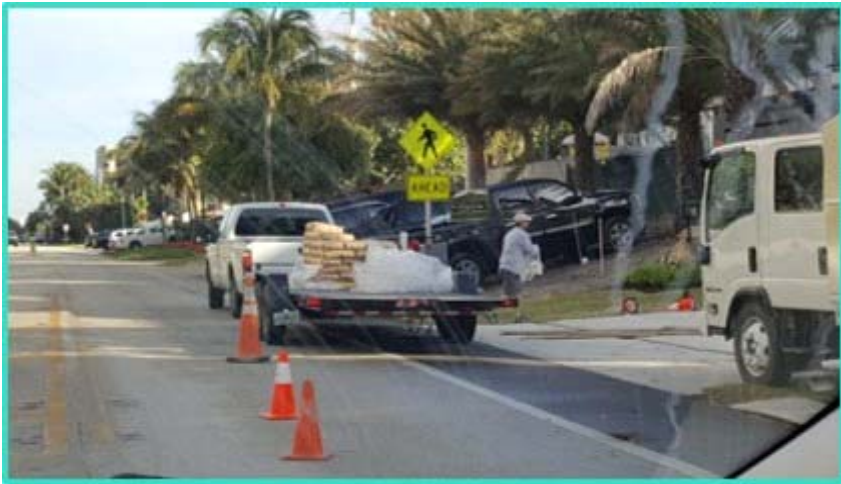
| ID | Location Description: | Corridorwide Observation Overview: | Suggestions for Consideration: |
|---|---|---|---|
| <b>C04</b> | SR-A1A at construction sites | MOT not followed correctly at private developments | Enforce MOT |

- During field observations, Maintenance of Traffic (MOT) for private developments along SR-A1A was not followed properly. MOT related issues included the following:
- Construction trucks observed parking in the bike lanes.
  - Visibility of construction signs were blocked by trees and bushes.
  - Minimal visibility of "Work Zone" or "Work Ahead" warning signs to properly warn drivers of construction vehicles blocking lanes
  - Incorrect placement of cones
