412 N Main St. – Addition of Vinyl Wrapped Metal Facade (H22-024-COA)

CITY OF HENDERSONVILLE - COMMUNITY DEVELOPMENT - HISTORIC PRESERVATION
COA STAFF REPORT

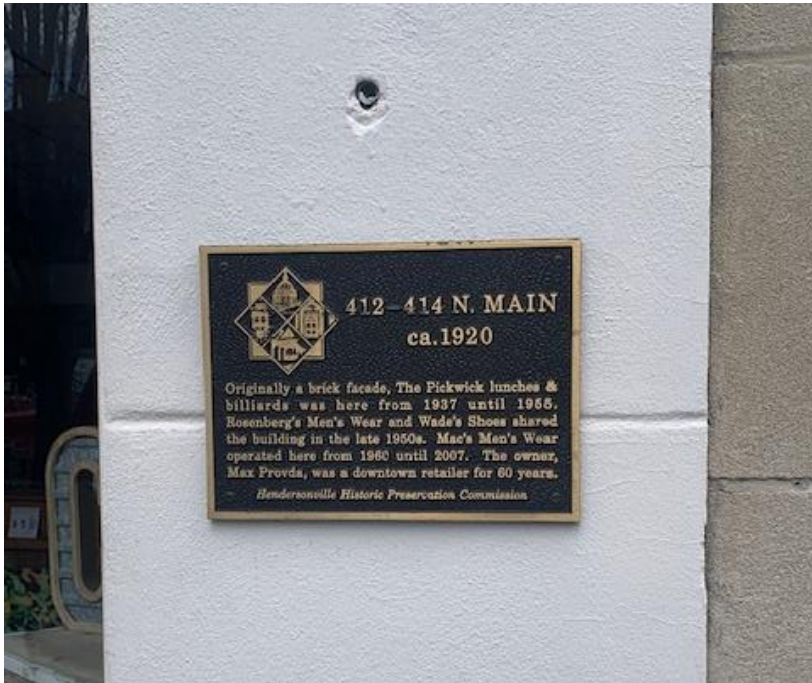
According to the HPC website, a historical marker was placed on the subject property in 2009. The marker states the following:

412-414 N. Main ca. 1920

“Originally a brick facade, The Pickwick, lunches & billiards, was here from 1939 until 1955. Rosenberg's Men's Wear and Wades' Shoes shared the building in the late 1950s. Mac's Men's Wear operated here from 1960 until 2007. The owner, Max Provda, was a downtown retailer for 60 years.”

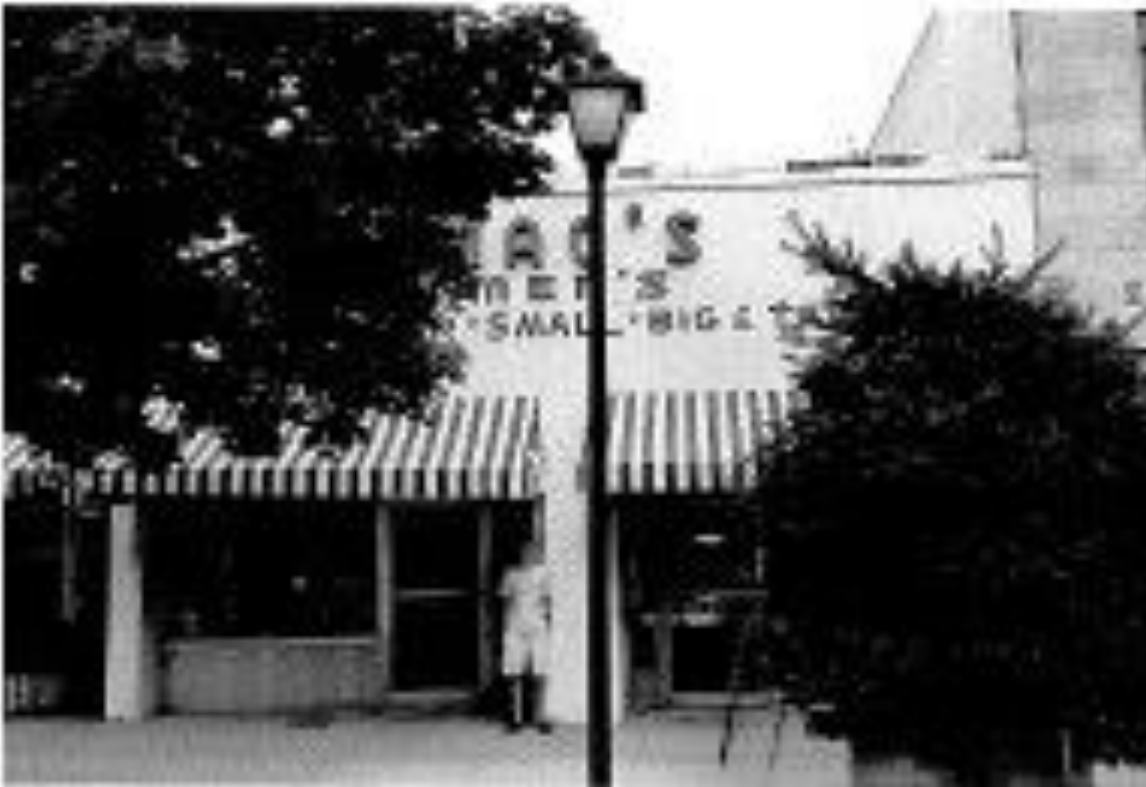
Image from 1987.

The subject property is a non-contributing building that was constructed ca. 1920. The subject property originally had a brick façade that has been stuccoed and modernized.
