# 344 N MAIN STREET – Storefront Rehabilitation

## (H24-098-COA)

CITY OF HENDERSONVILLE - COMMUNITY DEVELOPMENT - HISTORIC PRESERVATION  
COA STAFF REPORT

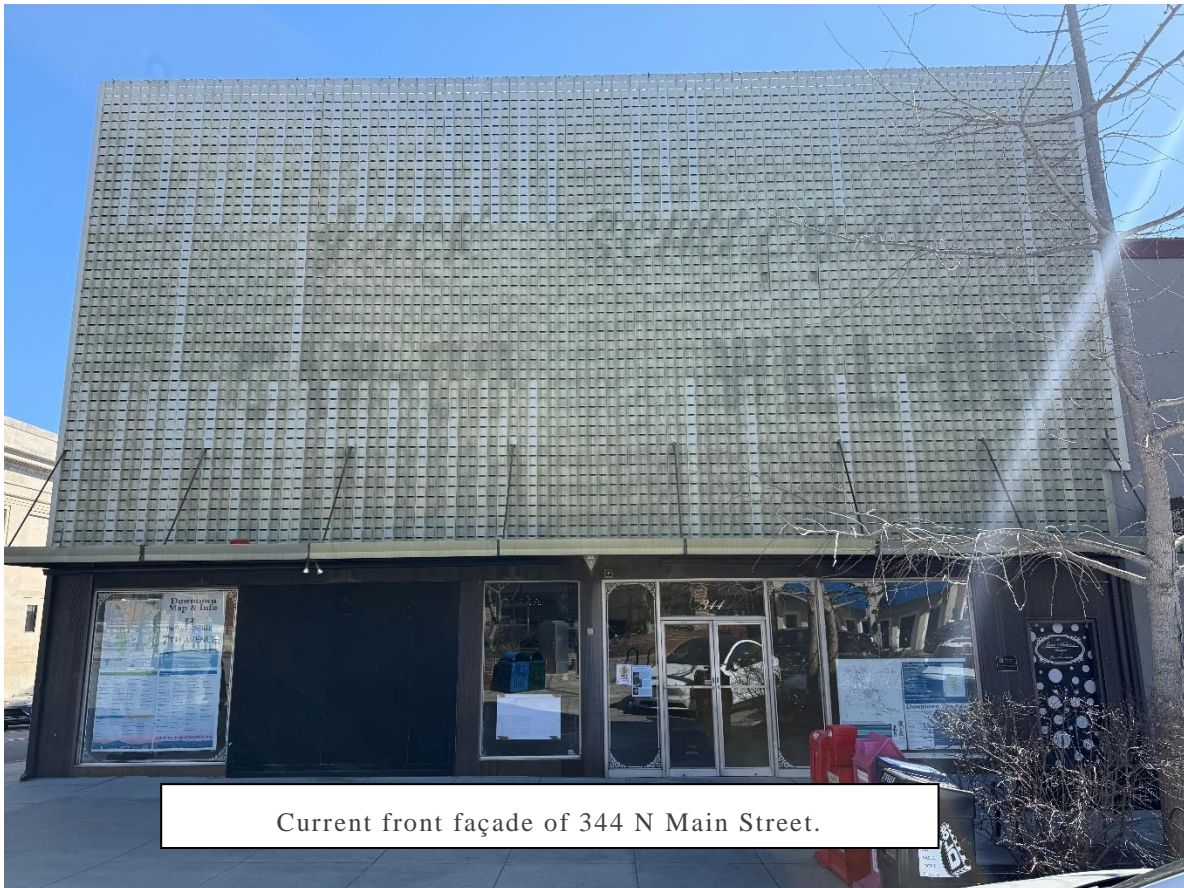
Current front façade of 344 N Main Street.

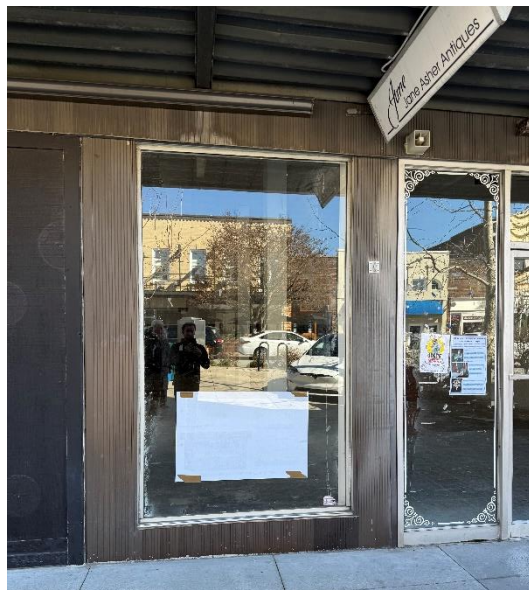
Close up of center columns proposed to be wrapped in wood.

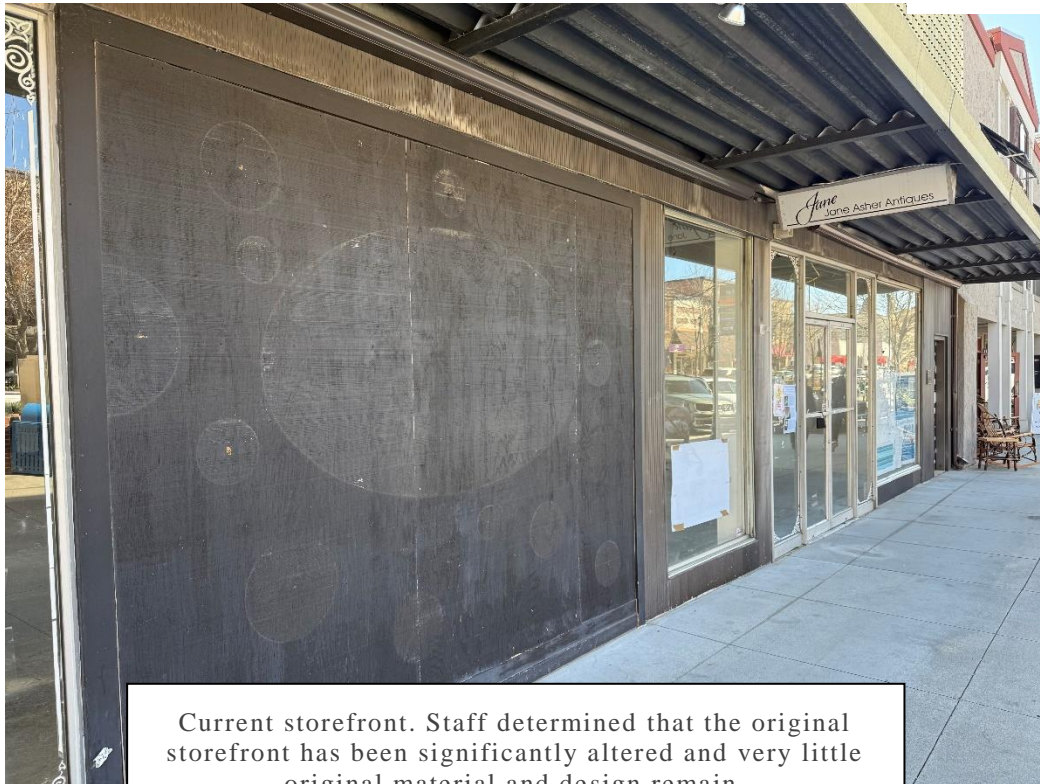
Current storefront. Staff determined that the original storefront has been significantly altered and very little original material and design remain.

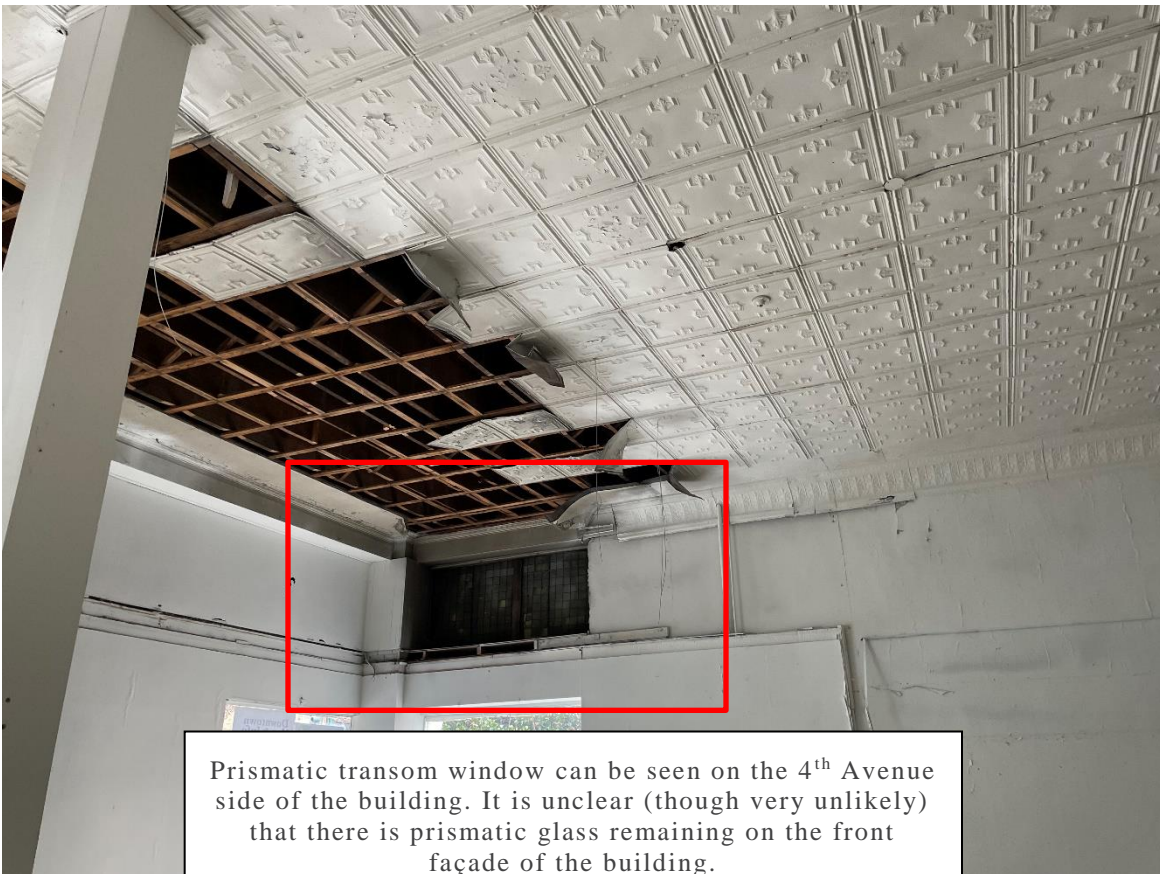
Prismatic transom window can be seen on the 4<sup>th</sup> Avenue side of the building. It is unclear (though very unlikely) that there is prismatic glass remaining on the front façade of the building.

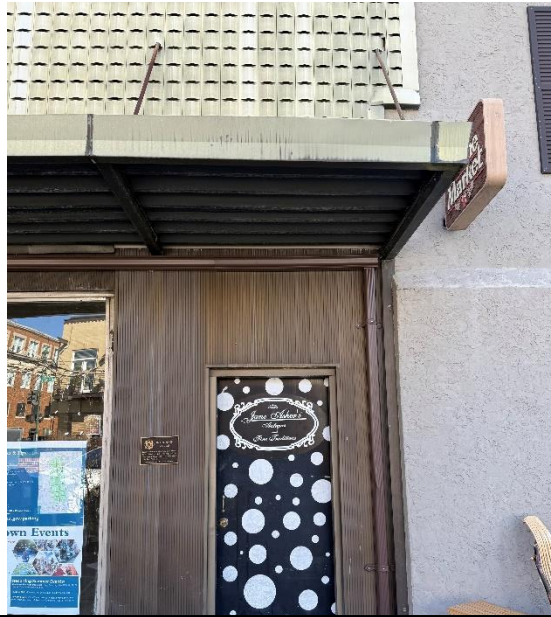
Right side of facade door. The applicant has proposed keeping the door but painting it to match the rest of the wooden façade.

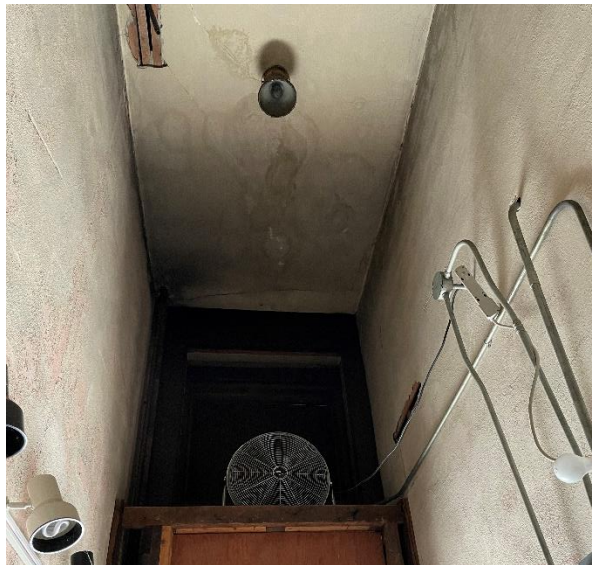
Window opening can be seen above the door on the right side of the front façade.. The applicant has proposed including a window in this opening.
