# 118 5<sup>th</sup> Ave W – Addition of Storefront Entry Door and Windows

## (H22-106-COA)

# <u>CITY OF HENDERSONVILLE - COMMUNITY DEVELOPMENT - HISTORIC PRESERVATION</u> <u>COA STAFF REPORT</u>

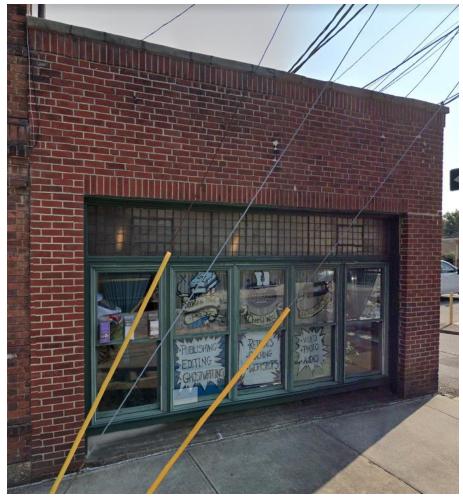
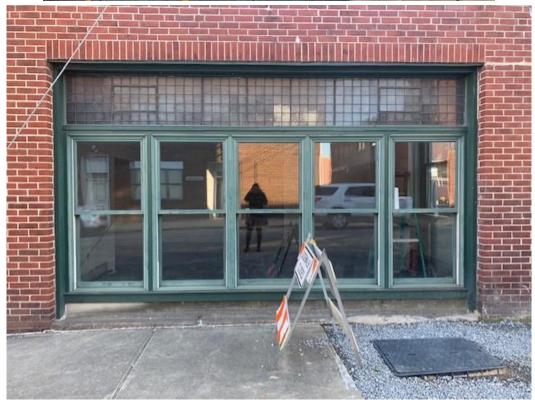
#### SITE CONDITIONS - SITE IMAGES

The subject property is a one-story brick addition at the northwest corner of a large, two-story brick commercial style building known as the "Morey Building." This commercial building was constructed ca. 1912 to house Hunter's Pharmacy, formerly located down the street. The subject property is described in the local historic district designation report as having "replacement fixed panes in the original display opening and a glass block transom."

- Windows 70" fixed glass panel in extruded aluminum frame; glass will be clear, non-glare
- Entry Door Glass commercial door with aluminum frame in bronze
