Design Proposal

July 20, 2022

434 N. Main St.

434 N. Main Street Hendersonville, NC

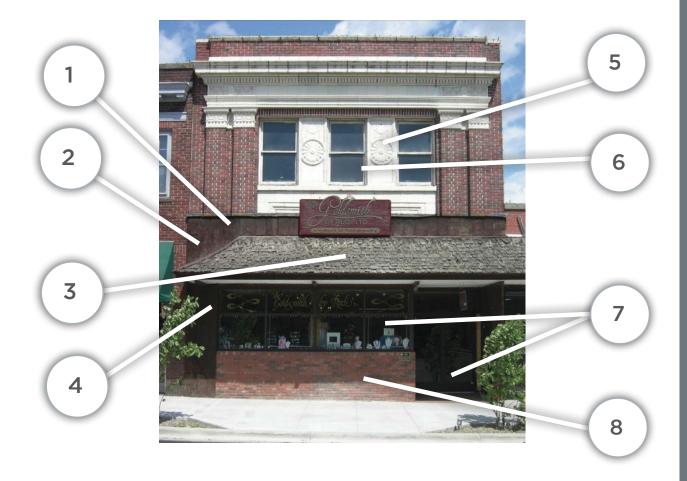
Work Description - Existing Conditions

1 Wood Panels -

Remove panels and framing concealing upper façade, and panels facing the storefront bulkheads and brick pilasters as well as all related hardware & fasteners. Take care not to damage brickwork.

Remove any existing facing material on transom framing.

2 Preparing Brick for Stucco Application - (currently covered by wood paneling)
Inspect and assess the condition of the facade masonry. If needed, repoint masonry
mortar joints to match in strength, color, and profile existing mortar joints as necessary
before stucco application. Scrape and prep all masonry walls for stucco application. For
more information on repairing mortar joints, see National Park Service Brief two https://www.nps.gov/tps/how-to-preserve/briefs/2-repoint-mortar-joints.htm

3 Awning -

Remove existing awning and its related hardware and fasteners above the storefront. Take care not to damage the facade. Carefully remove the existing wooden awning and framing and store for reinstallation. See Preservation Brief number 44 for more information: https://www.nps.gov/tps/how-to-preserve/briefs/44-awnings.htm Remove any extraneous hardware, signage, or fixtures from the facade. Take care not to damage the facade.

4 Pilasters - (currently covered by wood paneling)

If the pilasters behind the panels have been damaged, repair or replace brickwork as necessary.

5 Glazed Terra-Cotta -

Inspect and assess the condition of the terra-cotta details. Clean with water, detergent, and a natural or nylon bristle brush in the gentlest manner. More stubborn stains can be cleaned with steam. AVOID pressure washing or sandblasting of the facade, as these methods will do irreparable damage. For more information on repairing terra-cotta, see National Park Service brief 7:The Preservation of Historic Glazed Architectural Terra-Cotta.

6 Windows -

Repair & Prep for Repainting

Repair upper-story double-hung wood windows and related trim work following best practices for historic window repair. Reglaze and weatherstrip as necessary to ensure they are weathertight. Re-putty window glazing where putty is deteriorated or missing. (One recommended contractor for this type of historic window repair is Doublehung, LLC in Greensboro.) For more information on repair and maintenance of historic wood windows, see NPS Brief #9: https://www.nps.gov/tps/how-to-preserve/briefs/9-wooden-windows. htm.

7 Aluminum Storefronts -

Assess the condition of the metal storefront and make repairs or replacements as necessary to ensure they are weathertight. Routine maintenance will include replacement of missing screws and fasteners, hinges cleaned and lubricated, and masonry surrounds caulked. Repair and replace glazing where necessary using appropriate glazing compound.

Inspect Aluminum Storefront After Removing Facade Coverings

Once the T1-11 wood panels are removed, determine whether aluminum-framed storefronts can be modified and retained or if new storefronts sized to the original storefront bays need to be installed. If aluminum-framed storefronts can be retained (as shown for the north storefront in illustrated rendering), make repairs or modifications as necessary. Routine maintenance will include replacement of missing screws and fasteners, hinges cleaned and lubricated, and masonry surrounds caulked. Repair and replace glazing where necessary using appropriate glazing compound.

8 Brick -

Inspect & repair - brick after removing coverings

Once the wood T1-11 panels and wood awning are removed, assess the condition of the exposed facade. Repair areas of deteriorated brickwork and repoint masonry mortar joints as necessary to match existing mortar joints in strength, color, and profile. If the exposed brick is damaged beyond repair, replace it with new brick that matches the original in appearance, dimension and surface texture.

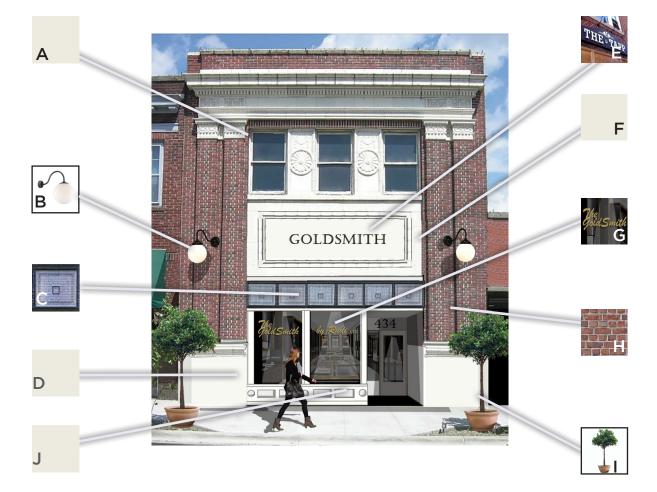
Design Proposal • Scheme 1 434 N. Main St.

- Windows Trim Color SW 7008 | Alabaster *Color Match
- B Lighting Lumens Globe wall mounted sconce
- C Prismatic Glass Bronze Trim
- D Cast Stone Pilaster Base Color and texture to match existing terracotta details
- E 3D Lettering Pin Mounted Bronze Brush Finish
- F Cast Stone or Stucco Panel Color and texture to match existing terracotta details
- **G** Signage Custom vinyl decals on storefront display windows
- H Pilasters Reconstruct to match existing brick
- **Landscape** Planters with native plants consistent with local design guidelines
- J Storefront New wood storefront with wood panel bulkhead and wood 3/4 lite door Paint SW 7008 | Alabaster

*Color to match existing window trim and stucco should be determined on-site. The approximate color is SW 7008 - Alabaster

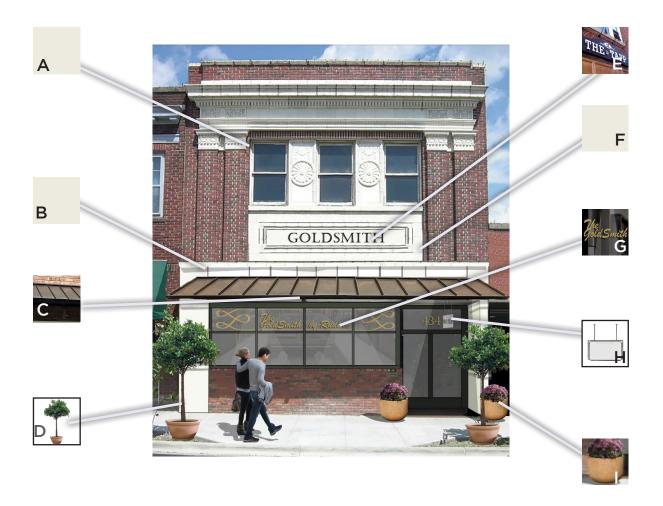
Design Proposal • Scheme 2 434 N. Main St.

- A Windows Trim Color SW 7008 | Alabaster *Color Match
- **B** Cast Stone or Stucco Panel Color and texture to match existing terracotta details
- **C** Awning Standing seam copper awning over wood or metal structure
- **D Landscape** Planters with native plants consistent with local design guidelines
- E 3D Lettering Pin Mounted Bronze Brush Finish
- F Cast Stone or Stucco Panel Color and texture to match existing terracotta details
- **G** Signage Custom vinyl decals on storefront display windows
- **H** Signage Blade sign hung from soffit
- I Landscape Planters with native plants consistent with local design guidelines
- *Color to match existing window trim and stucco should be determined on-site. The approximate color is SW 7008 - Alabaster
