Grey Hosiery Mill

Local Landmark Designation

Prepared by MacRostie Historic Advisors

Local Landmark Designation Report Grey Hosiery Mill Hendersonville, NC

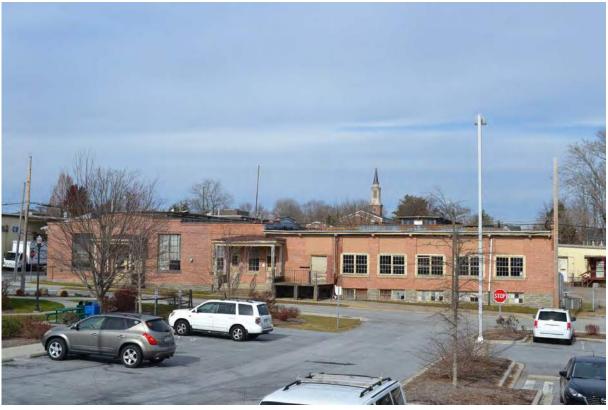
1. Grey Mill, South Facade, Looking North

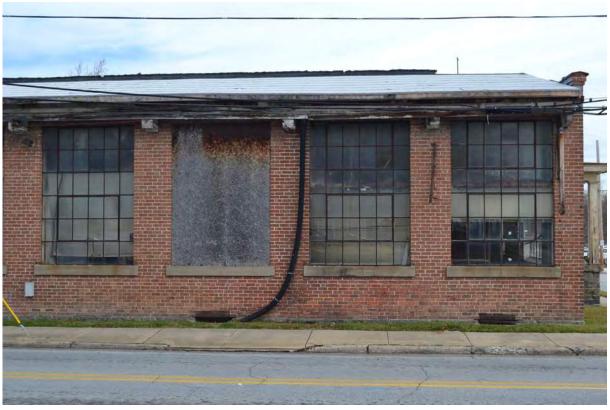
The west elevation is composed of two sections: the 1915 Knitting Room and a later 1947 addition to the north. The older 1915 portion has an overhanging roof with exposed rafter tails and large rectangular window openings with concrete sills. Five of the original steel-sash 36-pane windows with two operable pivoting panels remain at the southern end of the west elevation. The other remaining window bays have been infilled with brick and four have a smaller glass block window within the infill. The seventh bay from the south was later altered to fit a door that remains today.

7. Grey Mill, 1915 Building, West Elevation, Window Detail

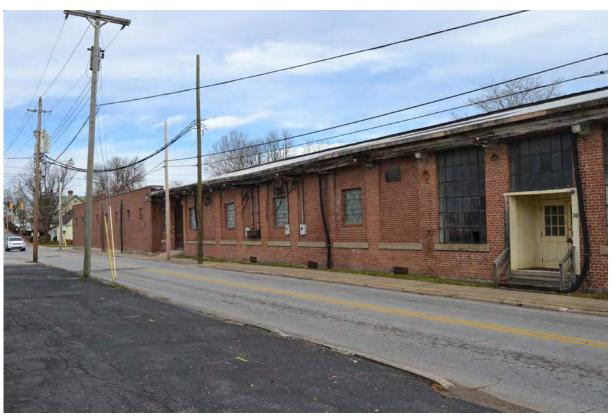
9. Grey Mill, 1915 Building, West Elevation, Looking Northeast

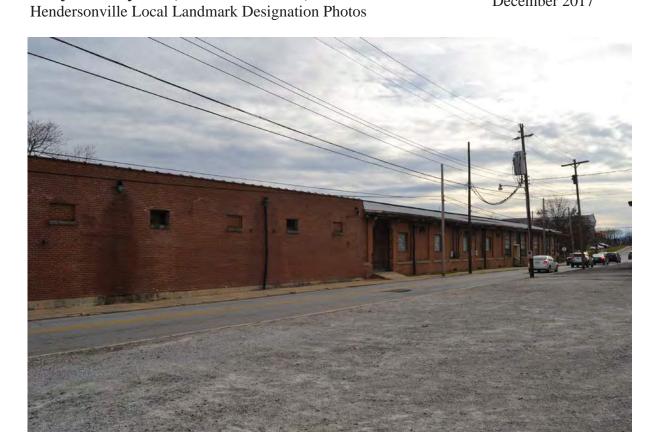
The single-story 1947 portion is primarily a blank brick wall with a flat roof and simple brick parapet. There are eight small, elevated windows that have since been infilled.

11. Grey Mill, 1947 Addition and 1915 Building, West Elevation, Looking Southeast

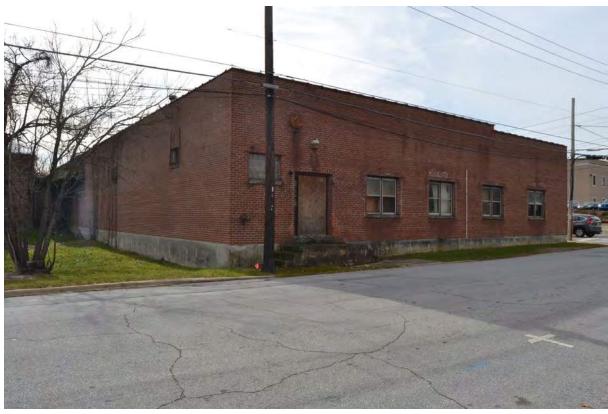
The north elevation of the Grey Mill complex consists of the 1947 addition, the 1926 Finishing Rooms, and the 1970s Warehouse. All are relatively single-story blank brick facades. The 1947 addition has four paired one-over-one aluminum windows and a single doorway. There is a small series of vents along the 1970s Loading Room.

13. Grey Mill, 1947 Addition, North Elevation, Looking Southwest

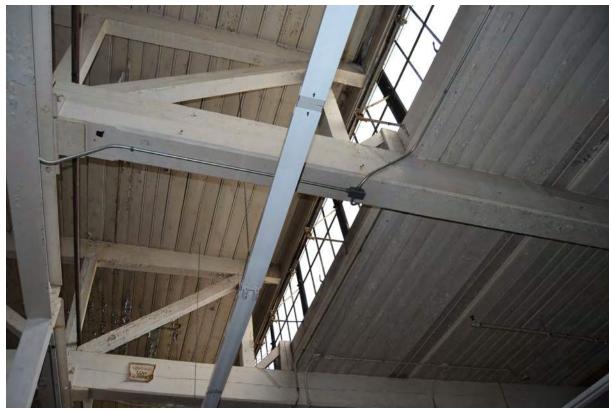
43. Grey Mill, 1915 Building, Monitor Detail

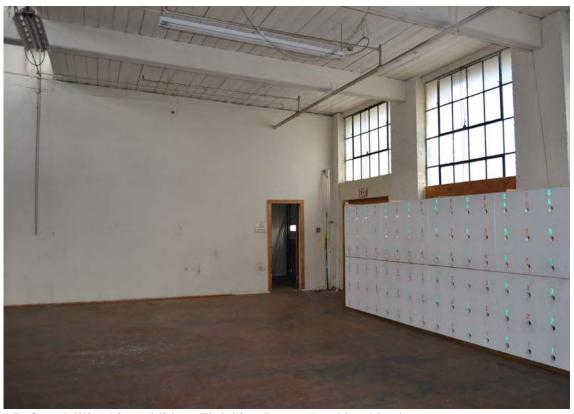
The interior of the Finishing Room is now divided into two sections with the four south bays separated from the remainder of the room by a floor to ceiling gypsum board partition. A single door at the east side of the partition provides access between the spaces. The south space is open with central wood columns, wood flooring, painted brick walls and exposed beams, ceiling and clerestory. A doorway holding paired wood doors with panels and 9-light windows sits in one bay along the west wall providing access to the courtyard. The remainder of the Finishing Room to the north of the partition has a series of framed office partitions along the east and west walls with hard ceilings below the full height of the building and concrete floors. Like the other older sections, a central line of columns runs down the middle of the building supporting the beams above and clerestory. The columns in the Finishing Room all appear to be wood with the exception of the north two bays that were added after the 1947 addition. This addition has steel columns and a corresponding change in brick visible from the courtyard.

67. Grey Mill, 1926 Addition, Finishing Room, Looking Northeast

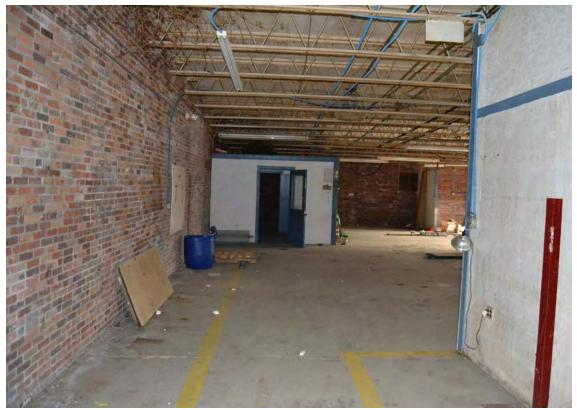
The Loading Room is an open room with exposed brick walls and steel scissor trusses spanning the space from north to south to support the flat roof. Plywood office enclosures have been created at the northeast and west and south sides of the room. Two garage doors sit at floor level to the east side of the uninsulated south wall and a concrete ramp at the west side of the Loading Room leads down to a third garage door at ground level.

87. Grey Mill, 1970s Warehouse, Looking East

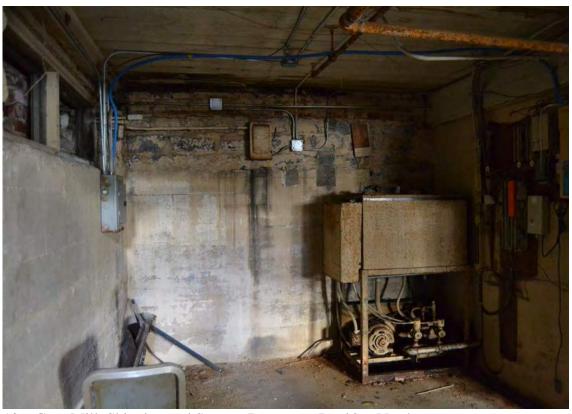
appears to have been built in the 1990s. A doorway at the northwest area of the Shipping Room holds tall double wooden doors with horizontal raised panels. A freight elevator now enclosed with gypsum board sits at the north wall near the northwest doorway. A storage or office enclosure has been built of plywood at the east end of the Shipping Room and a small doorway at the northeast corner of the Shipping Room leads into a restroom that was added after the original construction. A basement level exists below the Shipping Room with exposed stone foundation walls at the perimeter and unpainted exposed beams and columns.

106. Grey Mill, Shipping and Storage Basement, Looking North

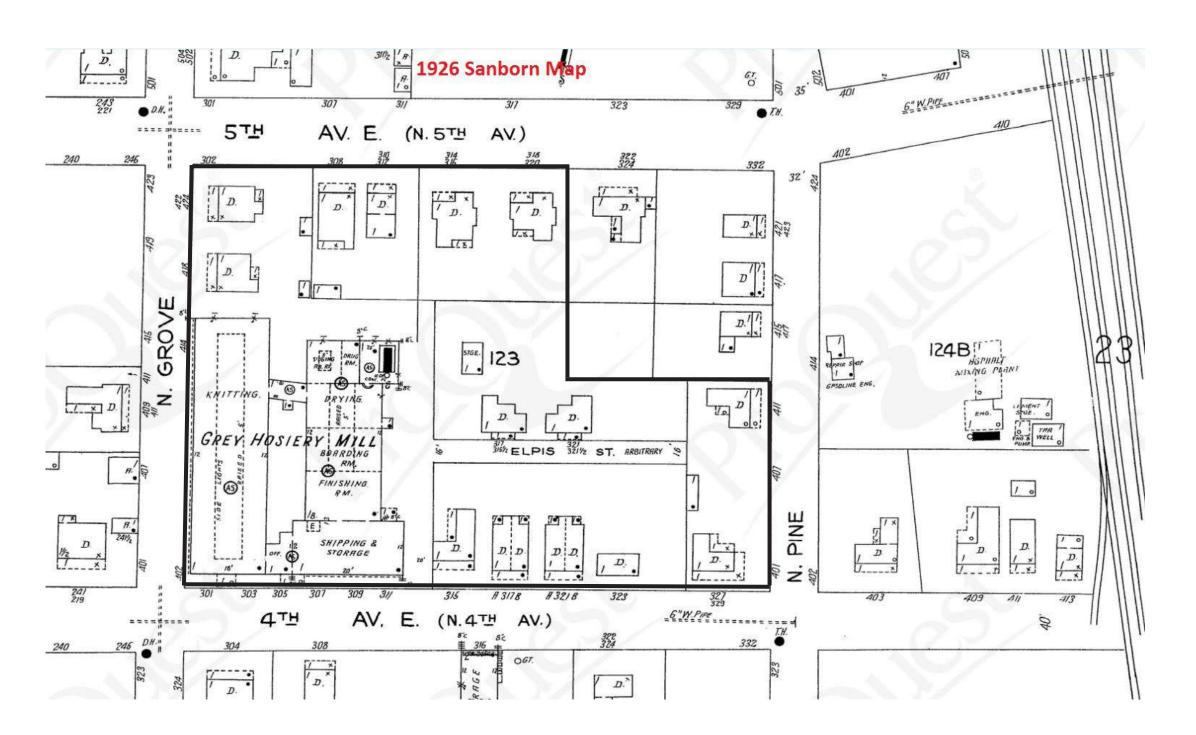
Local Landmark - Parcel History

Image Origin | Sanborn Fire Insurance Image Date | 1922

**Outline shows proposed landmark boundaries

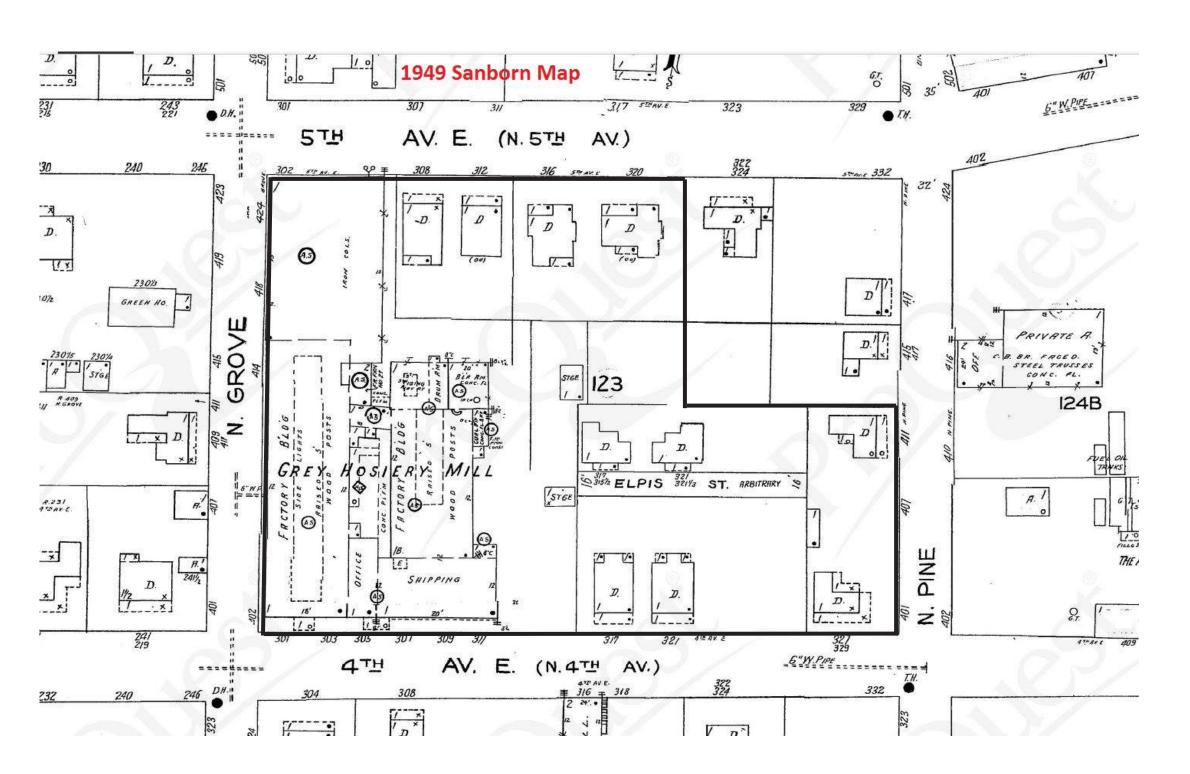
Local Landmark - Parcel History

Image Origin | Sanborn Fire Insurance Image Date | 1949

**Outline shows proposed landmark boundaries
