# TOWN OF JEROME

## Zoning Administrator Analysis Design Review Board Tuesday, July 28, 2026

**Location:** 38 Paradise Lane

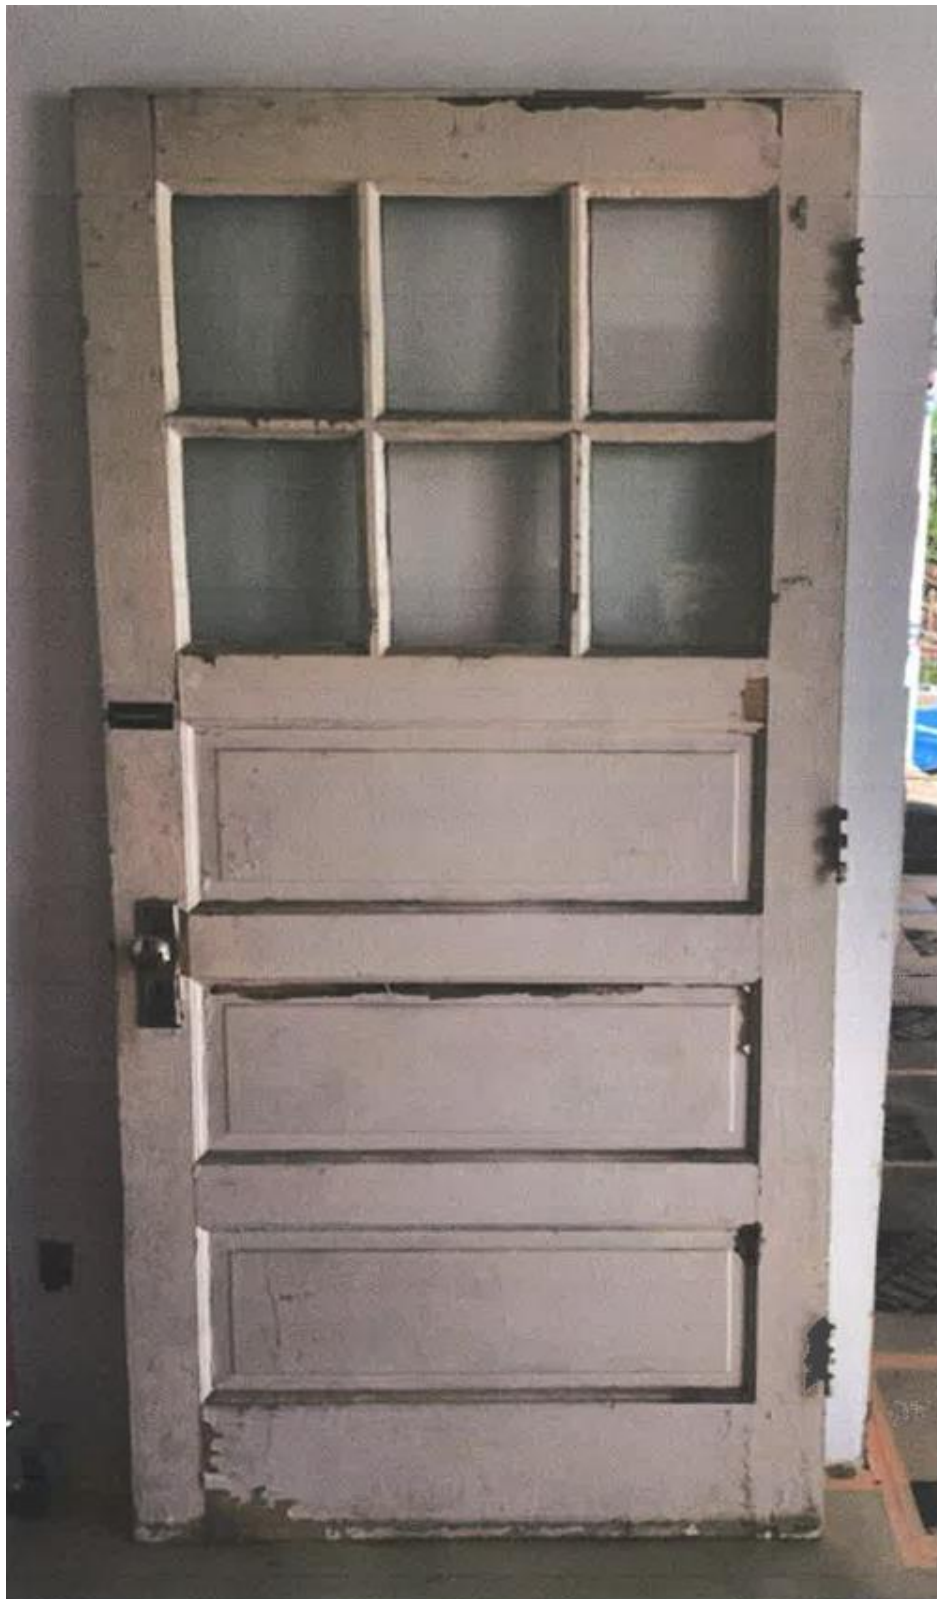
3'-5" x 6'-8"  
DOOR  
REAR DORMER
