TOWN OF JEROME

Zoning Administrator Analysis Design Review Board Tuesday, May 27, 2025

Location: 879 Hampshire Blvd
Applicant/Owner: Verde Exploration Ltd
Zone: I-1
APN: 401-11-021A
Prepared by: Will Blodgett, Zoning Administrator
Recommendation: Recommend discussion / approval

Project Description: Garage Door reconfiguration with new walk in entry

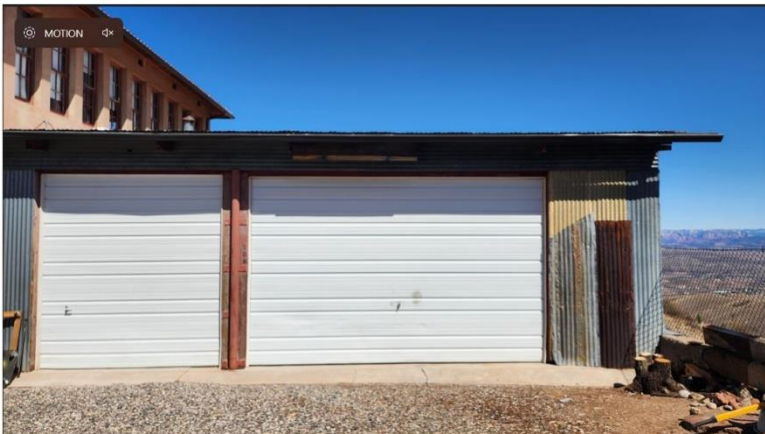
Current Configuration of West Wall of Tin Garage

- The front exterior wall of studio B-108 will be re-configured to move the existing roll up double garage door approximately 5 feet to the right as shown on the “Proposed Configuration” exhibit.
- The existing exterior tin siding will be salvaged and reused along with matching vintage tin as needed to replace areas previously patched with tan fiberglass. The tin to be used was salvaged from other old Jerome structures and is in storage at the mine yard property on Douglas Road.
- A 36-inch steel slab entry door will be added to the left of the roll up garage door. The door will be either industrial gray as shown or painted red to match existing trim at the high school. There is no plan to change the color of the roll up garage door(s).

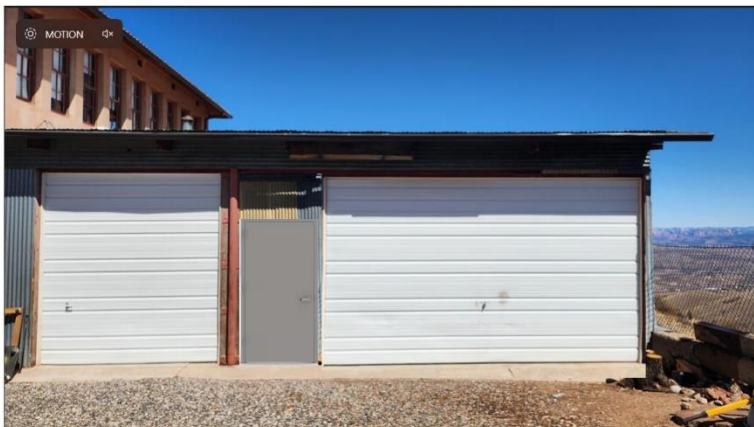
Proposed Configuration with added walk-in door

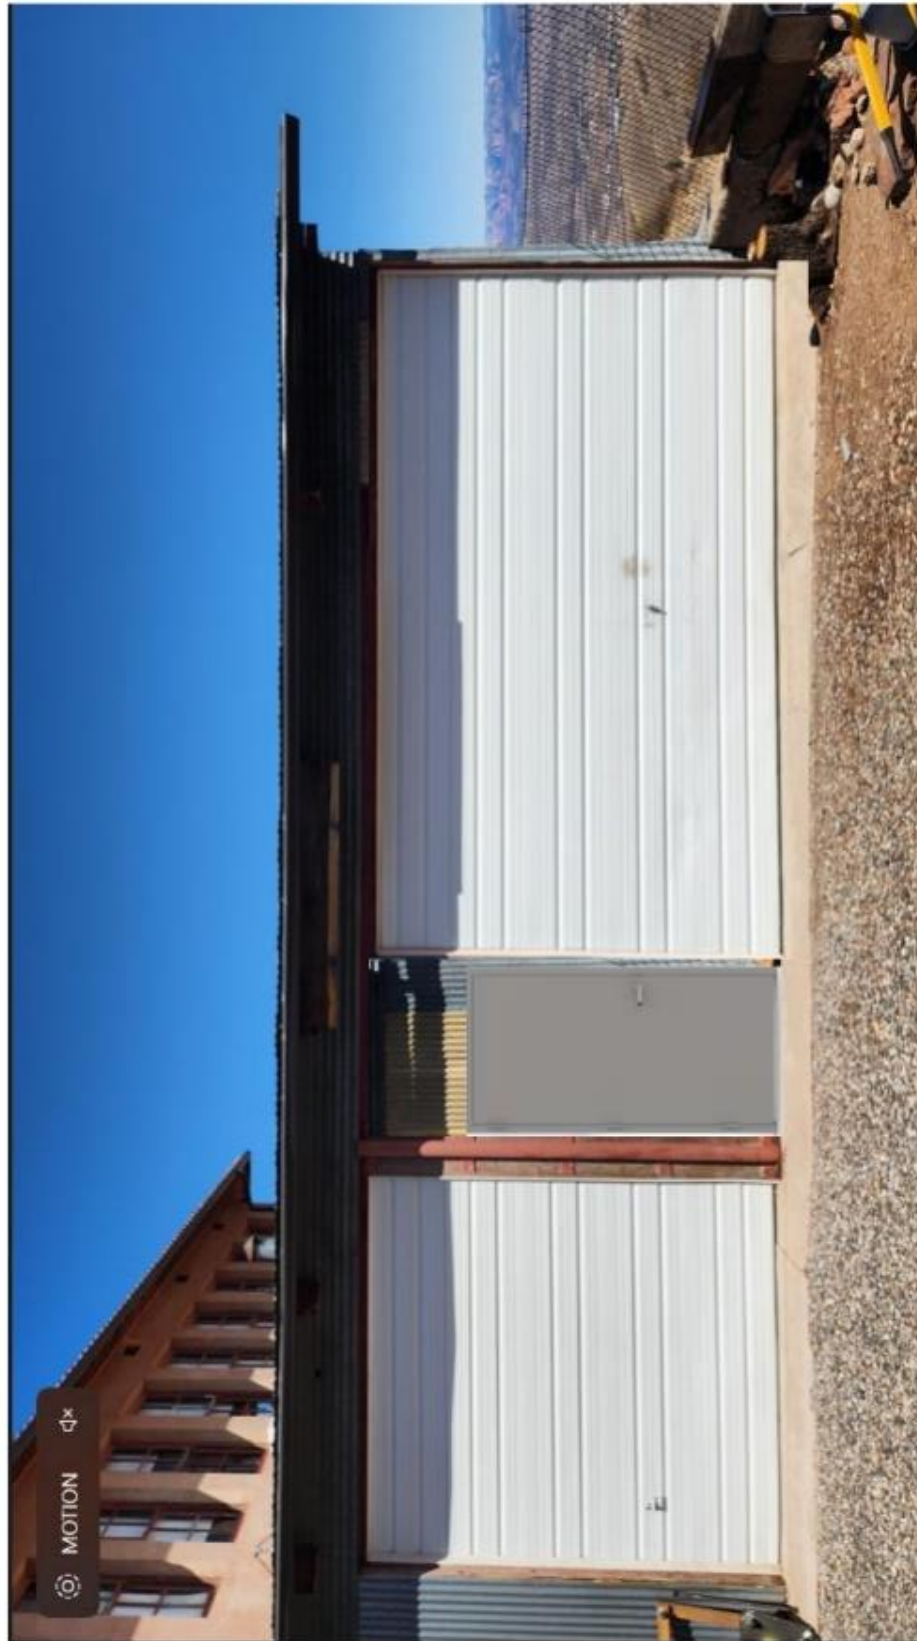
Proposed Configuration with added walk-in door

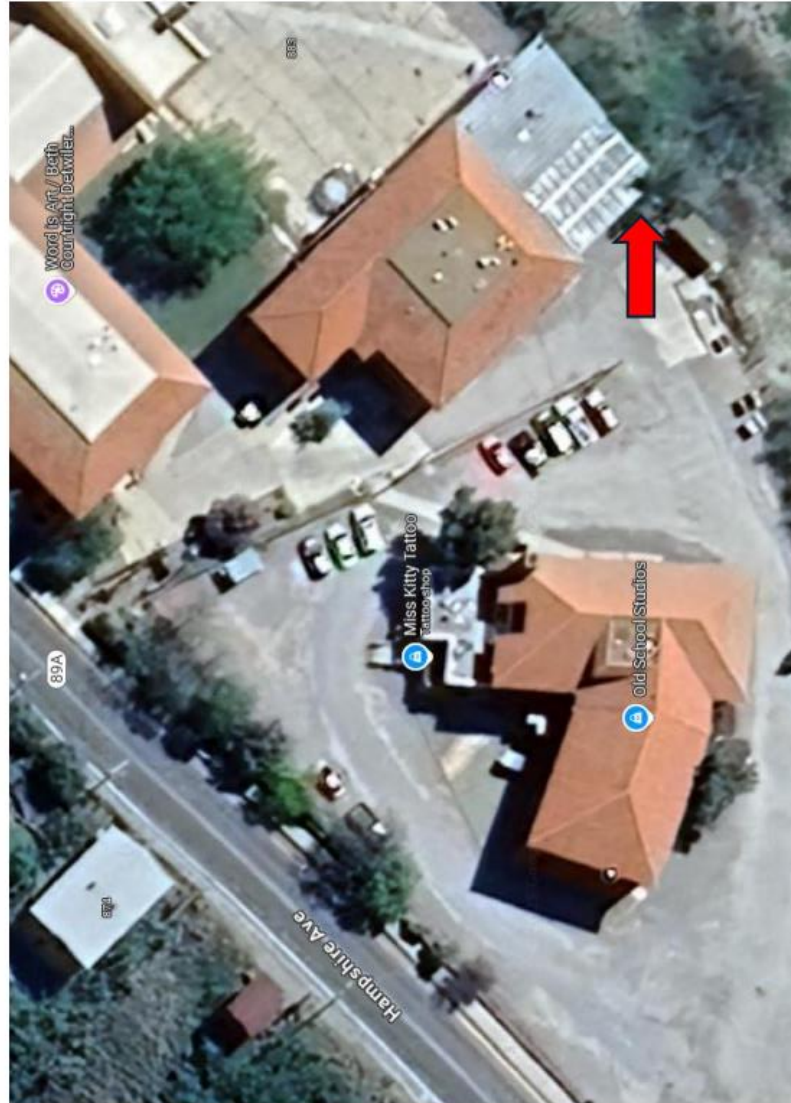
879 HAMPSHIRE STUDIO B108

The tin garage is an early 1960's addition to the automotive shop garage at the rear of Building B while in use by the Mingus Union High School District. The footprint of the tin addition is denoted by the roofing pattern with white/gray. The solid gray roof is the original automotive garage addition and is one of two additions to the Building B footprint that were made prior to 1940 while in use by the Jerome High School.

The scope of this project is limited to the west exterior wall of the tin garage (see red arrow).
