Sheet Contents:  
EXTERIOR ELEVATION

| Project: BLM JRMIC EGRESS DESIGN<br>JUNEAU, ALASKA | | | | | |
| Sheet: 001 of 01<br>DEMO SITE PLAN | | | | | |

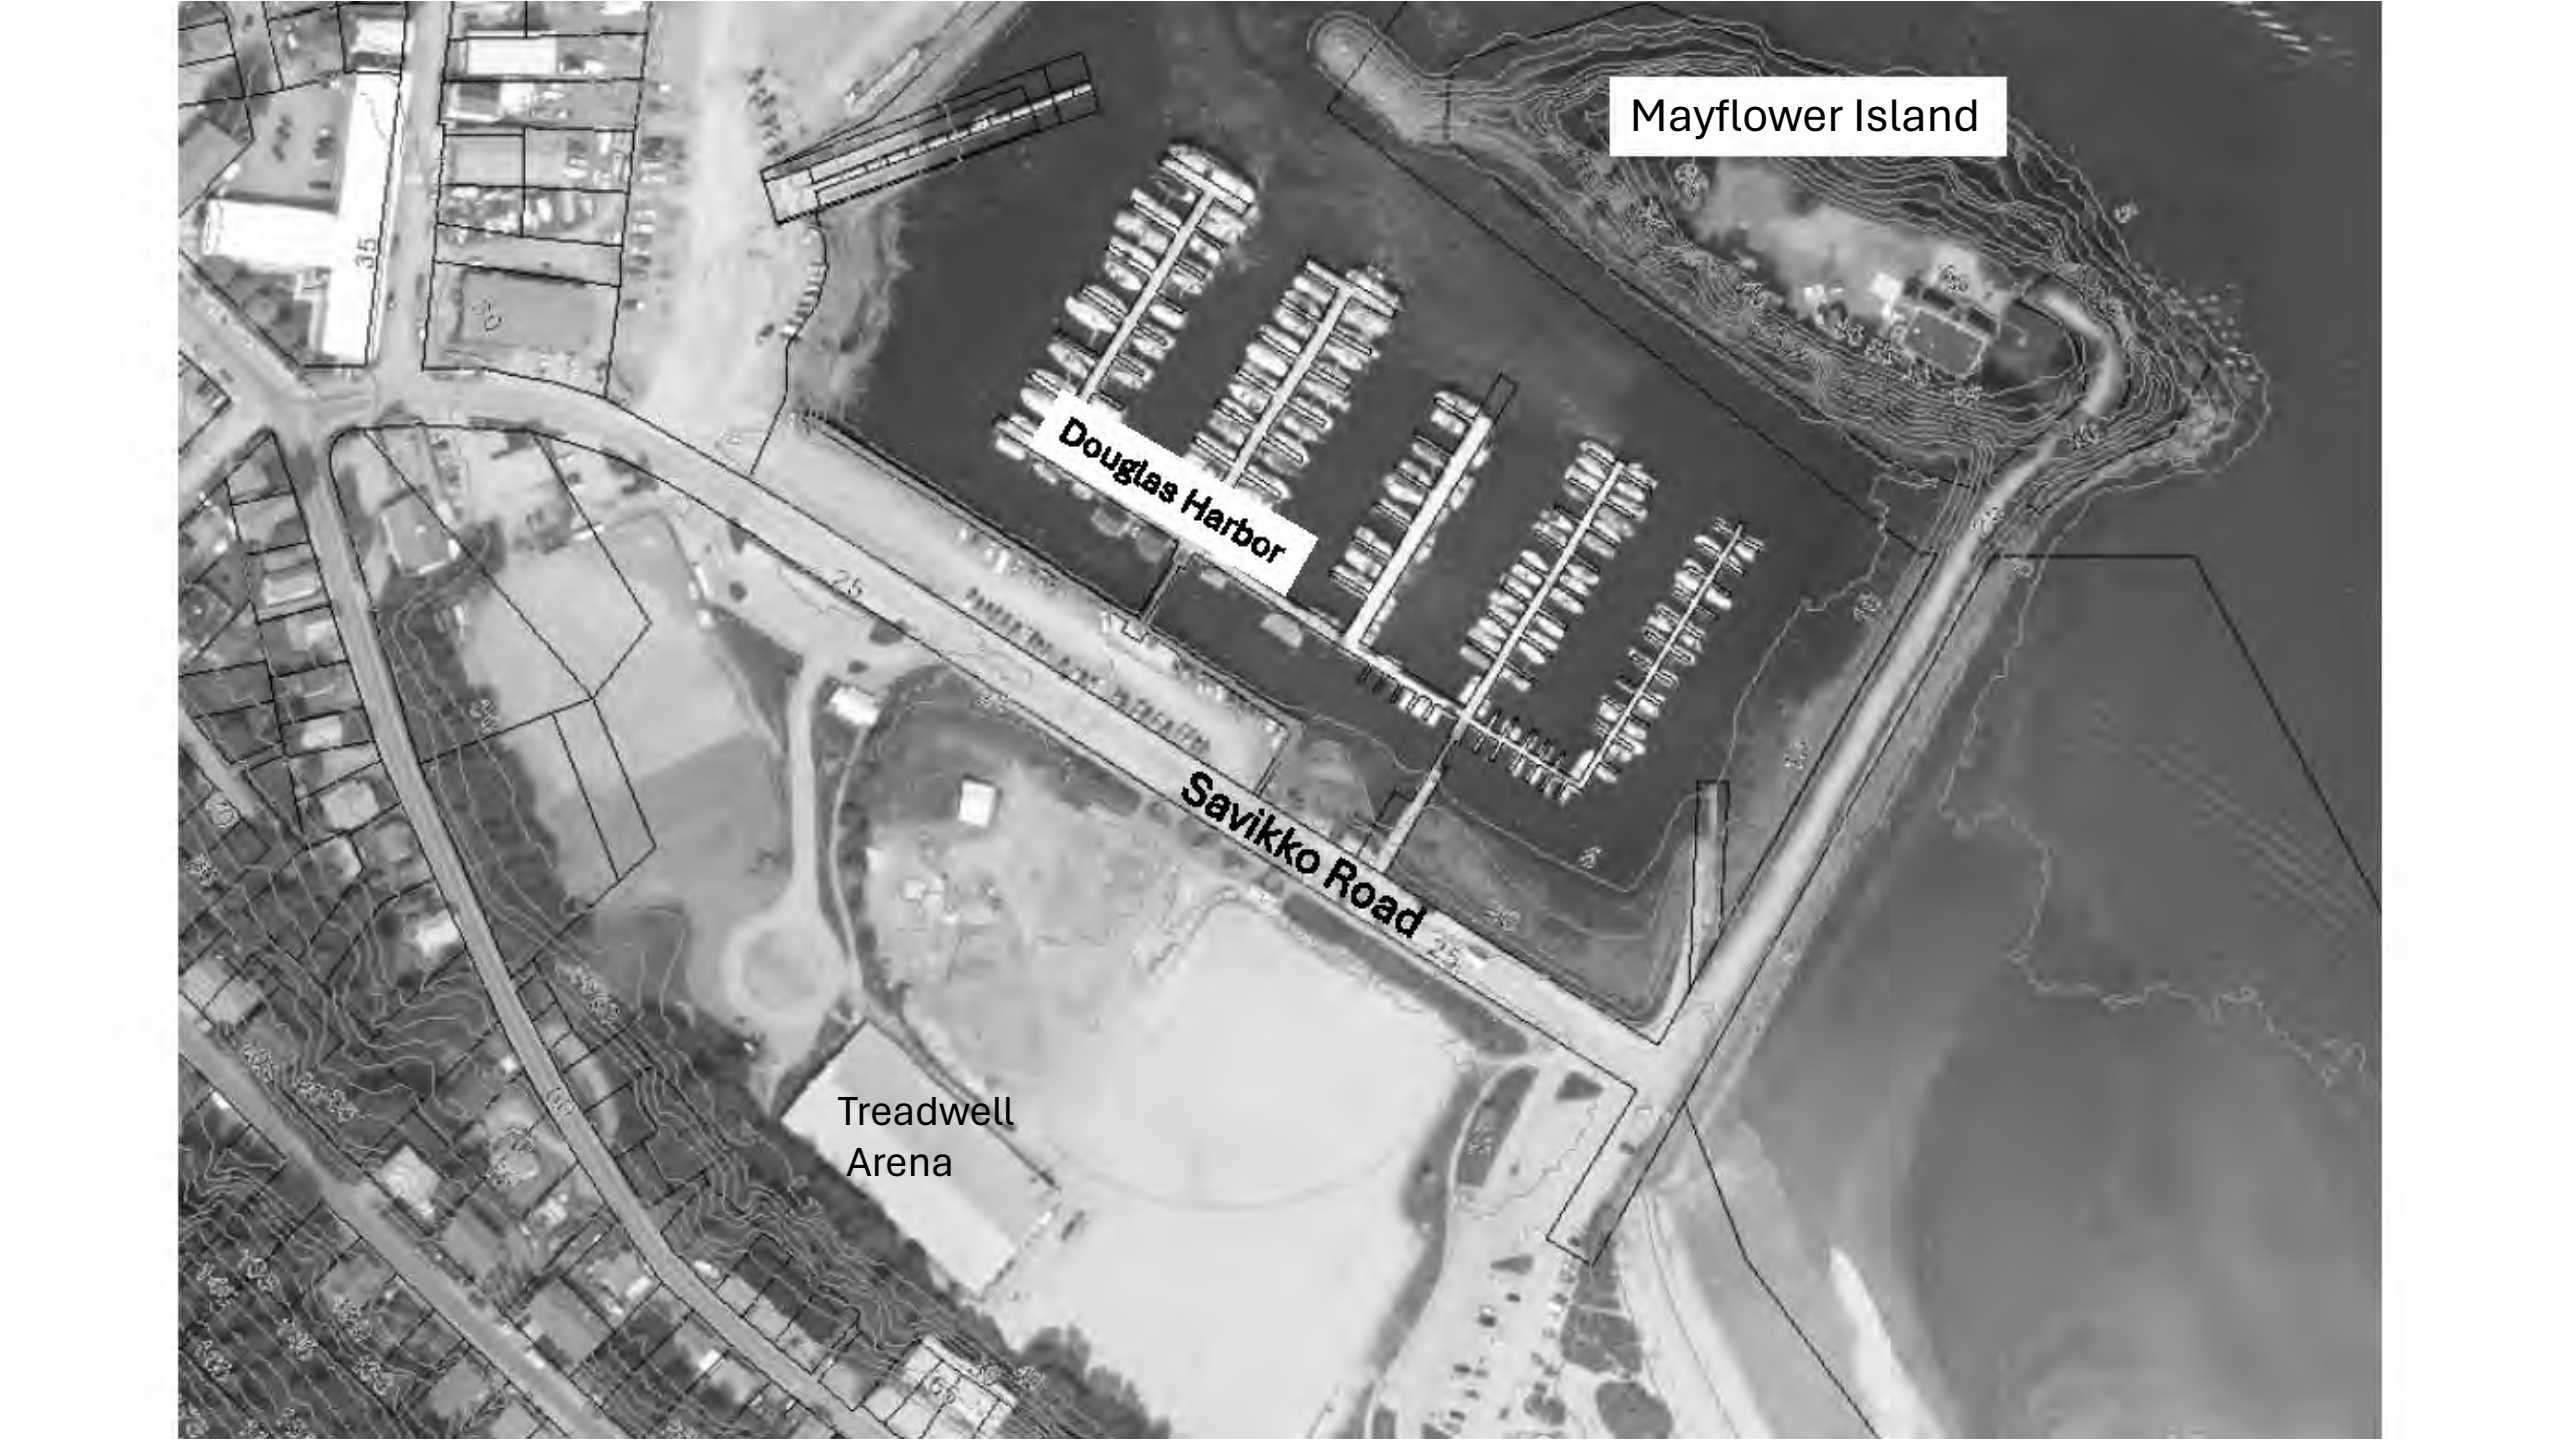
An aerial photograph of a coastal area. In the upper right, a small island is labeled 'Mayflower Island'. To its left is a large harbor area labeled 'Douglas Harbor', which contains several long piers with many small boats moored along them. A road, labeled 'Savikko Road', runs diagonally from the bottom left towards the harbor. Below the harbor, there is a large, flat, light-colored area labeled 'Treadwell Arena'. The surrounding land shows various buildings, parking lots, and some vegetation. The water is dark and calm.

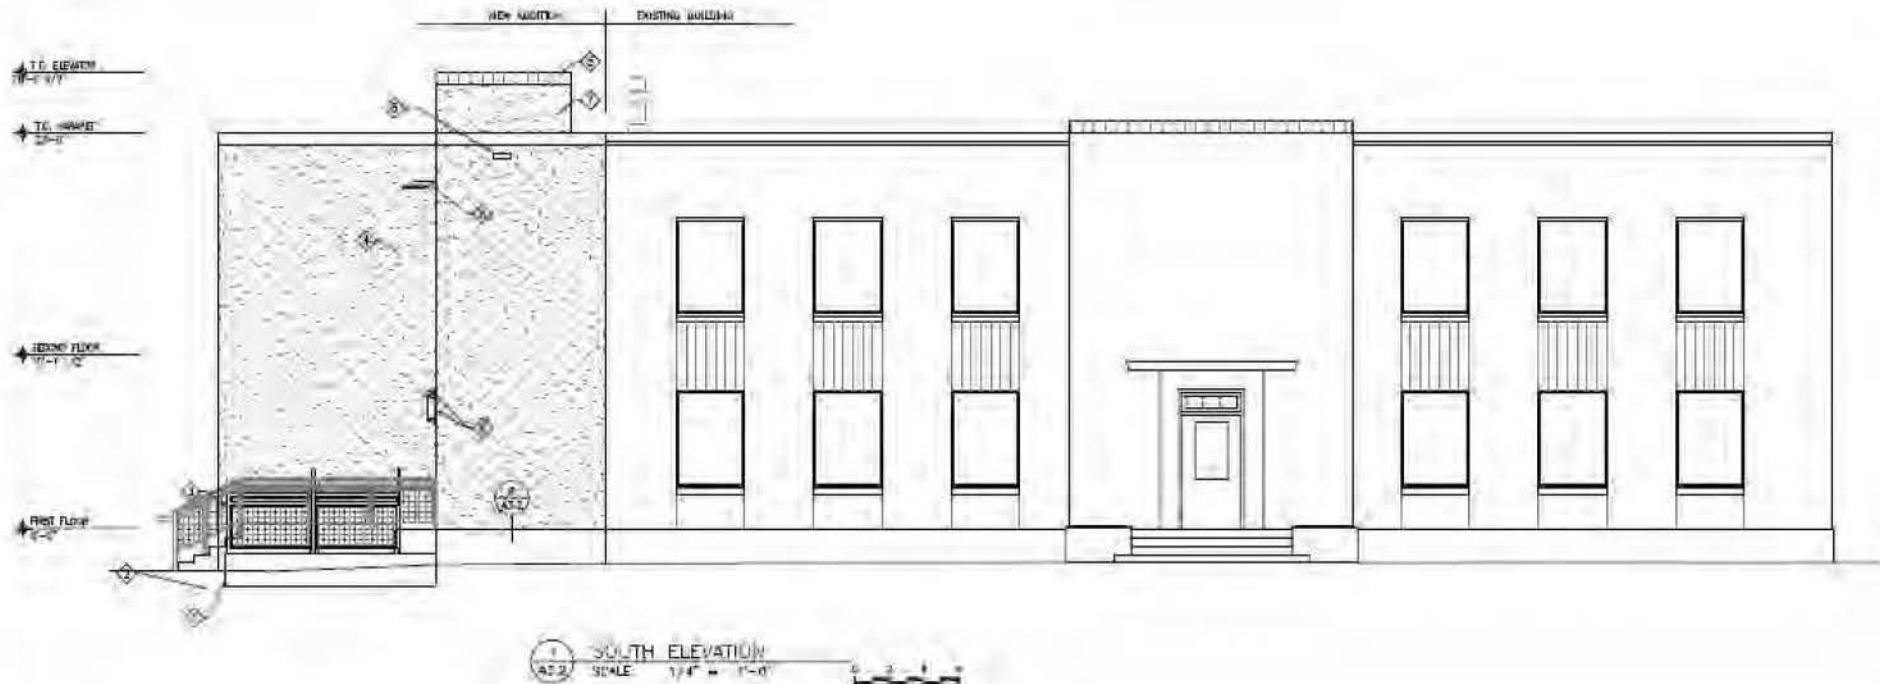
A3.2

1. NEW CONCRETE BASE
2. NEW CONCRETE STAIR
3. ALUMINUM PIPE CORRO. PAINT/MATERIAL
4. SMOOTH FACE NATURAL COLORED CONCRETE WALL WITH CUT GROOVES. SEE 2/A3.2
5. FINISHED HARVEST CAP
6. SCUPPER 4" X 12"
7. ELEVATOR ENCLOSURE
8. NEW LIGHT FIXTURE, SEE ELECTRICAL
