Engineering and Public Works Department  
155 South Seward Street  
Juneau, Alaska 99801  
Telephone: 586-0800 Facsimile: 586-4565

SUBJECT: Mendenhall River Drainage Outfall Culverts- Update – **CHECK VALVES INSTALLED!**

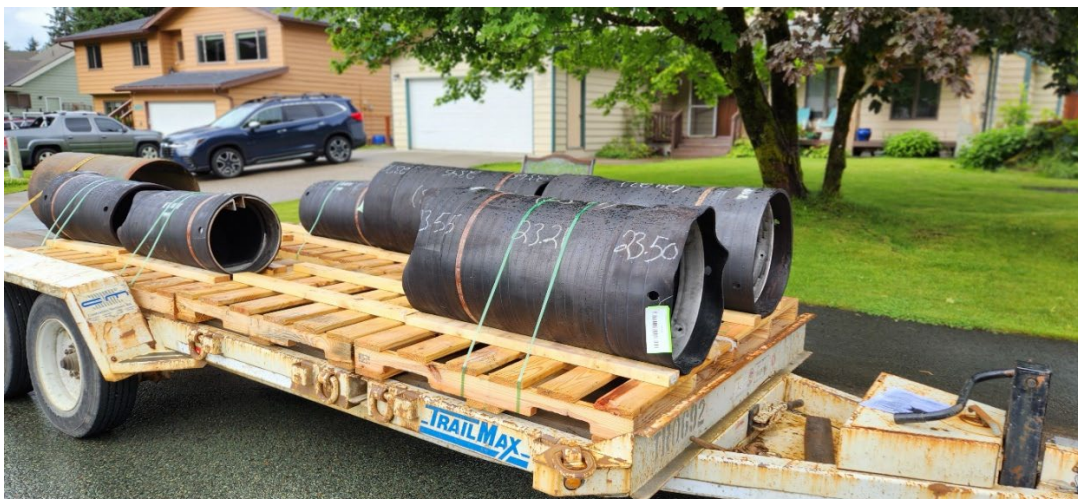
Figure 1 Image of Trailer load of In-line Check Valves

- **One-way check valve:** Is installed inside of the culvert with a pressure fit band sealing to the inside of the culvert. The rubber diaphragm (internal to pipe) remains sealed except when the inside water pressure is greater than the water pressure outside of the pipe. (Outside water pressure typically nonexistent except during flood events.)

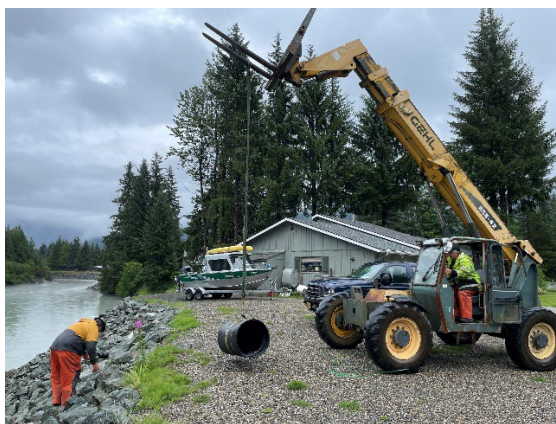
*Figure 2 Image of installation of check valve at Rivercourt Way.*

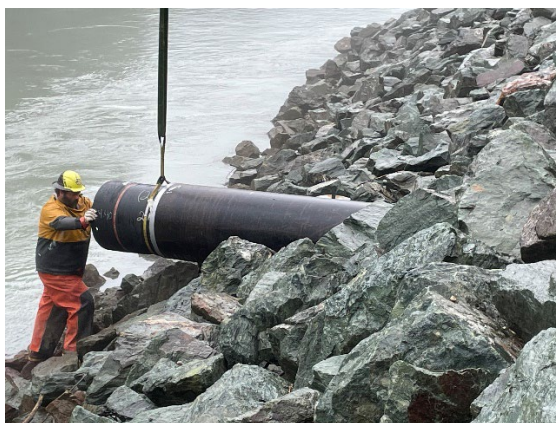
*Figure 3 Image of installation of check valve at Rivercourt Way.*

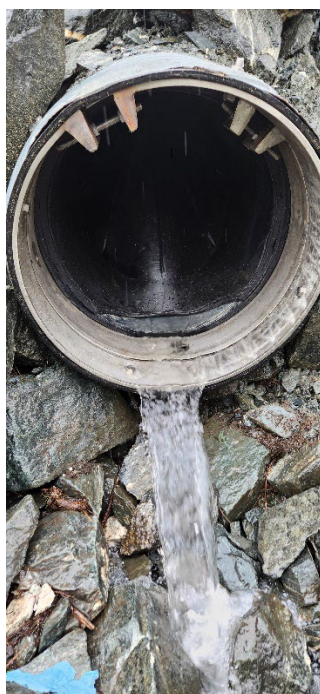
*Figure 4 Image of the installed and functioning check valve – Meander at Northland Outfall*

Meander at Northland Outfall - 20"  
Installed week of 7-15-24

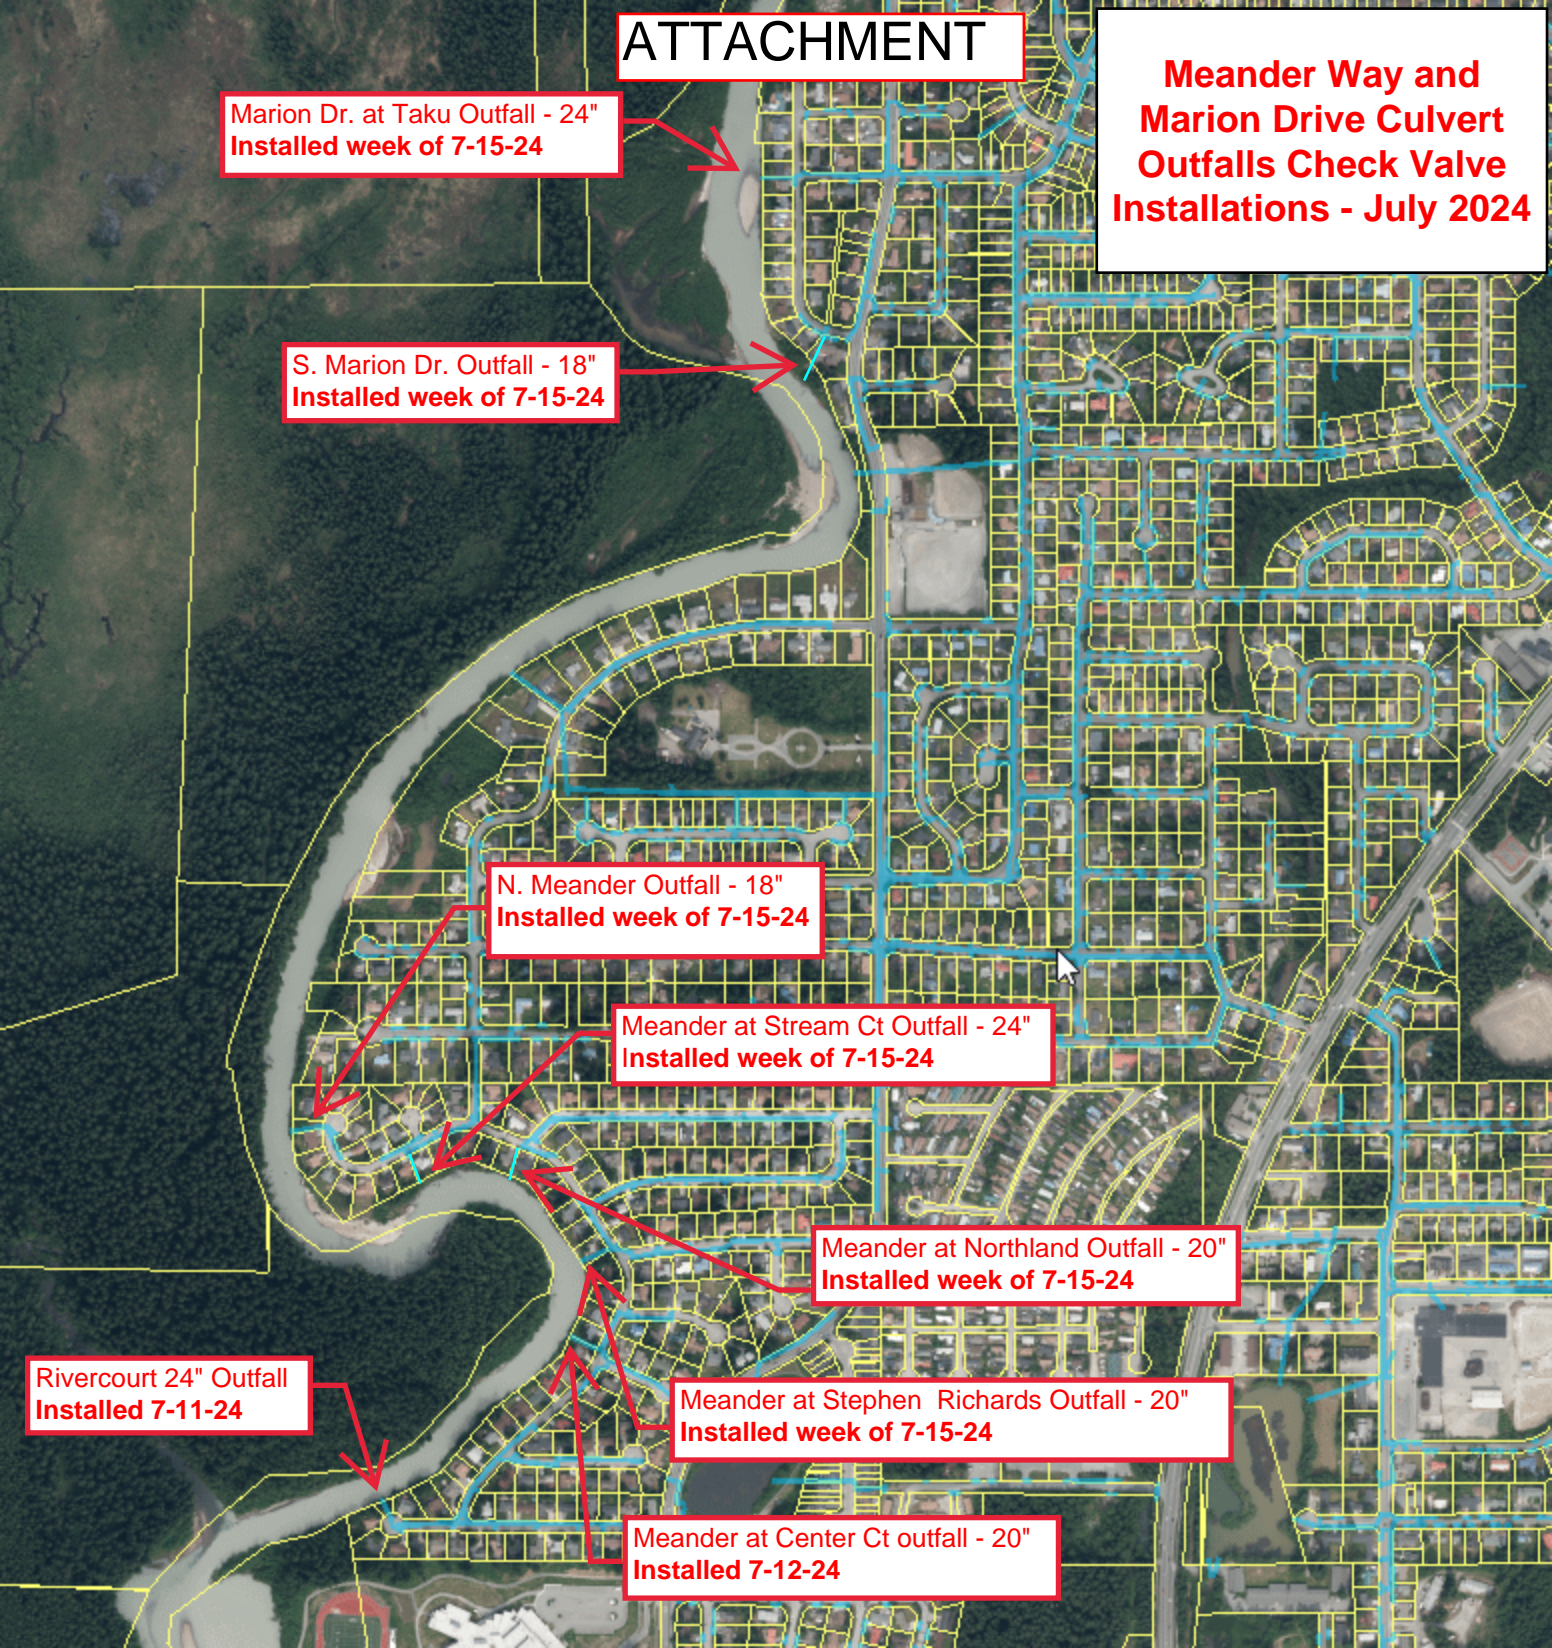
## Meander Way and Marion Drive Culvert Outfalls Check Valve Installations - July 2024

Marion Dr. at Taku Outfall - 24"  
Installed week of 7-15-24

S. Marion Dr. Outfall - 18"  
Installed week of 7-15-24

N. Meander Outfall - 18"  
Installed week of 7-15-24

Meander at Stream Ct Outfall - 24"  
Installed week of 7-15-24

Rivercourt 24" Outfall  
Installed 7-11-24

Meander at Stephen Richards Outfall - 20"  
Installed week of 7-15-24

Meander at Center Ct outfall - 20"  
Installed 7-12-24
