SUBJECT: Mendenhall River Drainage Outfall Culverts- Update – **CHECK VALVES INSTALLED!**

The eight culverts along Meander / Rivercourt Way and Marion Drive have check valves installed and complete as of July 19. The last update, on April 15, was a transfer request to help fund the check valve project. The PWFC recommended the request to the full Assembly for approval. The formal transfer was approved on April 29, 2024.

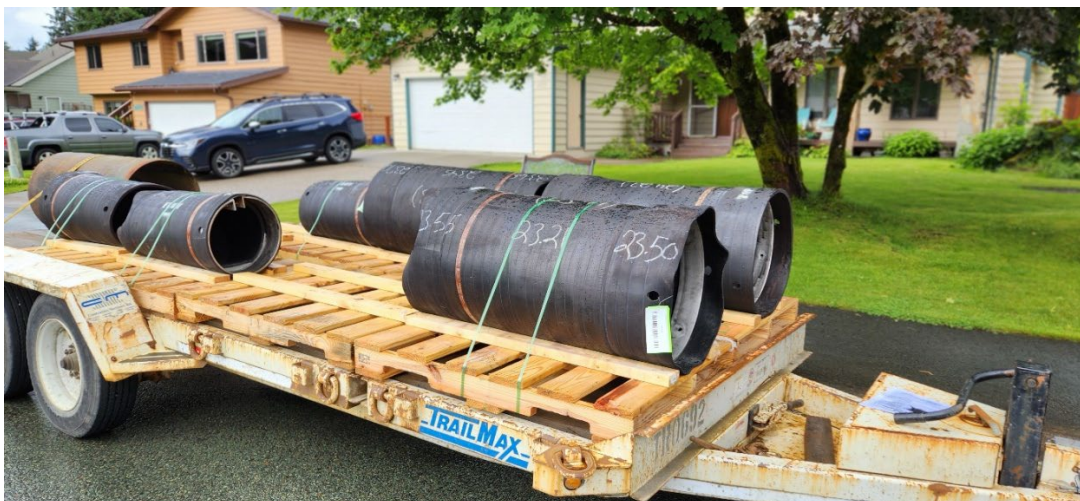
Figure 1 Image of Trailer load of In-line Check Valves

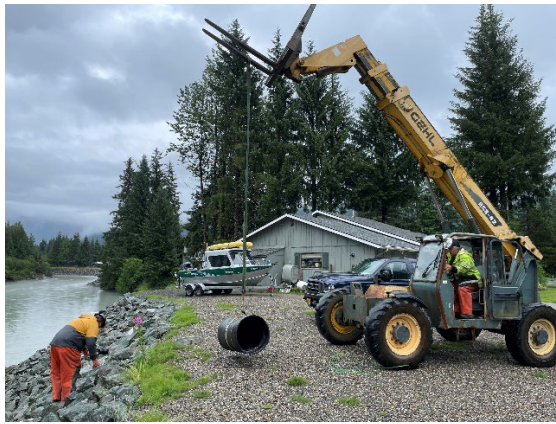
*Figure 2 Image of installation of check valve at Rivercourt Way.*

- **One-way check valve:** Is installed inside of the culvert with a pressure fit band sealing to the inside of the culvert. The rubber diaphragm (internal to pipe) remains sealed except when the inside water pressure is greater than the water pressure outside of the pipe. (Outside water pressure typically nonexistent except during flood events.)

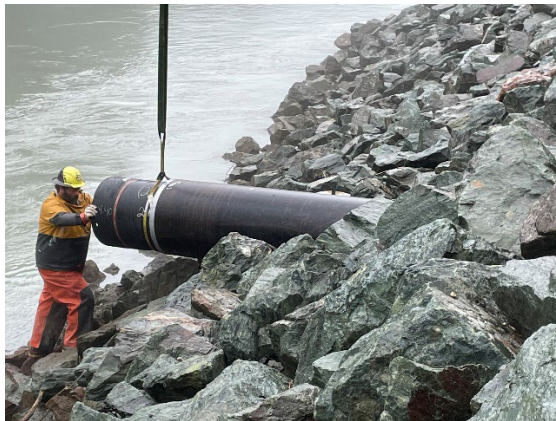
*Figure 3 Image of installation of check valve at Rivercourt Way.*

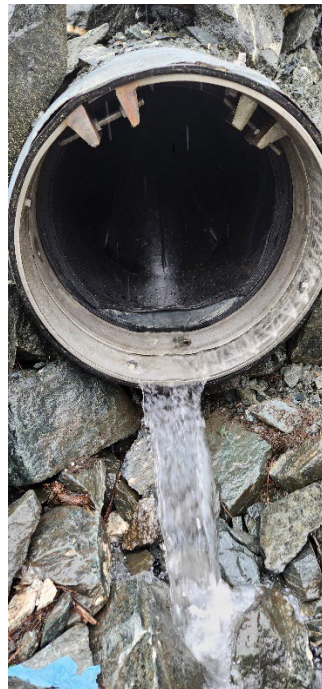
*Figure 4 Image of the installed and functioning check valve – Meander at Northland Outfall*
