PLANNING COMMISSION NOTICE OF RECOMMENDATION

Date: November 14, 2022
File No.: CSP2022 0004

PLANNING COMMISSION STAFF REPORT
CITY PROJECT REVIEW CSP2022 0004
HEARING DATE: NOVEMBER 8, 2022

PROPOSAL: Teal Street Right of Way Improvements, including repaving of two 12-foot lanes, addition of curb, gutter, sidewalks, street lighting, and street signage, replacement of water and sewer mains and services, improvement to drainage, and addition of a Capital Transit bus pull-out

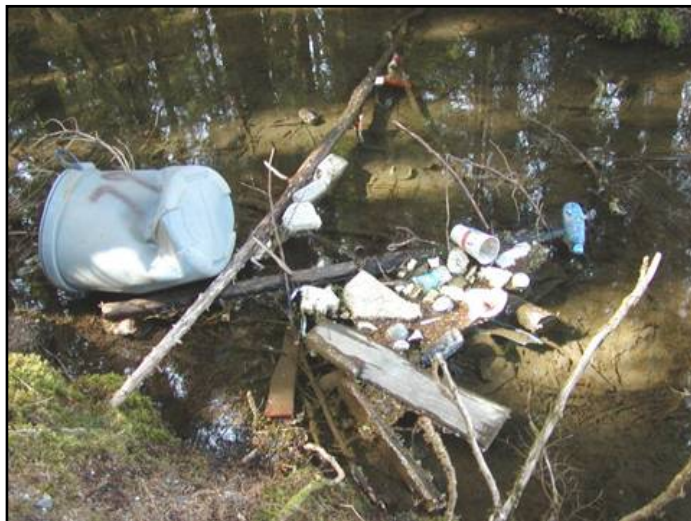
Figure 5: Garbage in Jordan Creek. May, 2003.

Household garbage pulled into the creek or its banks by bears is a substantial source of debris in the

side of Jordan Creek along Thunder Mountain. Improperly stored garbage has been documented as a prime bear attractant and has been a source of concern both from a public safety and a litter problem. CBJ records show that many of the reported bear sightings in the Mendenhall Valley are in the more densely populated areas that lie at the edge of the forest, such as Thunder Mountain Trailer Park. Most trailer residents do not have garages or outbuildings, and find it difficult to keep trash indoors between collections.

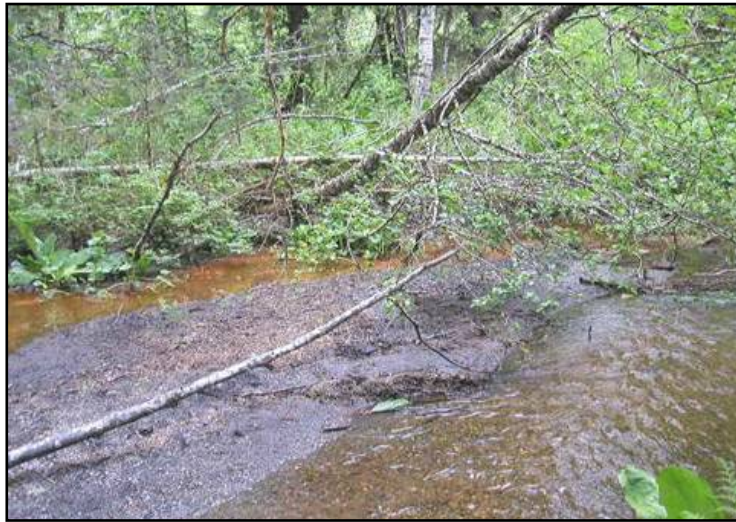
Figure 6: Iron precipitate in the main channel near Jennifer Drive. April, 2005.

The presence of rust-colored precipitate (Figure 6) confirms that groundwater entering Jordan Creek in some stream reaches is low in oxygen and contains substantial concentrations of iron. Anoxic groundwater picks up dissolved iron as it flows through iron-containing soil layers. Upon reaching the hyporheic zone and subsequently the water column, the dissolved iron binds with oxygen to form a precipitate. The process results in consumption of dissolved oxygen as surface waters mix with the groundwater and iron oxides are formed.

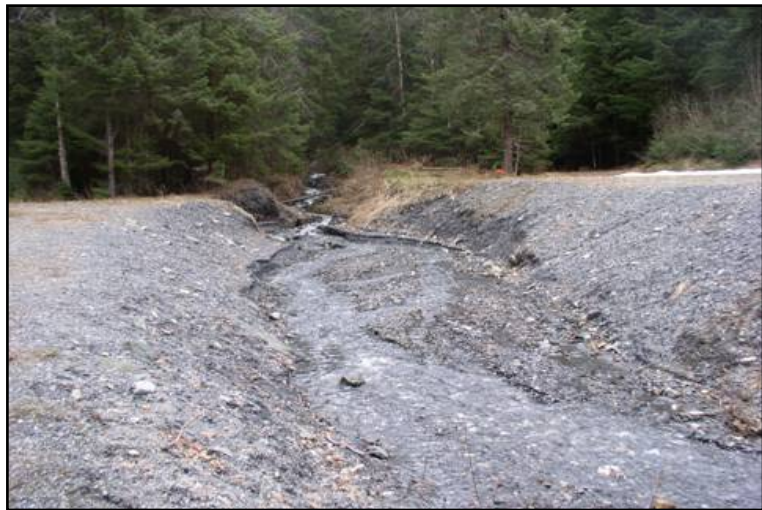
Figure 7: Streambank erosion near the City water tower. The tower is located to the right of the stream. April, 2005.

The low gradient of the main channel implies that Jordan Creek is extremely sensitive to sediment input; erosion is likely to occur on steep uplands and disturbed areas, and stream energy is not normally great enough to mobilize accumulated sediments. Although some sediment inputs can be expected under natural conditions, riparian and upland disturbance has occurred throughout the watershed as the area becomes more urbanized. Substantial erosion was reported during construction of the water tower east of Jordan Creek, an area that continues to contribute sediment to the stream (Figure 7). Illegal off-road vehicle use in the upper watershed has caused streambank, floodplain, and upland erosion. Riparian disturbance can frequently be observed in the lower stream corridor, where development is in close proximity to the stream.

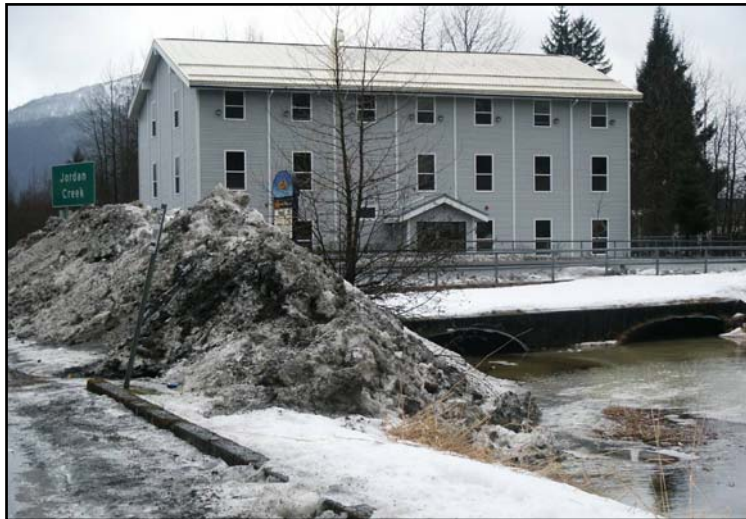
Figure 8: Snow plowed from streets and driveways stored in the creek near Jordan Creek Center. Sediment and debris are deposited in the creek when the snow melts. February, 2005.

Sand that is applied to roads and parking areas for traction during winter months also contributes to streambed sedimentation. The CBJ Streets Division cleans out sediment traps and oil-water separators in storm drains throughout the Borough at least once each year, which helps reduce the amount of sediment being delivered directly into surface waterways. However, sand used on local roadways accumulates in snow enters the creek during spring runoff or is deposited in the creek during snow removal and storage activities throughout the winter (Figure 8).

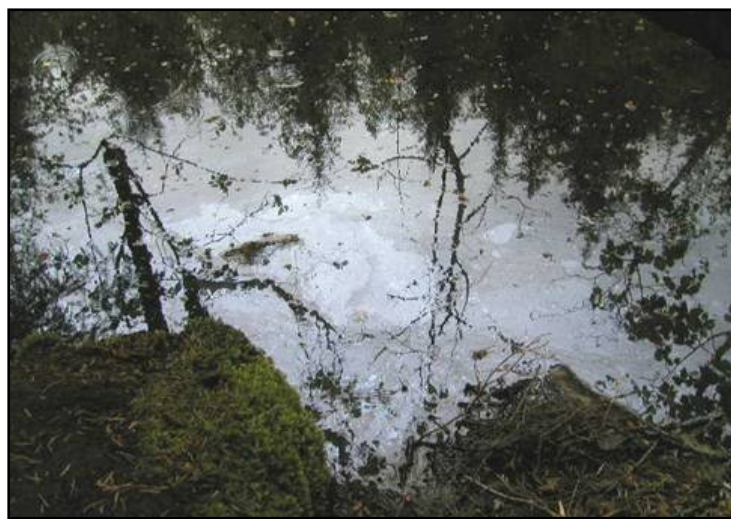
Figure 9: Hydrocarbon sheen on the water surface near Jordan Creek Center. February, 2005.

vegetation before entering ground or surface water. Household and industrial runoff may contain pollutants such as hydrocarbons, fertilizers, pesticides, pet feces, and various chemicals including solvents and cleaning fluids. Hydrocarbon sheen has been observed on the surface of Jordan Creek during stream surveys (Figure 9).

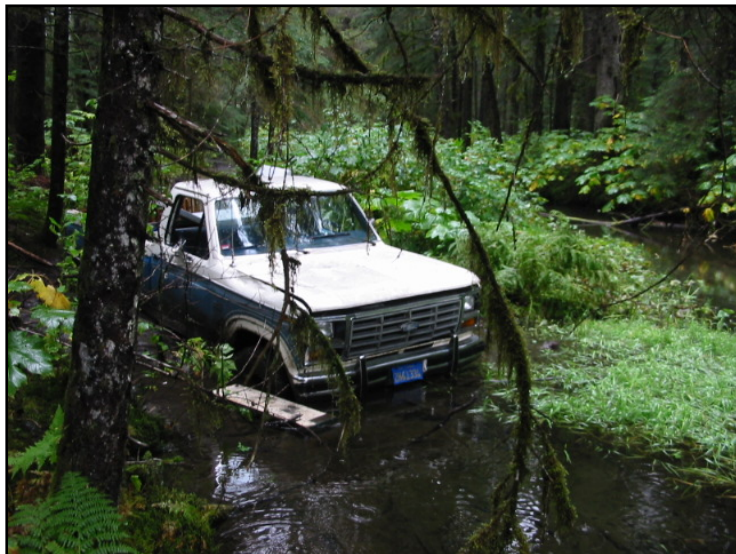
Figure 10: A truck in upper Jordan Creek. Spring, 2003.

The area near the former pond site continues to be used as an illegal dump site. Several similar illicit dumps exist in the upper creek corridor and may contain debris that includes toxic chemicals. Car batteries, fuel containers, appliances, paint cans, and even a vehicle (Figure 10) have been found in or near the creek.

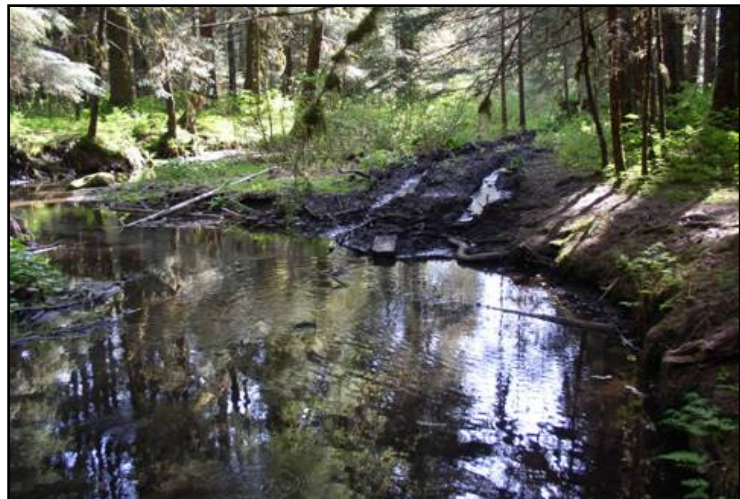
Figure 12: Damage to the streambed, banks, and adjacent wetlands in upper Jordan Creek due to illegal off-road vehicle use. May, 2004.

Elsewhere, riparian disturbance is less contrived. Clearing of riparian vegetation is sometimes conducted by streamside landowners. Riparian vegetation has been trampled in several locations in the lower creek corridor, particularly where parking lots and businesses are in close proximity to the stream. Damage caused by illegal off-road vehicle users is more common in upper Jordan Creek, where floodplain wetlands associated with the Jordan Creek drainage on the east side of the stream have also been affected (Figure 11). Several locations near

Nancy Street and Valley Boulevard have been damaged by vehicles driving through and sometimes in the creek. The loss of riparian vegetation decreases available cover for fish, but also tends to destabilize streambanks. Erosion—either natural or human-caused—will result in sediment deposition in the creek since most of the area’s soils have high sand and silt content (Schoephorster and Furbish, 1974), and the main channel lacks sufficient energy to mobilize fine materials. The result is a loss of spawning habitat and a decrease in egg survival rates.

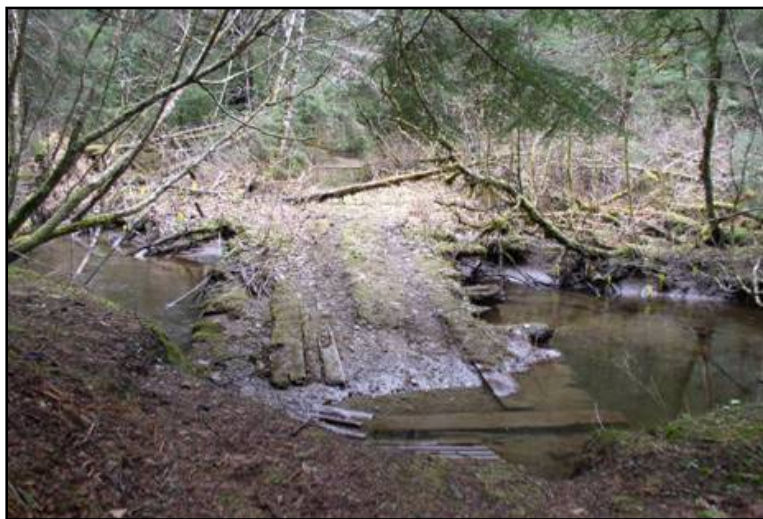
Figure 13: Collapsed bridge near Sasha Street. April, 2005.

Most of the crossings appear to be functioning, with the exception of the old bridge at Sasha Street (Figure 13). Near the outlet in the State Game Refuge, the Airport maintains four stream crossings in close succession on Jordan Creek, with culverts ranging from 81 to 350 feet in

Action 3.1.2 ⇒ *Remove the failed bridge at Sasha Street.*

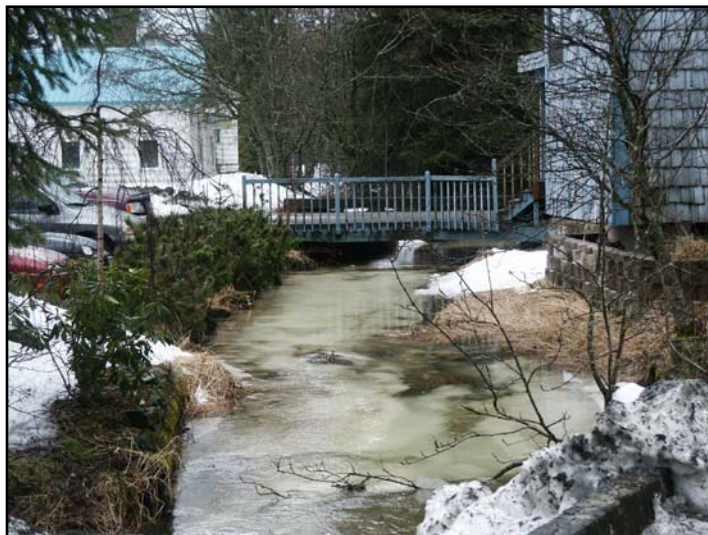
Figure 14: Buildings and parking areas in lower Jordan Creek that are situated within the 50-foot setback. February, 2004.

49.70.310). Structures and parking areas do exist within the setback, either because they were constructed prior to enacting the ordinance or because variances are granted. Development close to the creek is particularly evident downstream of Egan Drive (Figure 14).
