Recommendation To Approve Contract 20455 With Galena Engineering for Warm Springs Bridge Maintenance Permitting

Attachment B: ITD Inspection Report

Idaho Transportation Department Bridge Inspection Report

**ITD DISTRICT 4 OFF-SYSTEM
BRIDGE INSPECTION**

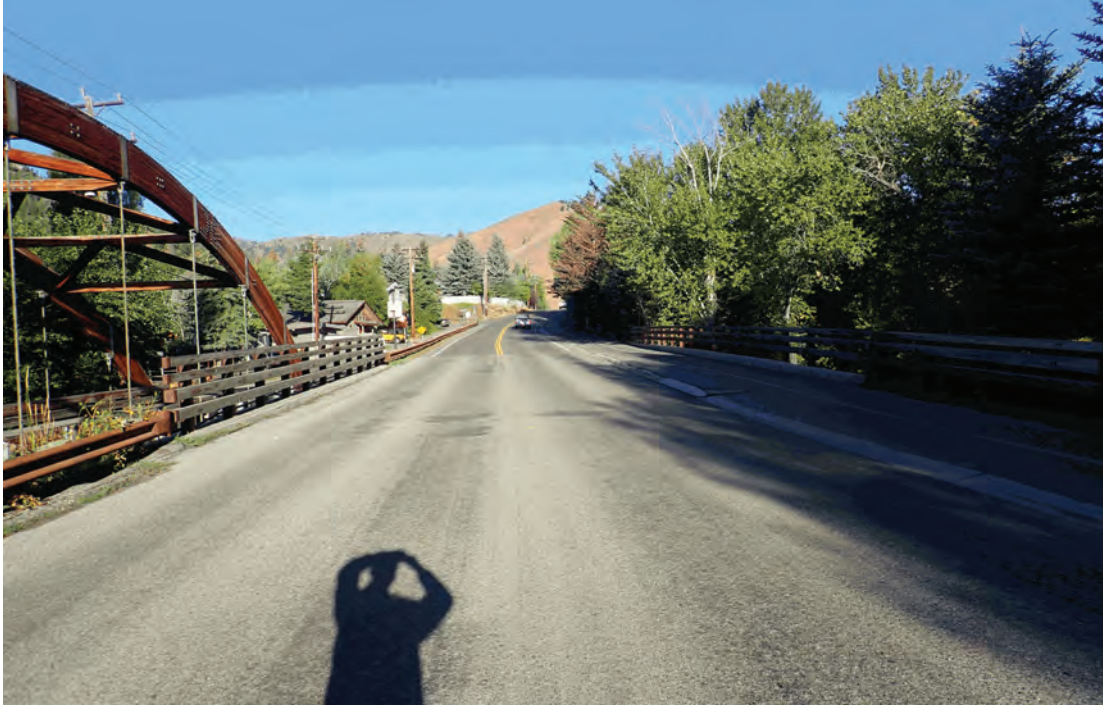
ROADWAY APPROACHES: Asphalt approaches have cracking and up to 1/2 inch settlement.

Approach looking west.

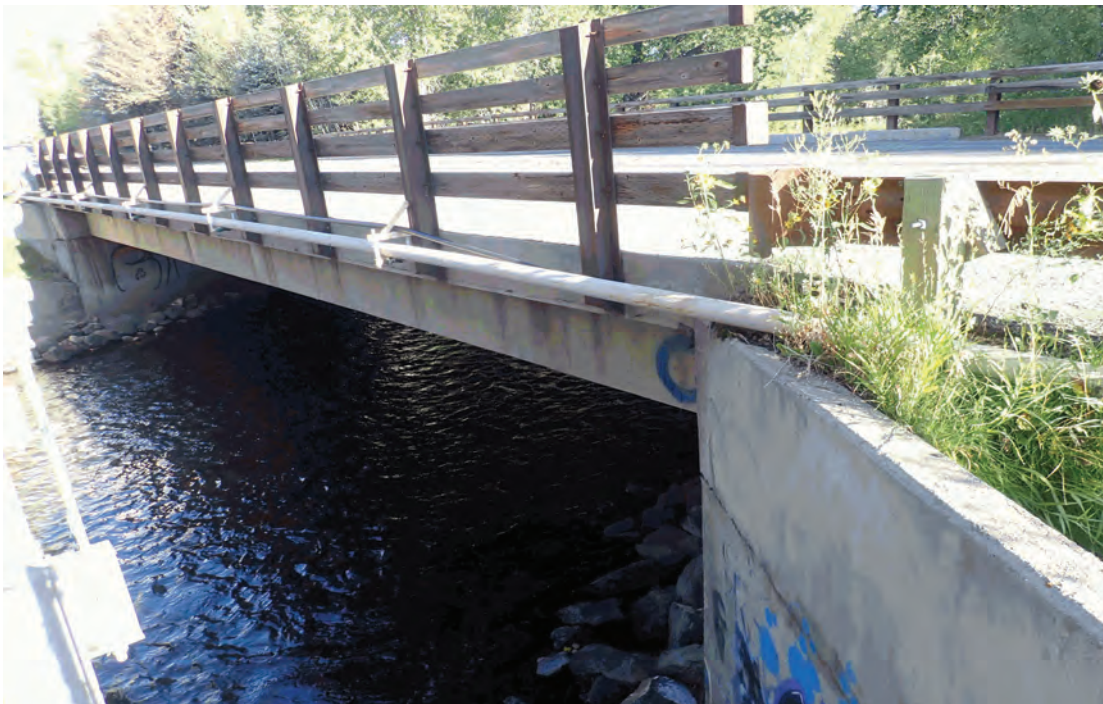
Overall looking northwest.

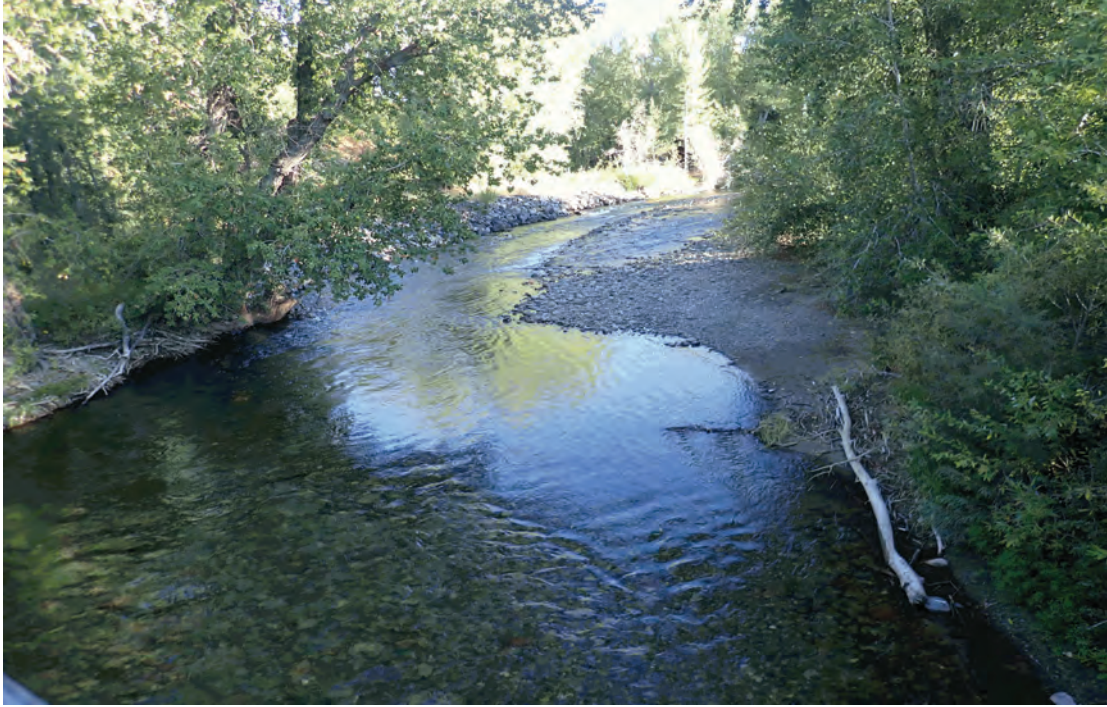
CHANNEL: Natural river channel. Channel bottom consists of cobble and boulders. Riprap along both abutments. Minor scour in northeast corner. Clear and stable. Substructure dry 9/2015. Cross section done 9/2012 and 9/2017.

Upstream looking north.

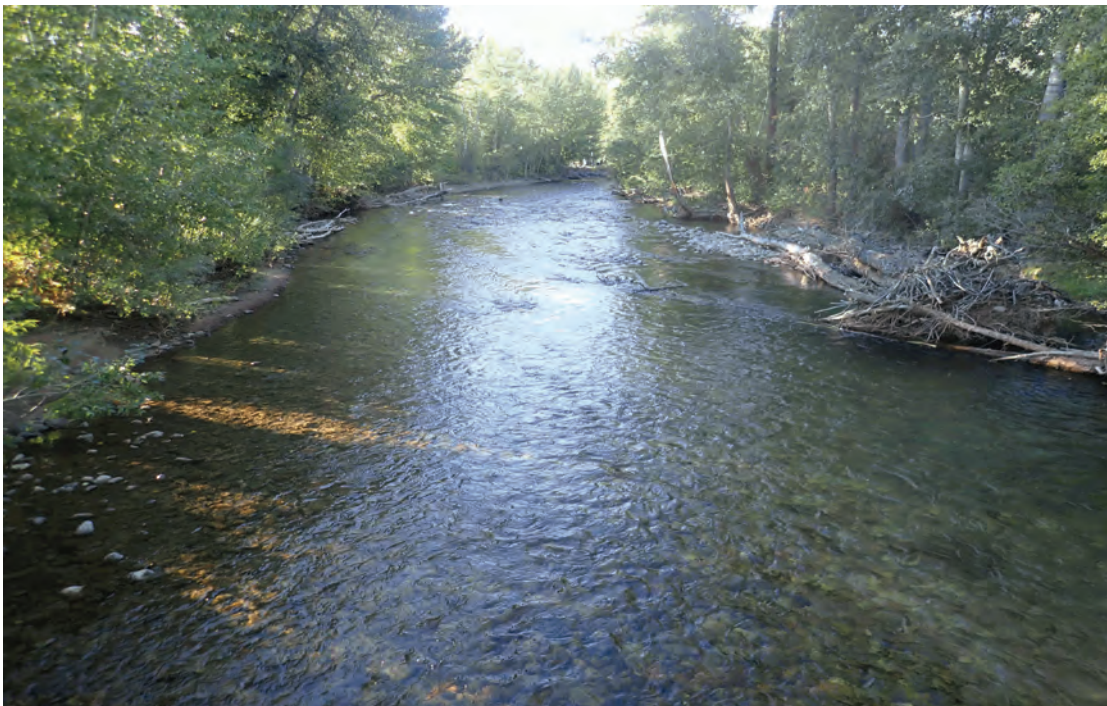
Downstream looking south.

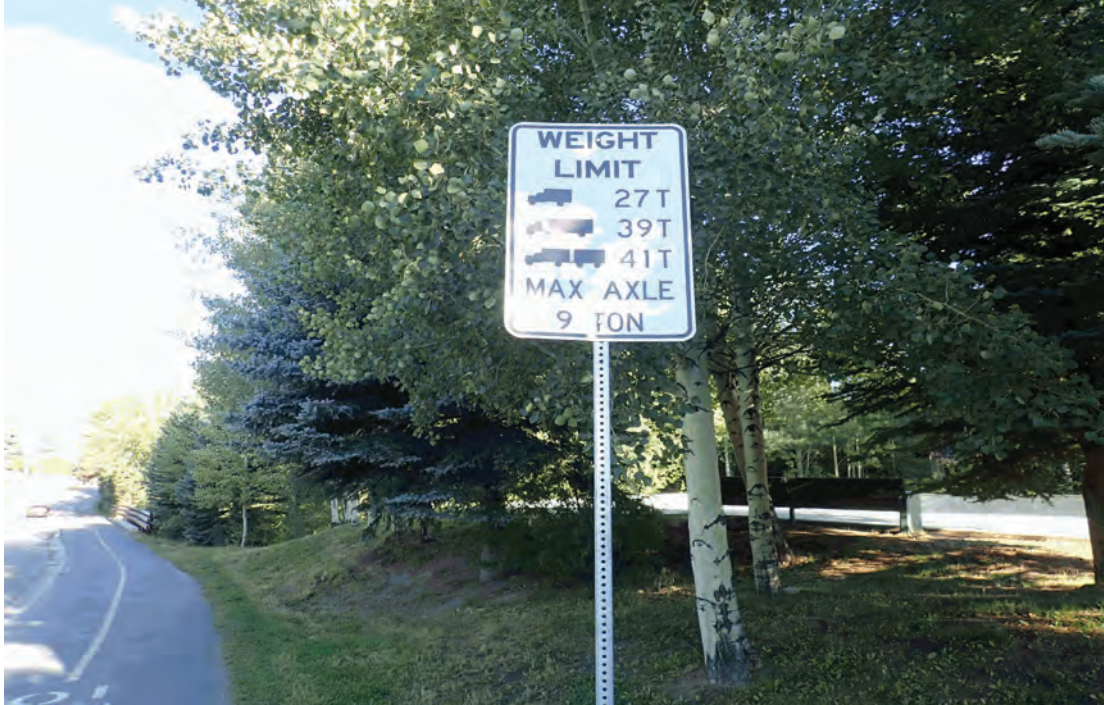
SIGNS: One hazard marker located at southwest corner. Weight limit signs reading 27T, 39T, 41T, Max Axle 9 TONS are up at both approaches.

NOTES: Letter sent to city on 3/4/13 letting them know that load posting signs can be removed, bridge has been load rated and does not required posting (load posting signs still in place 9/2019).

Weight limit sign at east approach looking west.

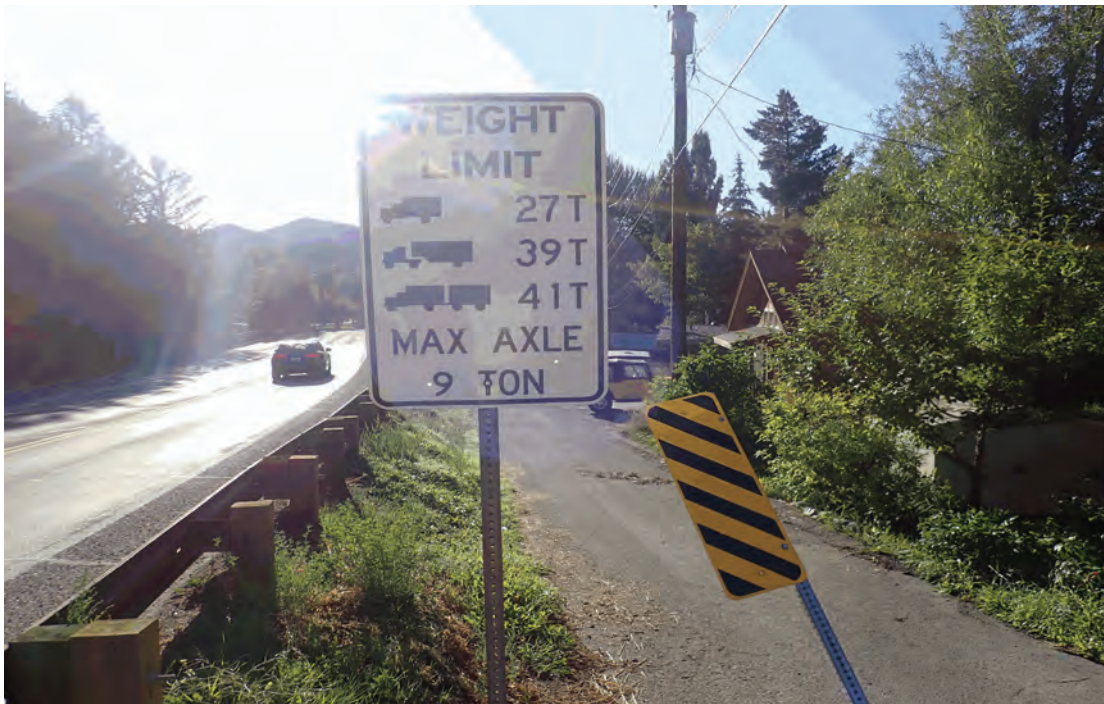
Weight limit sign at west approach looking east.

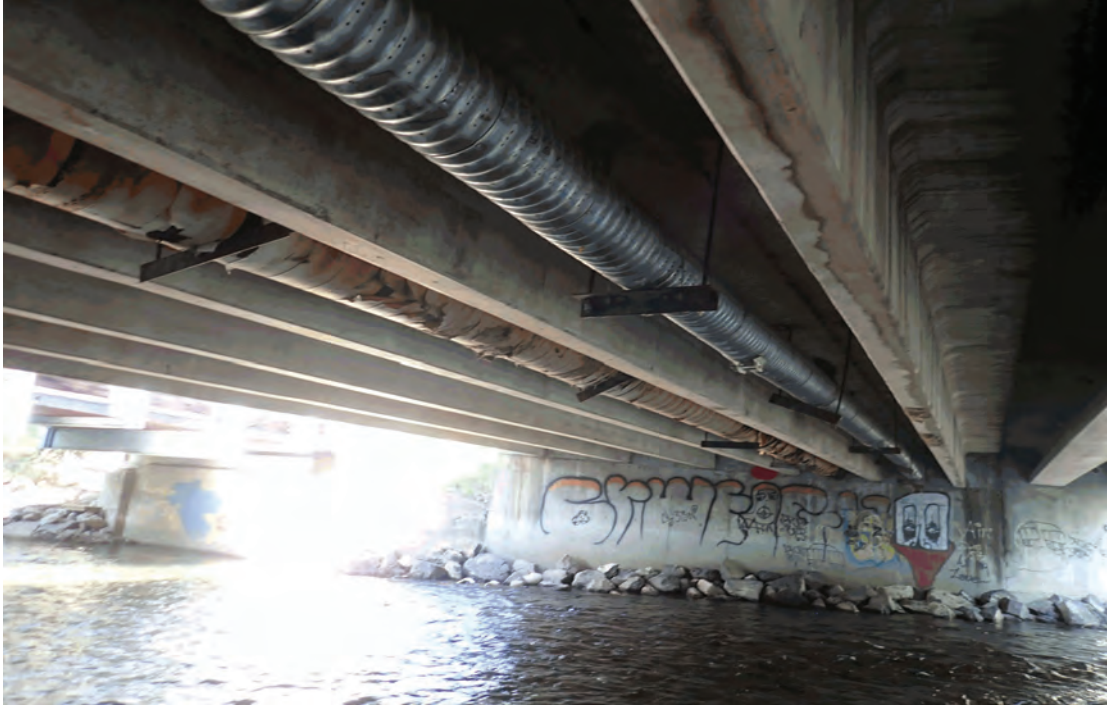
Elastomeric bearing pads on concrete abutments. Three pads at the west abutment are crushed.

Underside and west abutment looking southwest.

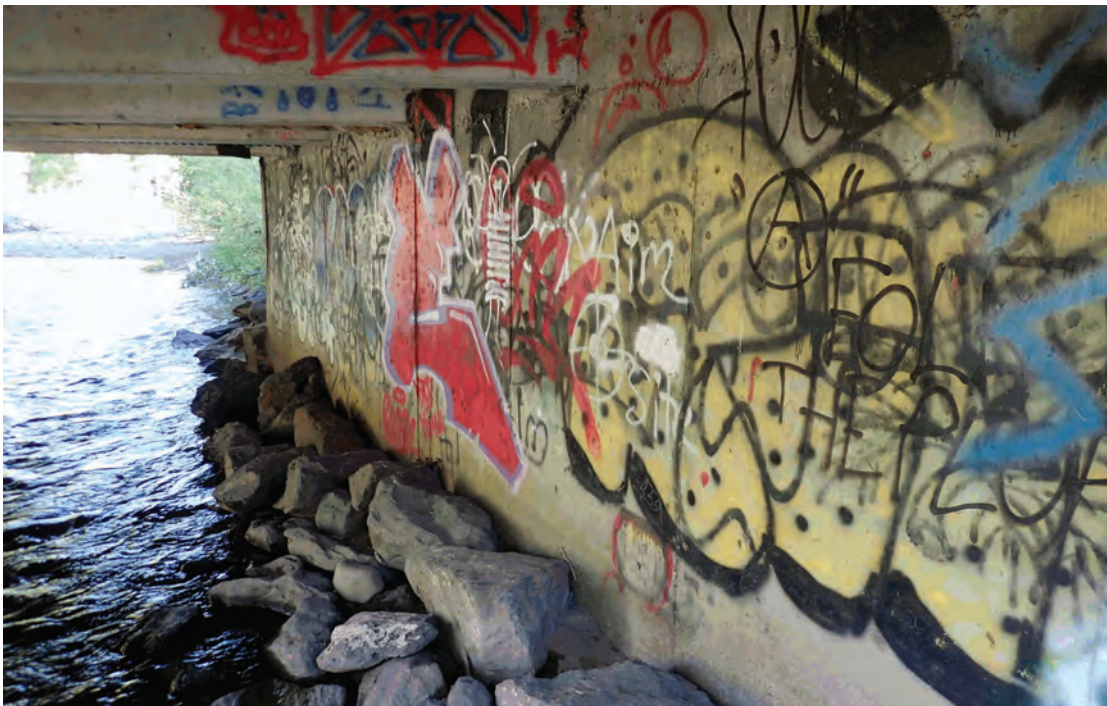
Reinforced concrete abutments. Wingwalls are integral with abutments on the south side only, wingwalls located on the north side are extended from adjacent pedestrian bridge. Northwest joint where sidewalk abutment adjoins bridge abutment has rust staining. Hairline vertical cracks with efflorescence. Scour located at the northeast corner is 4 feet in length with a maximum vertical exposure of 1 foot and 1 foot of penetration.

East abutment looking northeast.

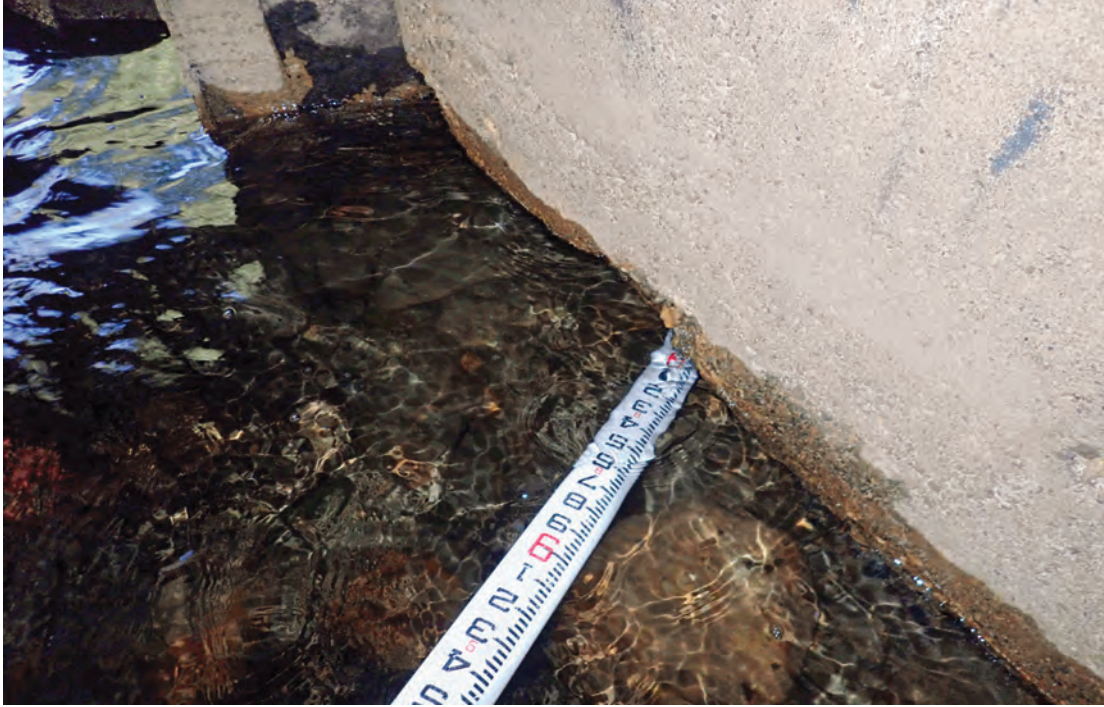
6000/3 Scour 4 ft 0 4 0 0
Scour located at the northeast corner is 4 feet in length with a maximum vertical exposure of 1 foot and 1 foot of penetration.

SCOUR REVIEW: Scour Committee reviewed 6/18/18, item 113 to remain U(L). Scour has progressed but substructure type is not apparent. Has a maintenance recommendation.

Undermining at northeast corner looking northeast.

Recommendation	Priority	Suggested Work Assignment
Mitigate scour northeast corner.	Medium	Local Agency

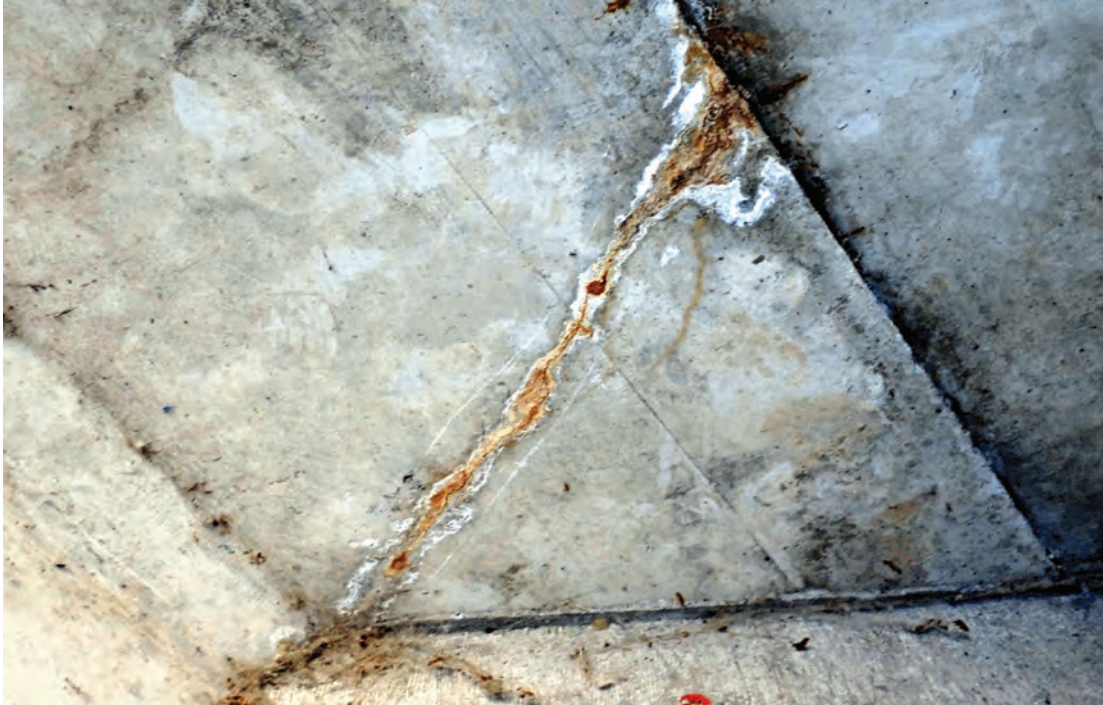
1080/2	Delamination/Spall/Patched Area	6	ft	0	2	4	0
	<i>One large and several small spalls on girder webs due to impact damage. Girder flange joints have random spalling.</i>						
1090/2	Exposed Rebar	86	ft	0	84	2	0
	<i>At the east abutment near the west 1/4 span, the flanges are damaged around the embeds with exposed rebar. Girder 6 near the west abutment has an 8 inch long x 2 inch wide spall with exposed rebar located on the underside of the top flange. Girder 1 has exposed rebar along the exterior flange for the full length.</i>						
1100/2	Exposed Prestressing	1	ft	0	1	0	0
	<i>Girder 1 near the east abutment has a small exposure of prestressing tendon end with exposed rebar located at the bottom of the web. The small exposure may be due to form work, no major distress in girder.</i>						
1110/2	Cracking (PSC)	4	ft	0	4	0	0
	<i>All girders at the east abutment and several girders at the west abutment have diagonal hairline to 1/32 inch cracks located on the flanges. Girder 5 near the west abutment has a hairline diagonal crack located at the top of the web.</i>

Cracks in flanges at east abutment.

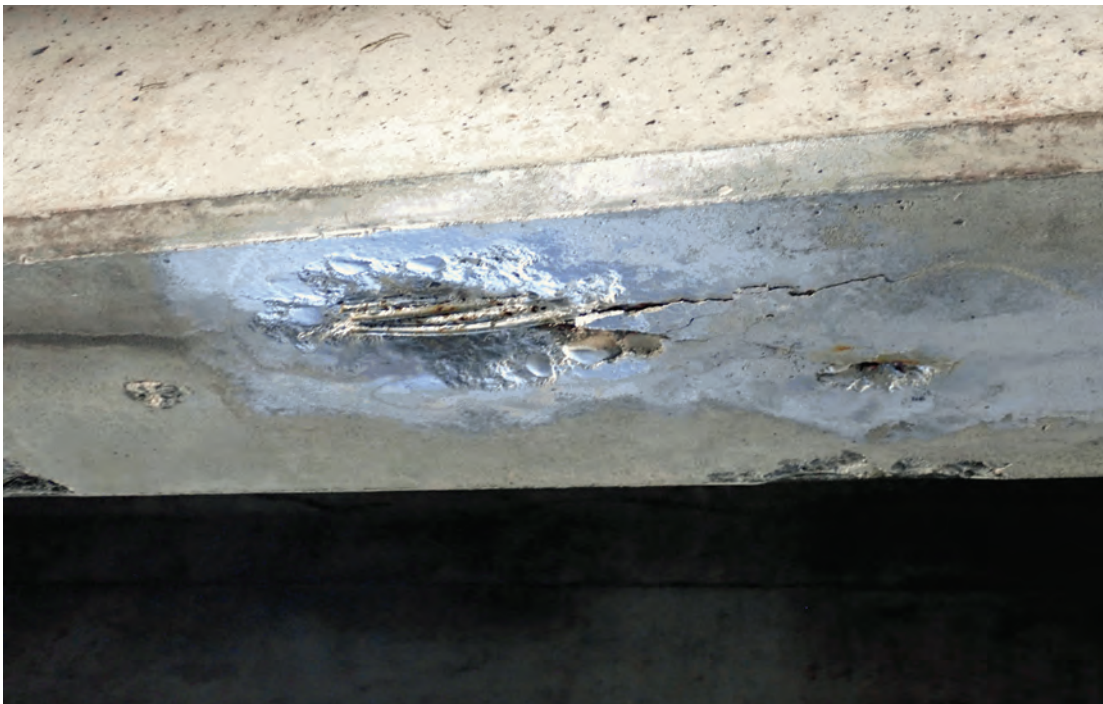
7000/2 Damage 8 ft 0 4 4 0
One large and several small spalls on girder webs due to impact damage. At the east abutment near the west 1/4 span, the flanges are damaged around the embeds with exposed rebar.

Exposed prestressing looking north.
