**STAFF REPORT
HISTORIC PRESERVATION COMMISSION
REGULAR MEETING OF September 28th, 2021**

PROJECT: Martha's Place (Formerly Known as the Batis House) Historic Building Demolition Request

FILE NUMBER: H21-051

REQUEST: Demolish the structure at 431 N Washington Avenue and replace structure with outdoor garden

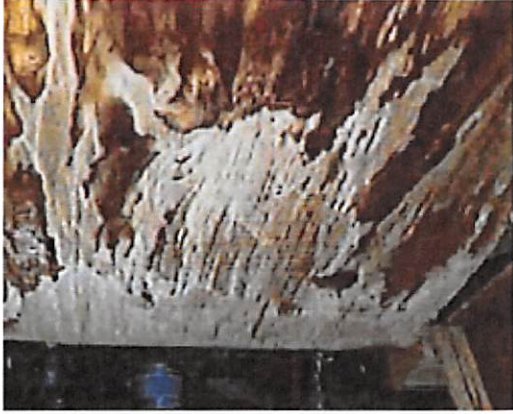
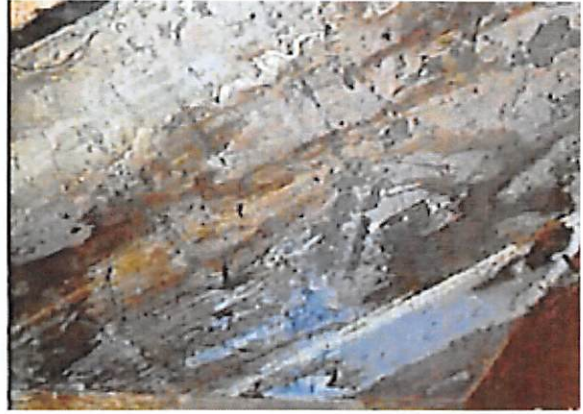
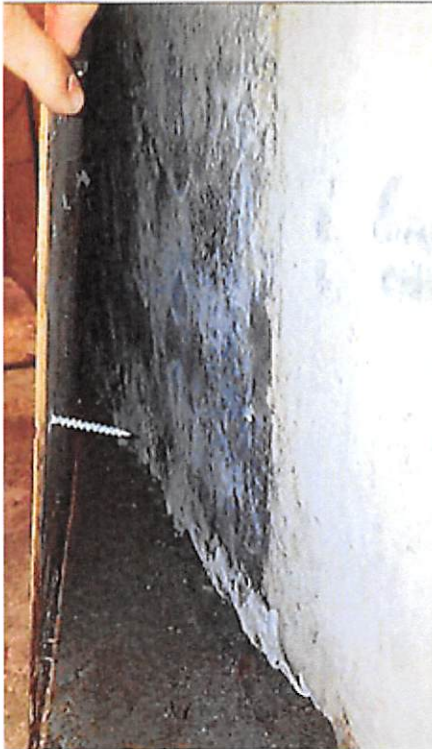
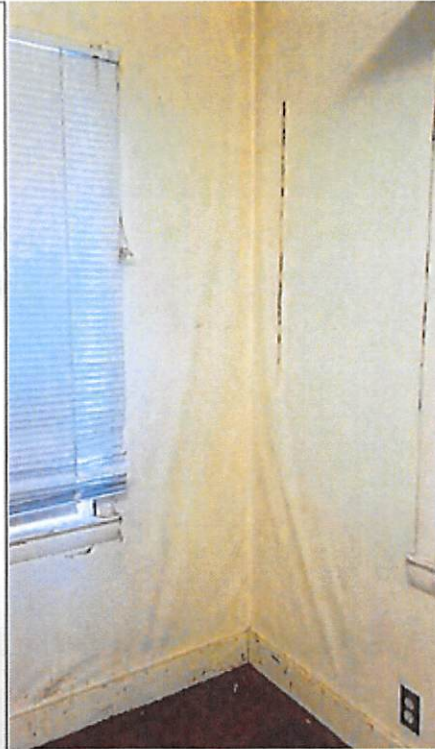
Mold Photos

Most plumbing throughout the house showed long terms signs of leaking along with visible mold growth

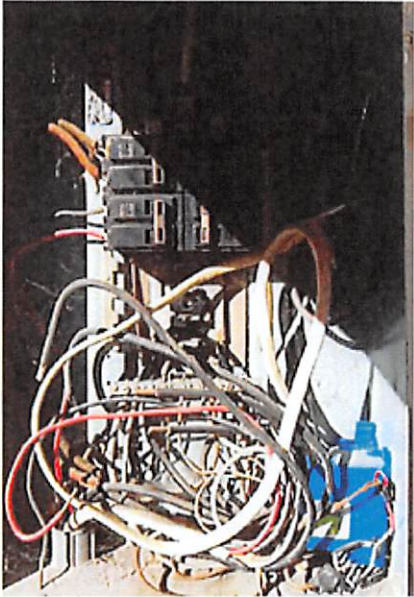
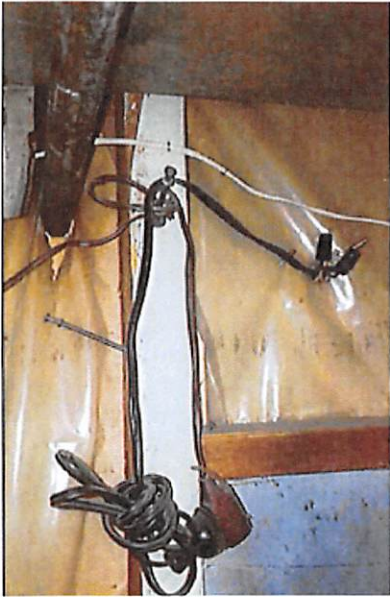
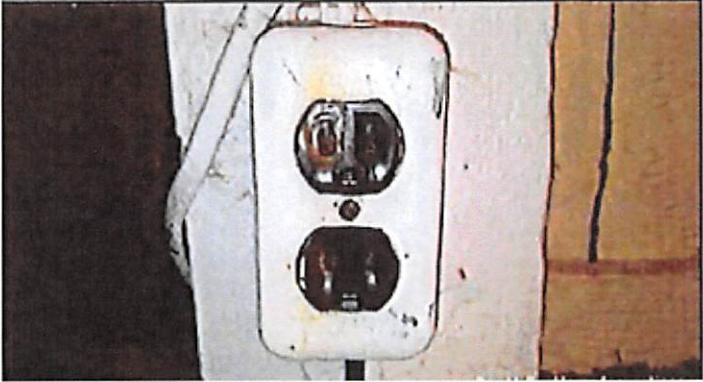
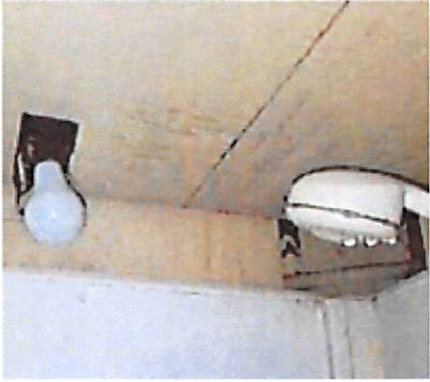
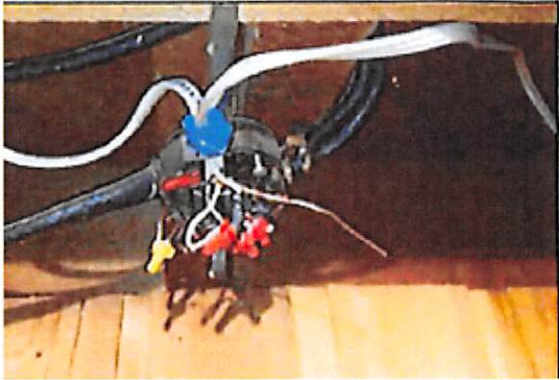
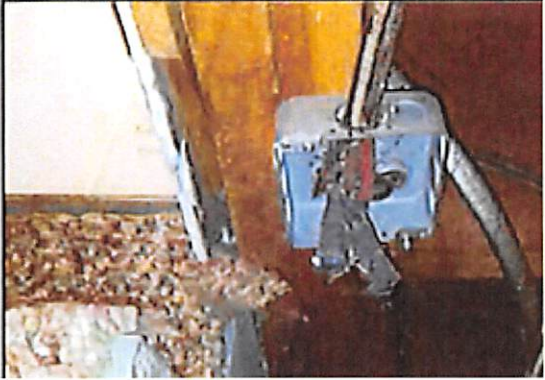
Electrical Photos

Noted electrical outlets exposed to moisture, some with visible burn marks, extension cords used as permanent wiring

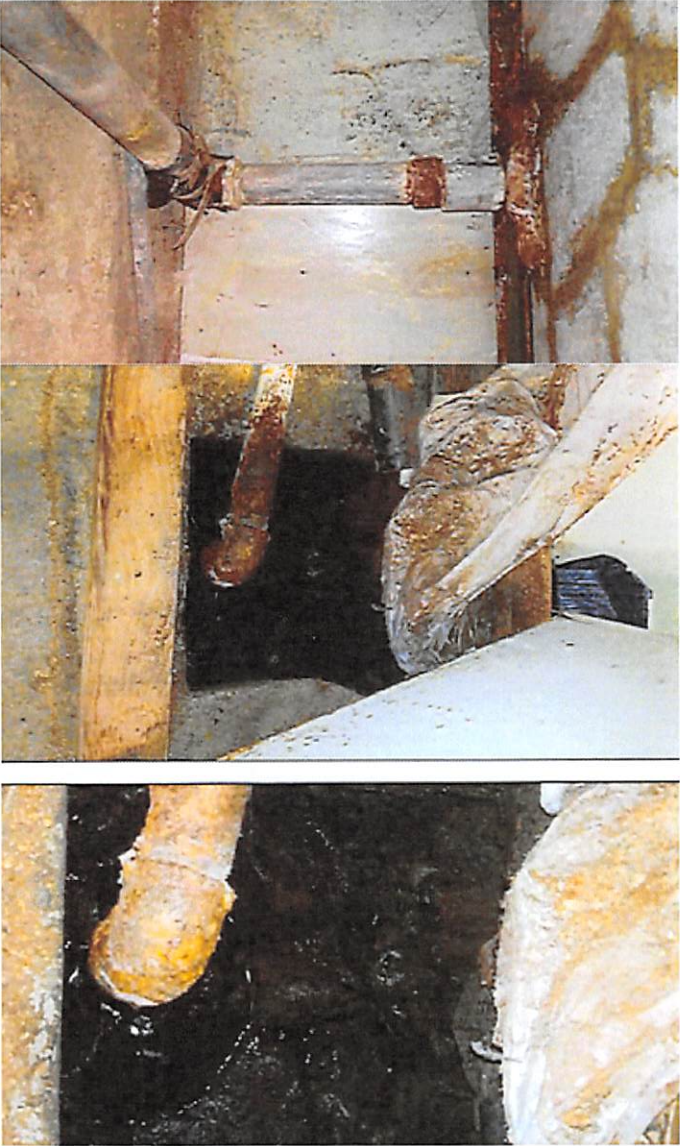
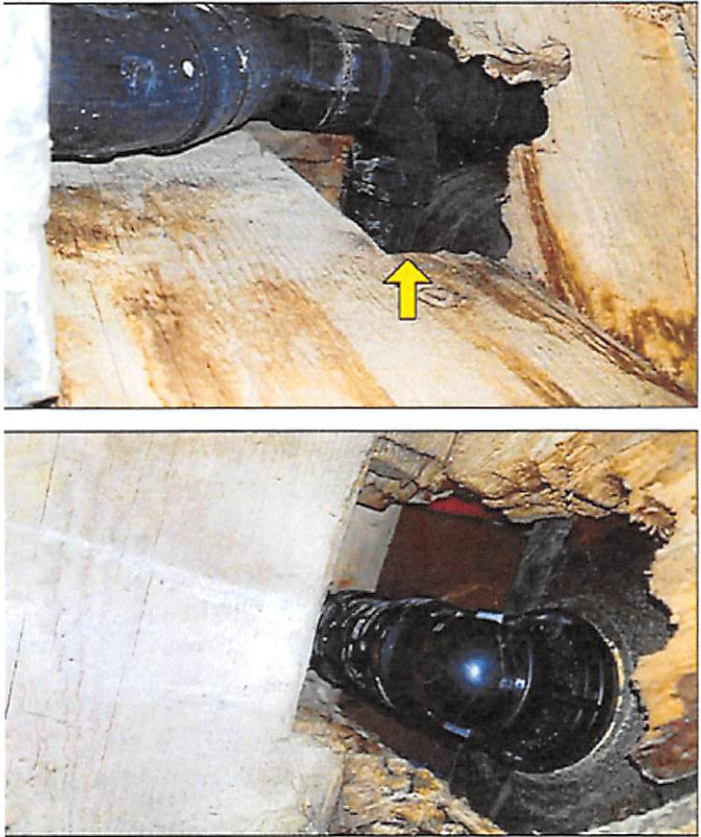
Plumbing

The visible water distribution pipes were a combination of 1/2-inch and 3/4-inch galvanized steel. These pipes are old and of a material no longer installed for this purpose due to bore shrinkage from accumulation of interior corrosion that over time reduces water flow.

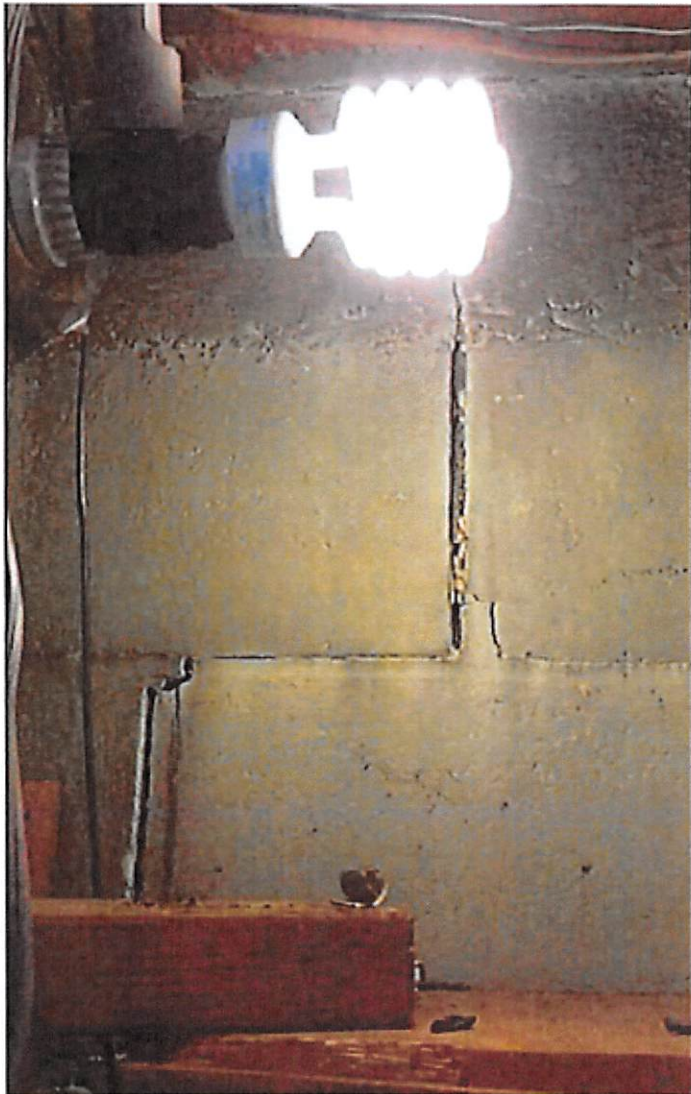
Foundation

The concrete masonry units (CMU) foundation had stepped cracking visible in mortar joints.
