CHANGE ORDER BREAKDOWN -- WORKSHEET

JOB NAME: **Kronenwetter Well**
 ARCH JOB NO: **2021.022**
 ELLIS JOB NO: **23061**
 CHANGE ORDER NUMBER: **ES-06**
 DESCRIPTION: **Well Pump Rebuild Extras**
 DATE: **07/16/24**

Project #: 23-066 Project: Kronenwetter Well #2

Kronenwetter Well 2 Breakdown:	Workers	Rate	Cost / Scope
Mobilize, Pull, Teardown			Original Scope
Call to discuss options			No Charge
Cut Shaft & Use Gear Puller Repeat Steps to Get Pump Apart	Elliott (8.5 hrs.)	\$65.00/hr.	\$552.50
	Andrew (7 hrs.)	\$65.00/hr.	\$455.00
	Jack (7 hrs.)	\$65.00/hr.	\$455.00
	Peter (7 hrs.)	\$65.00/hr.	\$455.00
Cleaned Components & Made New Shaft			Original Scope
Re-assembled			Original Scope
Take top stage and discharge case off and re-face in lathe and re-assemble	Elliott (4 hrs.)	\$65.00/hr.	\$260.00
	Andrew (3 hrs.)	\$65.00/hr.	\$195.00
	Jack (3 hrs.)	\$65.00/hr.	\$195.00
Paint Bowls			Original Scope
Reinstalled			Original Scope
Collect 2 Bacteriological Samples			Original Scope
Sub Total:			\$2,567.50
15% Allowable Adjustment			X .15
Total:			\$2,952.63

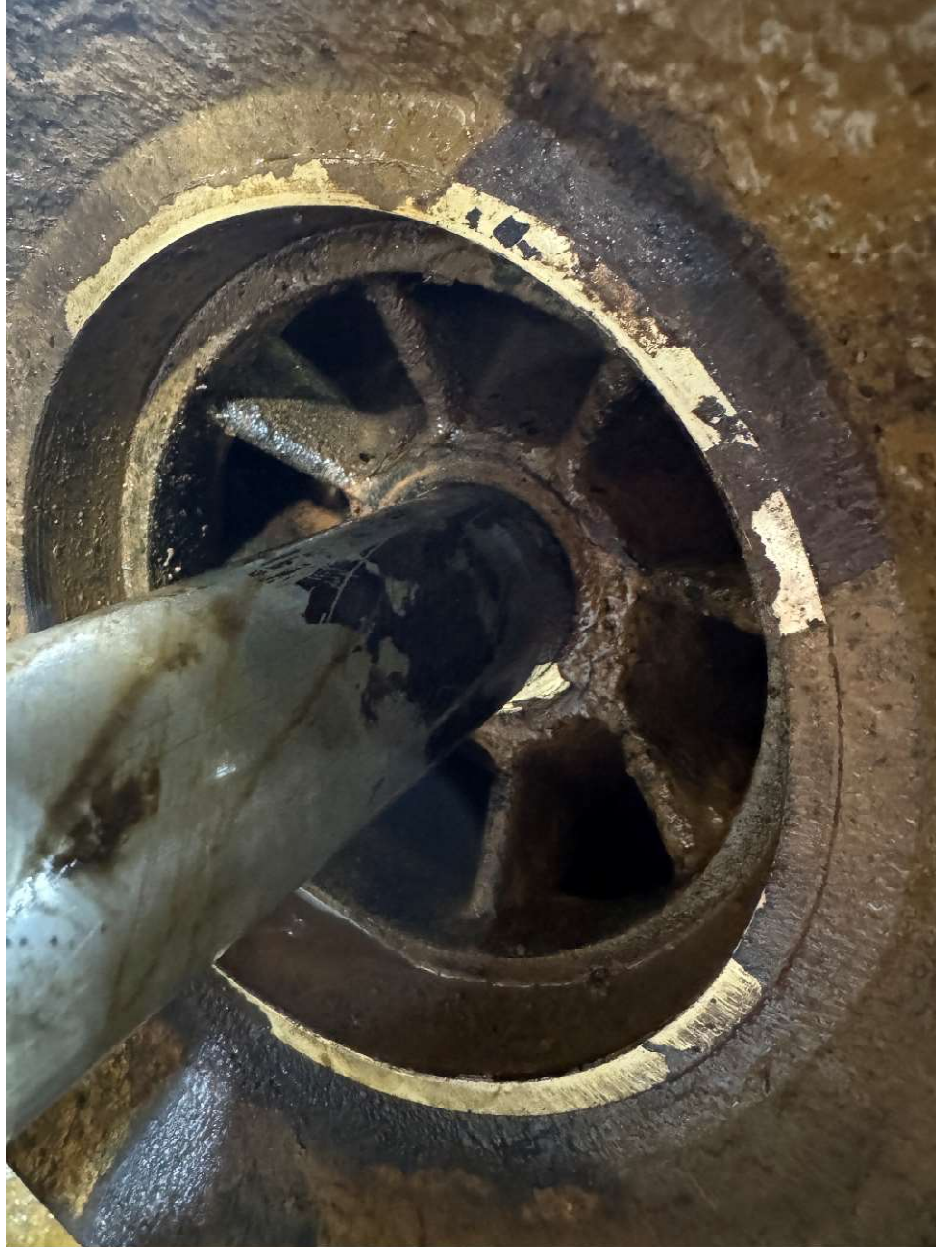
Top Side of Intermediate Pump Casting that was stuck on the pump shaft due to build up and sediment.

The stuck intermediate bearings were broken free by cutting the top of the bowl shaft off and using a 3-arm gear puller attached to the outside of the bowl casting with bolts and nuts on the backside to inch the bowl forward off the shaft without damaging it. I attached some pictures for visual. This is a very time-consuming process to not crack or damage the bowl casting. Once the bowl was free, we had to repeat these steps of cutting the shaft with the stuck bearing off to continue removing stages of the pump. All components were then pressure washed, and the bearings pushed out and replaced in each stage of the pump. A new bowl shaft was made, collets cleaned and re-assembled with the added stage and new ss bolting. The discharge case and the new stage had to be put in the lathe and re-faced to ensure a machined fit surface. The bowl was then painted and build completed.

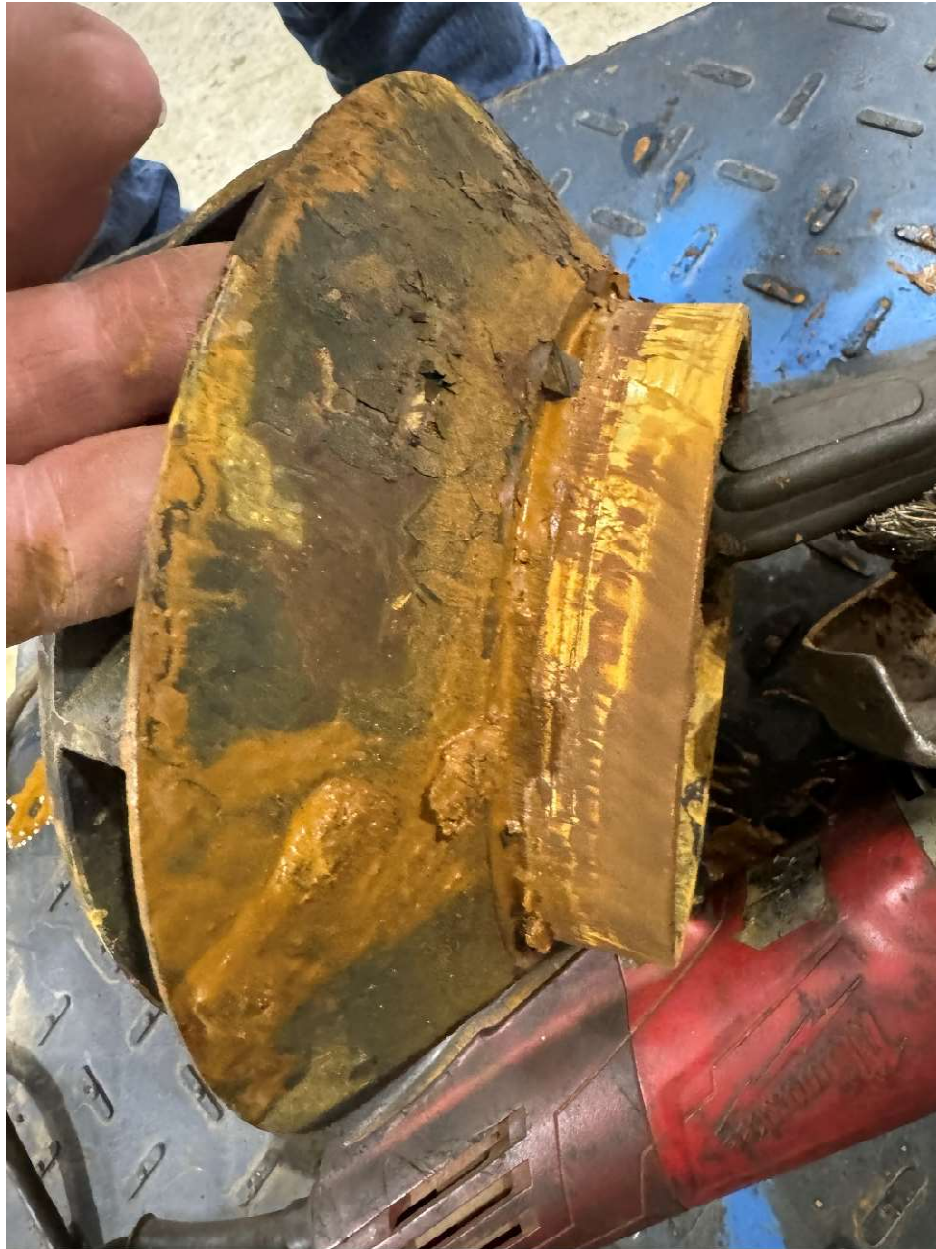
Bottom Side Skirt of the impeller with debris and wear that would not allow for standard removal leading to extra time and measures to salvage and re-use.

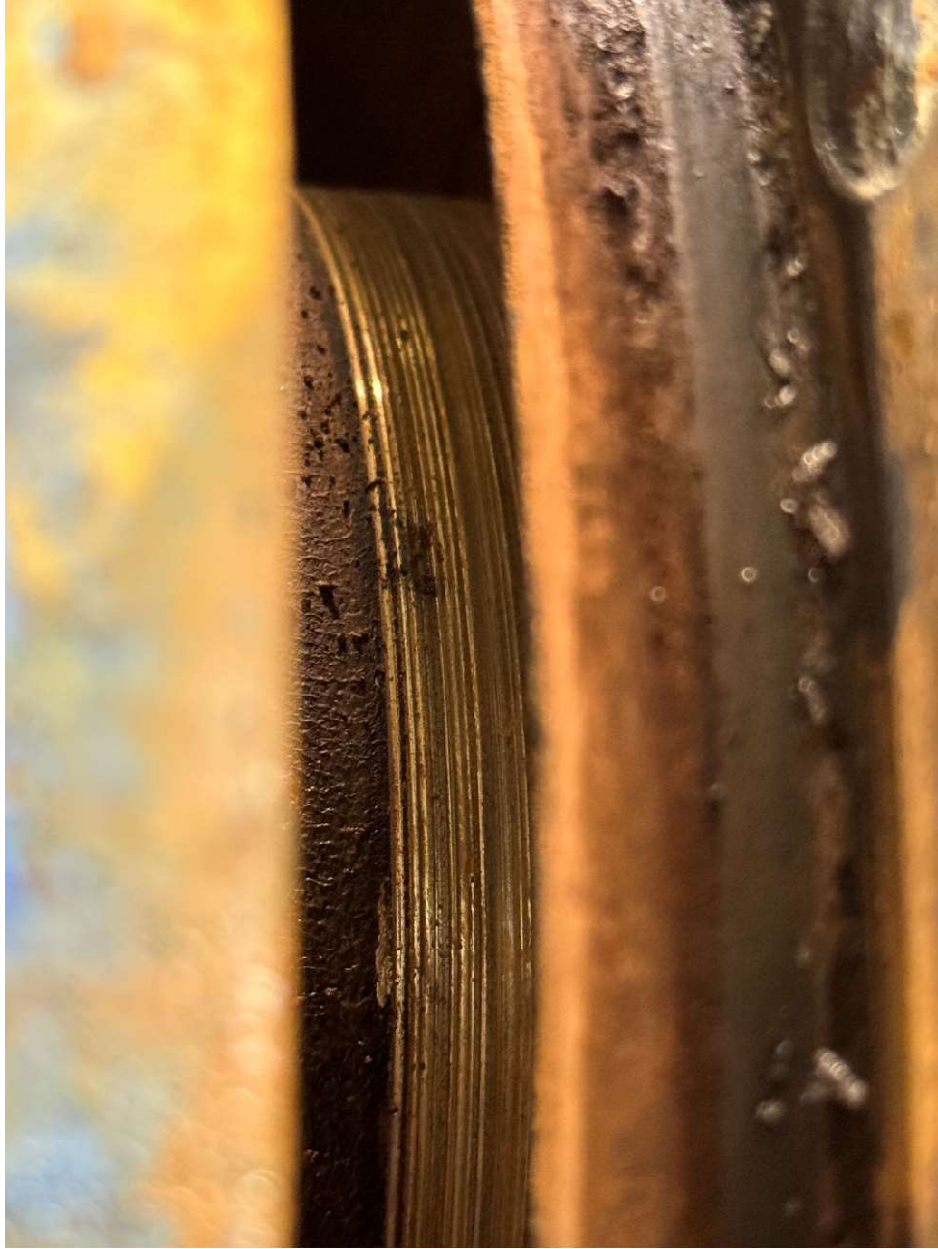
Picture between intermediates showing wear on impeller skirt.

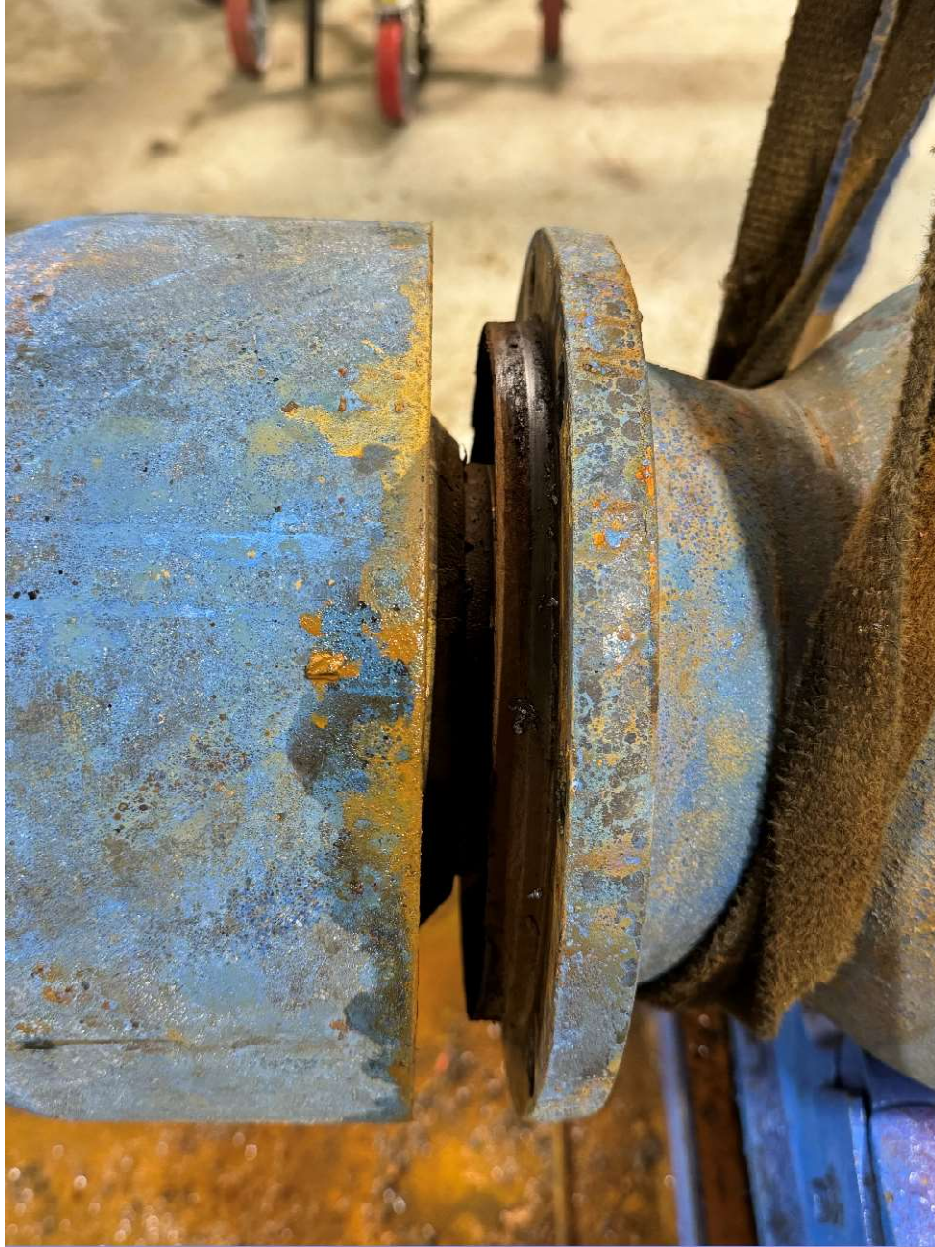
Side View Close up of intermediate and impeller stuck on shaft as pictured previously.

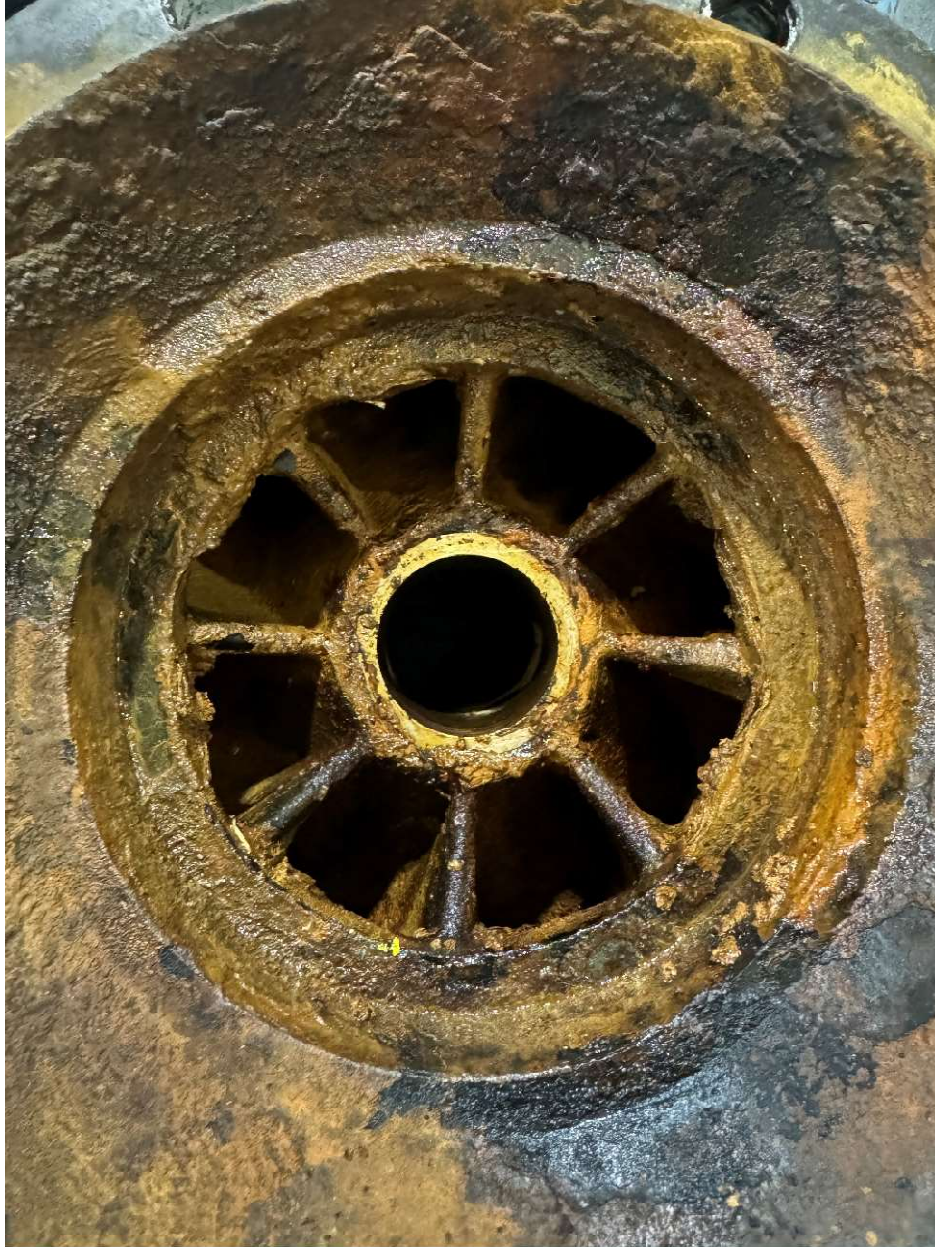
Top of Intermediate once the stuck intermediate and impeller were removed after all the additional efforts were made and successful in removing them with no damage to the pump. As you can see, there is a large amount of build up and sediment that were mainly the cause of the intermediate not coming off the shaft in a routine and easy fashion.
