GUEST HOUSE  
RENOVATION TO  
414 GREENBRIAR DR  
LAKE PARK, FL 33405

EXISTING  
INTERIOR  
PHOTOGRAPHS

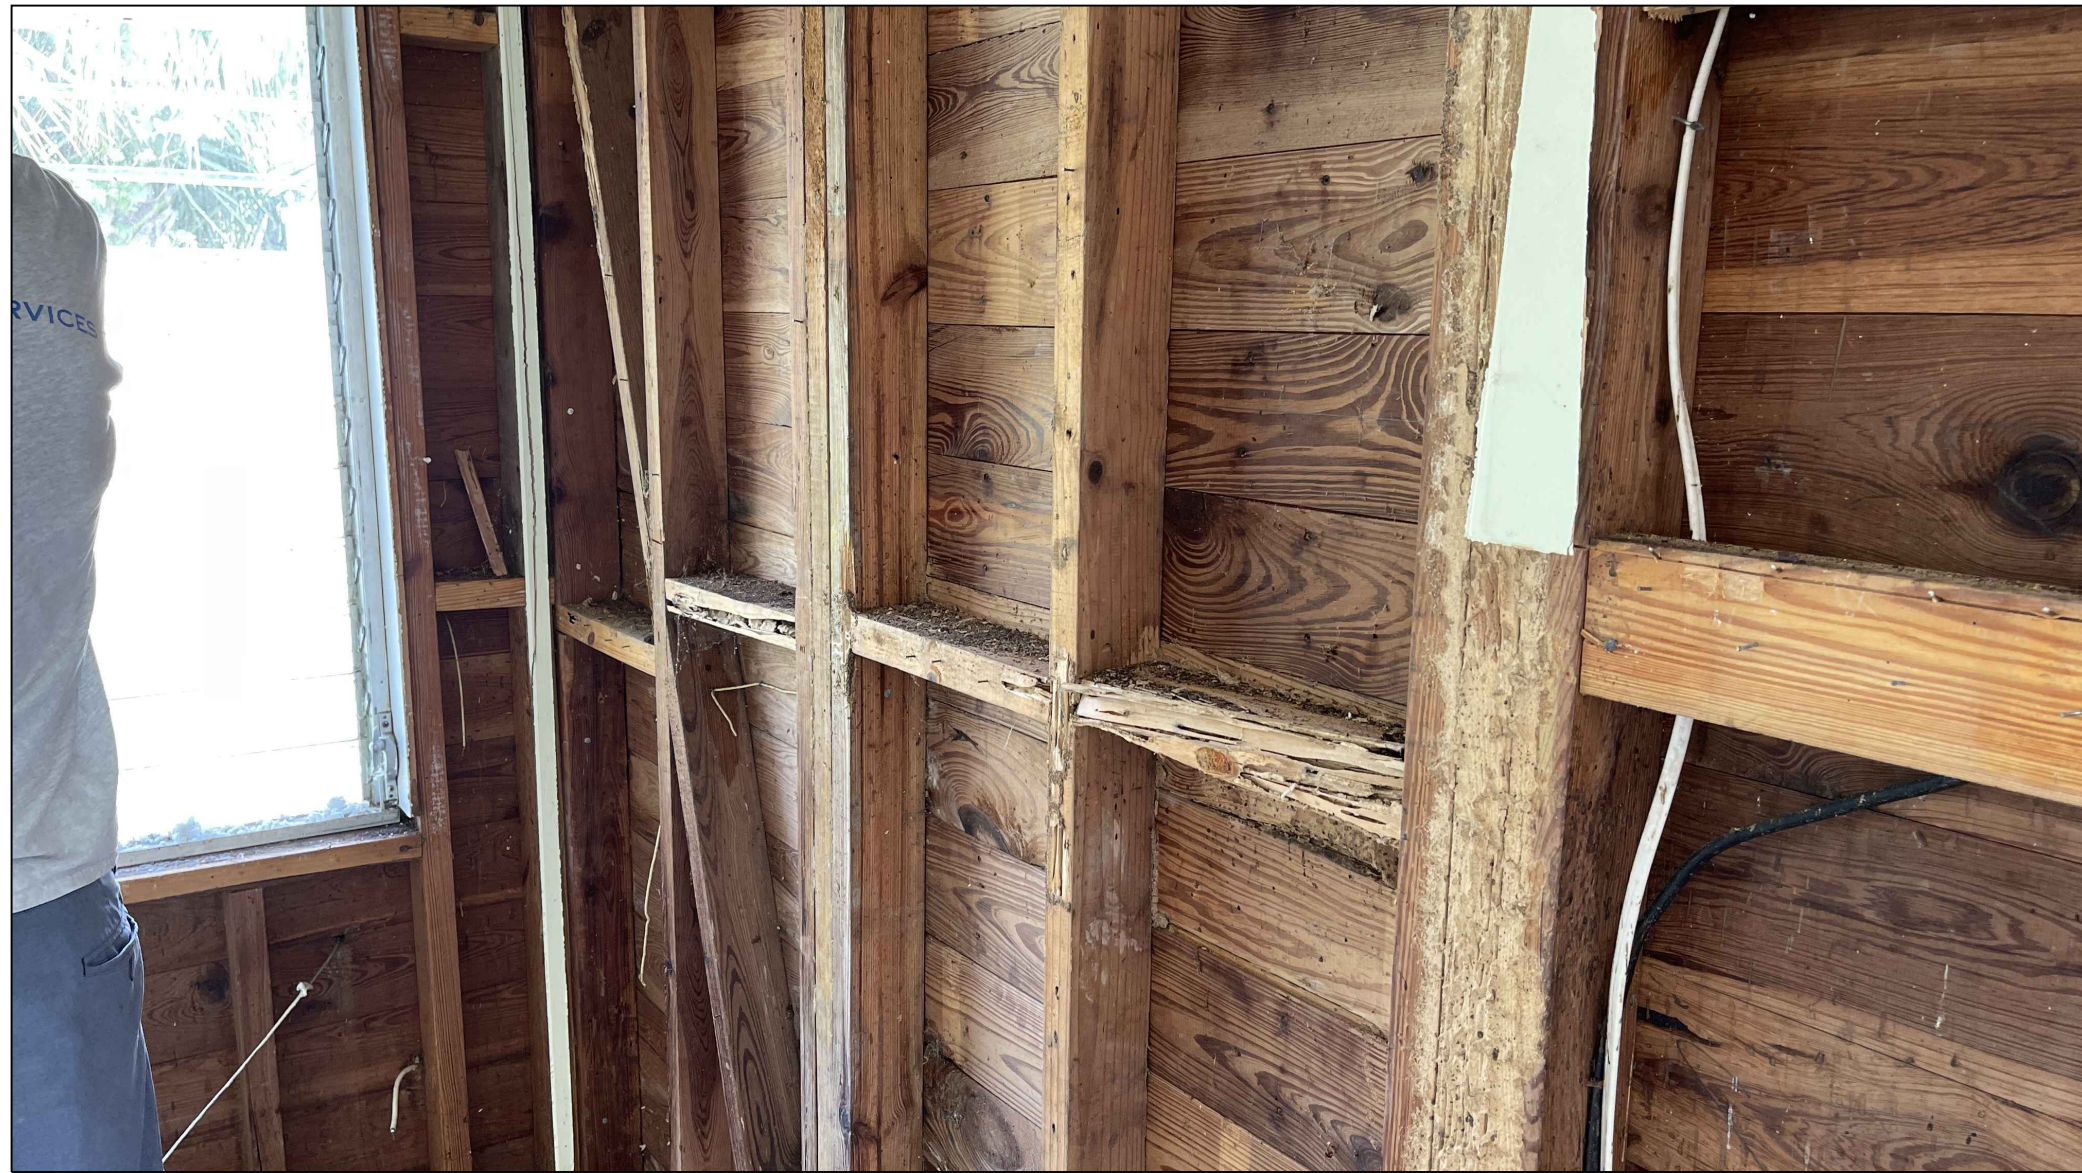
EXISTING PICTURE P11

AS SHOWN INTERIOR PICTURES; WOOD ROD AND TERMITE DAMAGED, INCLUDING BUT NOT LIMITED TO:

WINDOWS AND WINDOWS WOOD FRAMING, WOOD DOOR AND DOORS WOOD FRAMING, CASING, WOOD STUDS/ WOOD FRAMING, EXTERIOR WOOD SIDING AND SOME ROOF RAFTERS. STRUCTURAL ENGINEER VISITED THE SITE AND RECOMMENDED SHORING THE ROOF STRUCTURE.
